# Alaska Department of Fish and Game

## Corner Bay Uncataloged Stream 1

## ADDITION

**Survey date:** 8/18/2022

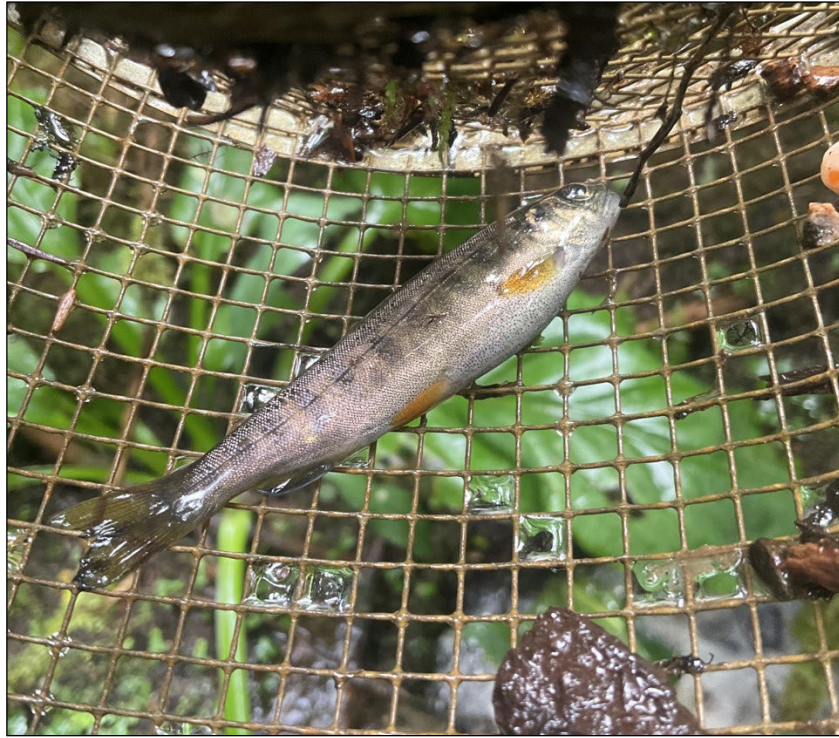
Figure 1.—Juvenile coho salmon captured at waypoint 1526.

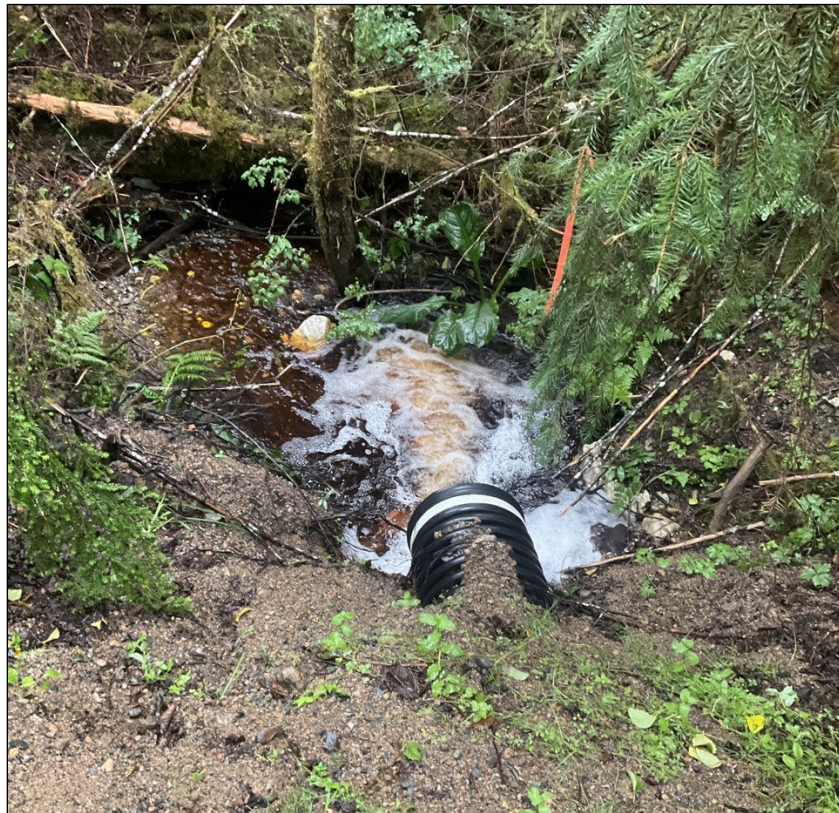
**Findings:** We surveyed this uncataloged stream using a backpack electrofisher, baited minnow traps, and GPS and captured juvenile coho salmon (Figure 1). The stream is forested and passes through a perched culvert (Table 1; Figure 2). Fish passage is likely blocked by this culvert.

Figure 2.—Culvert and channel at waypoint 1526.
