## RESTORATION OF SLOUGHS IN THE FAIRBANKS NORTH STAR BOROUGH (TANANA RIVER WATERSHED)

April 2006

Alaska Department of Natural Resources  
Office of Habitat Management and Permitting

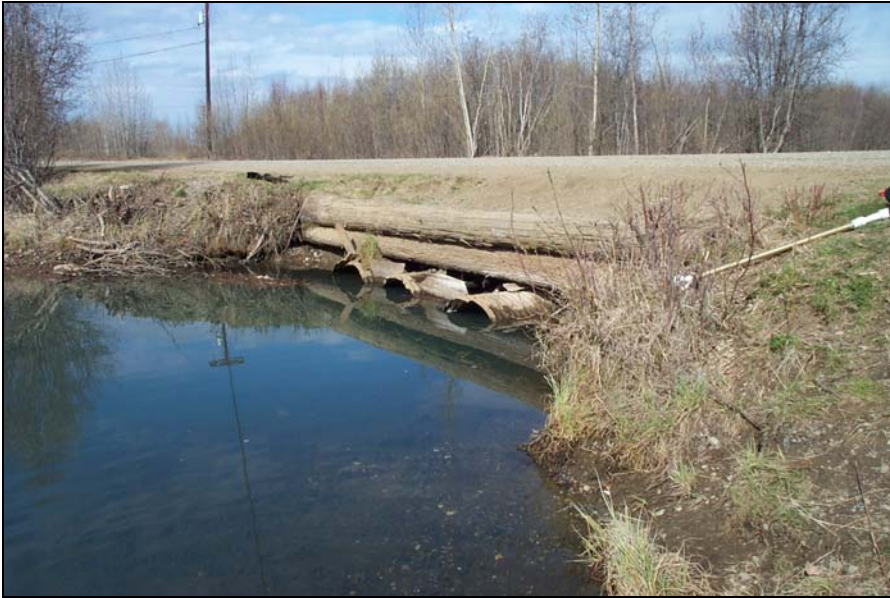
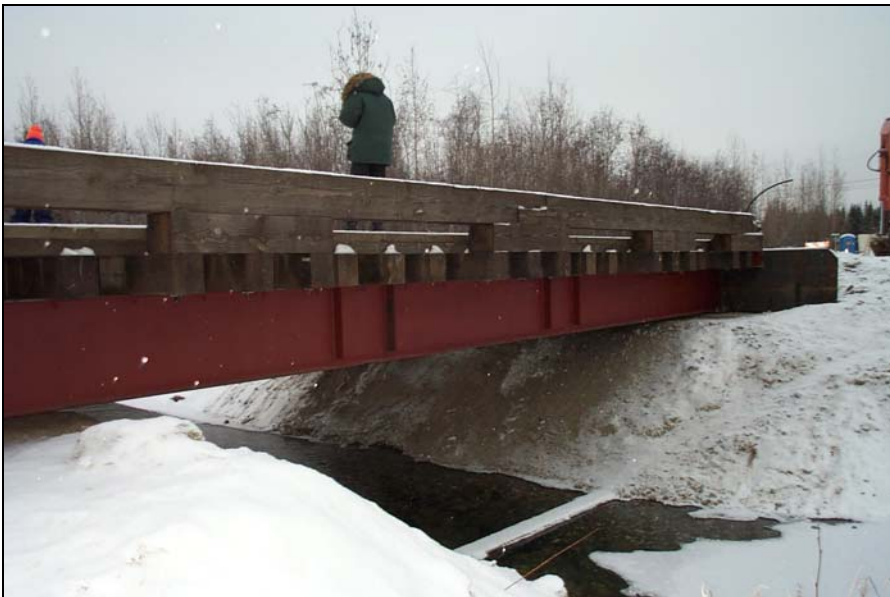
Before

After

In October 2001, 3-36” diameter culverts were removed from Airway Road crossing of Chena Slough and replaced with a free-span 40’ long steel bridge (originally used to access a timber sale on Montague Island) purchased and installed with a combination of funding and in-kind services from the NFWF Grant, Fairbanks Soil and Water Conservation District (FSWCD), ADNR-OHMP, ADOT/PF, USFWS, City of North Pole, and Airway Road Service District.

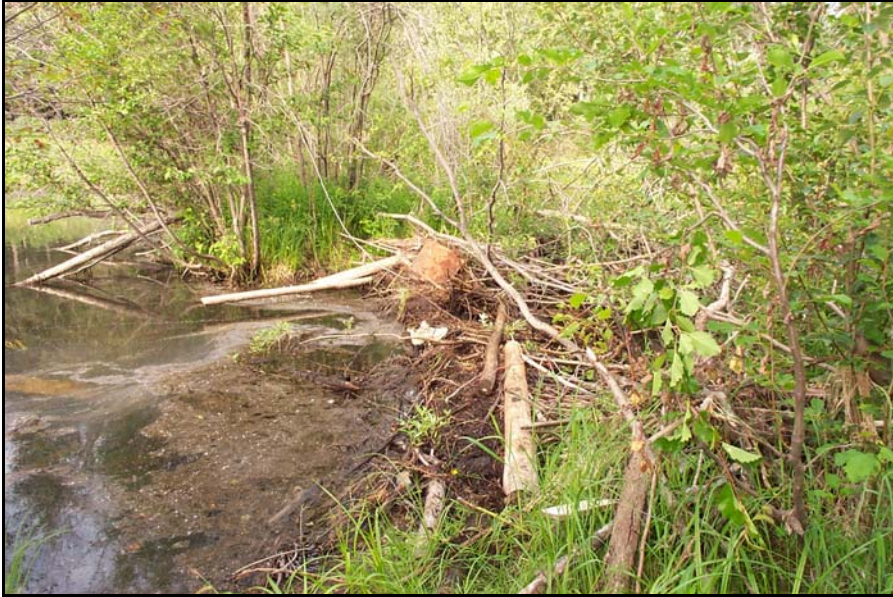
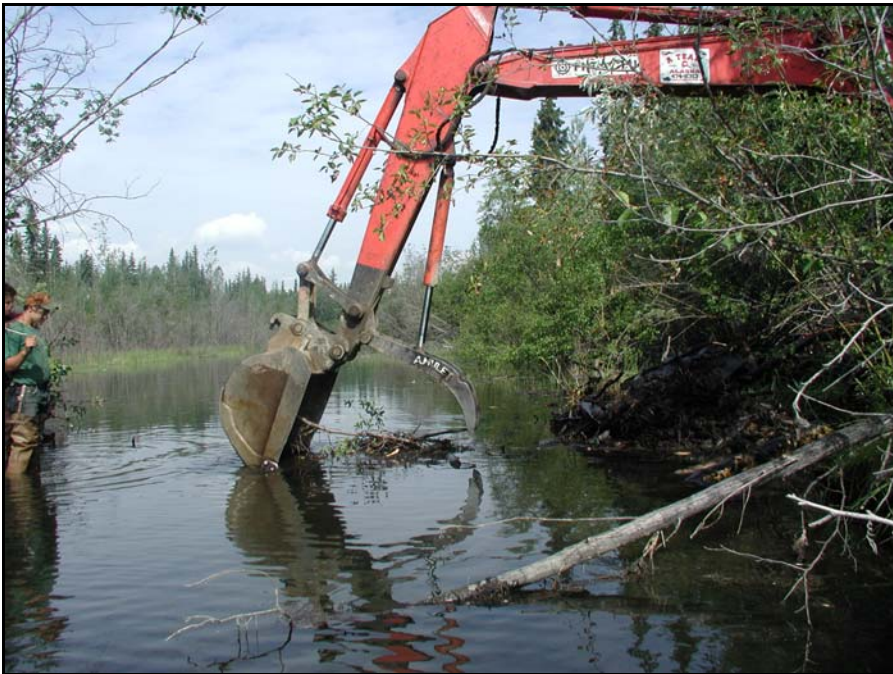
Before

After

In July 2001, a 25' section of an earth dam was breached to allow for fish passage. The dam was located just downstream from the Mission Road crossing of Chena Slough. Money from the NFWF Grant was used to hire the contractor.

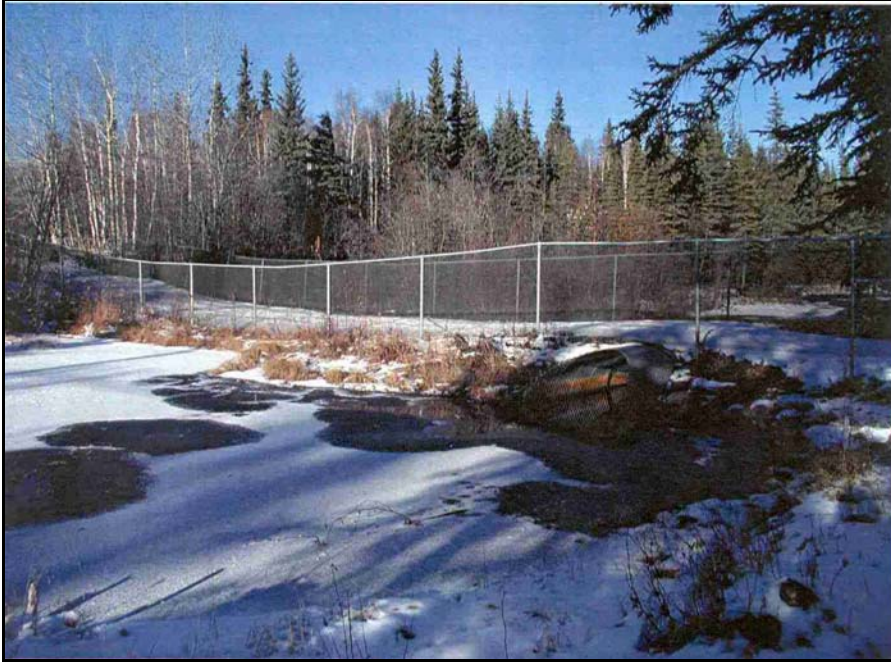
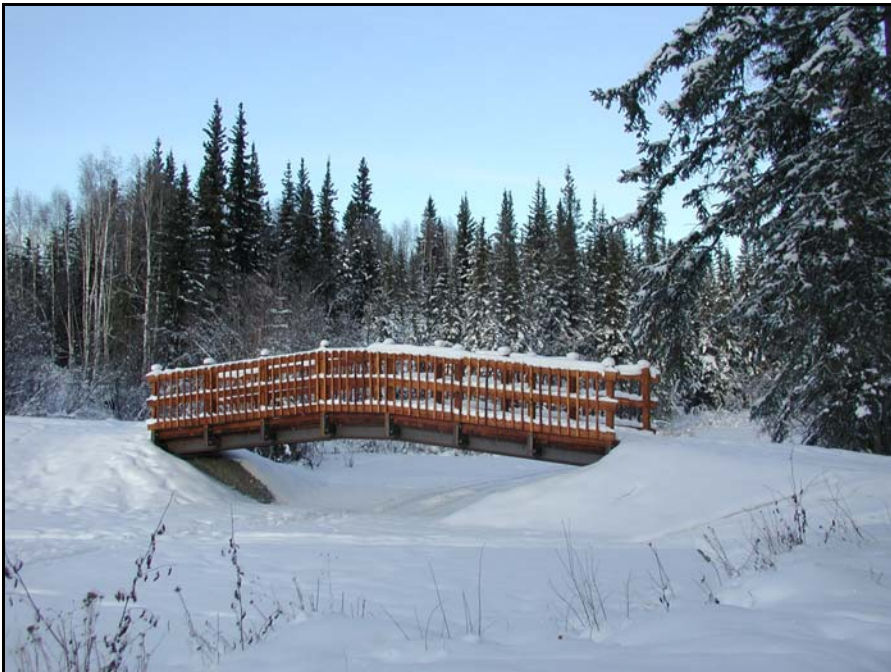
Before

After

In October 2001, to increase fish passage a causeway across Beaver Springs Slough that connected the elementary school to 5<sup>th</sup> Avenue Park was removed and replaced with a pedestrian footbridge. USFWS grant monies and the City of North Pole funded this project.

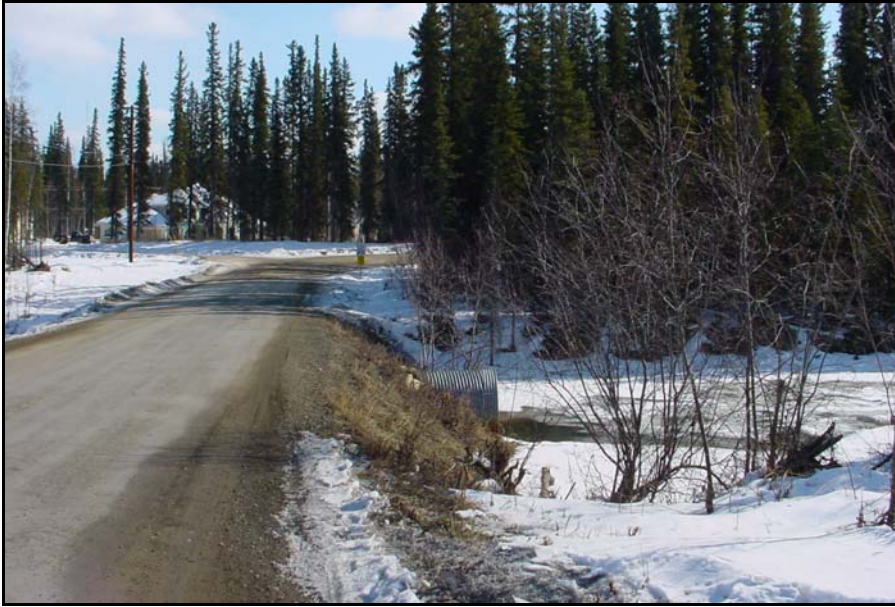
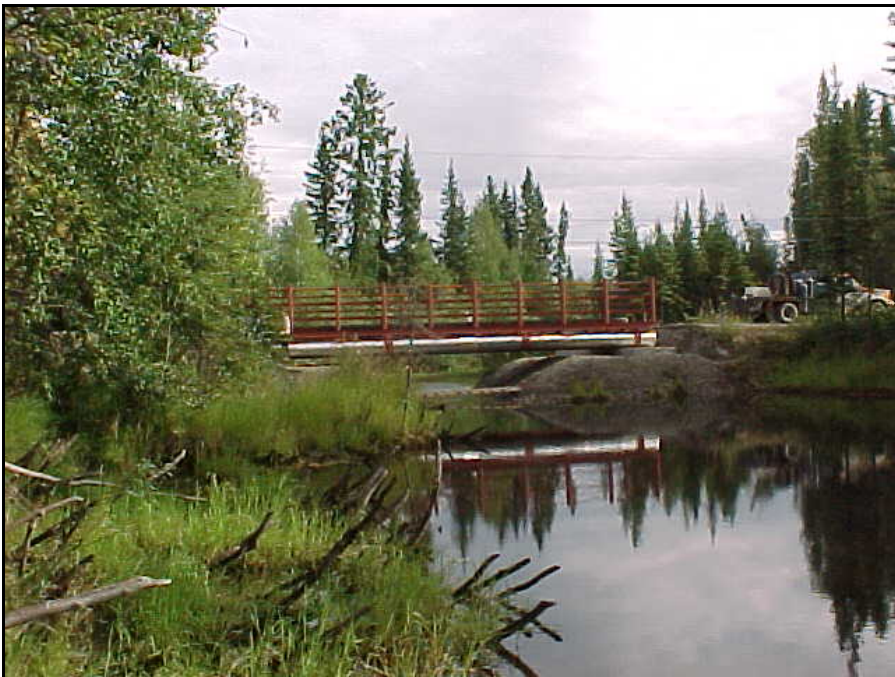
Before

After

In August 2003, one-5' diameter (extremely damaged) culvert was removed from the Doughchee Road crossing of Beaver Springs Slough and replaced with a free-span 40' long steel bridge (originally used to access a timber sale on Montague Island). Funding was generated from the USFWS grant program, City of North Pole, State grant monies, and NFWF Grant.

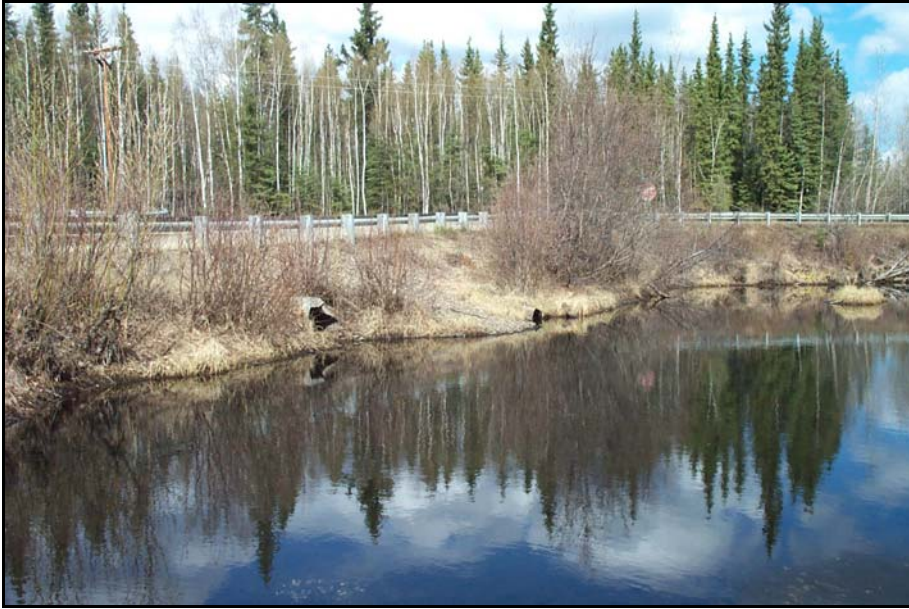
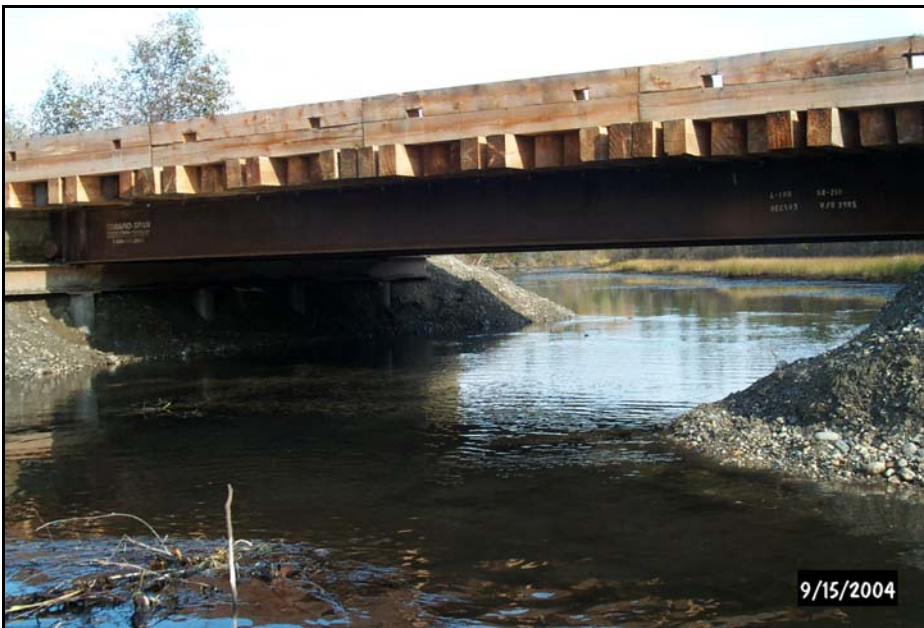
Before

After

In September 2004, 3-36" diameter culverts were removed at the Outside Hurst Road crossing of Chena Slough and replaced with a free-span 40' long steel bridge (originally used as a temporary bridge on the Pogo Mine Road). Funding was from USFWS grants and State grant monies.

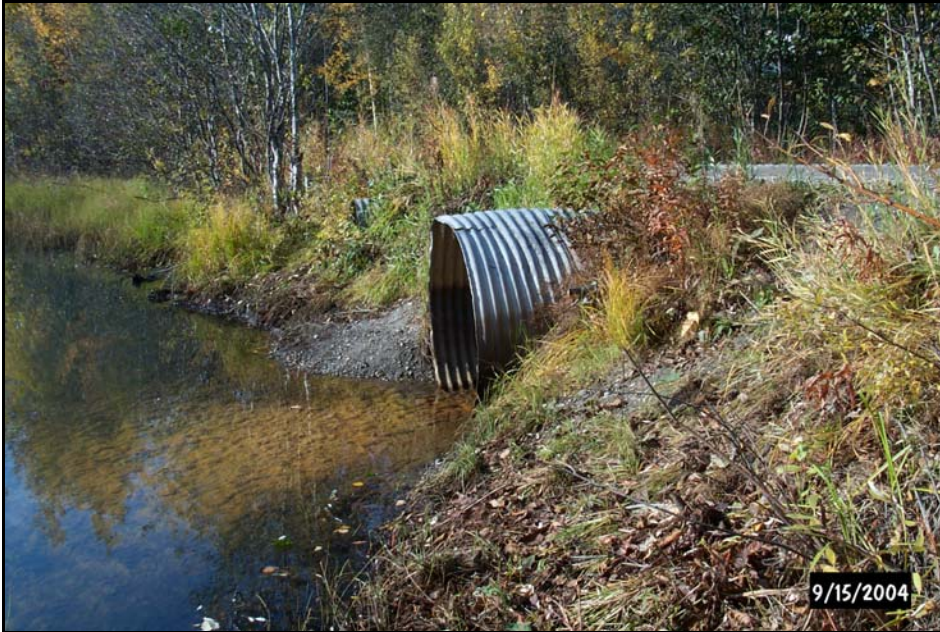
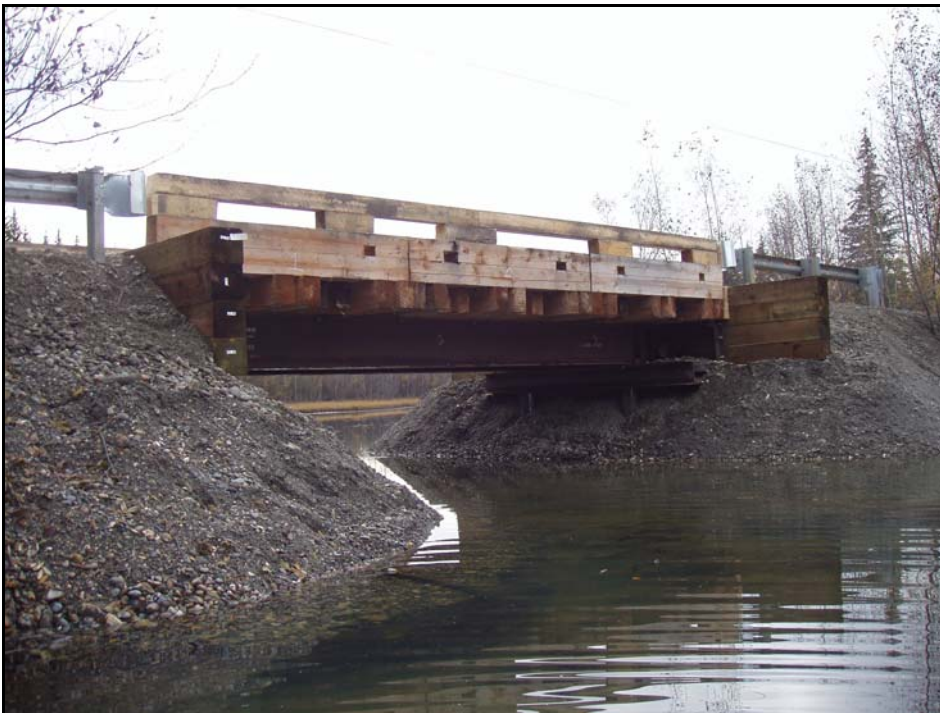
Before

After

In September 2004, one-36" culvert was removed from the Spruce Branch Road crossing of Chena Slough and replaced with a free-span 30' long steel bridge (originally used as a temporary bridge on the Pogo Mine Road). Funding was generated from the USFWS grant program and State grant monies.

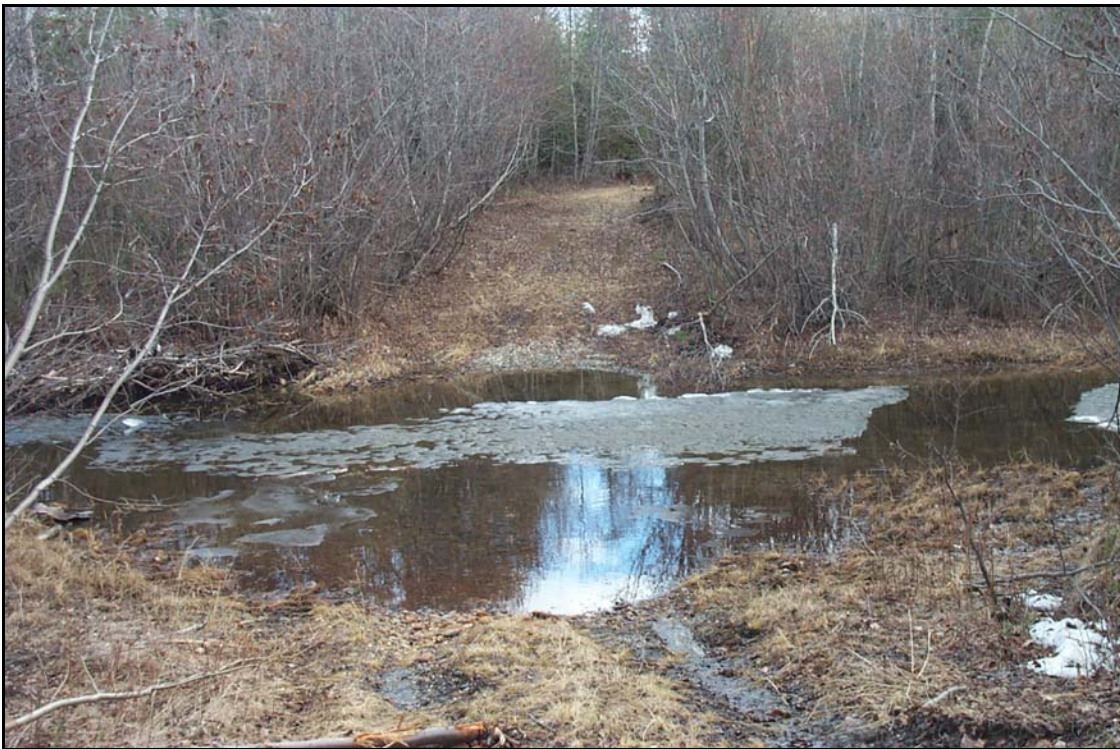
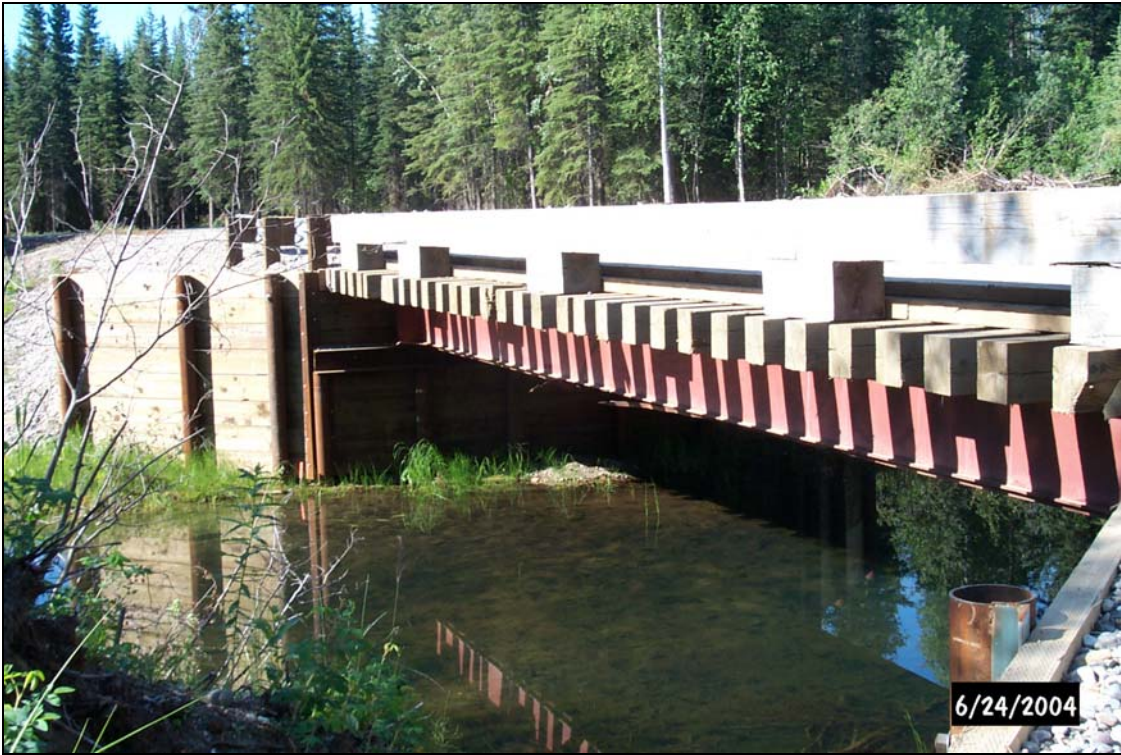
Before

After

In August 2003, a low water crossing of Twentythree Mile Slough was closed and a 40’ long steel bridge (originally used to access a timber sale on Montague Island) was constructed downstream from the low water crossing on the Old Valdez Trail. Funding came from the NFWF Grant, USFWS, and a State grant. Area residents provided material and in-kind work to install this bridge, re-connecting the original route of the Old Valdez Trail.

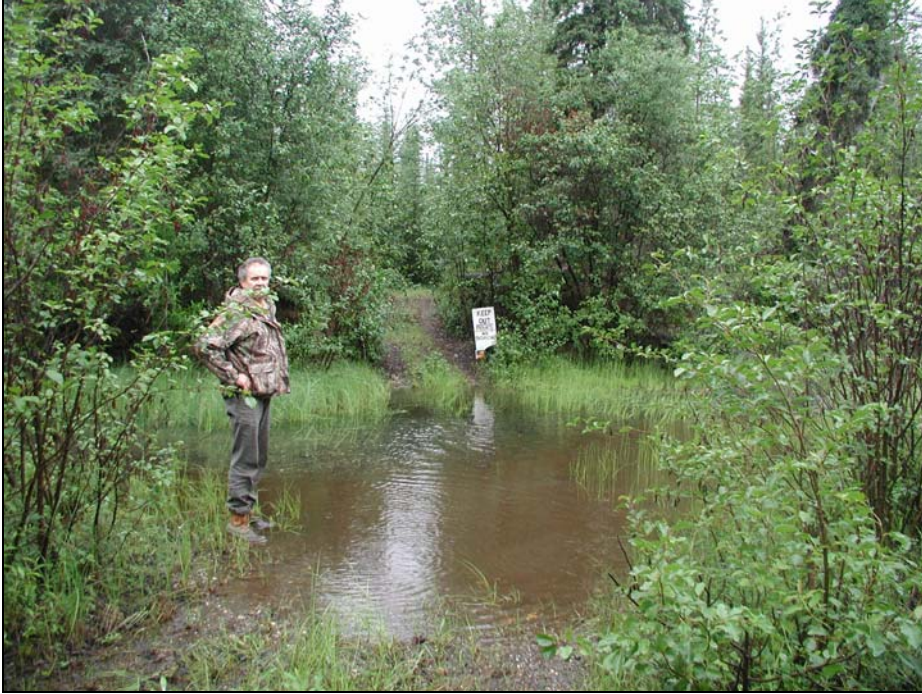
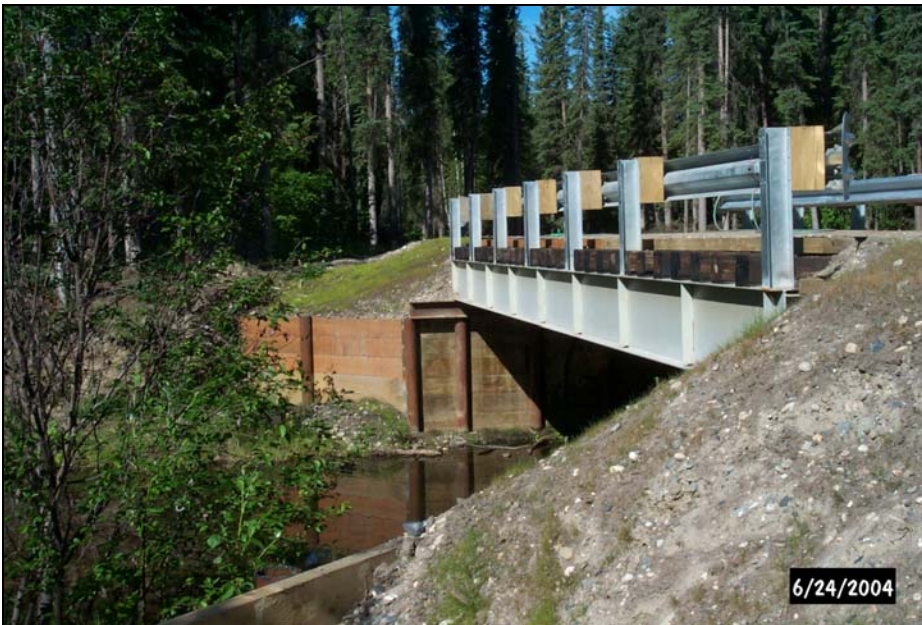
Before

After

In August 2003, a low water crossing of Twentythree Mile Slough was closed and a 40' long, free-span steel bridge (flatbed railcar) was constructed upstream from the low water crossing to access agricultural property and private homes. Money for this project was obtained from the USFWS and the private property owner.

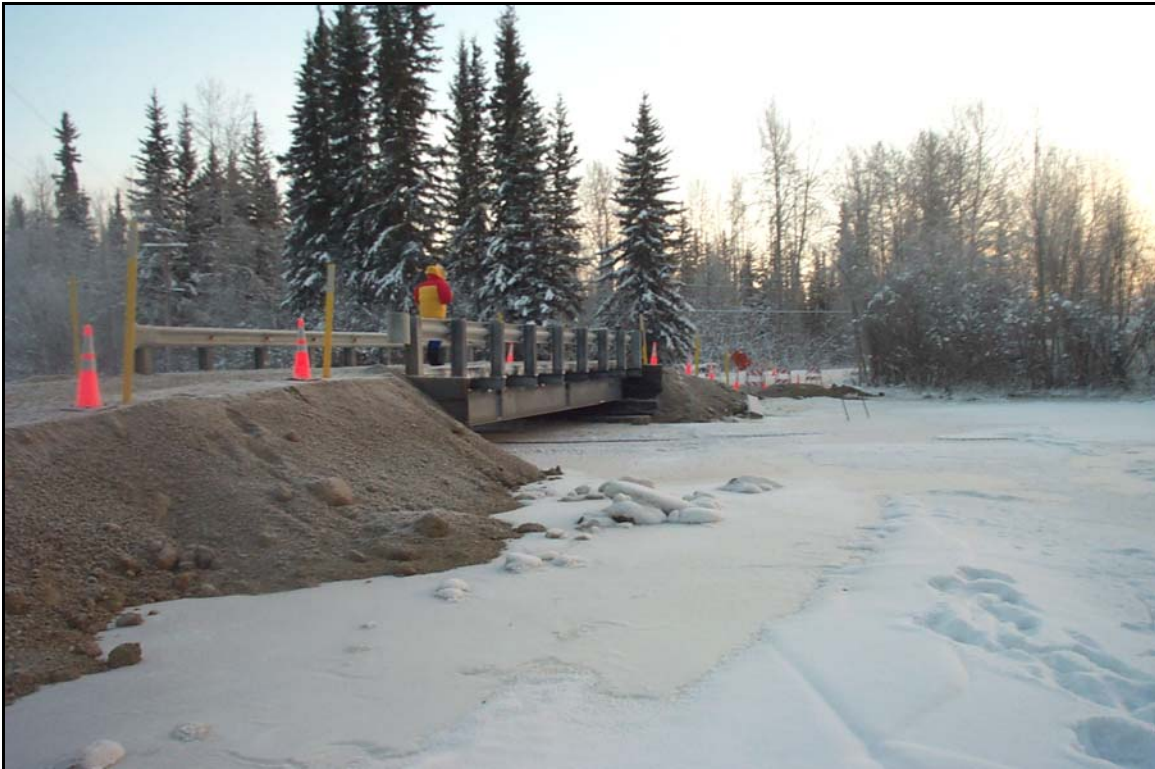
In January 2003 extensive overflow on Piledriver Slough at the Old Richardson Highway crossing (one 5’, one 4’ and one 3’ diameter culvert existed at the crossing) made the road unusable. The ADOT/PF Maintenance and Operation (M&O) crew installed a temporary bridge at the crossing site to keep the road open and safe.

Temporary bridge over the culverts

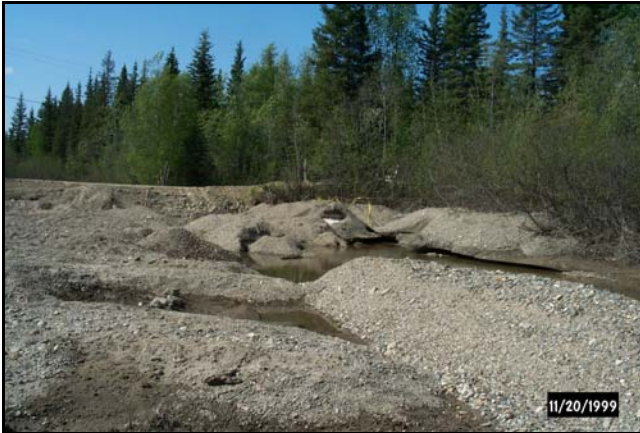
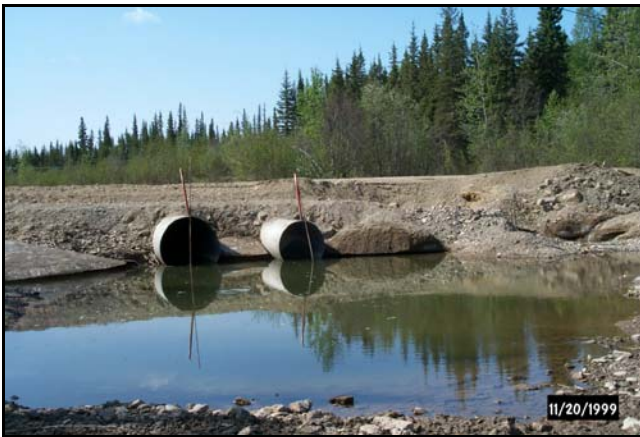
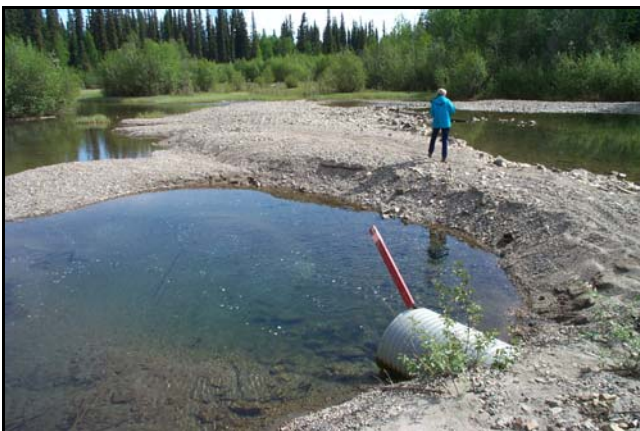
The Old Richardson Highway Piledriver Slough crossing caused problems on a yearly basis. Most often the road fill material would wash out during break-up (probably due to frozen, undersized culverts) and settle immediately downstream. Year after year new fill material would be brought in, and year after year it would wash downstream. This resulted in an extremely wide, braided channel immediately downstream of the crossing with large piles of gravel dividing the channels.

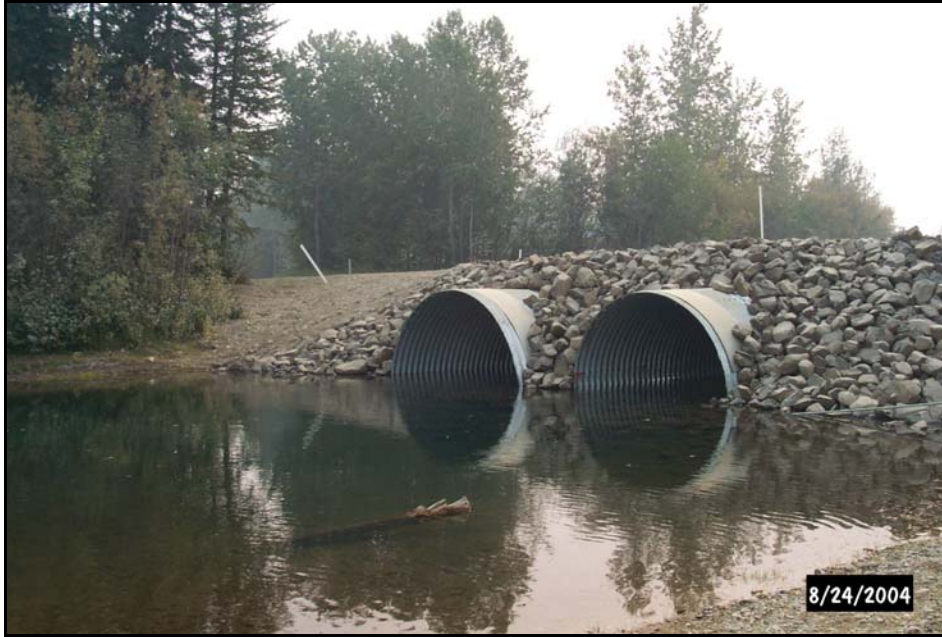
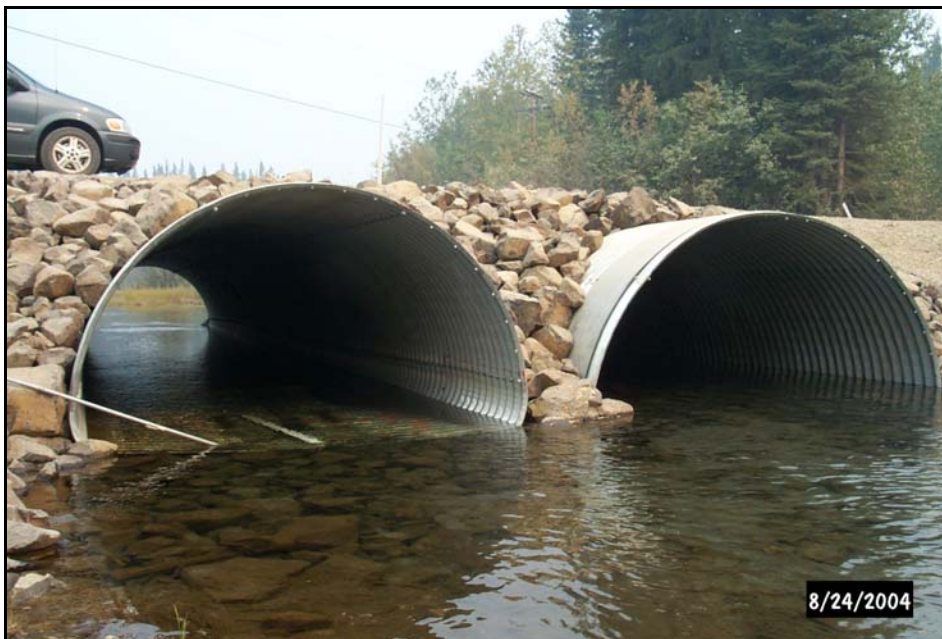
After (outlet – taken from bankfull bench)

After (inlet)

In October 2003, ADOT/PF M&O (with funding assistance from the USFWS) removed the existing culverts, created a “permanent” 30’ wide by 3’ deep channel with a bankfull bench at the downstream left-limit of the crossing, and installed two 12’ diameter arched culverts. The ADNR-OHMP and the USFWS worked closely with ADOT/PF to design and construct the new crossing and channel.

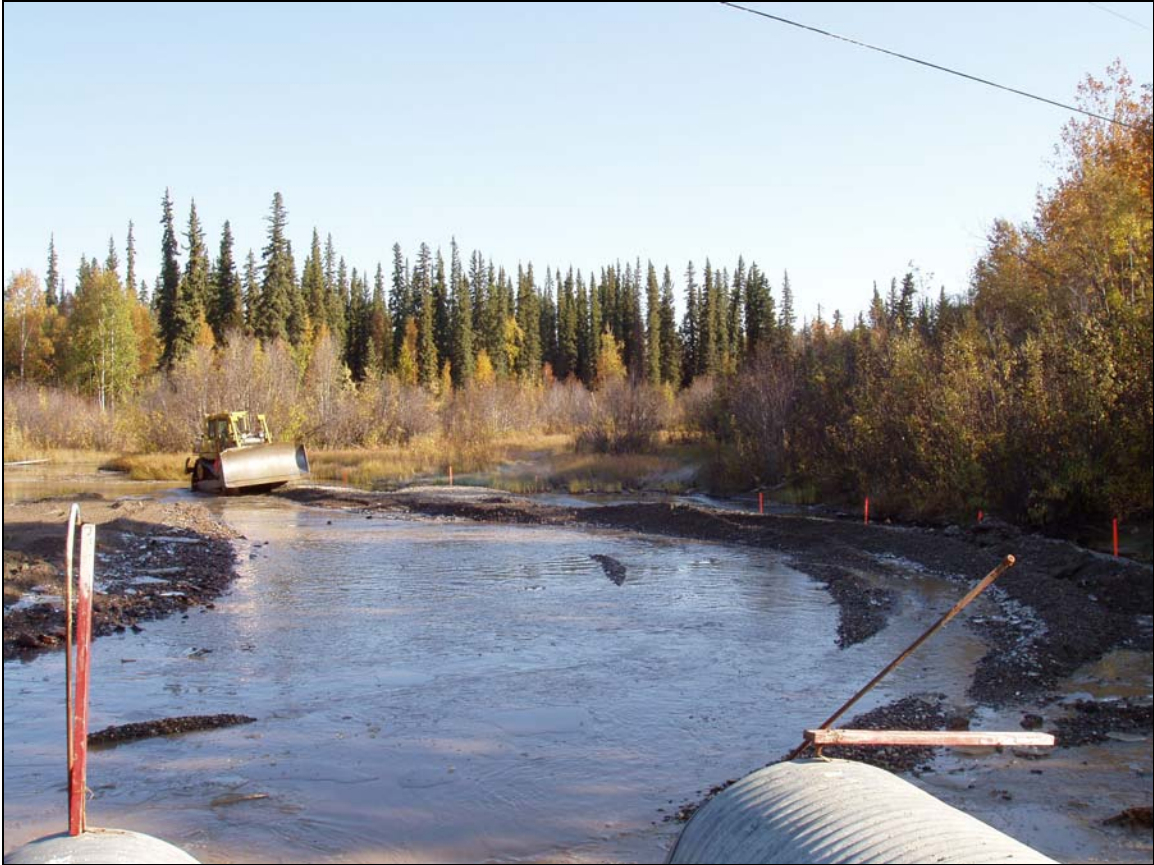
Constructing the permanent 30' wide by 3' deep channel downstream of the culverts and the bankfull bench on the left limit of the channel.

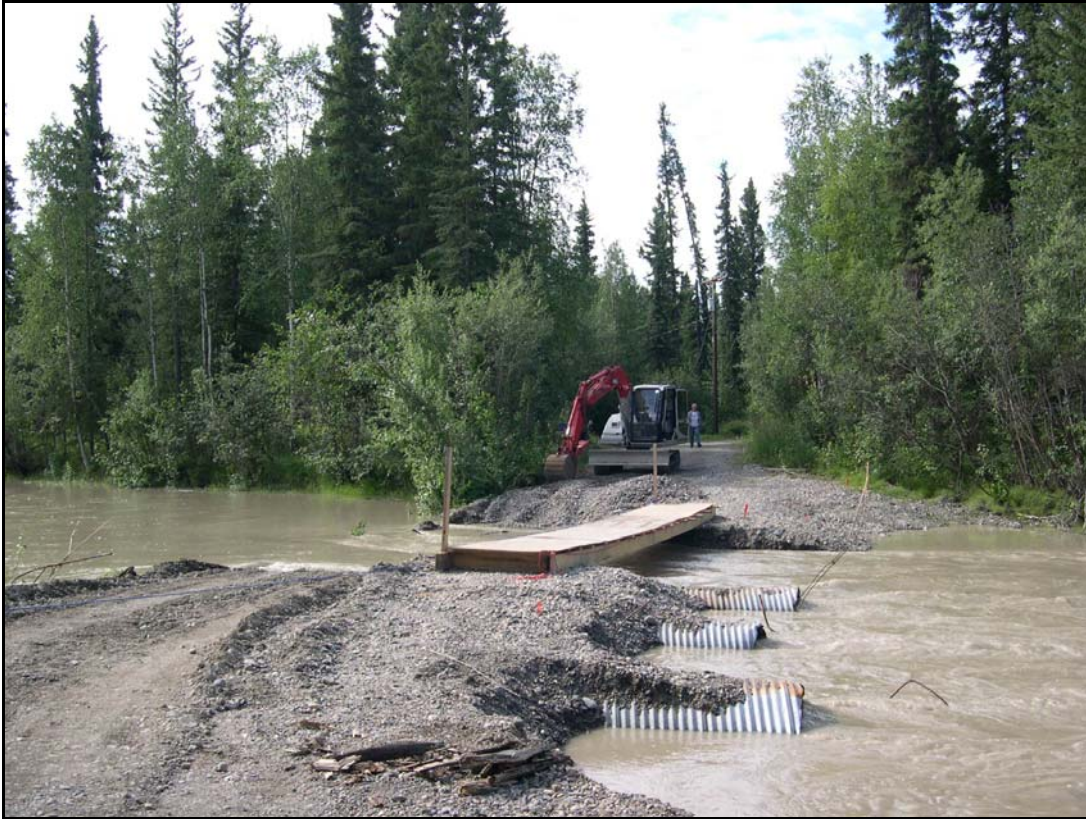
Piledriver Slough at Ingrid Road crossing

In July 2003, the Ingrid Road crossing of Piledriver Slough was washed out when water from the Tanana River inundated the slough. The subdivision was accessible only by foot for several days.

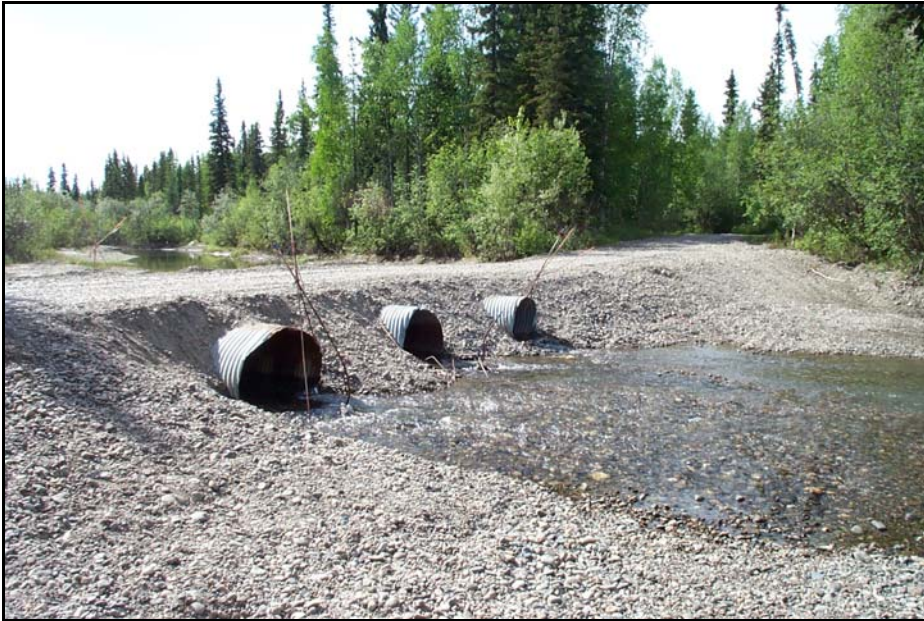
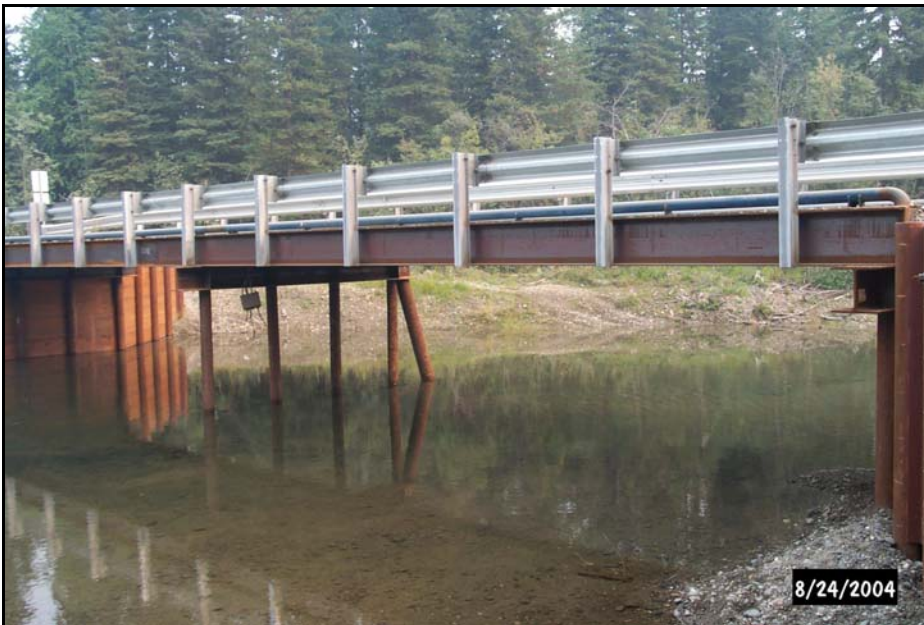
Before

After

In October 2003, the 3-36" diameter culverts at the Ingrid Road crossing of Piledriver Slough were removed and replaced with a 70' long steel bridge (old weigh station scales). The agencies involved and the contractor agreed to go with the longer bridge in case the Tanana River ever flooded this section of Piledriver Slough again. Funding was obtained from the USFWS, a State grant, and in-kind work performed by the residents of the subdivision.

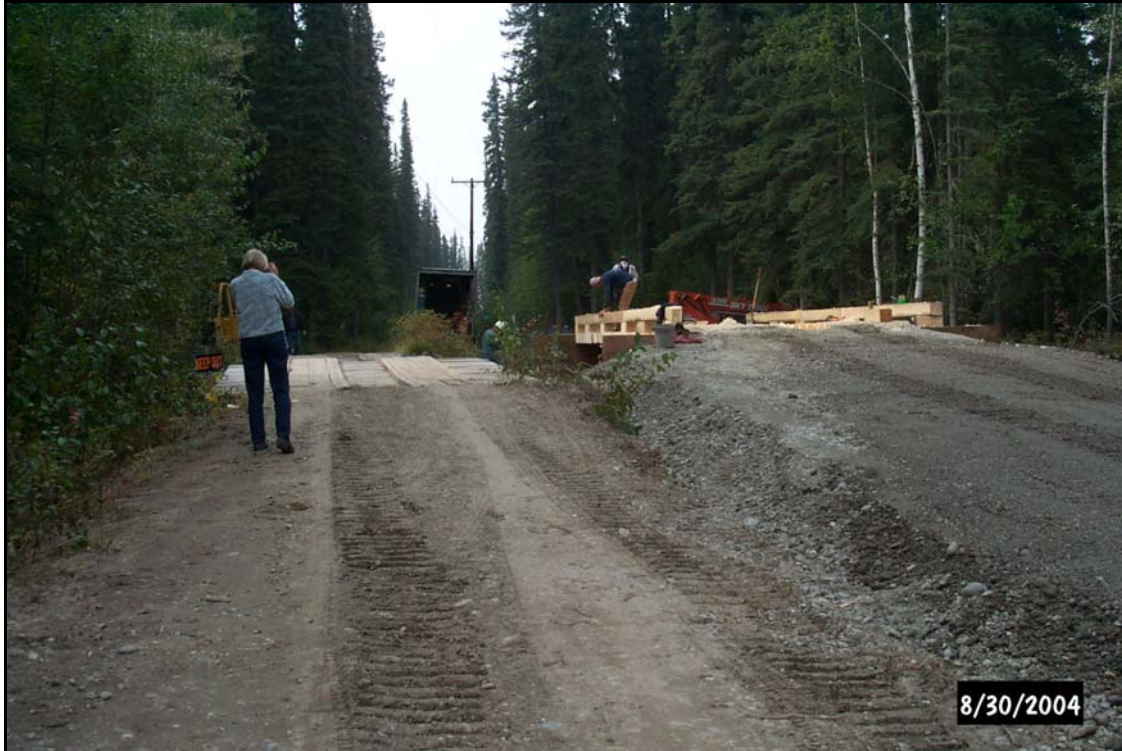
In August 2004, an old (unsafe) bridge with abutments in the stream bed was removed and replaced with a free-span 40' long steel bridge (flatbed railcar) at the Bradbury Road crossing of Piledriver Slough. The residents had created a low water crossing in the stream immediately downstream of the old bridge. The new bridge was purchased and installed using USFWS grant monies.

Old bridge on left, new bridge on right (over the top of the low water crossing)

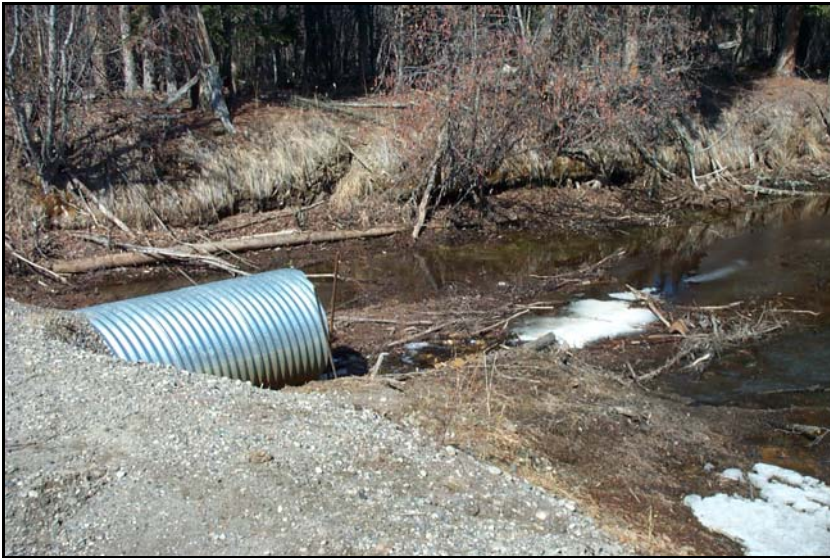
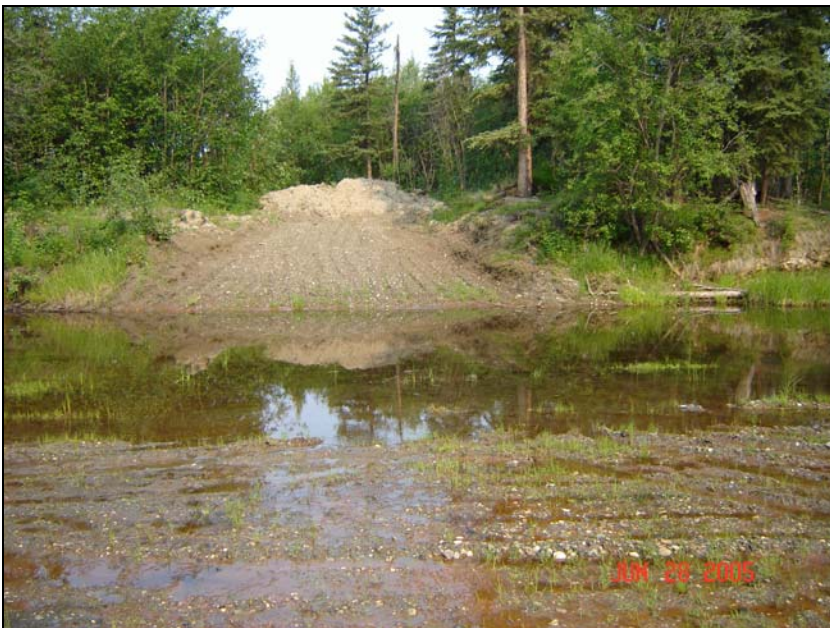
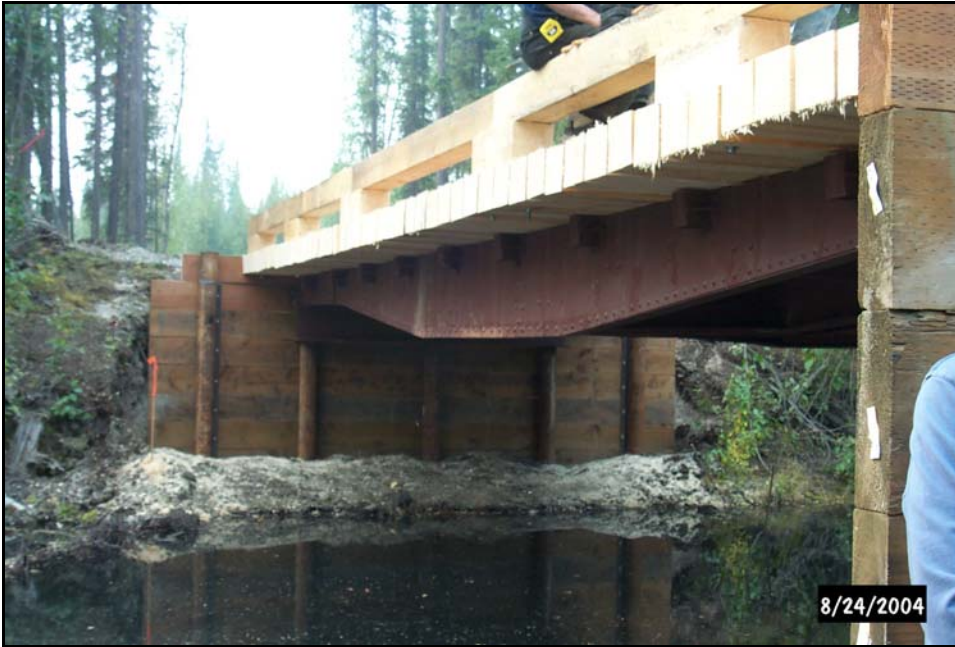
In August 2004, one 36” diameter perched culvert was removed from Twentythree Mile Slough. This culverted crossing completely blocked the upstream and downstream passage of fish for 15 years. The ADNR-OHMP, ADNR Lands and US COE had all issued notices of violation and requested that this culvert be removed. This crossing provided access to a private agriculture lot. Once the culverted crossing was removed, a free-span 40’ long steel bridge (flatbed railcar) was installed downstream from this site. Funding for the installation of the bridge was provided by the USFWS and the property owner.

Before

After

New bridge downstream from original crossing

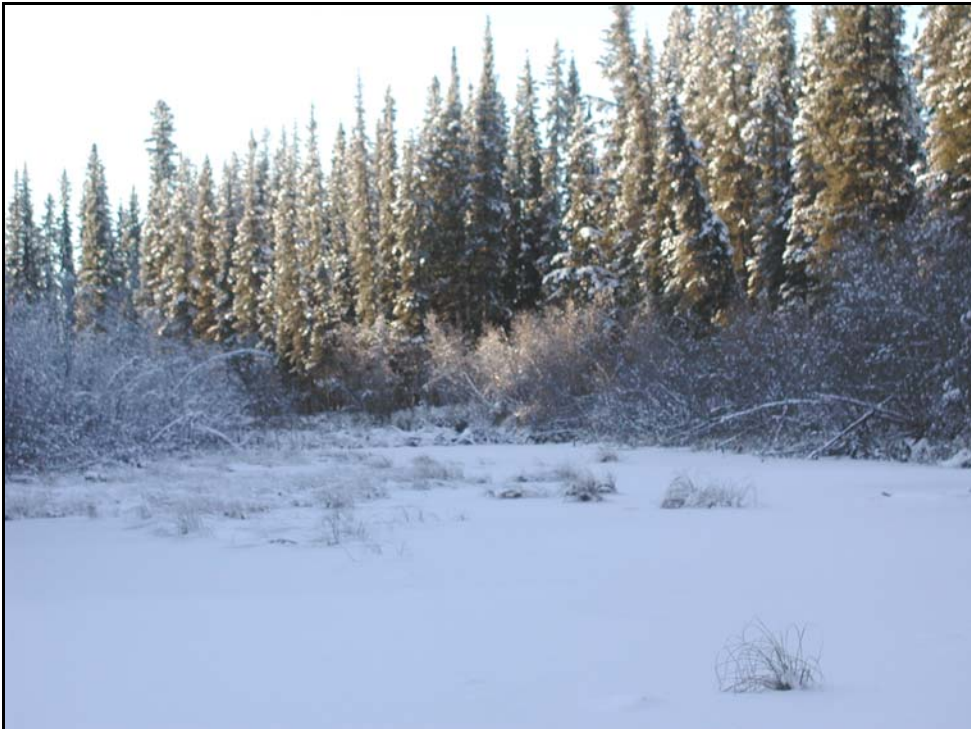
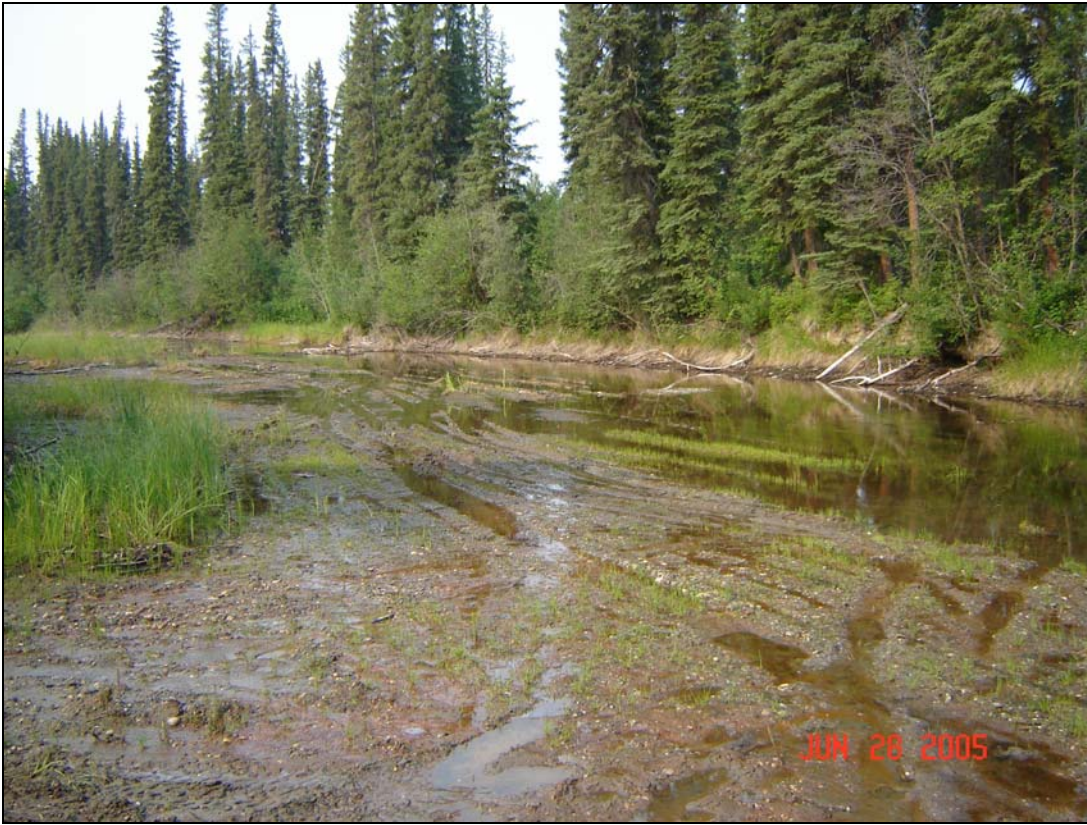
Before

After

For mitigation, the property owner removed an old earthen/grown-over/beaver dam located approximately 200 feet upstream of his original culverted crossing.

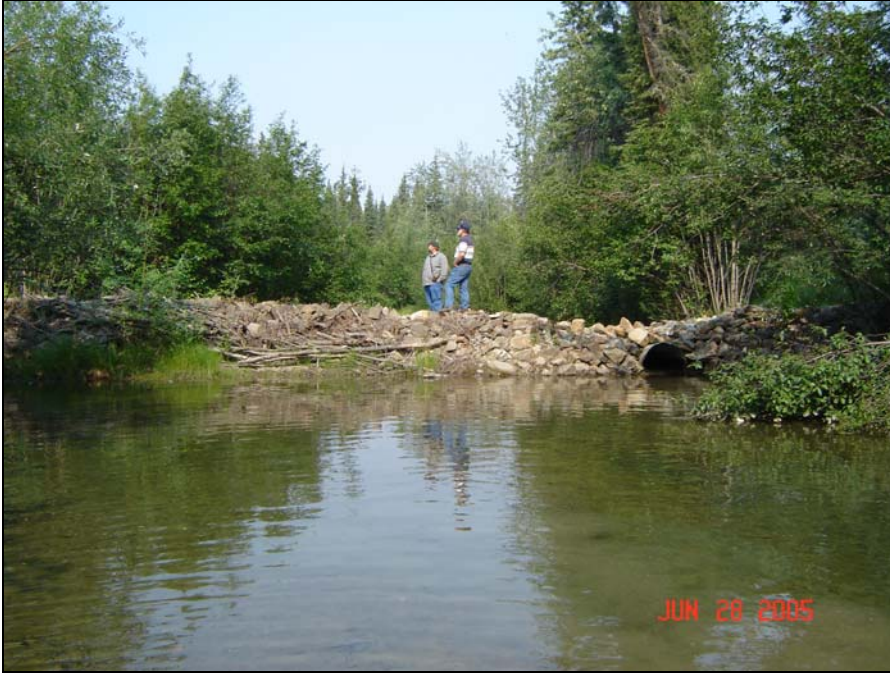
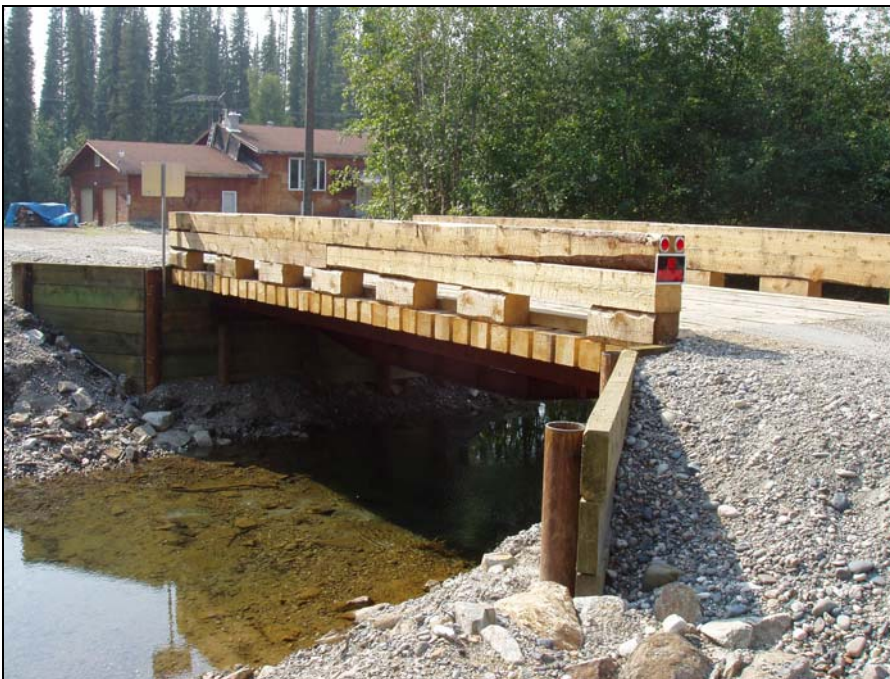
Before

After

In July 2005, one 36" diameter culvert and all the related fill material was removed from a crossing of Piledriver Slough. A 40' long, single span (flatbed railcar) steel bridge was installed at this private property driveway. Funding for the installation of the bridge was provided by the USFWS and the property owner.
