## RESTORATION OF SLOUGHS IN THE FAIRBANKS NORTH STAR BOROUGH (TANANA RIVER WATERSHED)

April 2006

Alaska Department of Natural Resources  
Office of Habitat Management and Permitting

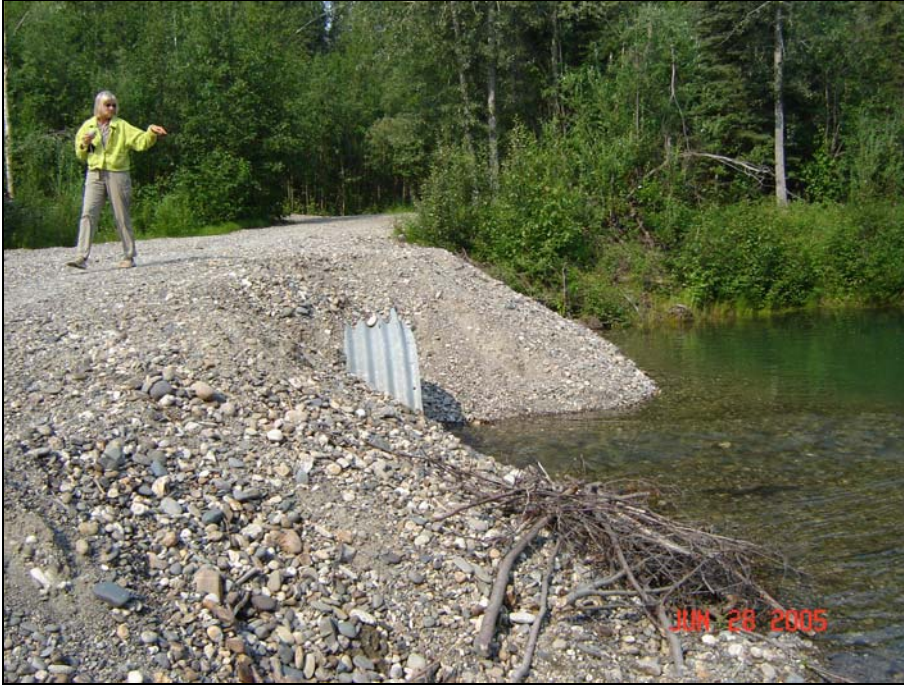
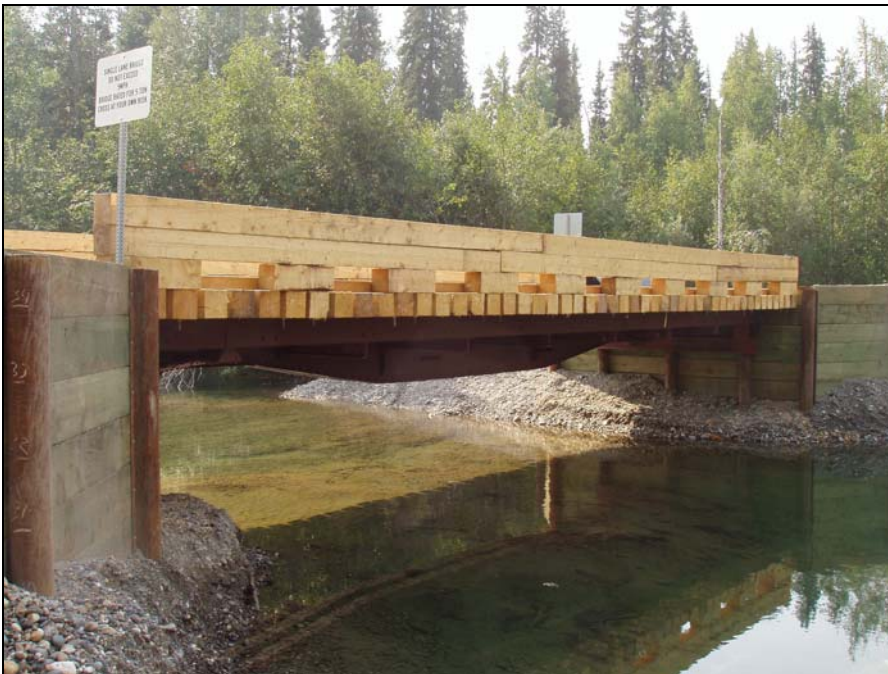
Before

After

In July 2005, one 4' diameter culvert and all the related fill material was removed from a crossing of Piledriver Slough. A 40' long, single span (flatbed railcar) steel bridge was installed across this private property driveway. Funding for the installation of the bridge was provided by the USFWS and the property owner.
