**Technical Report No. 11-10**

# **Haines Highway Mile 25 to the Border: 10-Year Mitigation Monitoring**

Alaska Department of Fish and Game

Division of Habitat

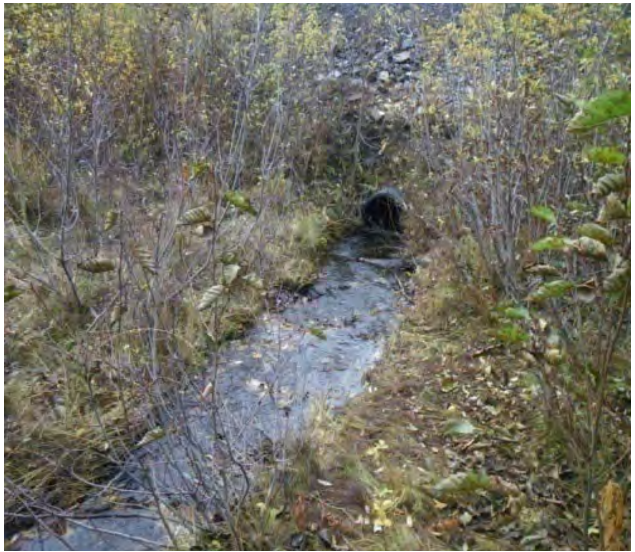
Figure 9.—Culvert draining WT-6.

The mitigation objective of wetland WT-6 has been achieved. Wetland vegetation is well established and ground saturation indicates a typical wetland water regime. The culvert (Figure

9) and channel that drain the pond in WT-6 are not identified in the original mitigation monitoring plan (Inter-Fluve, 2000) and it is not clear when ADOT&PF installed the culvert designed for water conveyance rather than fish passage.

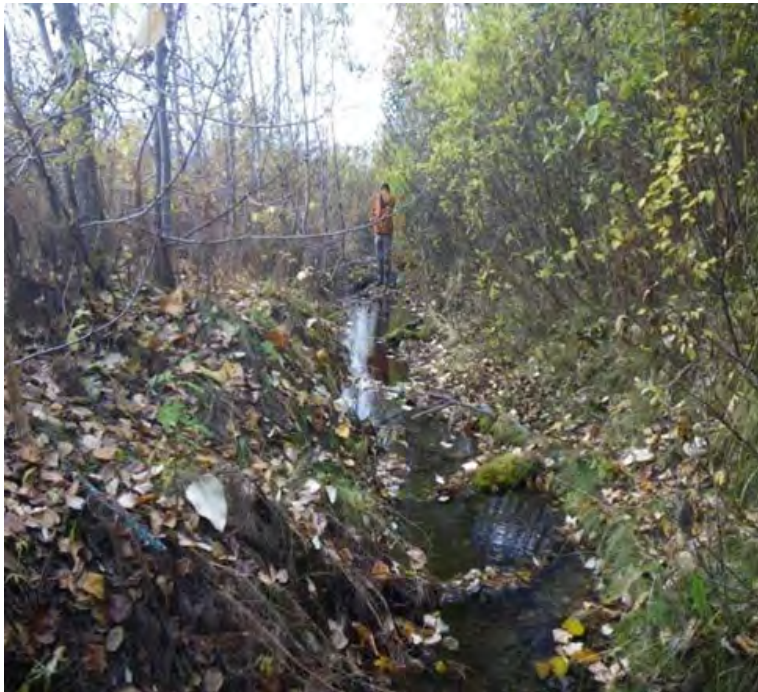
We observed juvenile salmonids (> 200) while we tracked the stream, though the water level in CH-12 was low. We captured 45 Dolly Varden char (50–120 mm) in the minnow trap near the inlet of culvert CV-6, and no fish near the upper extent of CH-12. The riparian area along both sides of the channel slopes gradually and is well vegetated with grasses and deciduous trees and shrubs (Figure 10). The streambed material in CH-12 consists of organics and sand, with a few areas of small gravel. Though woody debris and large rocks are present in a few areas of the channel, they are limited. The majority of the channel consists of shallow, slow moving water with a few small pools.

Stream channel CH-12 provides fish habitat and the mitigation objective has been achieved, as riparian vegetation is well established and contributes to in-stream cover and woody debris.

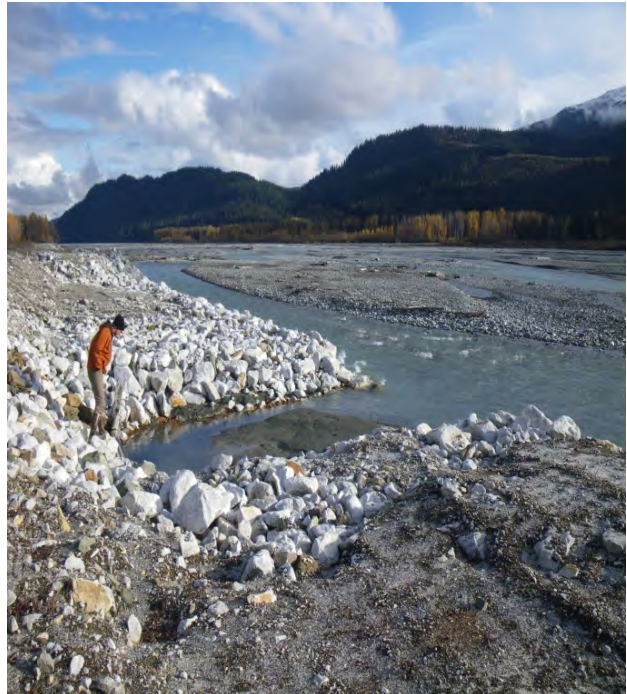
Figure 22.—Fill material placed near CV-6.

Culvert CV-6 is located in a section of the Haines Highway that is directly adjacent to the Klehini River (Stream No. 115-32-10250-2077). Fill material has been placed along this section of the highway (1–2 miles) to help stabilize the highway embankment and protect against erosion. This project is not identified in the original mitigation plan. It is not clear when the

material was placed; it was not present during the 2006 mitigation monitoring event (Appendix A), and I was unable to locate any Fish Habitat Permit history on the project.

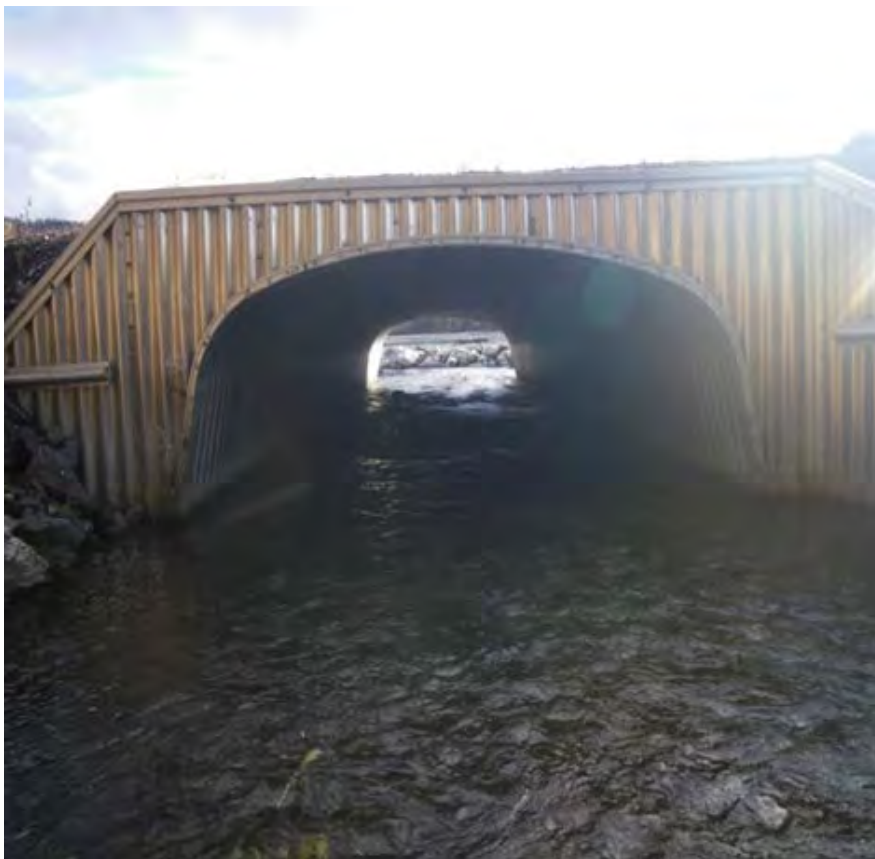
Figure 23.—Inlet to culvert CV-7.

Streambed material within culvert CV-7 is stable (spawning sized gravel; Kondolf and Wolman, 1993), and the culvert is the appropriate size for the stream (Figure 23). Water velocity through the culvert does not appear to change or represent a fish passage barrier. We set two baited minnow traps near the culvert inlet allowed them to soak for 24 hours, capturing 7 Dolly Varden char (40–95 mm) and 1 coho salmon (60 mm). We observed multiple redds approximately 20 feet upstream of the culvert inlet, and Divisions of Habitat Sport Fish staff observed adult Chinook salmon actively spawning within the culvert earlier in the season.

The mitigation objectives for culvert CV-7 have been achieved. The culvert provides fish passage, and the modifications associated with the culvert provide suitable fish habitat.
