**Technical Report No. 12-08**

## **Haines Highway Mile 25 to the Border: 2012 Mitigation Monitoring**

**Joseph P. Hitselberger**

November 2012

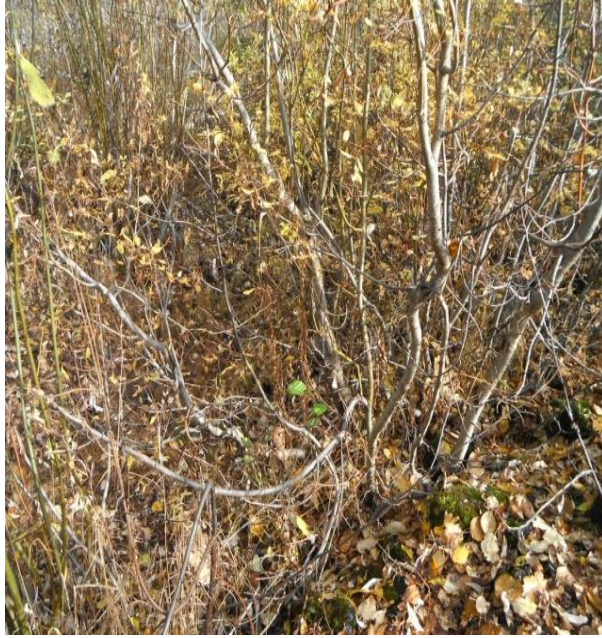
During the 2011 survey, both sections of CH-16 were dry (Figure 2). There was no sampling effort for adult or juvenile salmonids within the stream channel. Surface water was only present in the upper pond, where an adult Dolly Varden char was observed. During the 2011 survey, it was not clear if design features of the channel contributed to the seasonal flows of Spring Pond Creek. Therefore, it was recommended that ADF&G biologists return to survey the site during a period of high water so it can be determined if a modification is required (Hitselberger and Kern, 2011).

Figure 2.–Lower section of CH-16 10/10/2011.

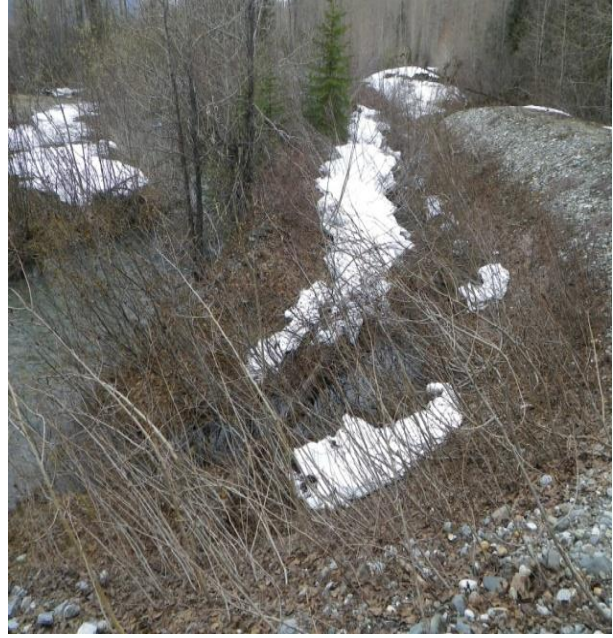
During our survey, surface water was present in both the upper and lower stream channels. Water was flowing between the two ponds, and the lower section of CH-16 was conveying flow into 37 Mile Creek (Figure 3). We electrofished the lower section of stream channel CH-16, capturing one Dolly Varden char (45 mm).

Figure 3.–Lower section of CH-16 5/10/2012.

The mitigation objective for stream channel CH-16 has been achieved. Stream channel CH-16 has restored a segment of Spring Pond Creek from a culvert to an open channel. The upstream section does connect the two ponds, and the downstream section conveys flow into 37 Mile Creek. Seasonal flows do limit fish passage and use of the channel, however design features of CH-16 do not restrict fish passage. There are no modifications required to achieve the mitigation objective.

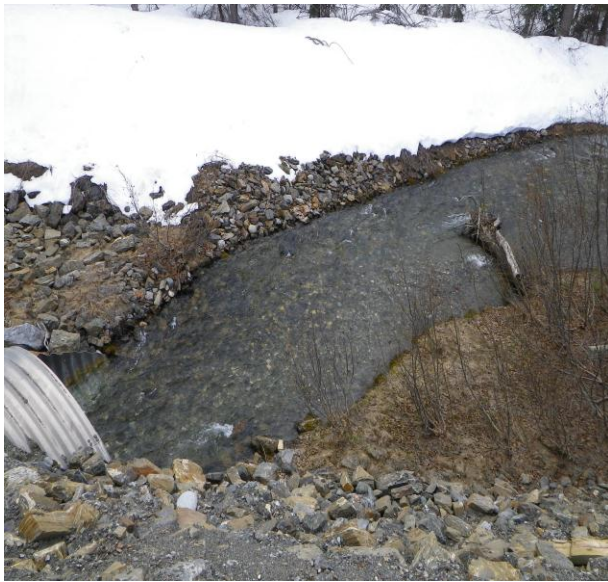
The water level in culvert CV-9 was higher during our 5/10/12 survey than it was during the 2011 survey. Water velocity appeared to increase through the culvert; however, it was not measured. Streambed material within culvert CV-9 is stable and is comprised of spawning sized gravel (Kondolf and Wolman, 1993) and no evidence of streambed scouring was observed. The average bank-full width measured above culvert CV-9 is 19.6 ft (Figure 6). The average bank-full width measured below culvert CV-9 is 25 ft (Figure 7). These values were calculated from measurements taken at 20, 40, and 60 ft above and below culvert CV-9.

Figure 6.–Culvert CV-9 inlet 5/10/12.

The mitigation objective for culvert CV-9 has been achieved. Anadromous fish have been documented both upstream and downstream of the culvert, demonstrating that the culvert provides adequate fish passage. Bank-full width measurements indicate that the water velocity may increase through the culvert, however there is no evidence that the culvert limits fish passage.

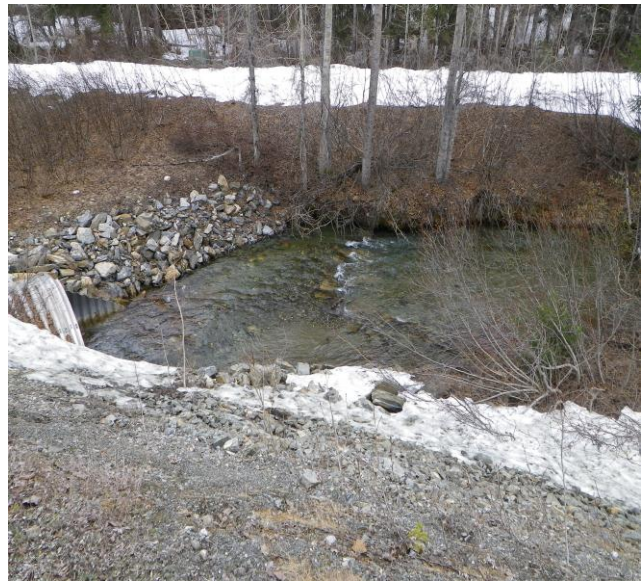
Figure 7.–Culvert CV-9 outlet 5/10/12.

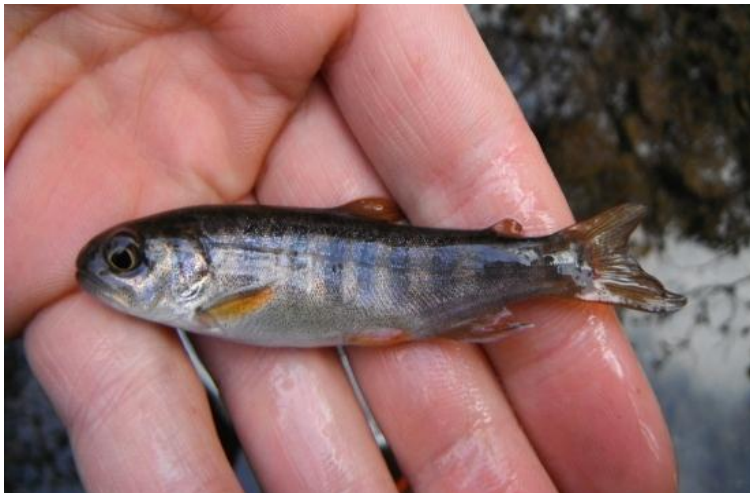
The culvert appears to be installed to the design specifications, and water is flowing from stream channel CH-18 through the culvert. Streambed material within the culvert is stable, and the water velocity remains unchanged through the CMP. We electrofished upstream of the culvert in stream channel CH-18 and 37½ Mile Pond, however no fish were observed or captured while electrofishing. Baited minnow traps were placed in the upper section of stream channel CH-18 on 6/13/12, and were set for 24 hours. Four juvenile coho salmon (40–60 mm) were captured when we retrieved the traps on 6/14/12 (Figure 8).

Figure 8.—Coho salmon captured above CV-10.

The mitigation objective for culvert CV-10 has been achieved. The culvert provides adequate passage for fish upstream and downstream.

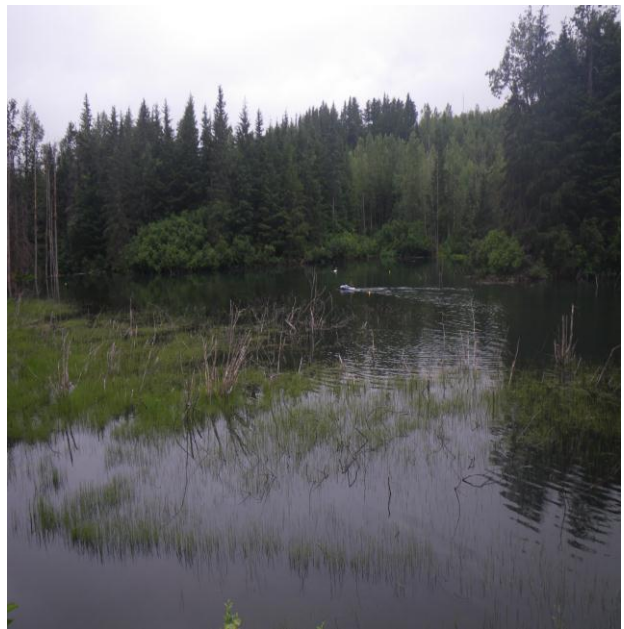
The culvert appears to be installed to the design specifications; however ice and snow limited our 5/10/12 survey (Figure 9). No fish were observed or captured while electrofishing above the culvert. Baited minnow traps were placed up and downstream of the culvert on 6/13/12. They were retrieved on 6/14/12 with no fish were captured. On 8/5/12, six baited minnow traps were placed downstream of culvert CV-11 in a large pond (Figure 10). This pond is also directly downstream of culvert CV-12. Minnow traps were retrieved on 8/6/12 with no fish captured in the pond. However, multiple Dolly Varden char (350–400 mm) were documented during a rod and reel survey of the pond that same day.

Figure 10.—Pond below CV-11 8/5/12.

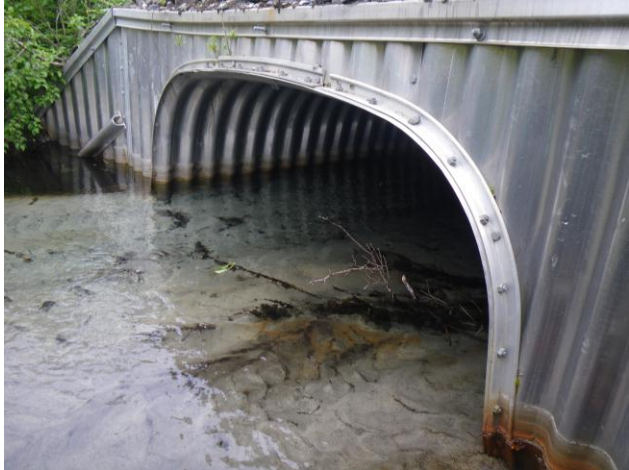
Culvert CV-12 is a 58 ft 6 in long by 13 ft 3 in by 6 ft 9 in aluminum box culvert (Figure 12 and 13). The culvert is located on Stream No. 115-32-10250-2077-3136-4053. Approximately 1.0 ft of streambed material was placed in the culvert.

The culvert is installed to the design specifications, and streambed material (sand) within the culvert is stable. Water velocity through the culvert does not change and there is no indication that the culvert represents a fish passage barrier. No fish were observed or captured while electrofishing above the culvert on 5/10/12. Baited minnow traps were placed up and downstream of the culvert on 6/13/12. They were retrieved on 6/14/12 and no fish were captured.

Figure 12.—CV-12 outlet 6/13/12.

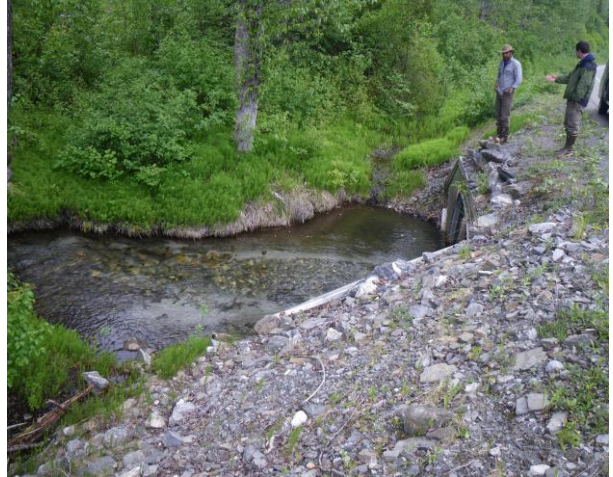
Figure 13.—Upstream of CV-12 6/13/12.

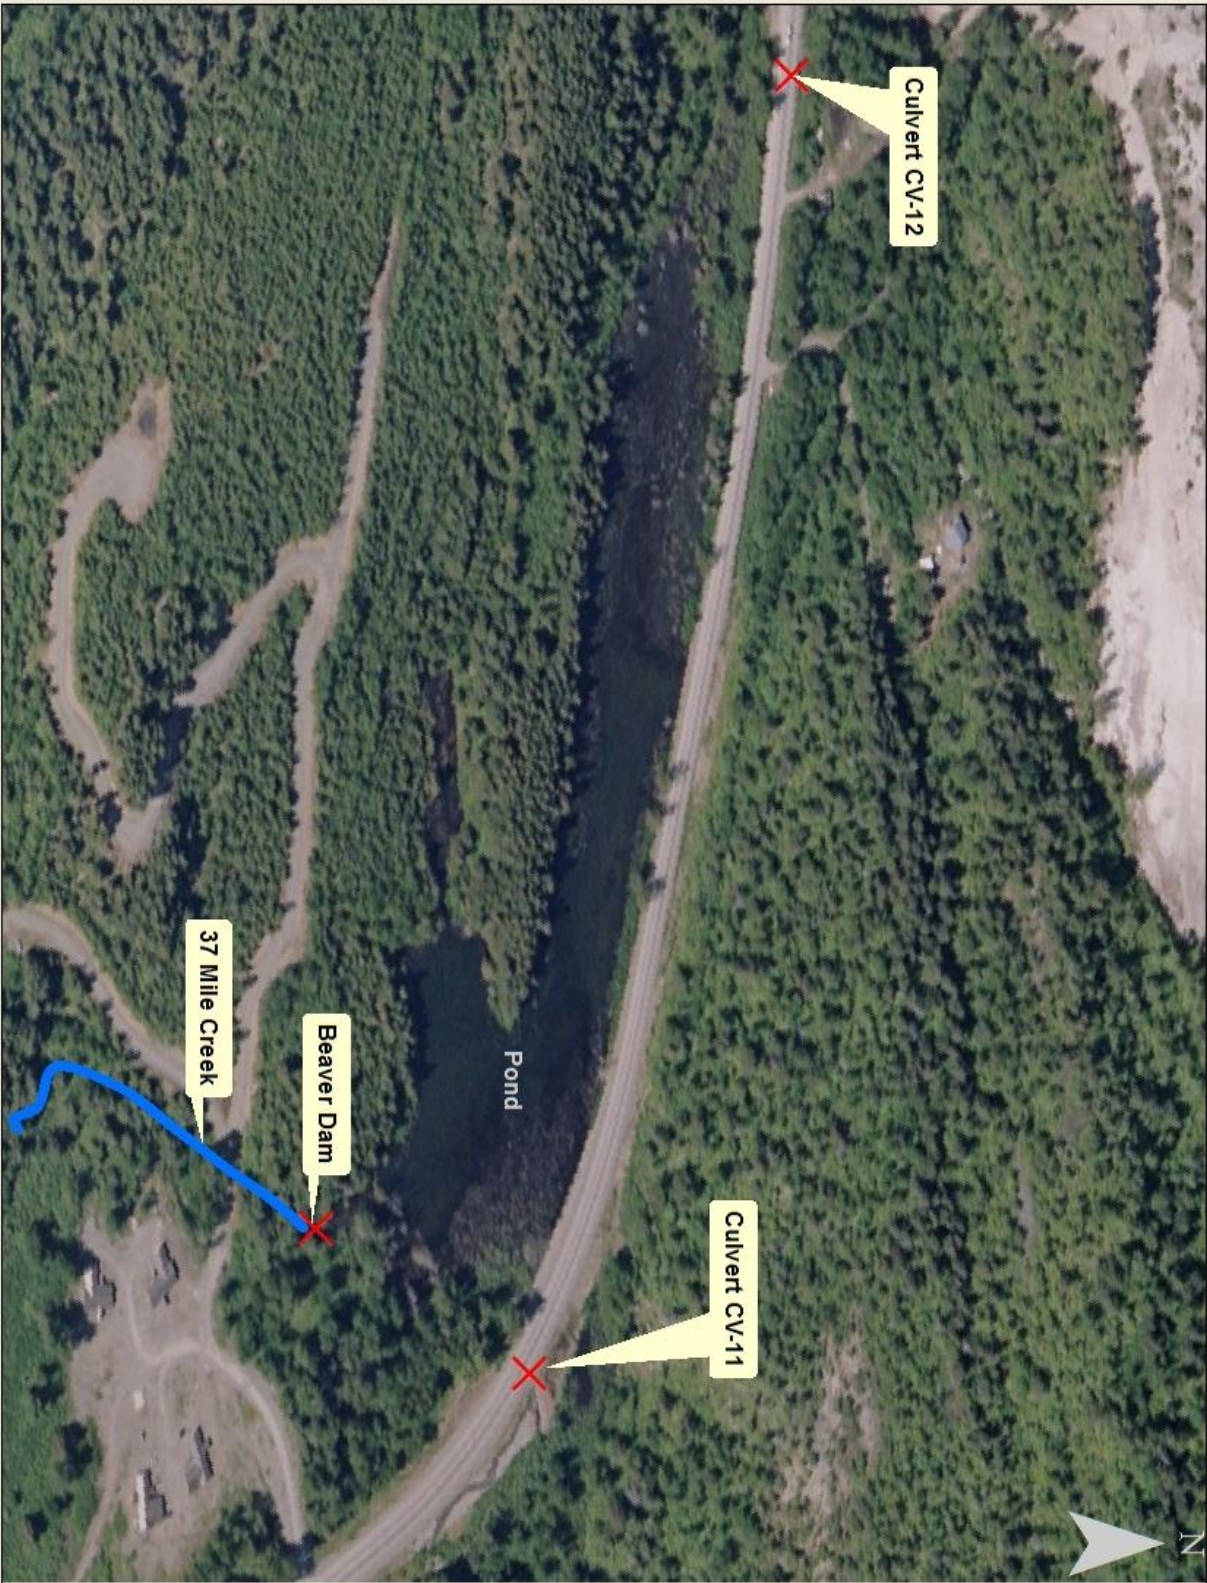
During this survey, anadromous fish were not documented above culvert CV-12 because of a downstream anadromous fish barrier (Figure 14). The culvert is designed and installed to specifications and there are no modifications needed to provide adequate passage for fish upstream and downstream.

Figure 14.—Location of beaver dam, and Culvert CV-11 and CV-12.
