# Alaska Department of Fish and Game

## 111-50-10680 Tributary 1

## ADDITION

**Survey date:** 5/12/2022; 10/20/2023

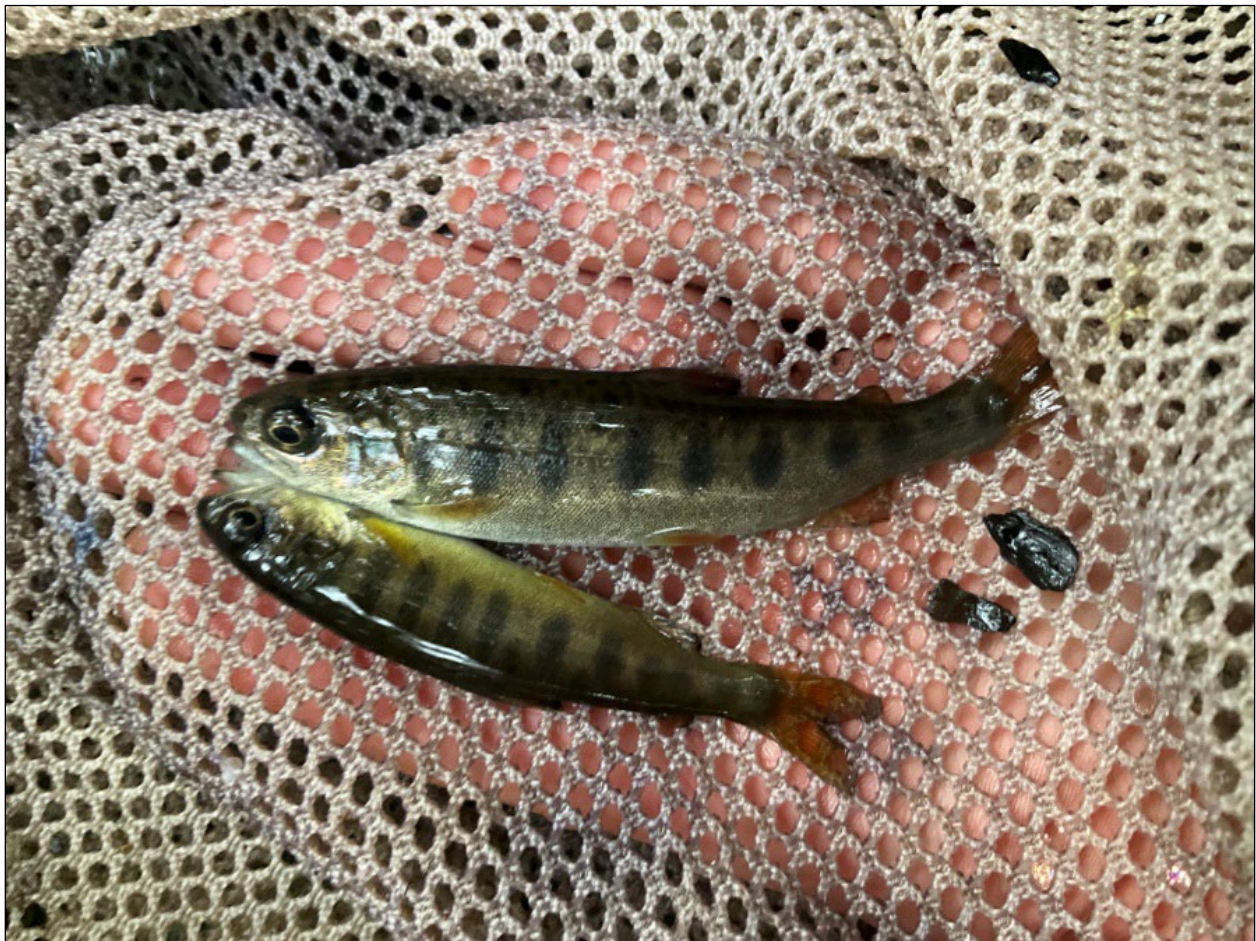
Figure 1.–Juvenile coho salmon captured at waypoint 1039.

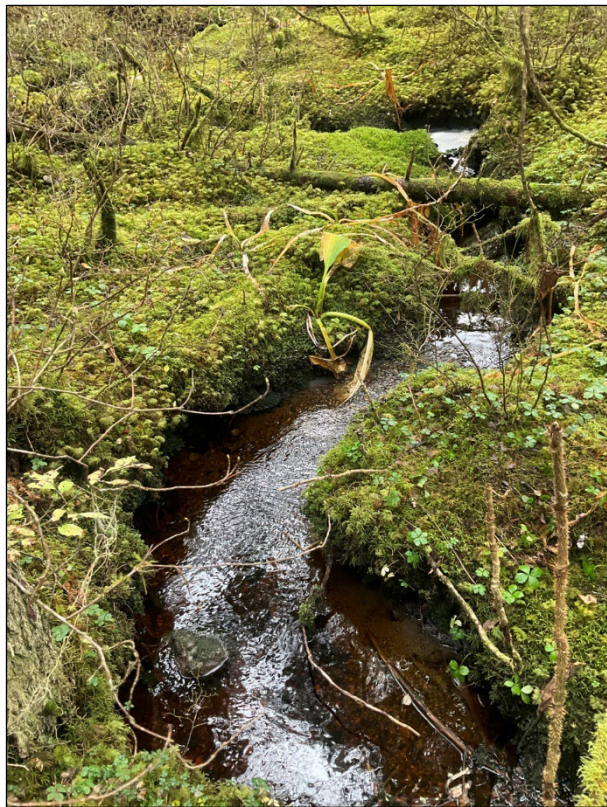
Figure 2.—Tributary 1 at waypoint 1040.

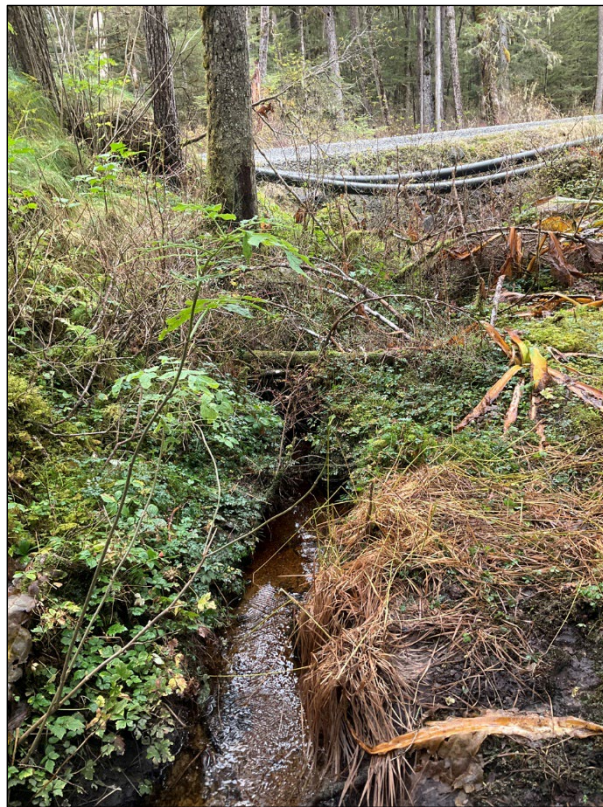
**Findings:** We surveyed this uncataloged stream using a backpack electrofisher and GPS and captured juvenile coho salmon. The stream has marginal habitat upstream of a small culvert where the channel becomes overcrowded by woody debris, but has quality rearing habitat downstream to the confluence with a cataloged stream (Table 1; Figures 1–3).

Figure 3.—Overcrowded channel just downstream of culvert outlet at waypoint 1041.
