Alaska Department of Fish and Game

111-50-10690 Tributary 1

ADDITION

Survey date: 10/19/2023; 10/31/2023

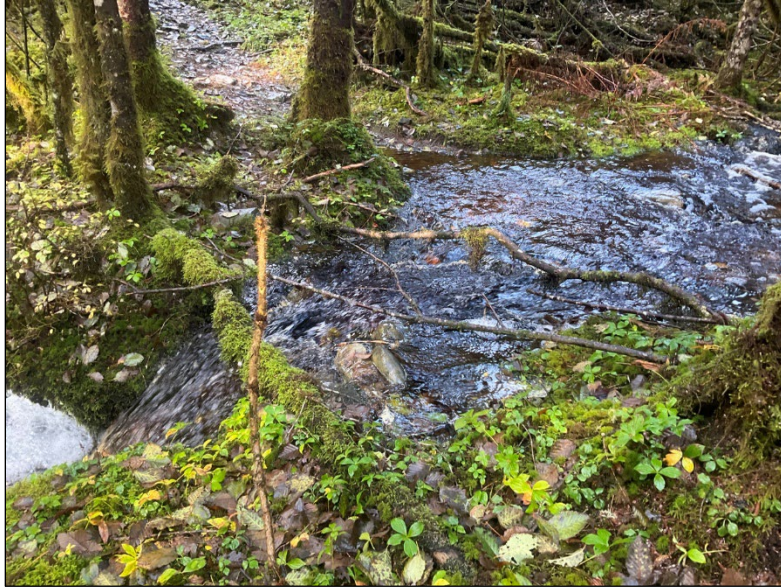
Figure 1.—Small falls at confluence of tributary 1 and main channel downstream of waypoint 1020.

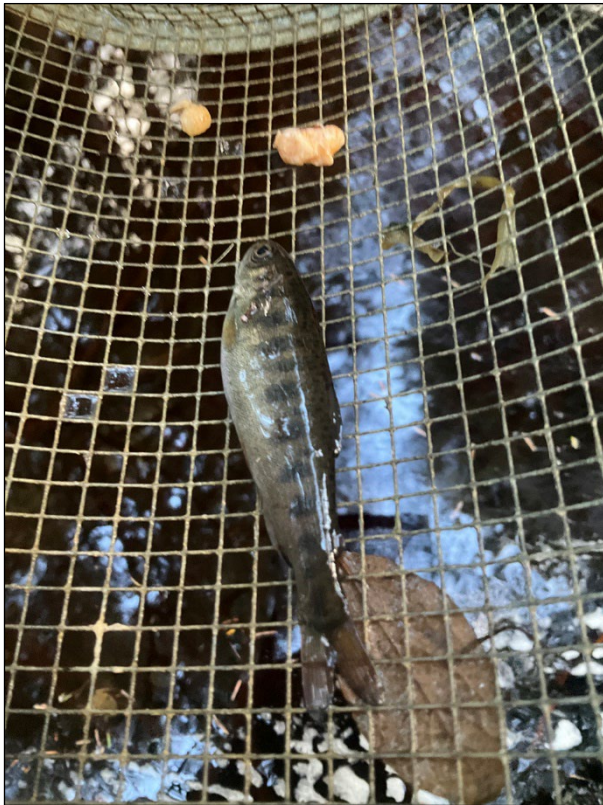
Figure 2.—Juvenile coho salmon captured at waypoint 1020.

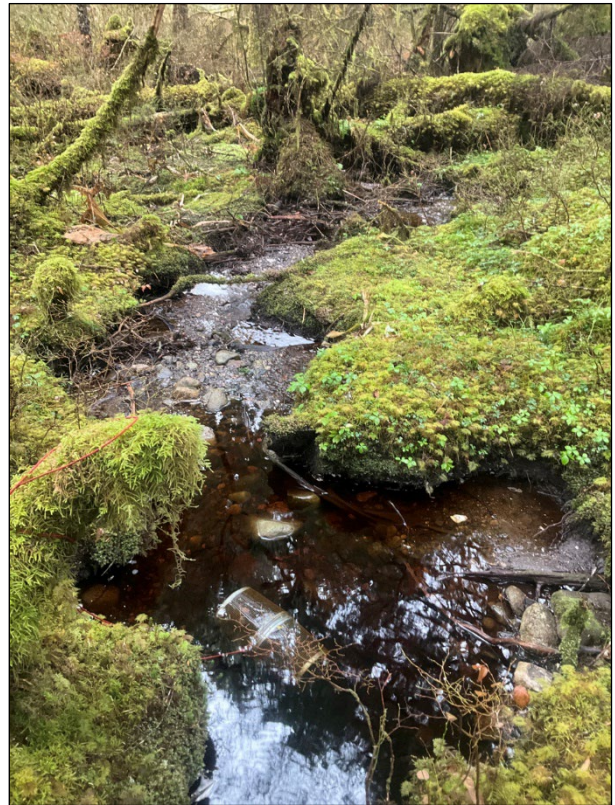
Figure 3.—Downstream view of re-channelized stream at waypoint 1098.
