Alaska Department of Fish and Game

Habitat Section
Southeast Region

Gastineau Channel Uncataloged Stream

ADDITION

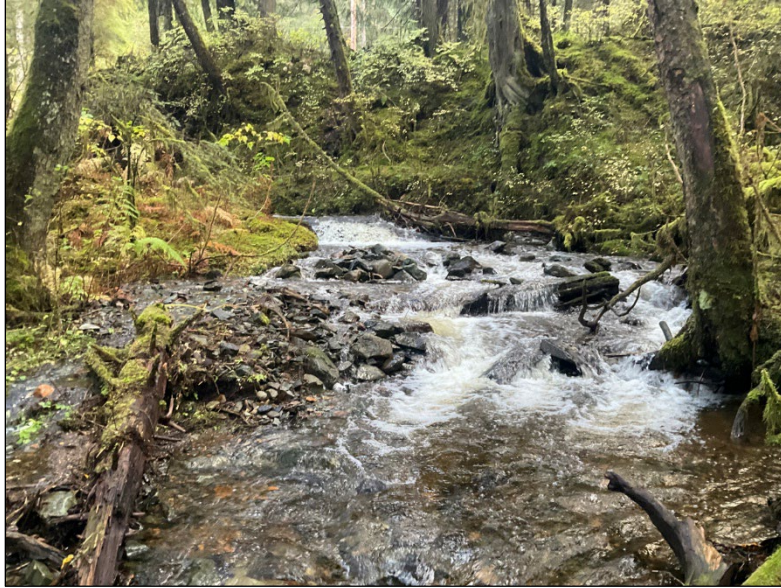
Figure 1.—Upstream view of stream at waypoint 1035.

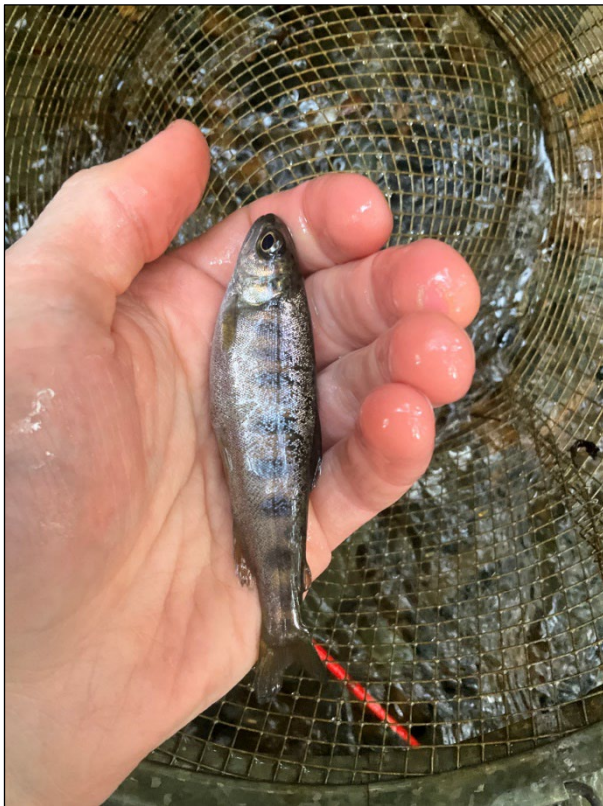
Figure 2.—Juvenile coho salmon captured at waypoint 1036.

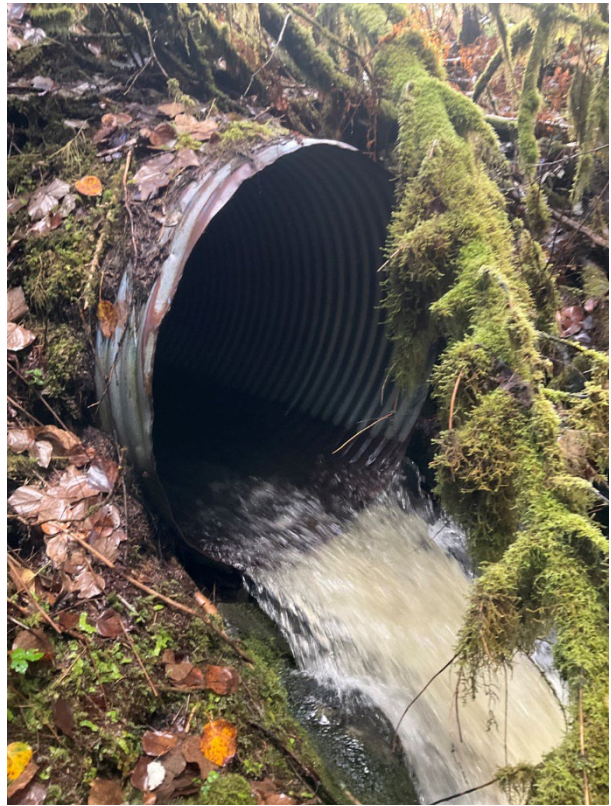
Findings: We surveyed this cataloged stream using baited minnow traps and GPS. We captured juvenile coho salmon, Dolly Varden, cutthroat trout, and sculpin. The stream flows down a hillside, through a 4-foot culvert with 2-foot perch, and into the intertidal (Table 1; Figures 1–3).

Figure 3.—Perched culvert outlet at waypoint 1036.
