# Alaska Department of Fish and Game

Habitat Section  
Southeast Region

## 114-31-10130 Tributary 2

## ADDITION

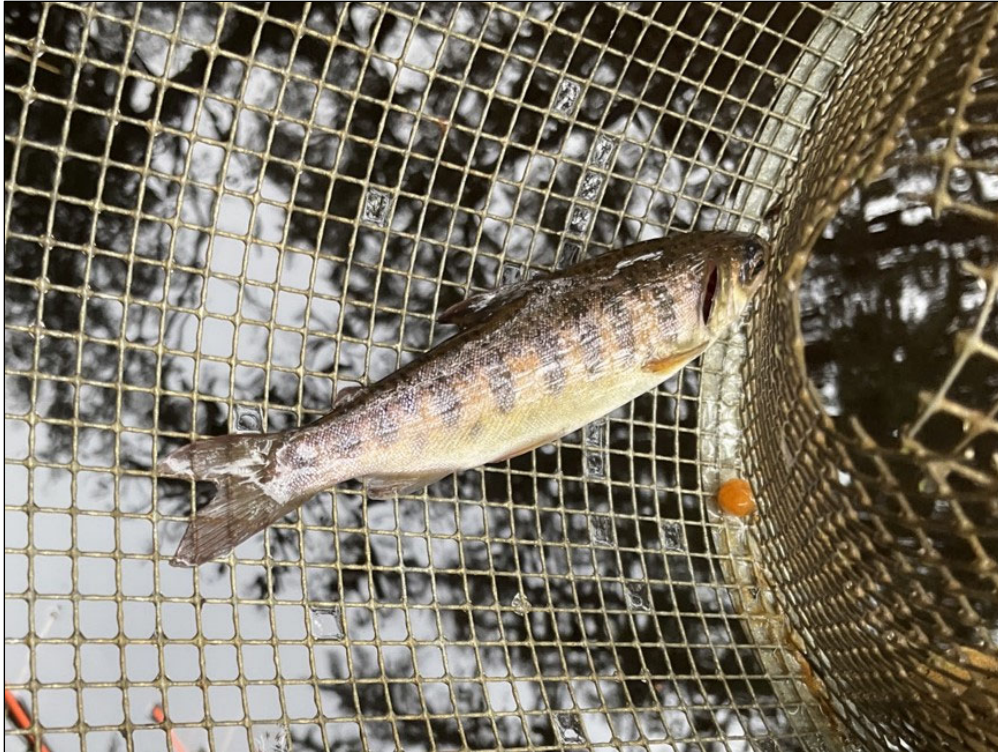
Figure 1.—Juvenile coho salmon captured at waypoint 1696.

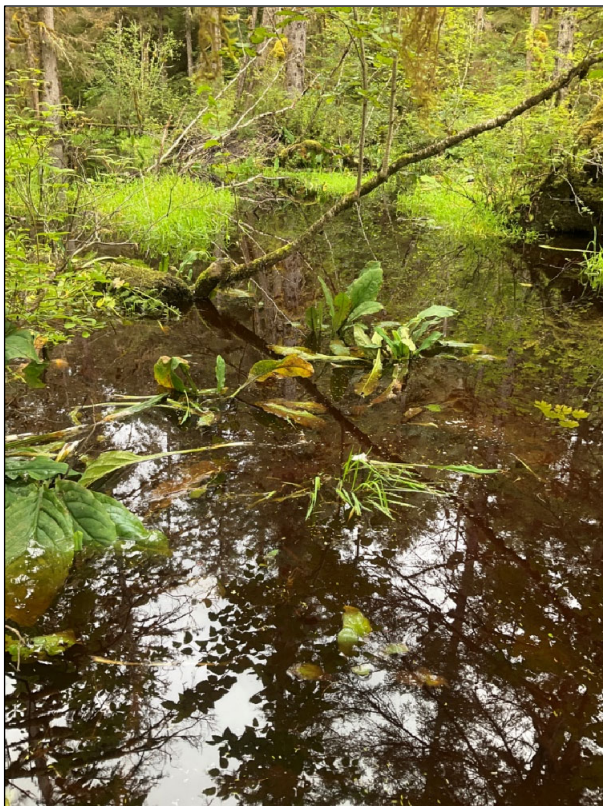
Figure 2.—Ponded water at waypoint 1696.

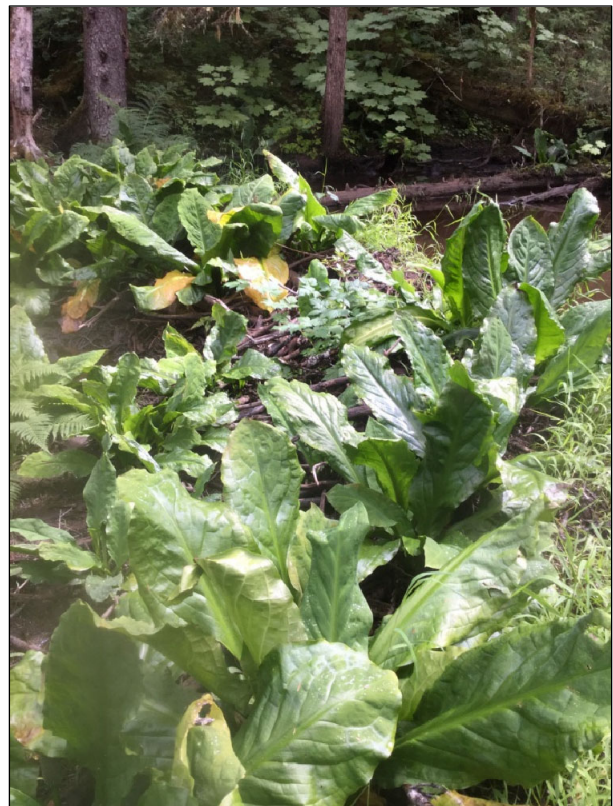
Figure 3.—Beaver dam overgrown with skunk cabbage at waypoint 1055.
