Alaska Department of Fish and Game

Habitat Section
Southeast Region

114-31-10130-2004

ADDITION & ROUTE CORRECTION

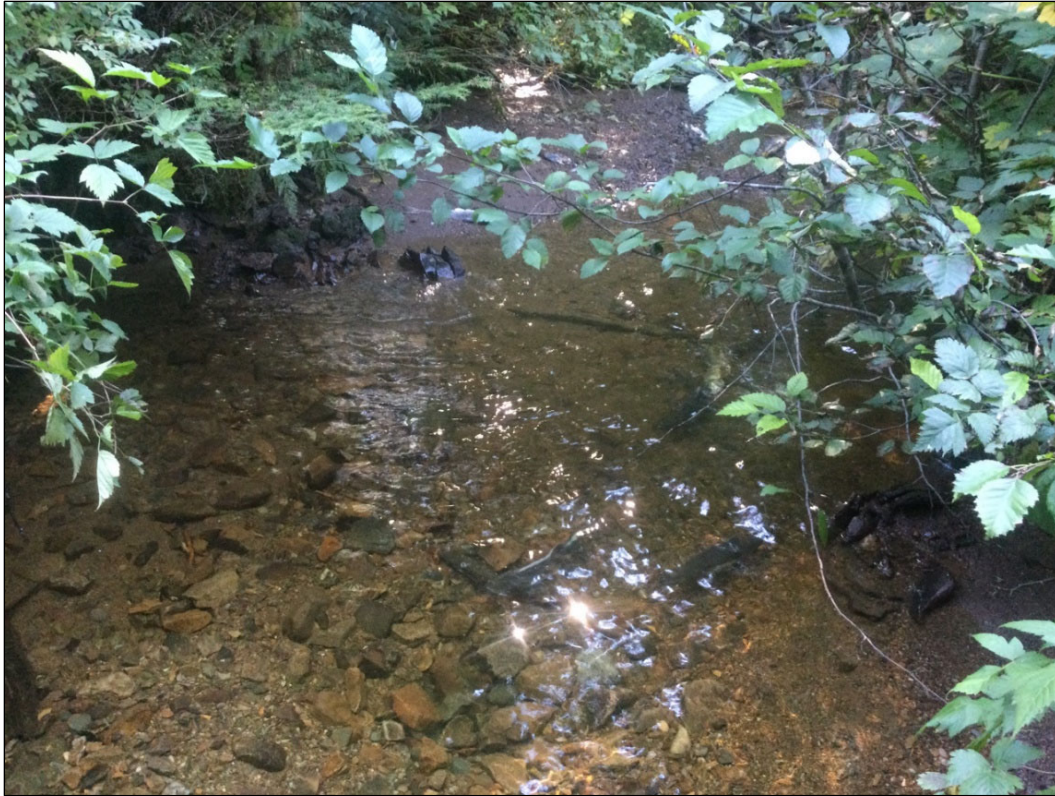
| Waypoint | Latitude | Longitude | Notes | Stream Width ft | Stream Substrate | Habitat Features | Gradient % | Sample Effort | Sample Results |
|---|---|---|--|---|---|---|---|---|---|
| 2279 | 58.061618 | -135.488352 | Adult pinks spawning. No armor on river-right, starting to undercut on downstream end. | 15-20 | Small Gravel Large Gravel | Spawning Substrate | 2-4 | MT | 12 P 3 CO 1 DV |

Figure 1.—Pink salmon spawning in channel at waypoint 2279.

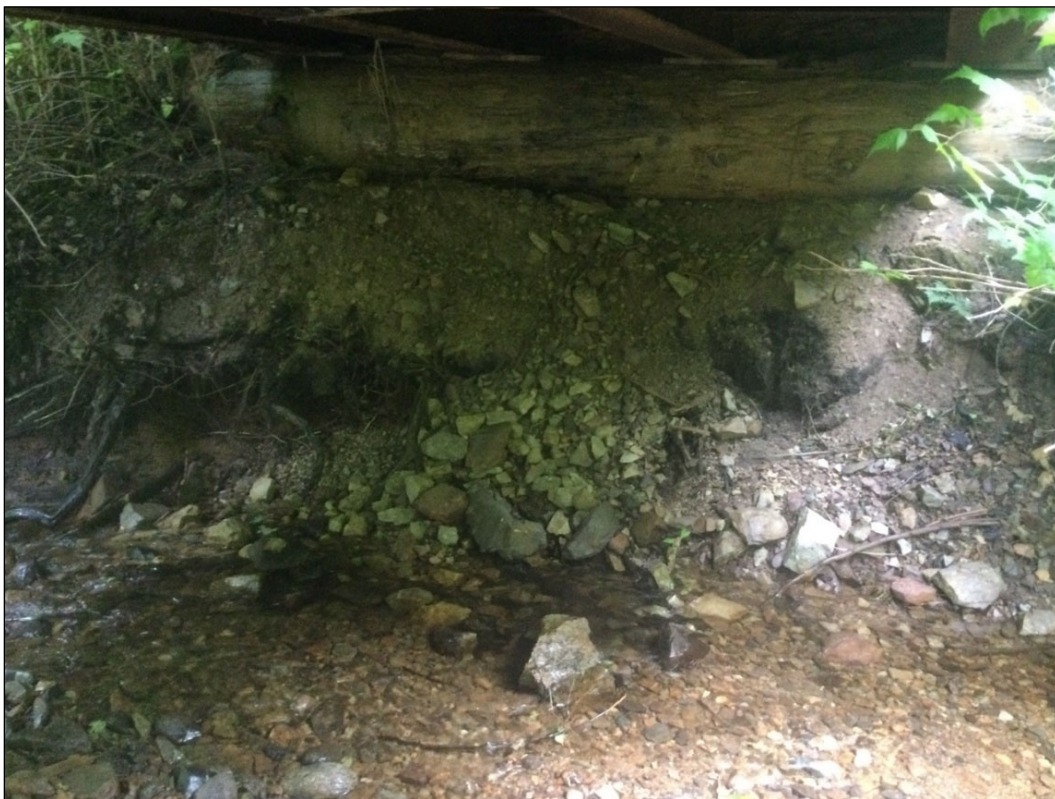
Figure 2.—Eroding river-right bridge abutment at waypoint 2279.

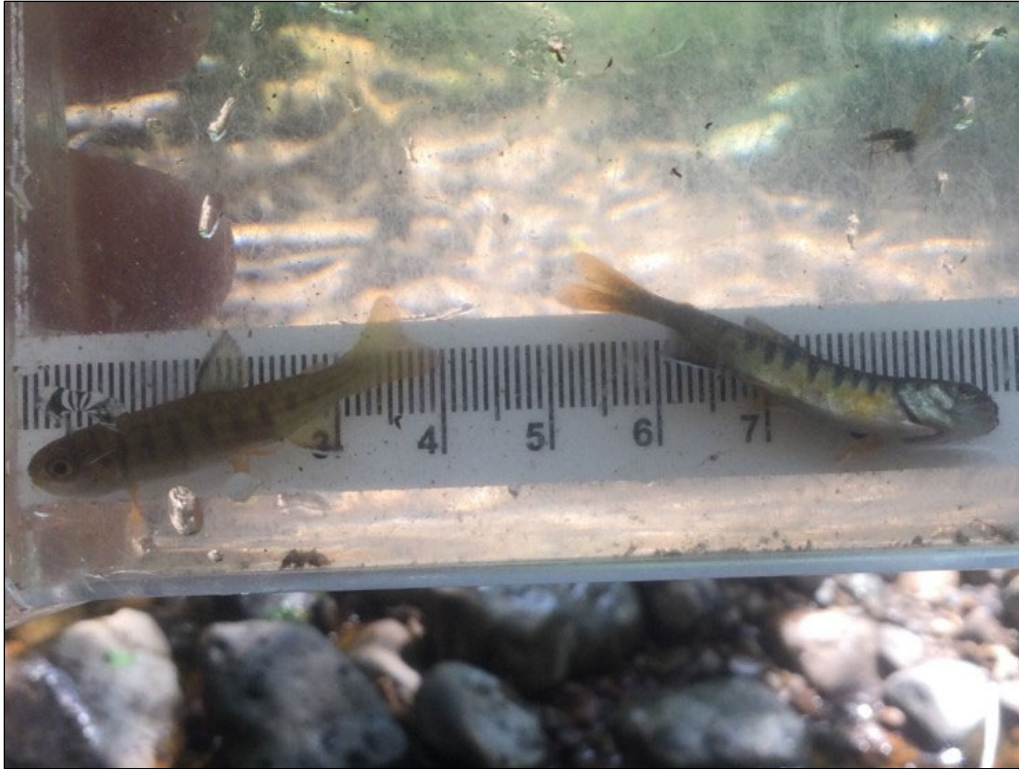
| Waypoint | Latitude | Longitude | Notes | Stream Width ft | Stream Substrate | Habitat Features | Gradient % | Sample Effort | Sample Results |
|---|---|---|--|---|---|---|---|---|---|
| 926 | 58.059075 | -135.491574 | Grade flattens out compared to upstream. Young-of-year CO. Log jam upstream blocks fish passage. | 15-20 | Large Gravel Cobble | | 1-2 | EF | 4 CO |

Figure 3.—Juvenile coho salmon captured at waypoint 926.

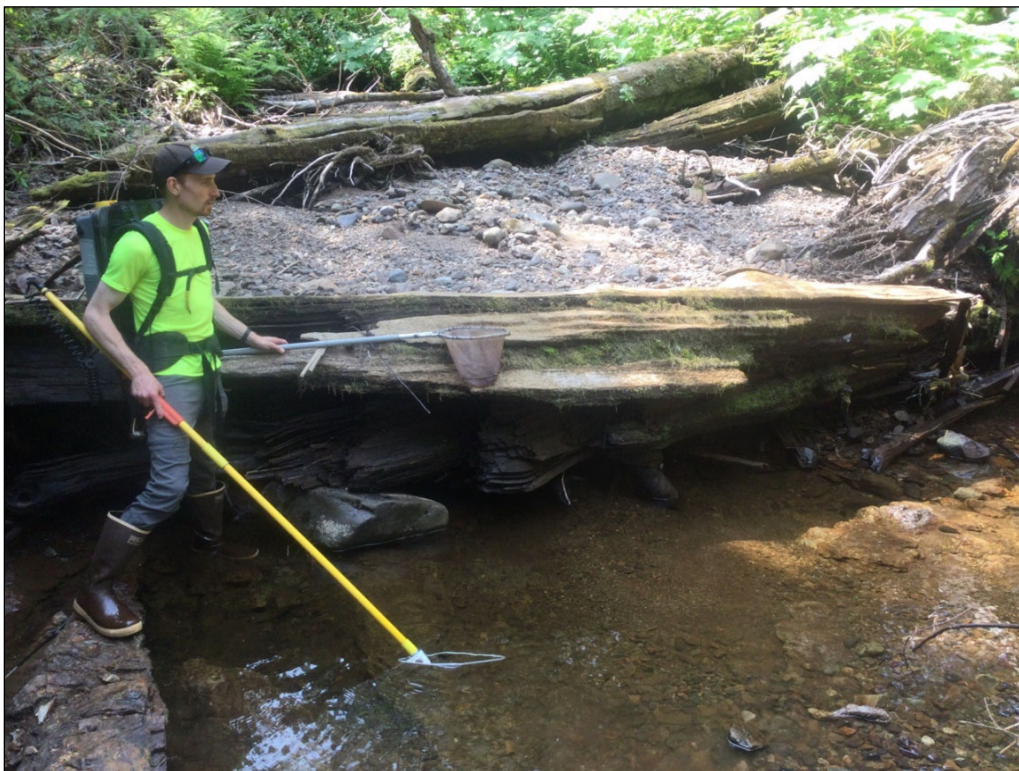
Findings: We surveyed this cataloged stream using a backpack electrofisher, baited minnow traps, and GPS. We captured juvenile coho salmon, Dolly Varden, cutthroat trout, and sculpin. We also observed spawning pink salmon. The tributary stream falls over at least two large (about 4 ft tall) log jams, one of which seems to comprise a temporary barrier to fish passage as it is collecting gravel and burying the stream channel (Table 1; Figures 1–4).

| Waypoint | Latitude | Longitude | Notes | Stream Width ft | Stream Substrate | Habitat Features | Gradient % | Sample Effort | Sample Results |
|---|---|---|--|---|---|---|---|---|---|
| 927 | 58.058891 | -135.491973 | Log jam ~4' tall. Water seeps through gravel, blocking fish passage. Resident fish capture only upstream. | 15-20 | Large Gravel | | 2-4 | EF | 4 CT 1 SC |

Figure 4.—Temporary fish block comprised of a large log jam collecting gravel sediment at waypoint 927.
