# Alaska Department of Fish and Game

**112-50-10100-2065**

**ADDITION**

**Survey date:** 8/30/2022

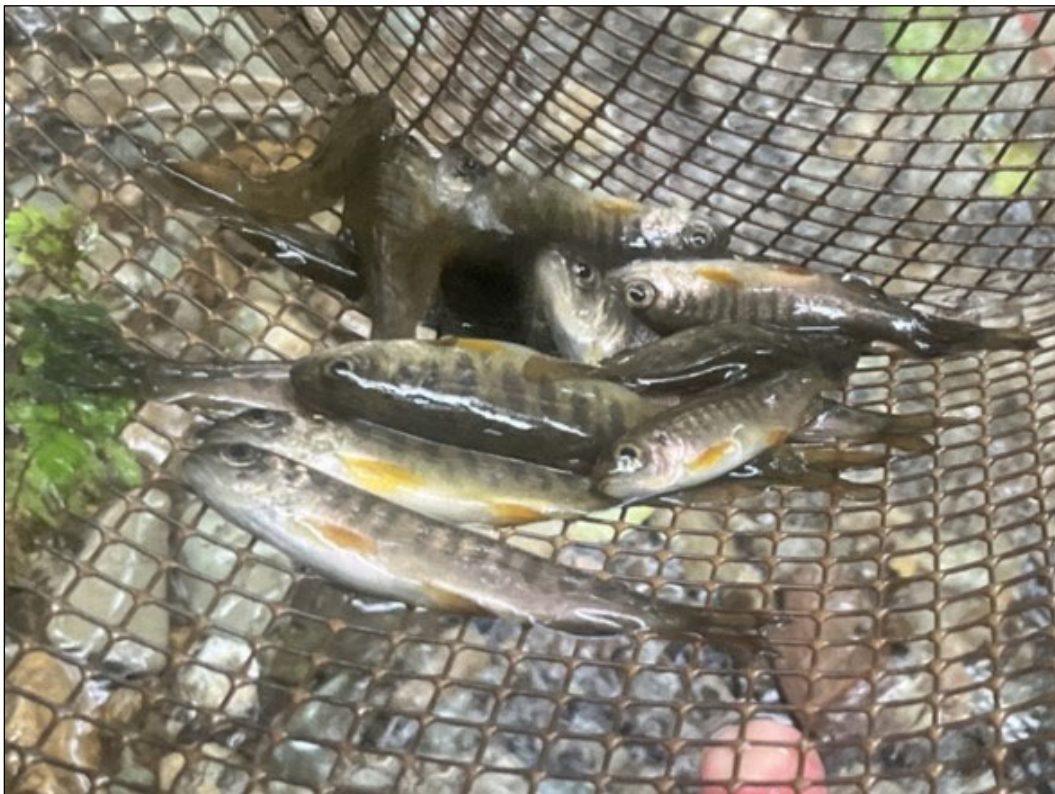
Figure 1.—Juvenile coho salmon captured at waypoint 1638.

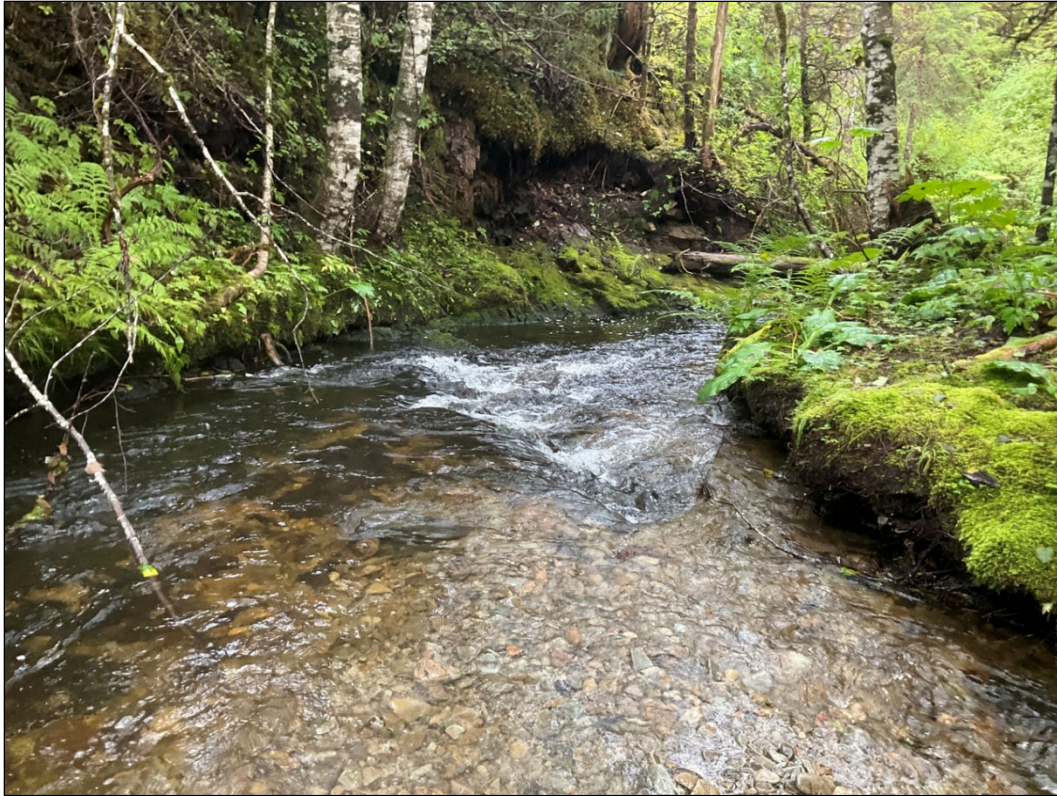
Figure 2.—Downstream view of channel at waypoint 1656.

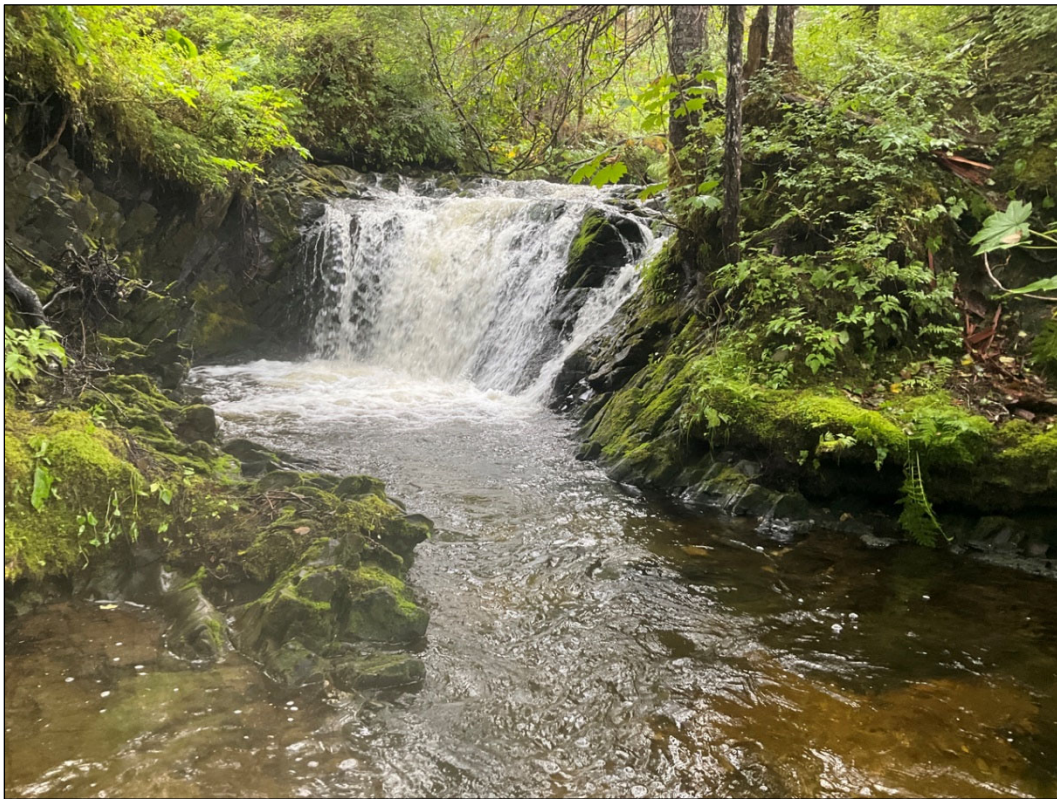
**Findings:** We surveyed this cataloged stream up to an anadromous fish barrier using a backpack electrofisher, baited minnow traps, and GPS. We captured juvenile coho salmon and Dolly Varden. The stream falls over a 12-to-15 ft tall bedrock falls, blocking fish passage, and flows through a broad channel, passing under a bridge downstream (Table 1; Figures 1–3).

Figure 3.—Bedrock falls comprising an anadromous barrier at waypoint 1655.

**Recommendations:** Extend upper extent of Stream No. 112-50-10100-2065 in the anadromous waters catalog. Add anadromous fish barrier (Figure 4).
