Alaska Department of Fish and Game

Habitat Section
Southeast Region

114-31-10130 Tributary 13

Survey date: 7/15/2022

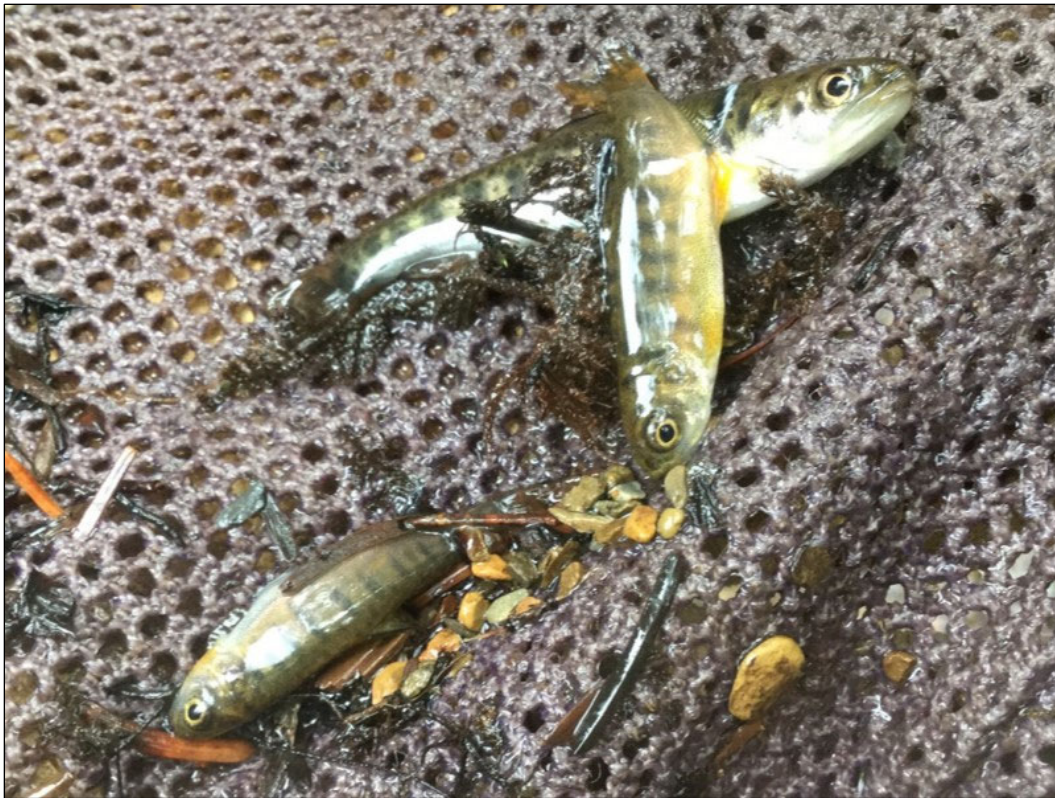
Figure 1.—Juvenile coho salmon and cutthroat trout captured at waypoint 1090.

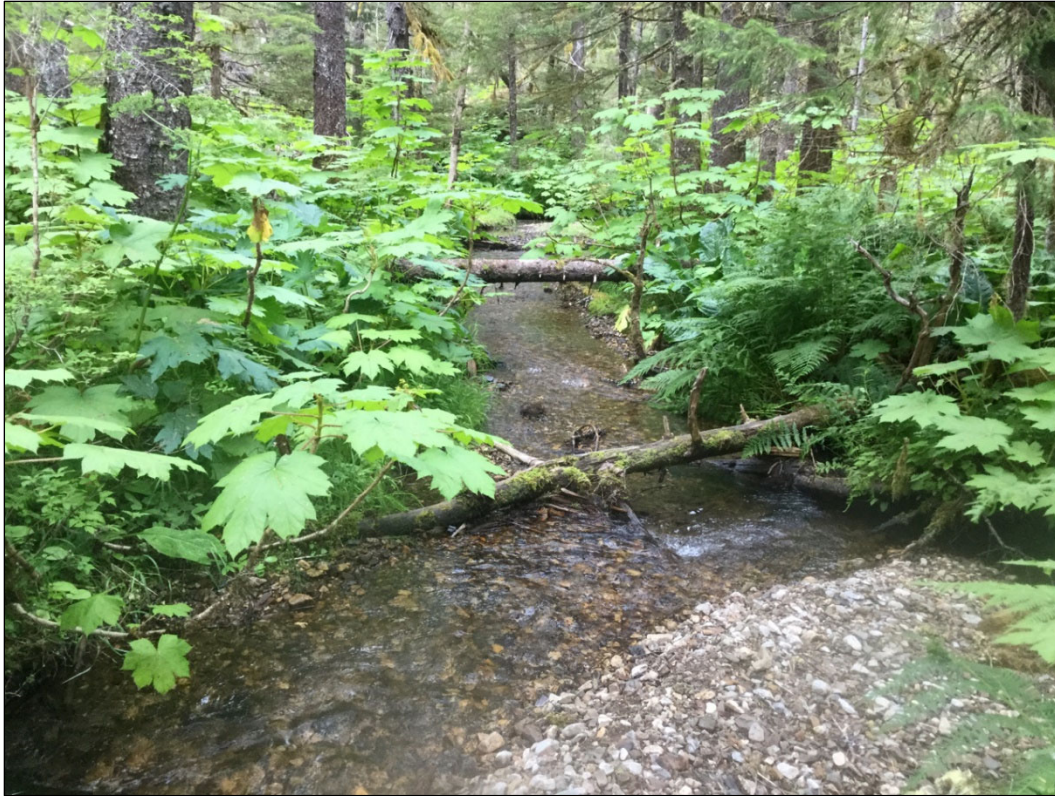
Figure 2.—Channel at waypoint 1089.

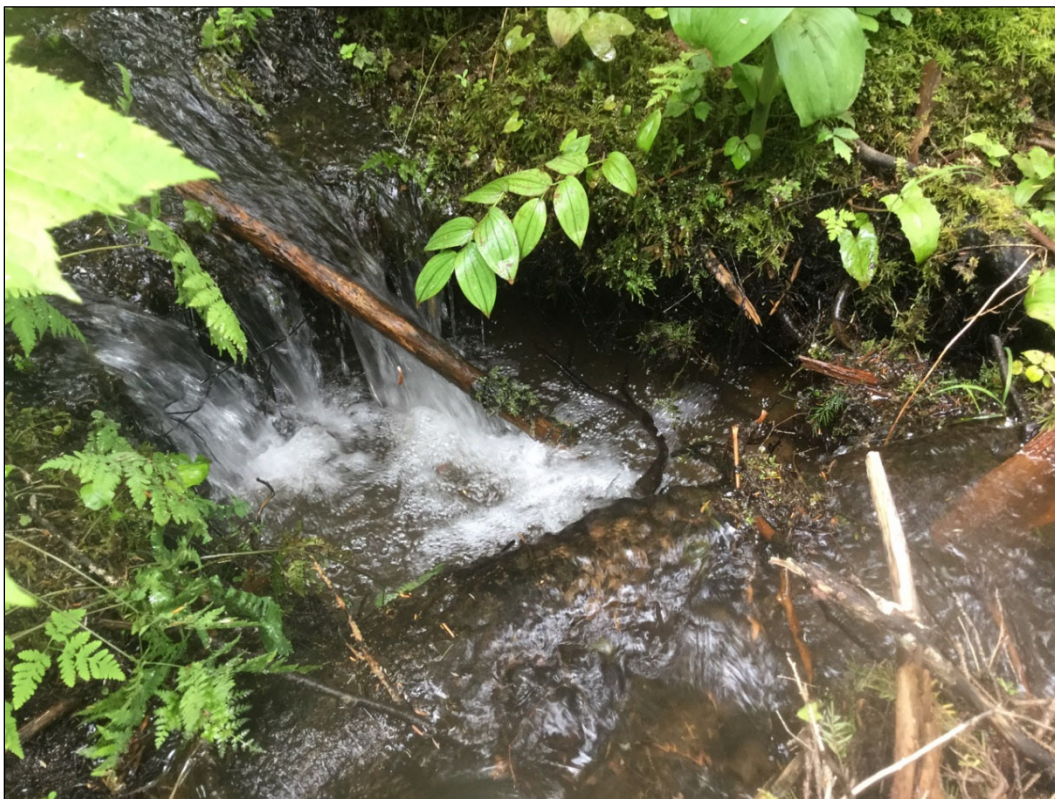
Findings: We surveyed this uncataloged stream using a backpack electrofisher and GPS. We captured juvenile coho salmon, Dolly Varden, and cutthroat trout. Channel erosion at the base of a tree has formed a 3 ft diameter hole, which likely constitutes a temporary barrier to fish passage (Table 1; Figures 1–3).

Waypoint	Latitude	Longitude	Notes	Stream Width ft	Stream Substrate	Habitat Features	Gradient %	Sample Effort	Sample Results
1100	57.969288	-135.442216	Water circles around and flows into ~3' diameter hole near base of tree and downed woody debris. Falls from surface to pool below hole is 18-24". Stream then flows subsurface for at least 30-40' and reappears downstream, seemingly from multiple underground outlets. Seems to constitute temporary but significant barrier to fish passage.			Log Jams LWD		EF	No Fish
1101	57.969290	-135.442440	Young-of-year CO capture. Stream goes subsurface for ~30-40' upstream of here (see upstream waypoint).	4-6	Large Gravel Fine Organic		4-6	EF	3 CO 2 DV

Figure 3.—3 ft diameter hole where stream enters subsurface flow at waypoint 1100.
