# Alaska Department of Fish and Game

**114-27-10300**

**ADDITION**

**Water body name:** Spasski Creek

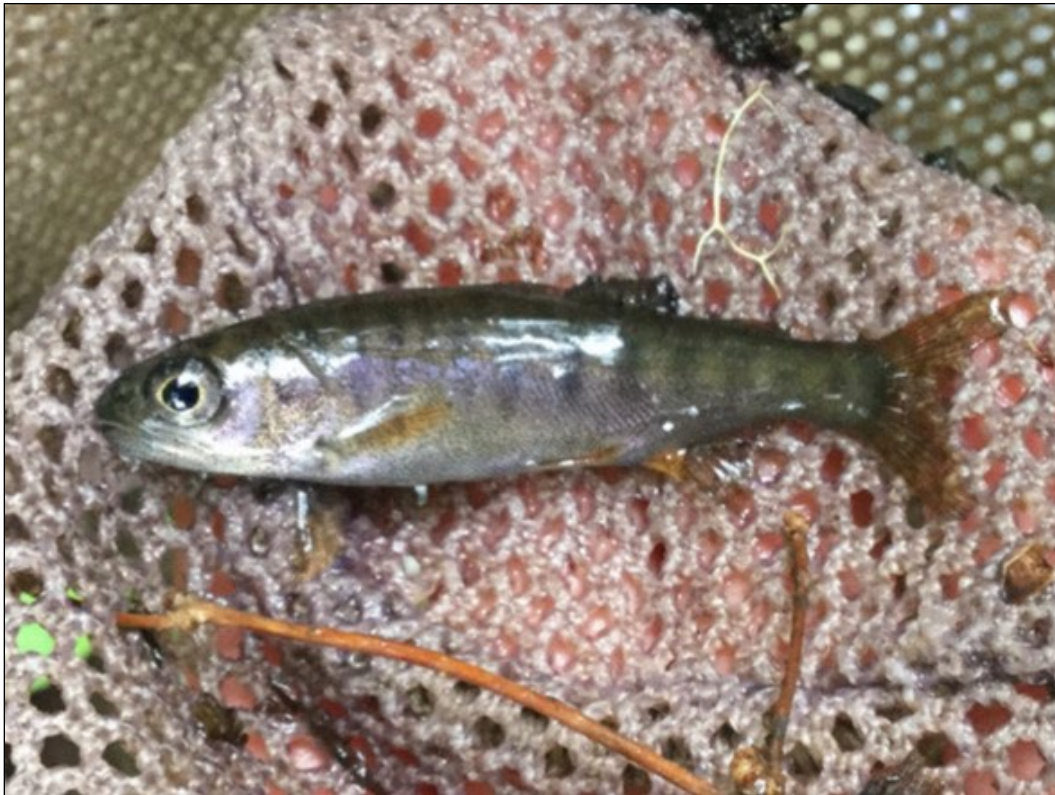
Figure 1.—Juvenile coho salmon captured at waypoint 718.

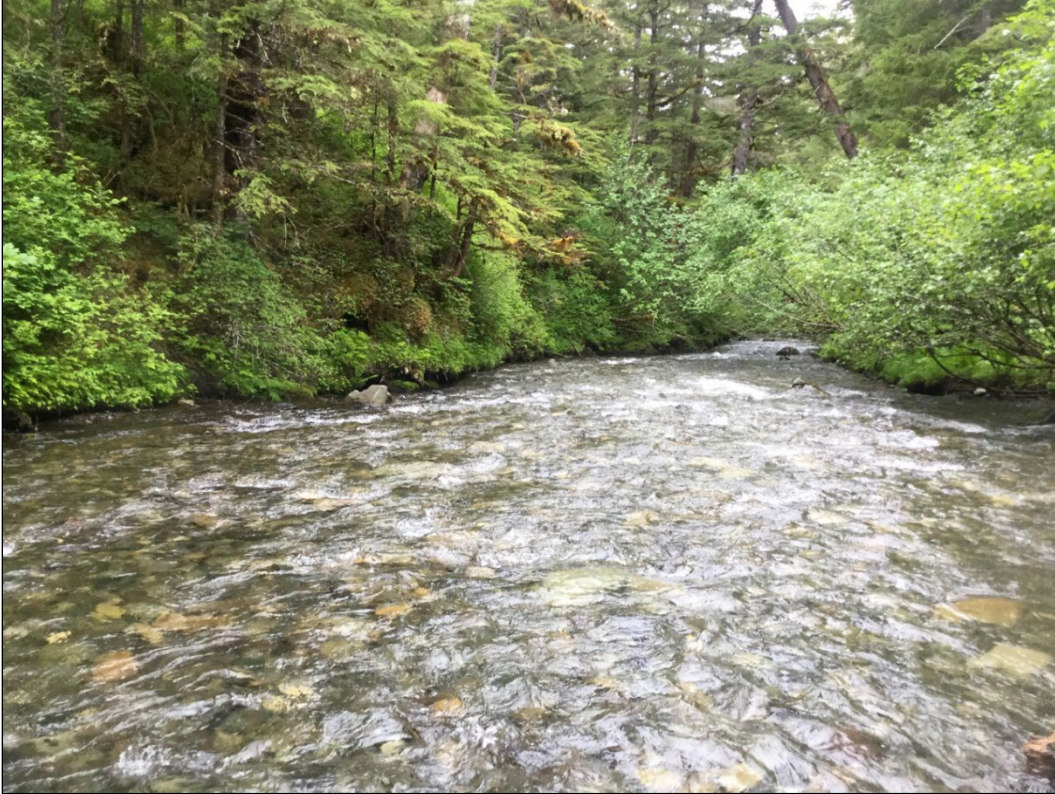
Figure 2.—Downstream view of channel at waypoint 715.

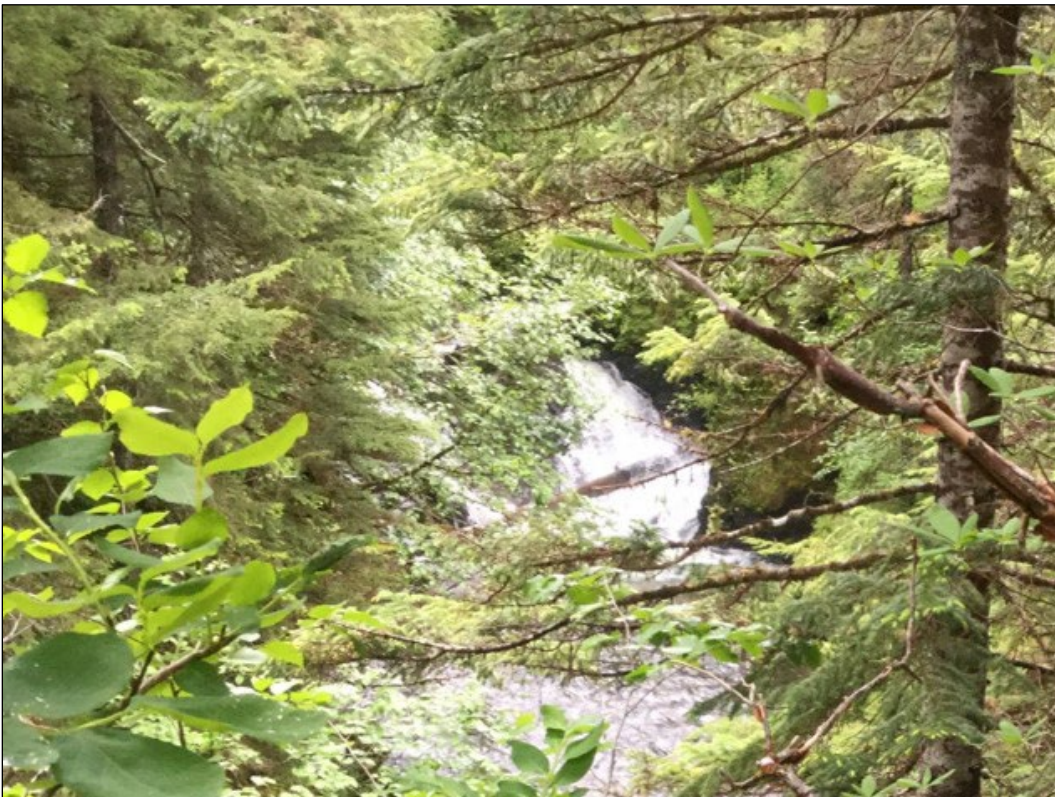
Figure 3.—Bedrock falls at waypoint 717.
