# Alaska Department of Fish and Game

**112-42-10160-2021**

**ADDITION and CORRECTION**

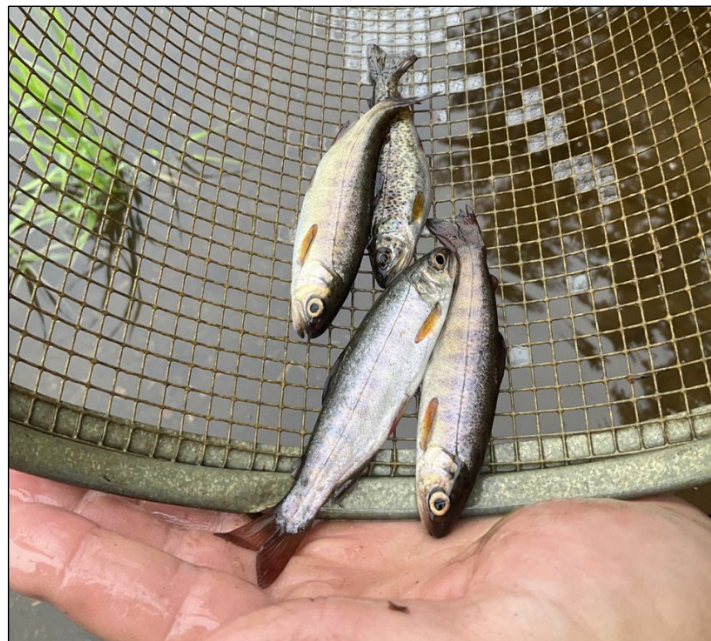
Figure 1.–Juvenile coho salmon and a cutthroat trout captured at waypoint 1440.

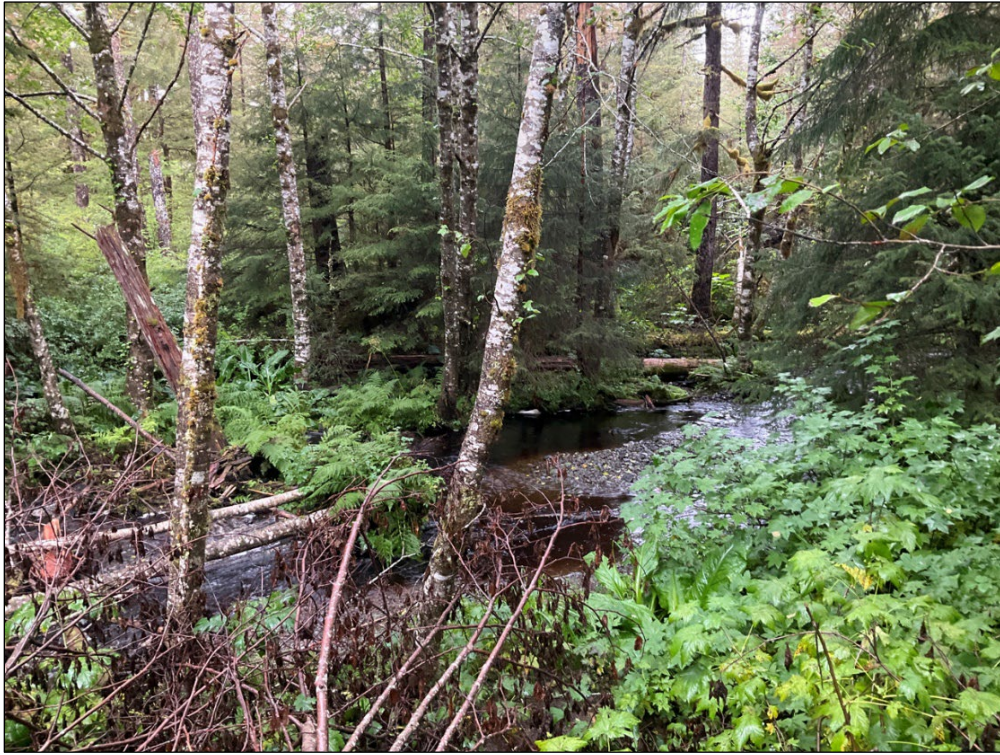
Figure 2.—Channel at waypoint 1425.

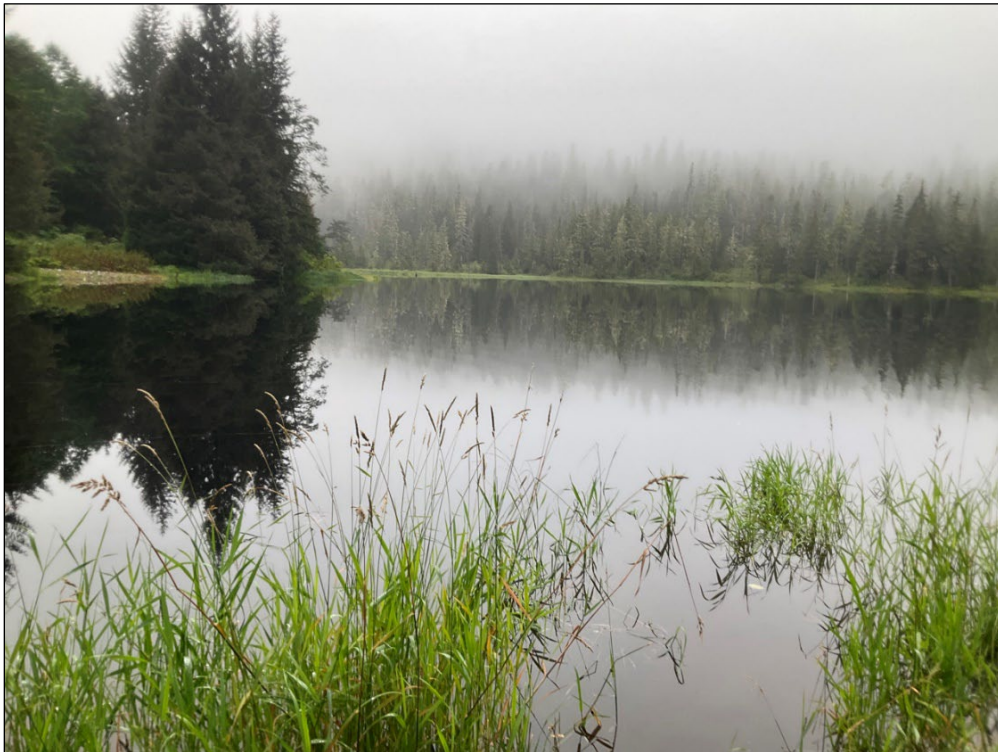
Figure 3.—Lake at waypoint 1440.

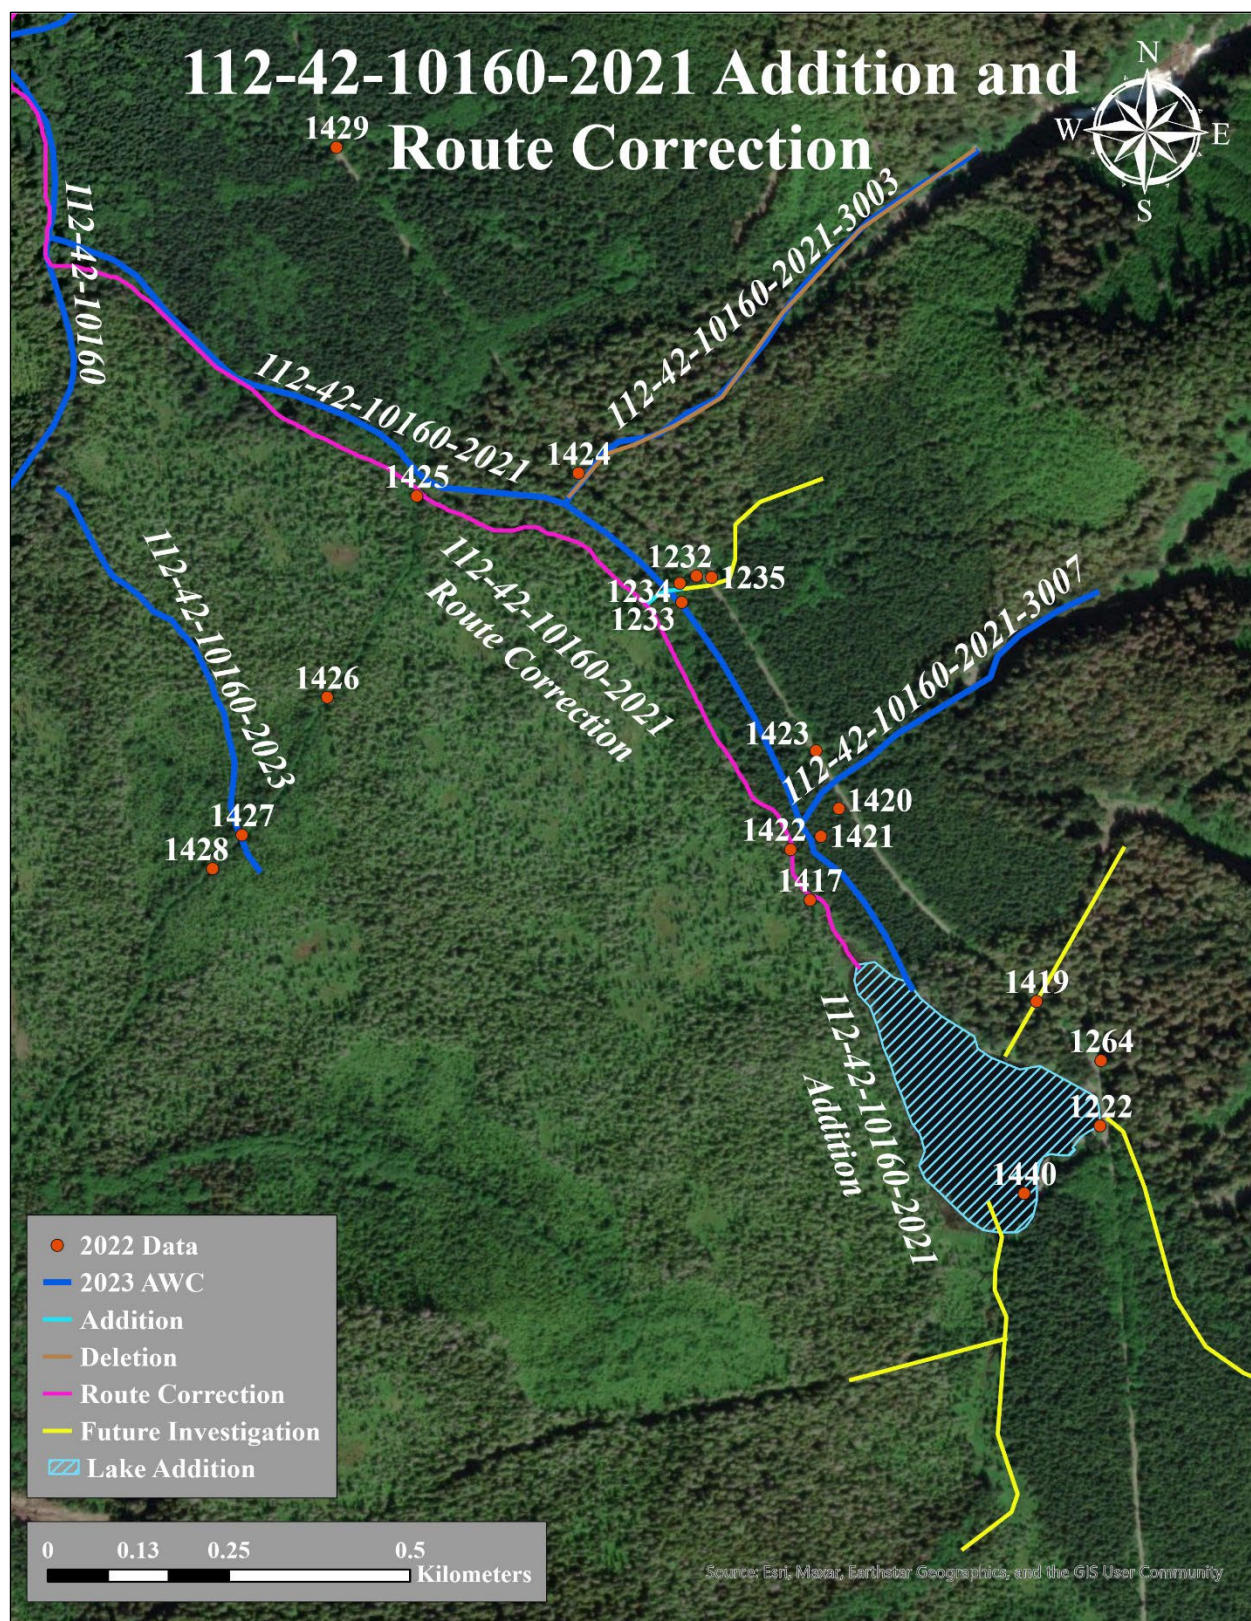
Figure 4.—Stream No. 112-42-10160-2021 addition and route correction map.

**Recommendations:** Extend upper extent of Stream No. 112-42-10160-2021 in the anadromous waters catalog for rearing coho salmon (Figure 4). Correct the route of this stream to match the field verified path drawn from a combination of survey points, USFS data and imagery.
