Alaska Department of Fish and Game

112-42-10200

CORRECTION

Water body name: *Muri Creek

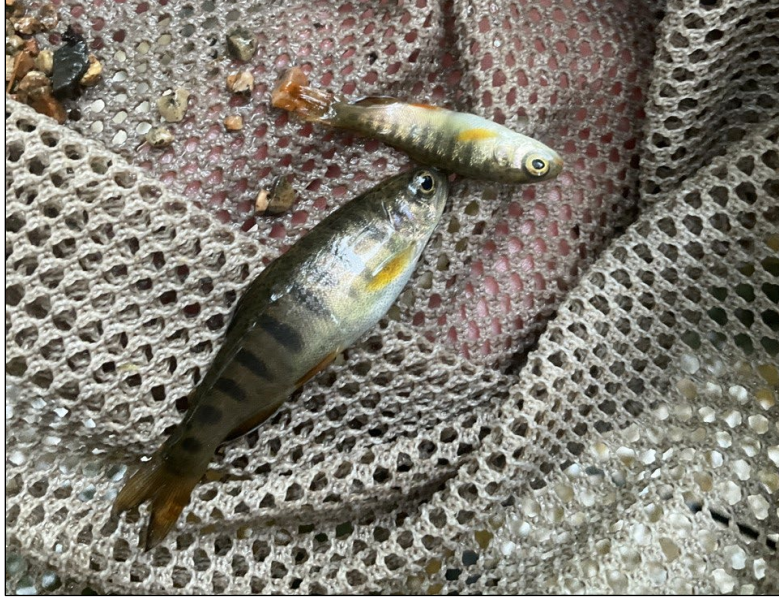
Figure 1.—Juvenile coho salmon captured at waypoint 1510.

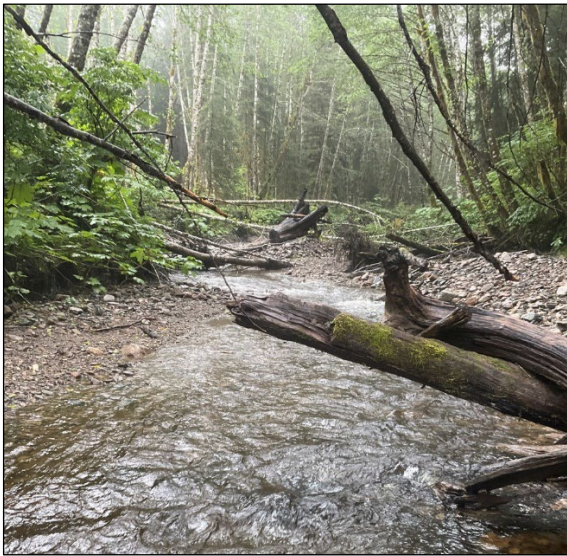
Figure 2.—Channel at waypoint 1510.

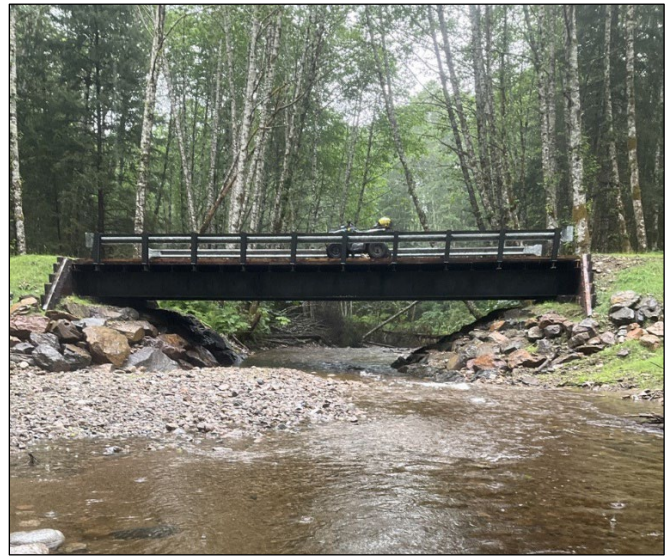
Figure 3.—Bridge at waypoint 1510.

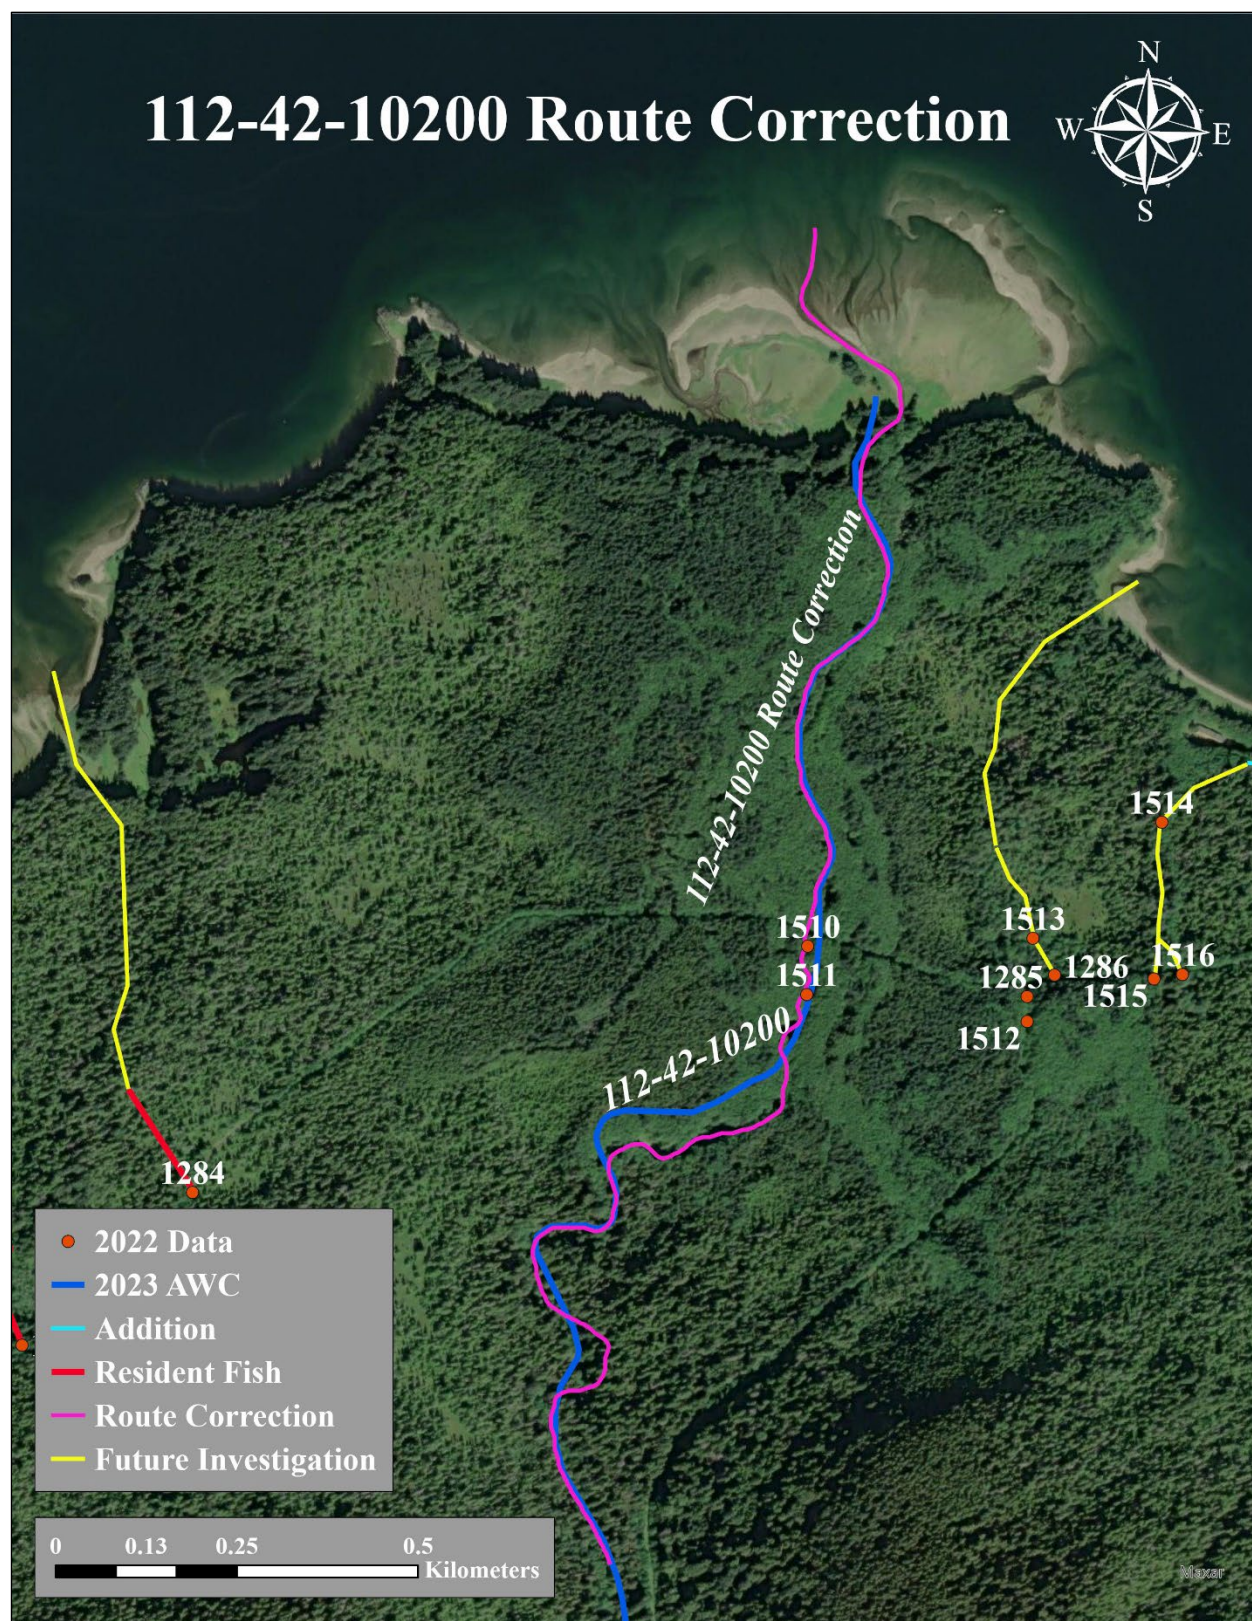
Figure 4.—112-42-10200 route correction map.

Findings: We surveyed the road crossing of this cataloged stream using a backpack electrofisher and GPS. We captured juvenile coho salmon and found that the stream path incorrectly mapped (Table 1; Figures 1–3).

Recommendations: Correct Stream No. 112-42-10200 in the anadromous waters catalog to reflect the field verified stream path drawn using updated imagery and USFS data (Figure 4).
