Alaska Department of Fish and Game

114-34-10200 Tributary 8

ADDITION

Survey date: 9/16/2022

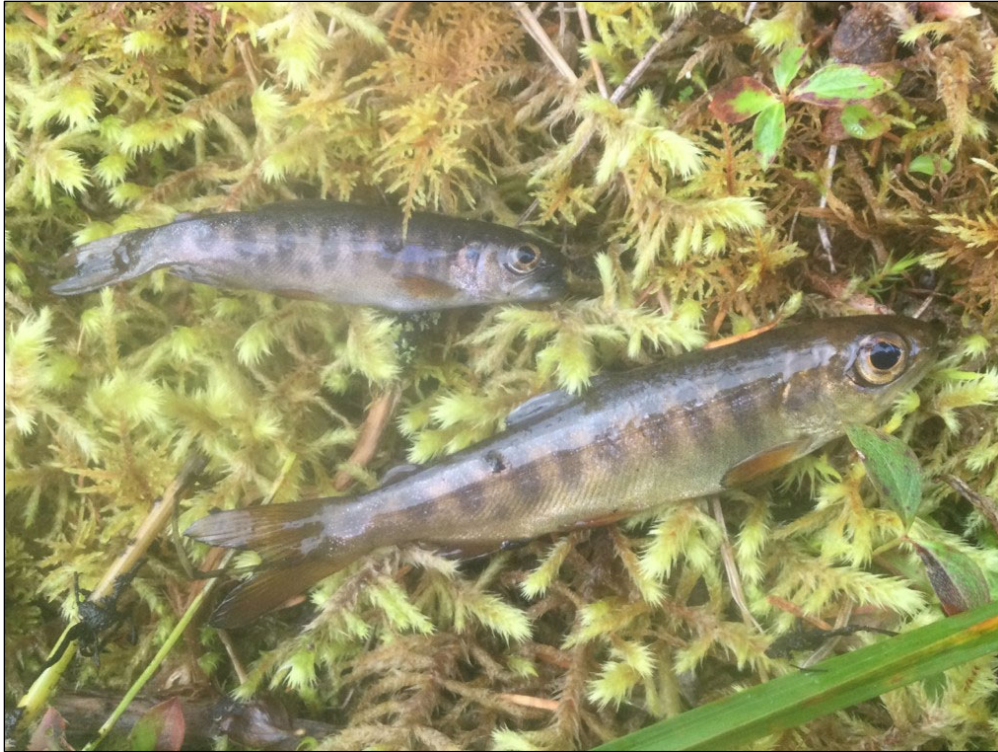
Figure 1.—Juvenile coho salmon captured at waypoint 1852.

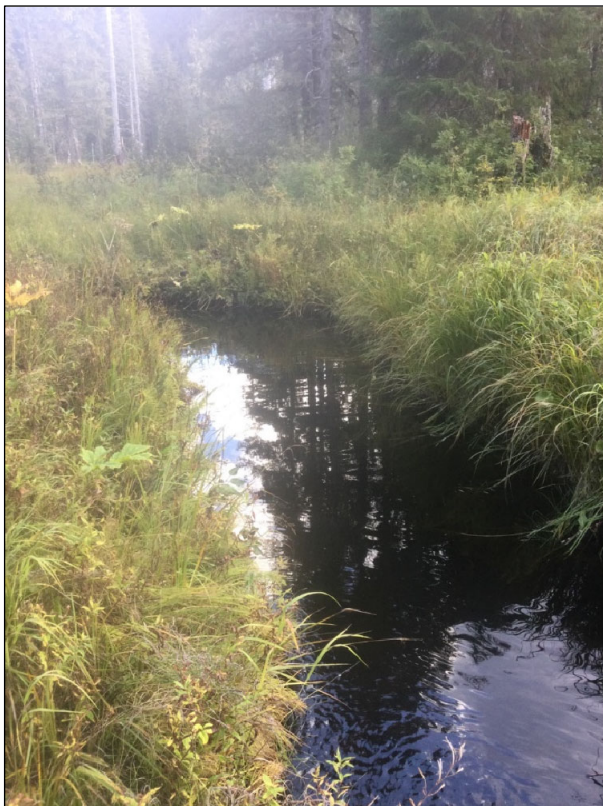
Figure 2.—Channel at waypoint 1862.

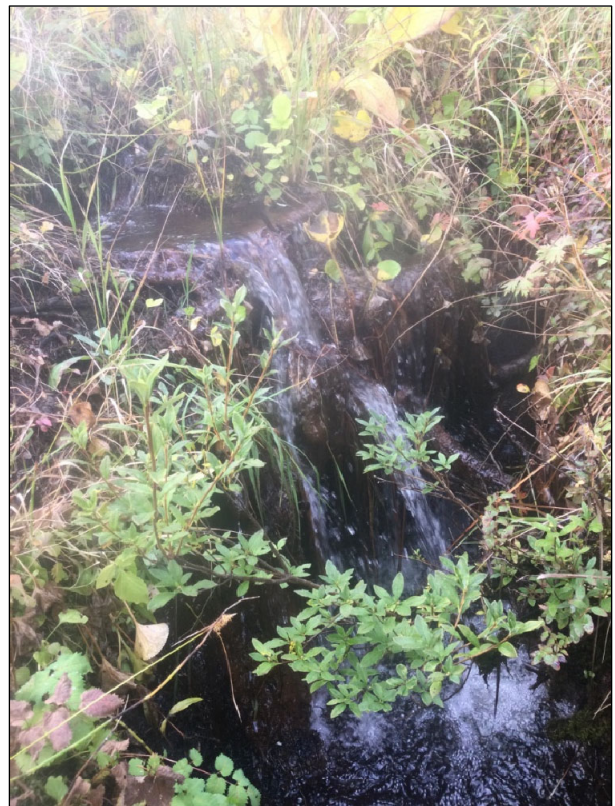
Figure 3.—Debris jam falls at waypoint 1852.
