# Alaska Department of Fish and Game

## 114-34-10100-2018 Tributary 1

## ADDITION

**Survey date:** 7/6/2022

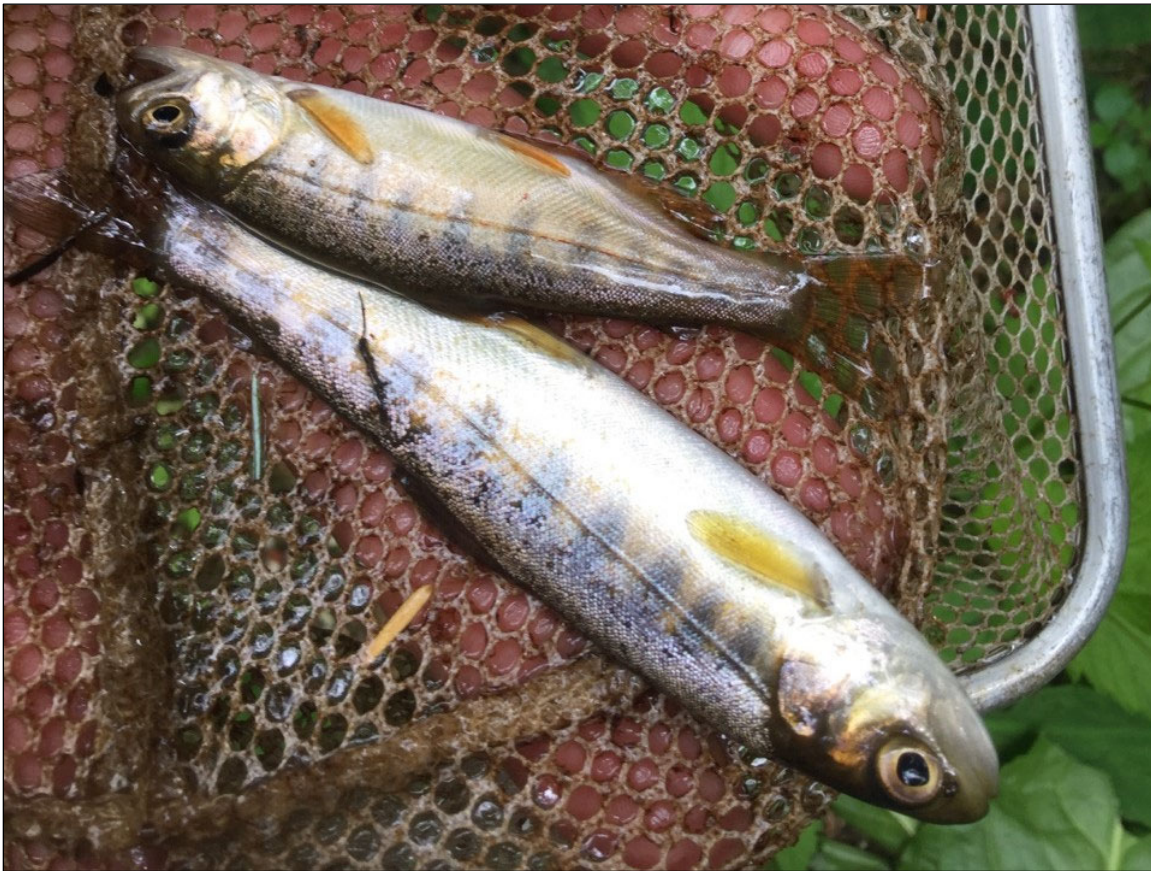
Figure 1.—Juvenile coho salmon captured at waypoint 933.

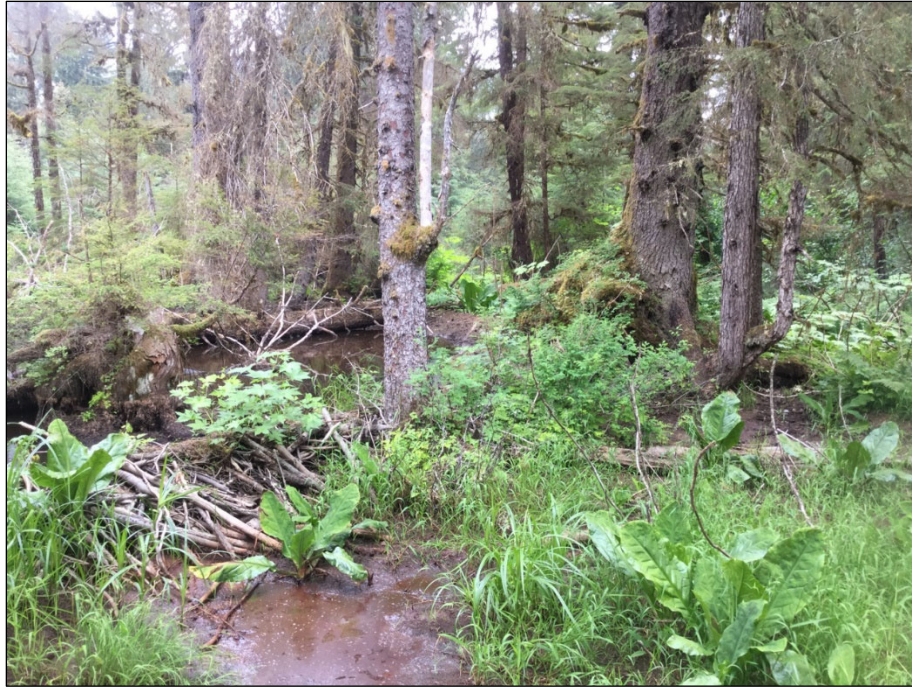
Waypoint	Latitude	Longitude	Notes	Stream Width ft	Stream Substrate	Habitat Features	Gradient %	Sample Effort	Sample Results
933	58.112005	-135.607166	Long beaver dam with ponded water upstream. Disconnected ponded water downstream of dam to river-right; channelized and connected straight downstream. Dam likely temporary barrier to juvenile fish passage. 2-yr CO capture just downstream of dam. End of survey on tributary.			Beaver Pond		EF	2 CO

Figure 2.—Complex of beaver dams at waypoint 933.

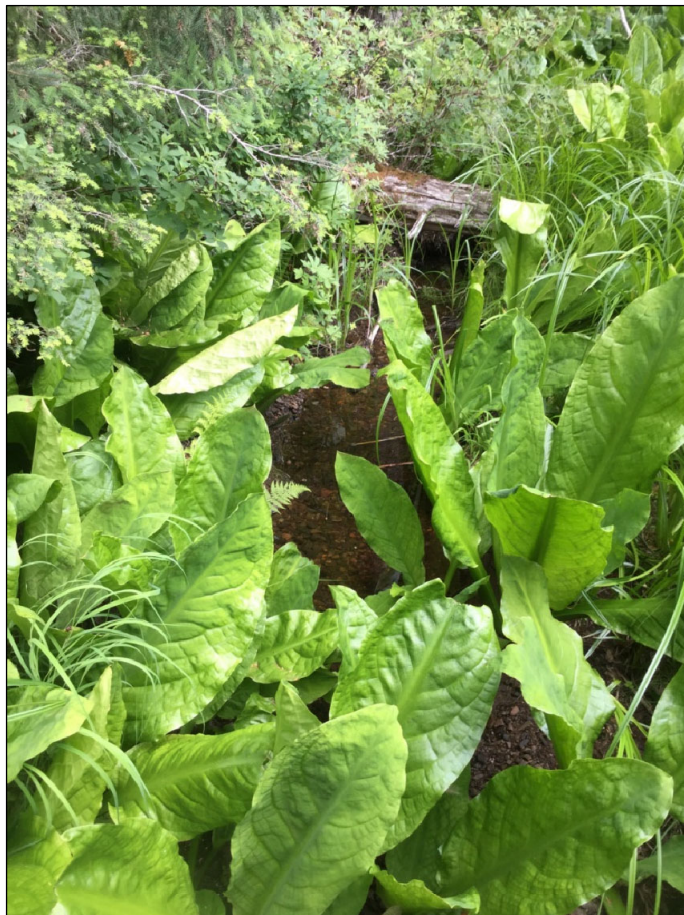
Waypoint	Latitude	Longitude	Notes	Stream Width ft	Stream Substrate	Habitat Features	Gradient %	Sample Effort	Sample Results
929	58.112413	-135.607659	No defined channel at road, crossing structure removed. Wetland on both sides, no surface water.	2-4			0-1	Not Fished	
930	58.112586	-135.608225	Channel flowing on edge of hillside. Large wetland on lowland side.	2-4	Small Gravel		0-1	EF	No Fish
931	58.112439	-135.608230	Advancing downstream on channel along edge of hillside; taking waypoints for possible route correction. Low water level. Resident fish capture.					EF	4 DV
932	58.112084	-135.607681	Beaver dam providing temporary barrier to fish passage. Low water level; at ordinary high water, dam likely 2-3' higher than water with no practical jump pool due to roadbed. Resident fish capture upstream of dam; no fish downstream.	2-4	Fine Organic	Beaver Pond	1-2	EF	4 DV

Figure 3.—Channel at waypoint 930.
