# Alaska Department of Fish and Game

Habitat Section  
Southeast Region

## 114-33-10230 Tributary 7

## ADDITION

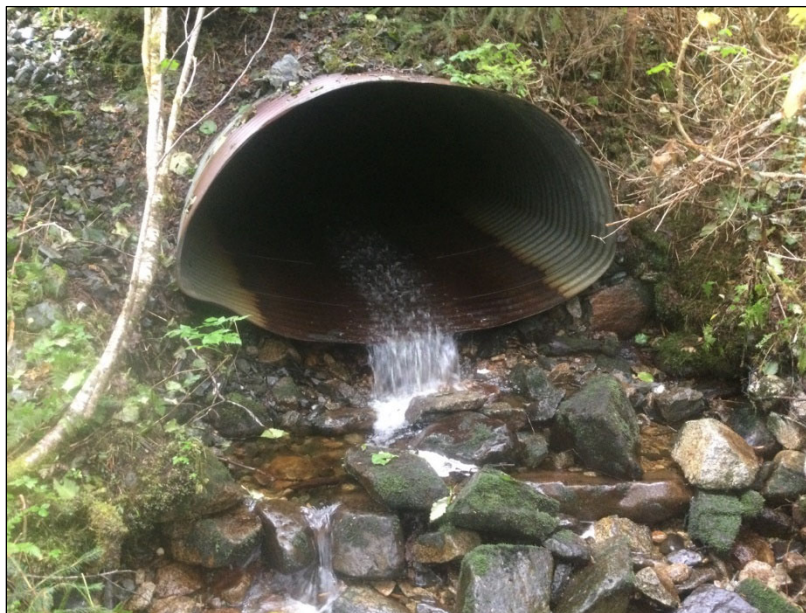
Waypoint	Latitude	Longitude	Notes	Stream Width ft	Stream Substrate	Habitat Features	Gradient %	Sample Effort	Sample Results
1804	58.092211	-135.854782	6' wide steel squash pipe, perched 4" but outfalls on to rip rap. Pipe is ~4% gradient and likely a non-FRPA barrier to anadromous fish passage. Incised channel below, 3'.	8-10	Cobble		8-10	EF	
1805	58.092400	-135.854005	Stream losing water. 4' tall root/debris jam that is likely a temporary, non-FRPA barrier at most flows.	8-10	Cobble Large Gravel		4-6	EF	2 CO 2 DV

Figure 1.—Culvert outlet at waypoint 1804.

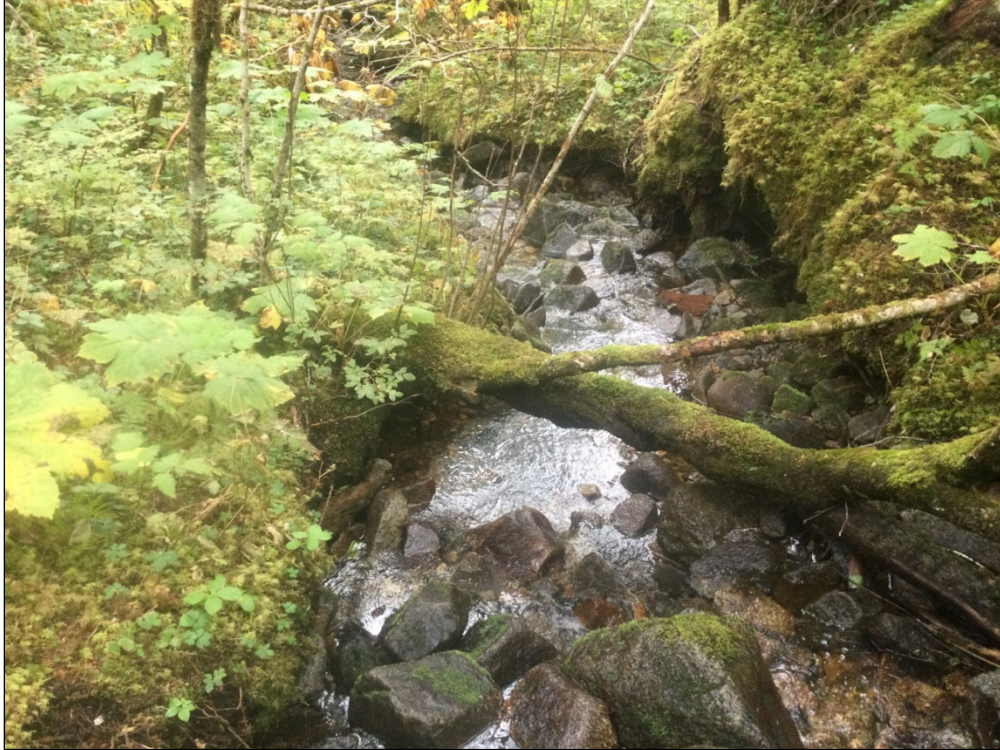
Figure 2.—Downstream view of channel at waypoint 1804.

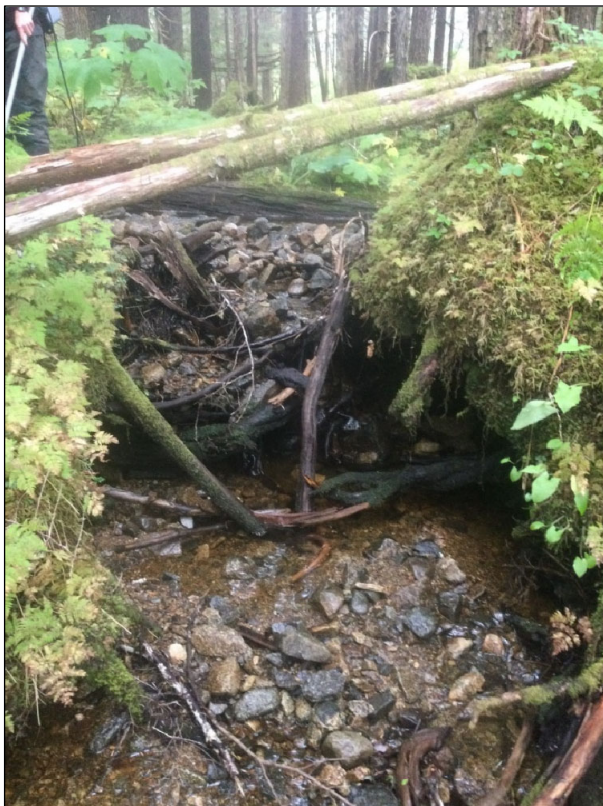
Figure 3.—Rootwad/debris jam at waypoint 1805.

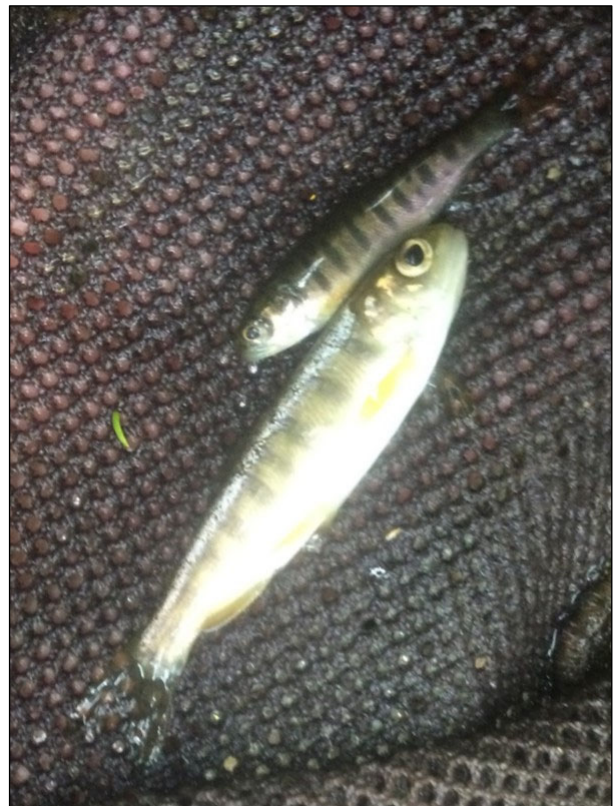
Figure 4.—Juvenile coho salmon captured at waypoint 1805.
