# Alaska Department of Fish and Game

## 113-51-10040 Tributary 6

## ADDITION

**Survey date:** 8/3/2023

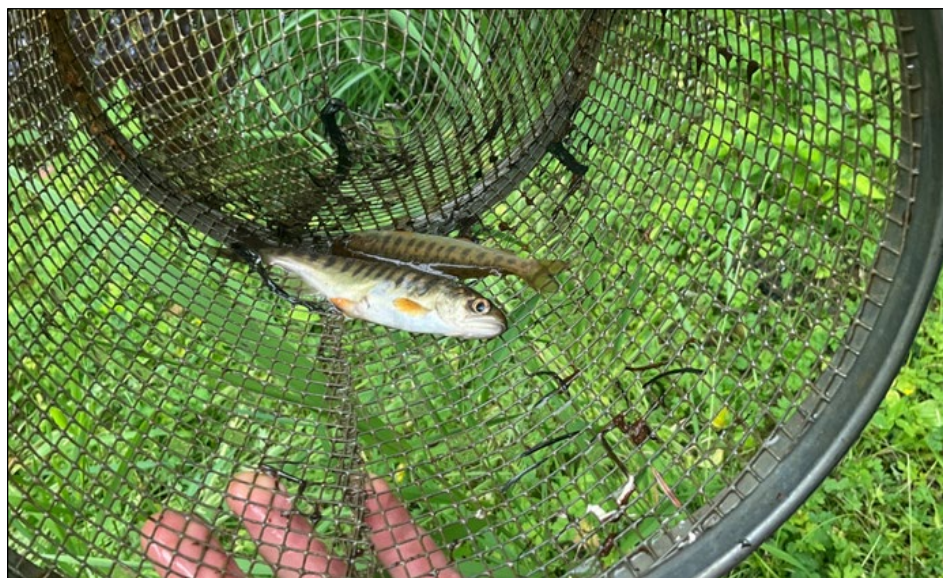
Figure 1.–Juvenile coho salmon caught at waypoint 428.

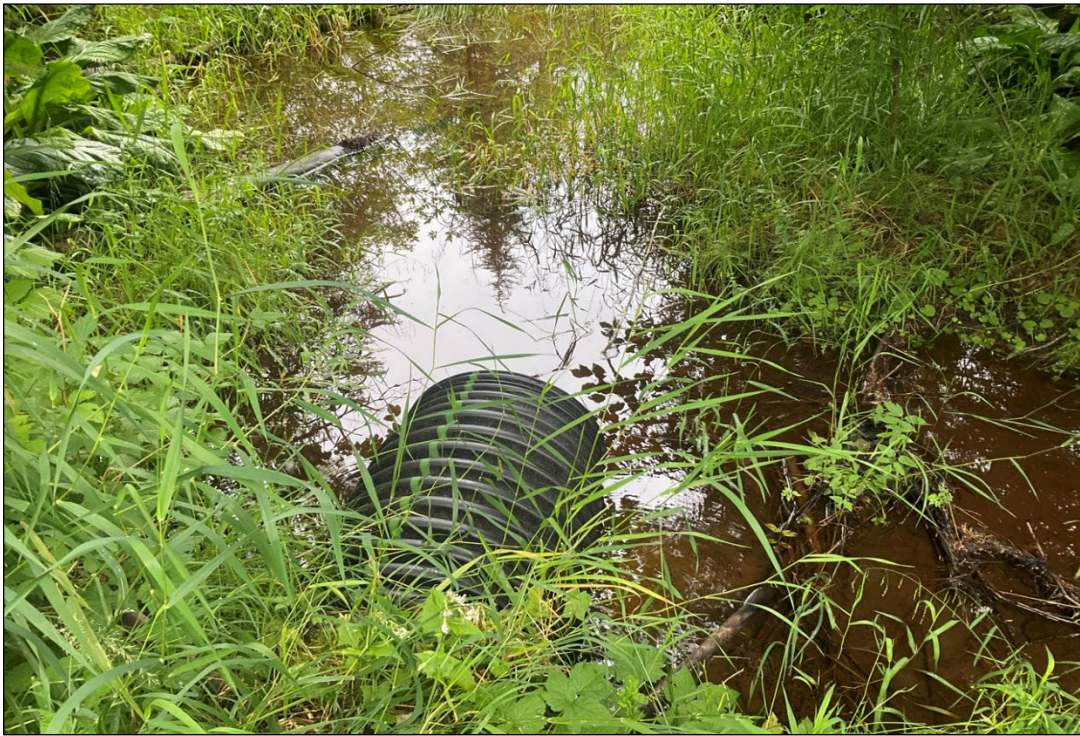
**Findings:** We surveyed this uncataloged stream using baited minnow traps and GPS and captured juvenile coho salmon. This stream is conveyed through a corrugated plastic pipe culvert at the road crossing. Water is ponded on the upstream side of the road, potentially from a nearby beaver complex. The culvert outlet was slip lined with a downward facing L-shaped metal pipe (Table 1; Figures 1–3). Baited minnow traps were used further upstream at the road crossing at waypoint 447, but no fish were caught; I recommend future investigation as fish habitat may continue.

Figure 2.—Culvert inlet at waypoint 428.

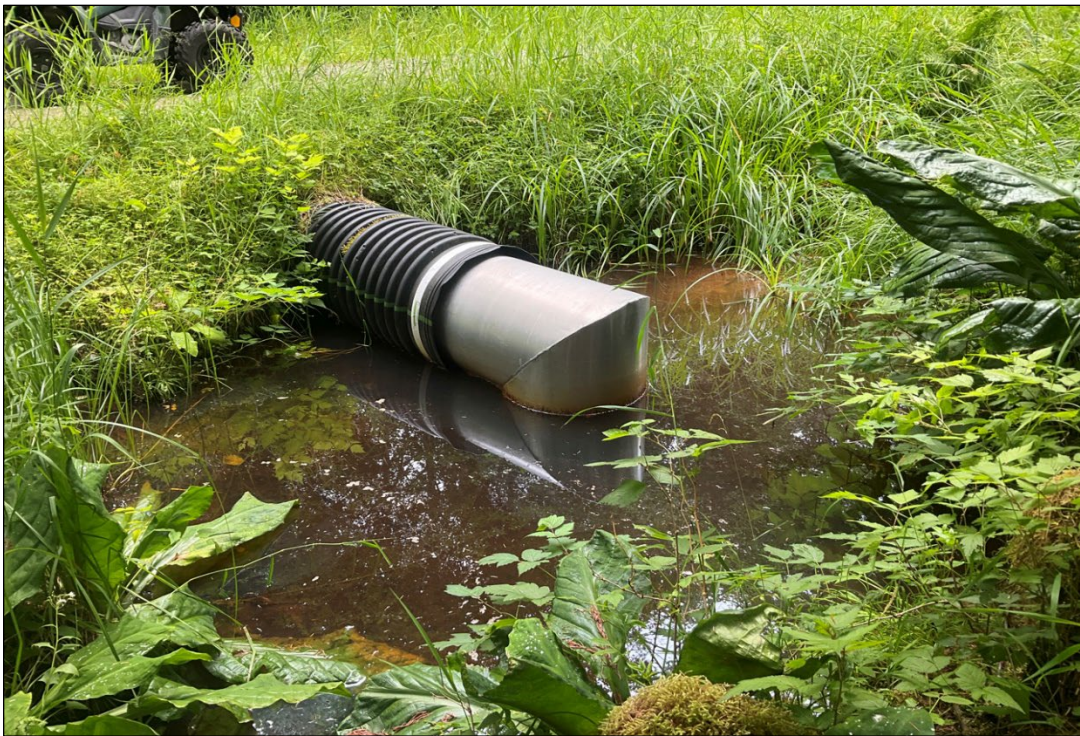
Figure 3.—Culvert outlet at waypoint 428.
