# Alaska Department of Fish and Game

Habitat Section  
Southeast Region

## 113-51-10040-2005 Tributary 3

## ADDITION

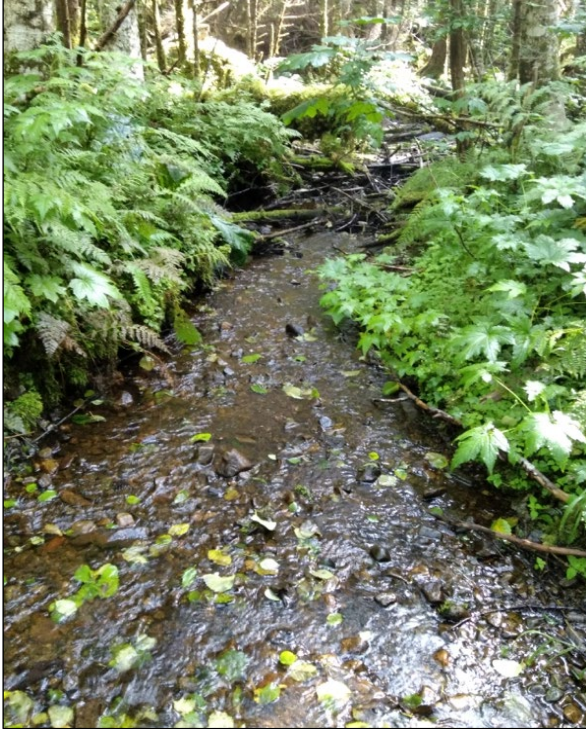
Figure 1. Upstream at waypoint 570.

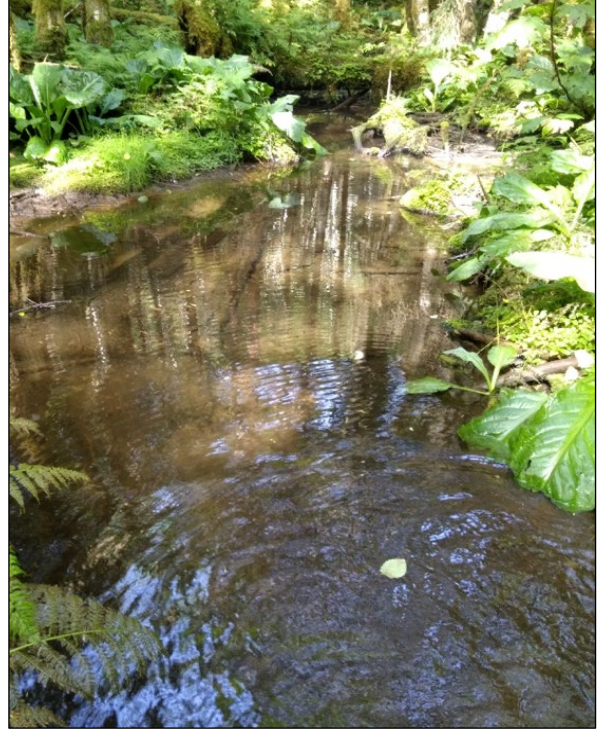
Figure 2. Downstream at waypoint 570.

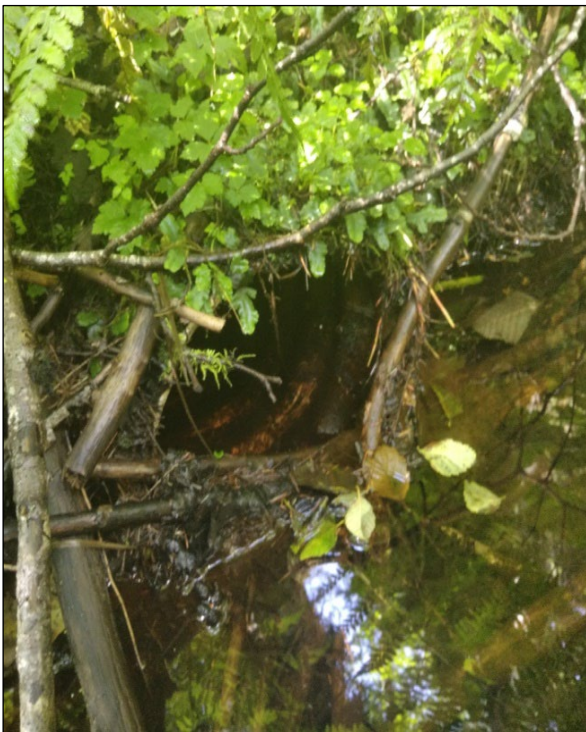
**Findings:** We surveyed this uncataloged stream using a backpack electrofisher and GPS and captured juvenile coho salmon and Dolly Varden char. This tributary leads to an old, corrugated metal pipe that has partial blockage at the inlet due to debris build up, but water still flows through. Only resident fish were seen above the pipe. A section of an old second pipe was partially buried in the ground near the stream as well (Table 1; Figures 1–6).

Figure 3. Culvert inlet at waypoint 571.

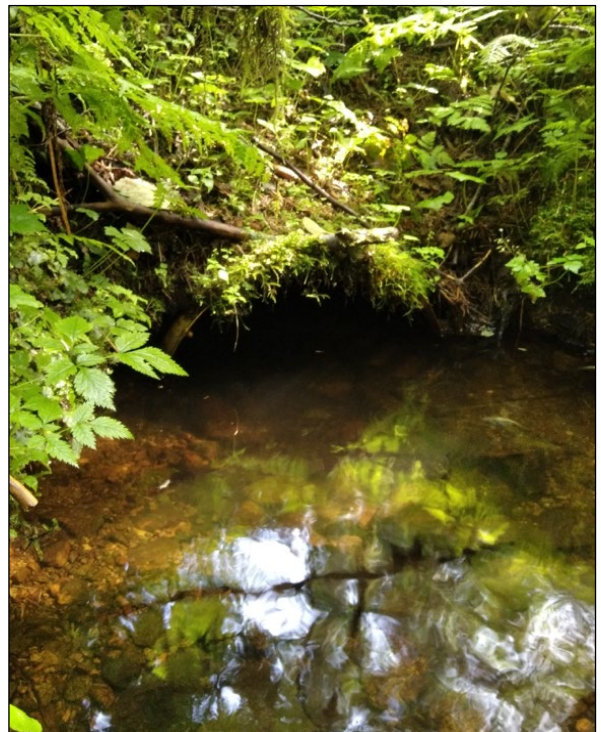
Figure 4. Culvert outlet at waypoint 571.

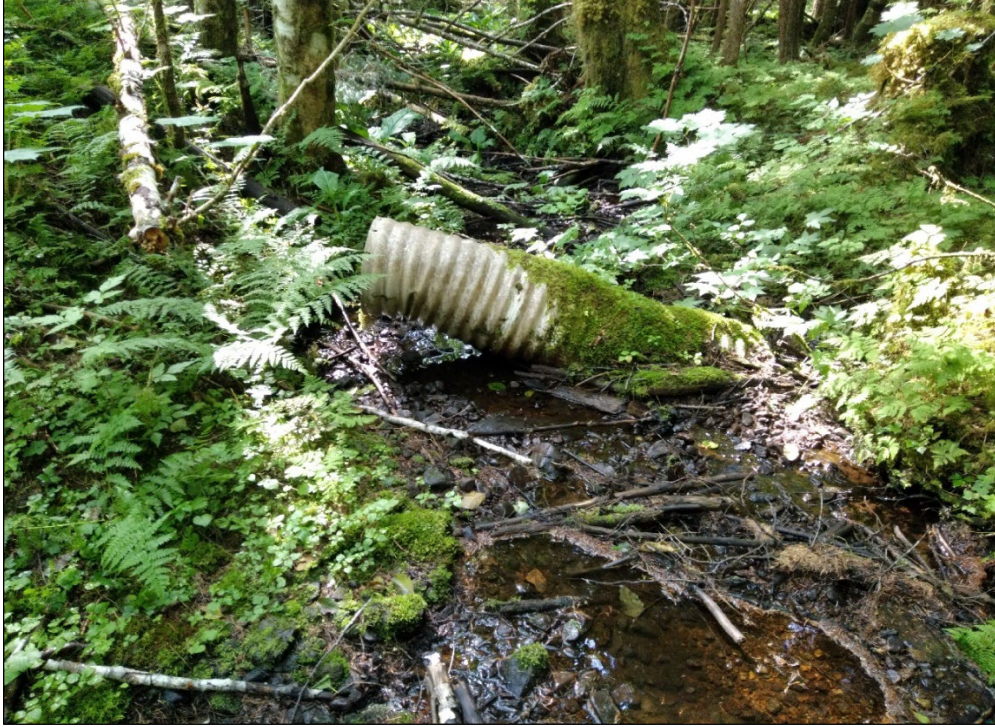
Figure 5. Old pipe section at waypoint 571.

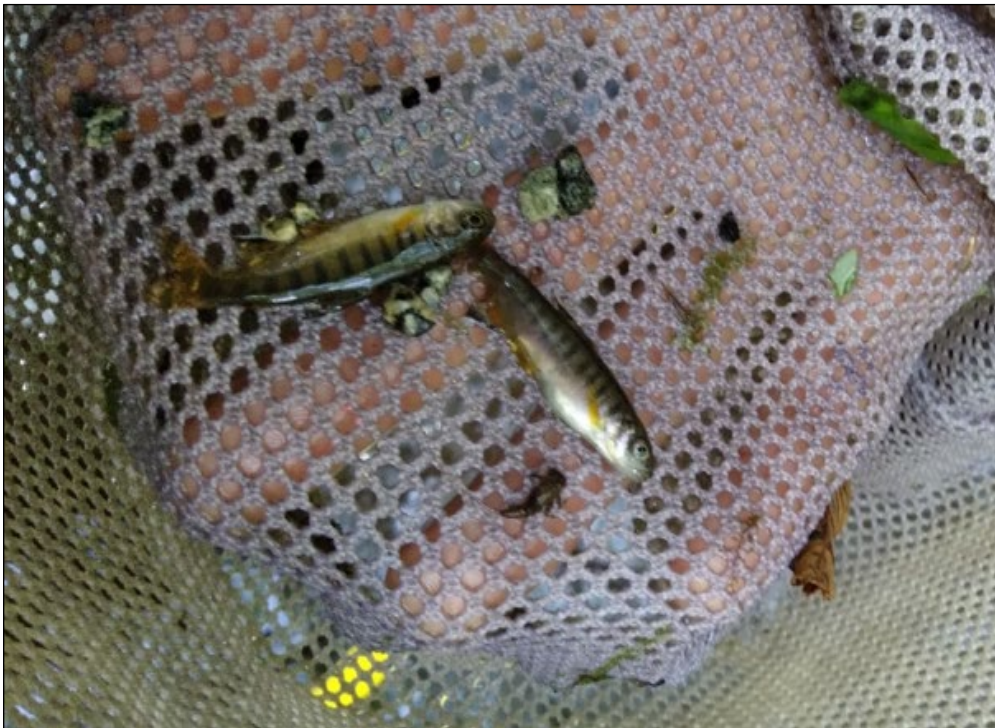
Figure 6. Juvenile coho salmon caught at waypoint 570.

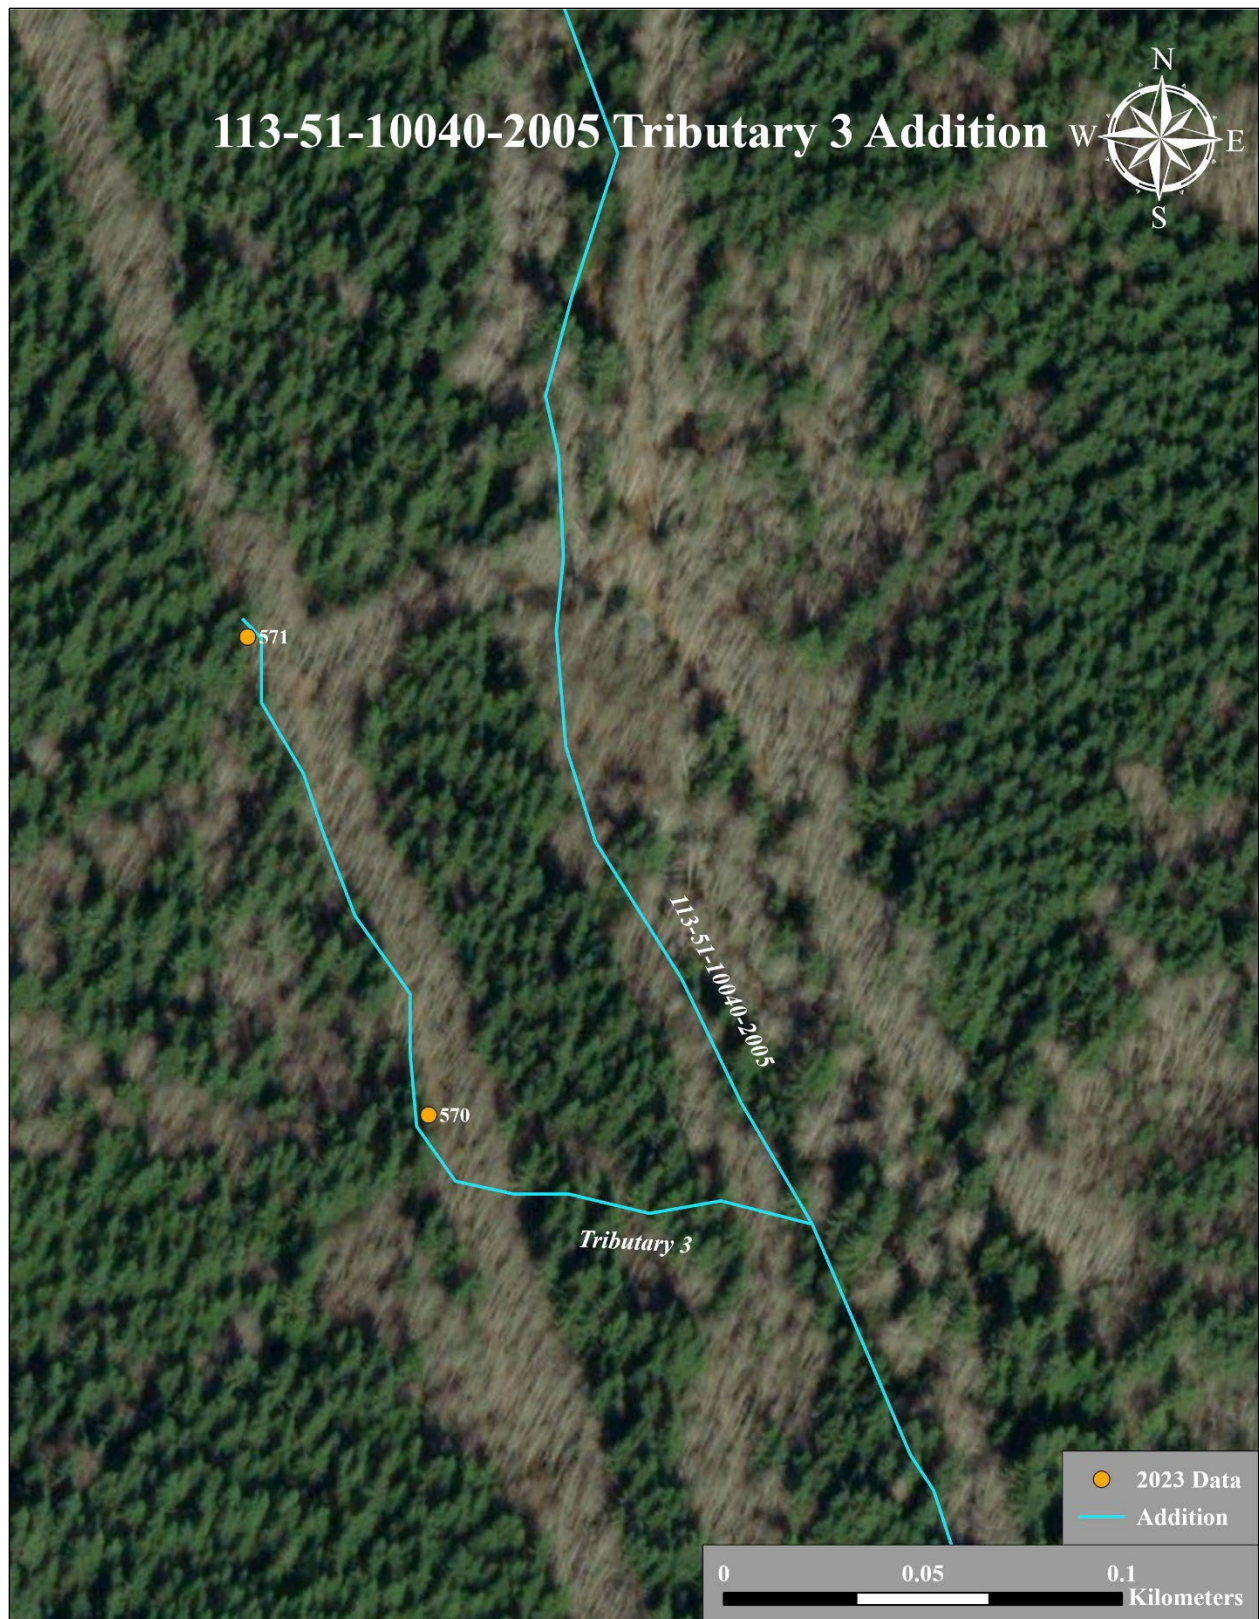
Figure 7. 113-51-10040-2005 Tributary 3 Addition map.

**Recommendations:** Add this uncataloged stream up to waypoint 571 to the anadromous waters catalog for rearing coho salmon (Figure 7).
