# Appendix: Skagway

## Guide to direct fieldwork for cataloging anadromous water bodies in Southeast Alaska

## SKAGWAY SURVEYS

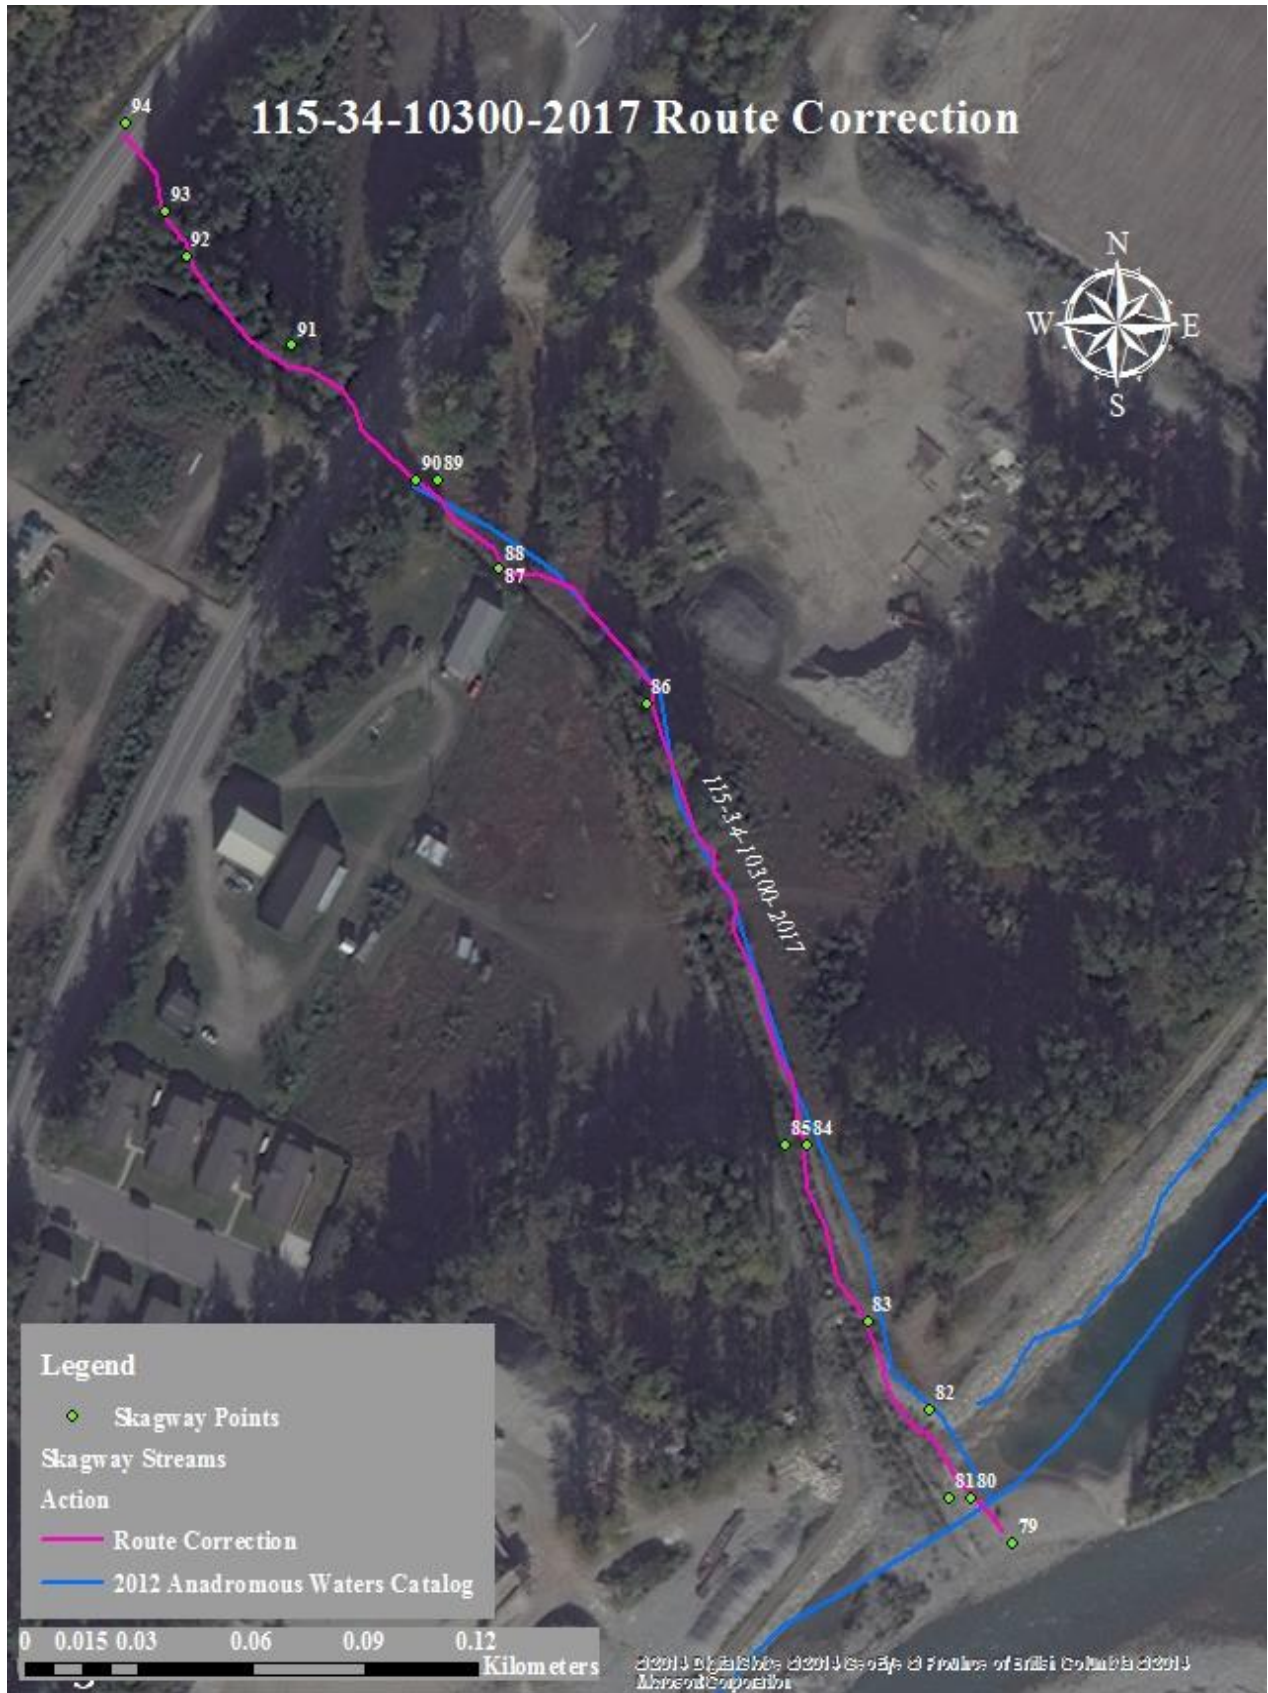
Figure 1.—115-34-10300-2017 route correction map.

**Findings:** We surveyed and tracked this stream and found juvenile coho salmon present past the current AWC upper extent (Table1). There is a barrier cascade just upstream of the culvert that passes under the Klondike Highway. Several juvenile coho salmon were in the pool under the cascade.

**Recommendations:** Extend coho salmon rearing for this stream in the AWC (Figure 1).

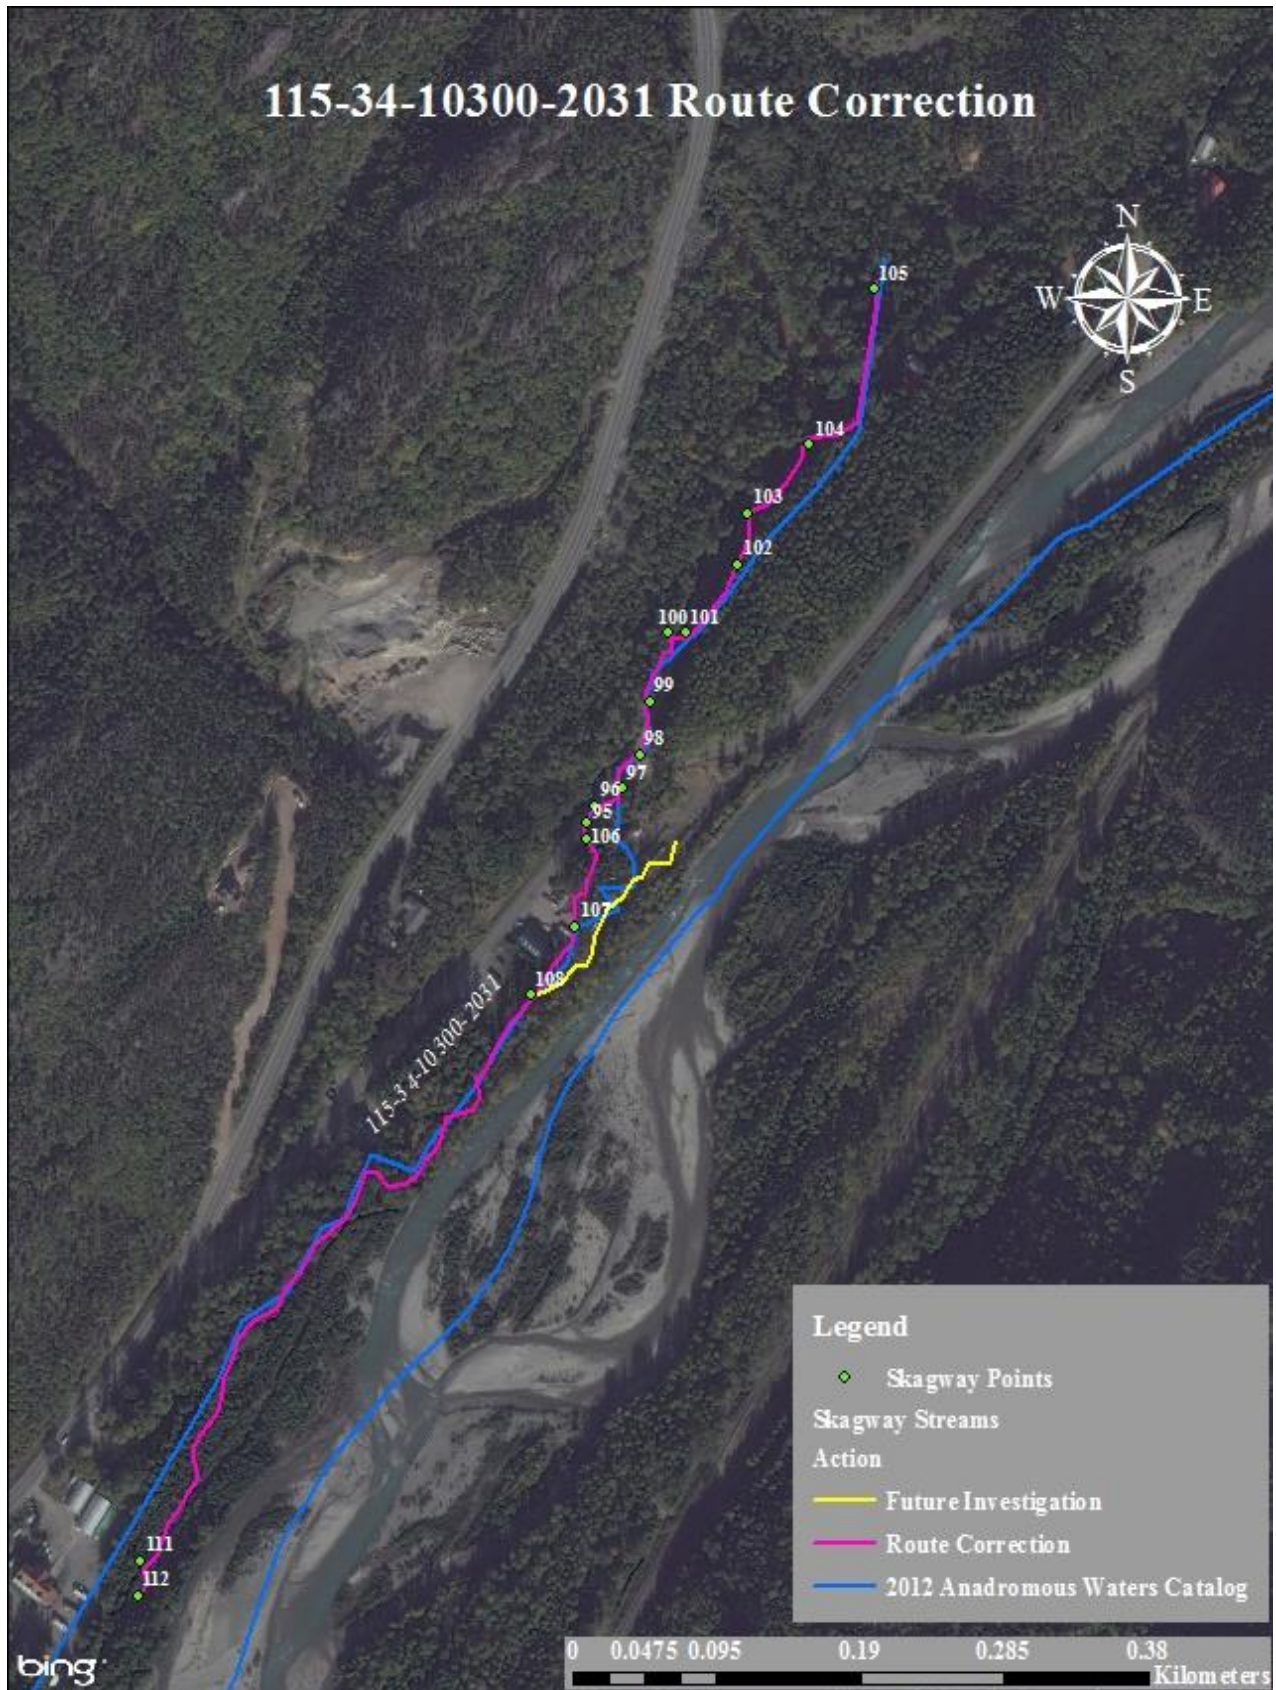
Figure 1.—115-34-10300-2031 route correction map.

**115-34-10300-2031****CORRECTION****Water body name:****Survey date:** 8/29/2012**Water body number:** 115-34-10300-2031**Species & Lifestage:** CO, DVr**Watershed:** Skagway River**MTR:** C027S060E **Quad:** Skagway B-1**Findings:** We tracked and surveyed this stream and found its route differs from the catalog (Table 1). We followed stream to its confluence with Skagway River.**Recommendations:** Update stream route in AWC (Figure 1).**Nomination:** 12-615

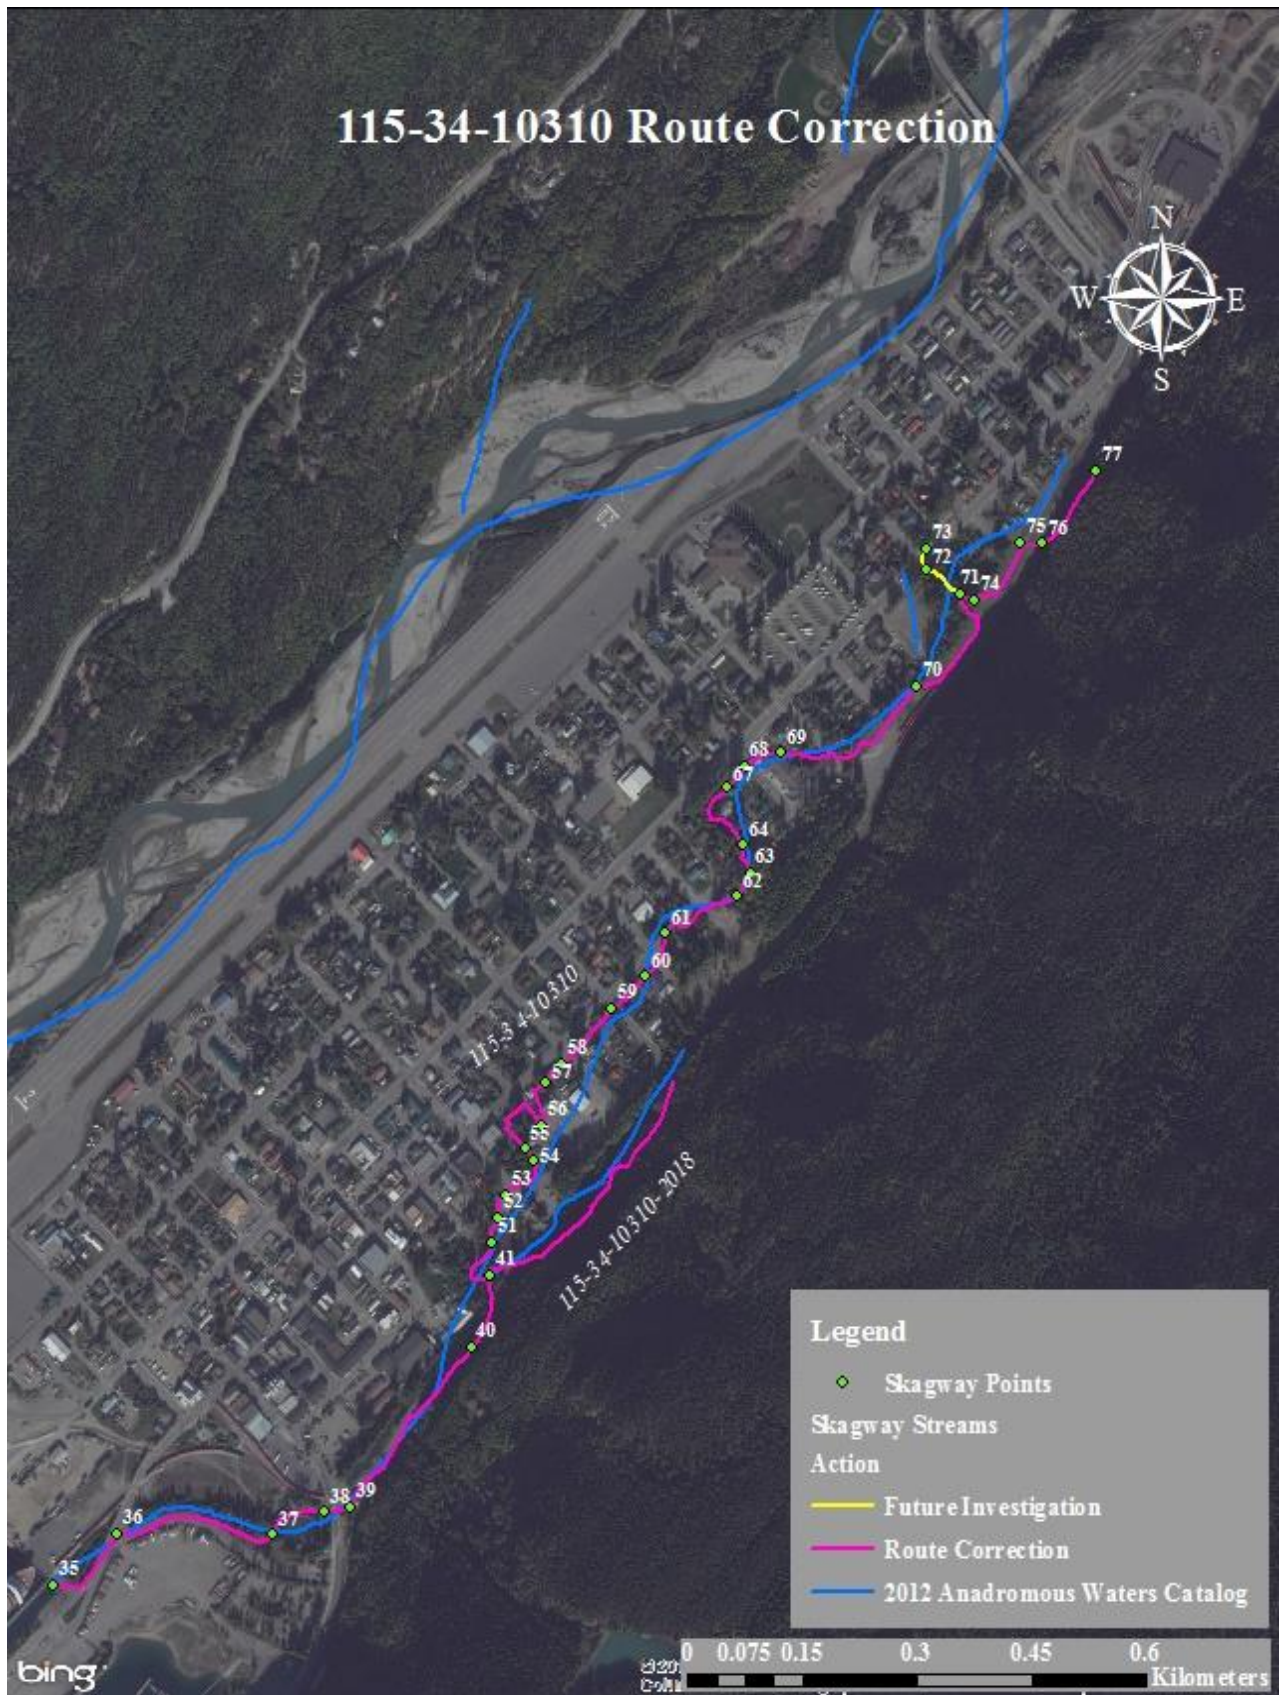
Figure 1.—115-34-10310 route correction map.

**115-34-10310****CORRECTION****Water body name:** Pullen Creek**Survey date:** 8/29/2012**Water body number:** 115-34-10310**Species & Lifestage:** CHp, COsr, Ps, DVsr**Watershed:** Skagway River**MTR:** C028S059E **Quad:** Skagway B-1**Findings:** We tracked and surveyed this stream and found the stream route differs from the catalog (Table 1).**Recommendations:** Update the stream route in the AWC (Figure 1).**Nomination:** 12-612

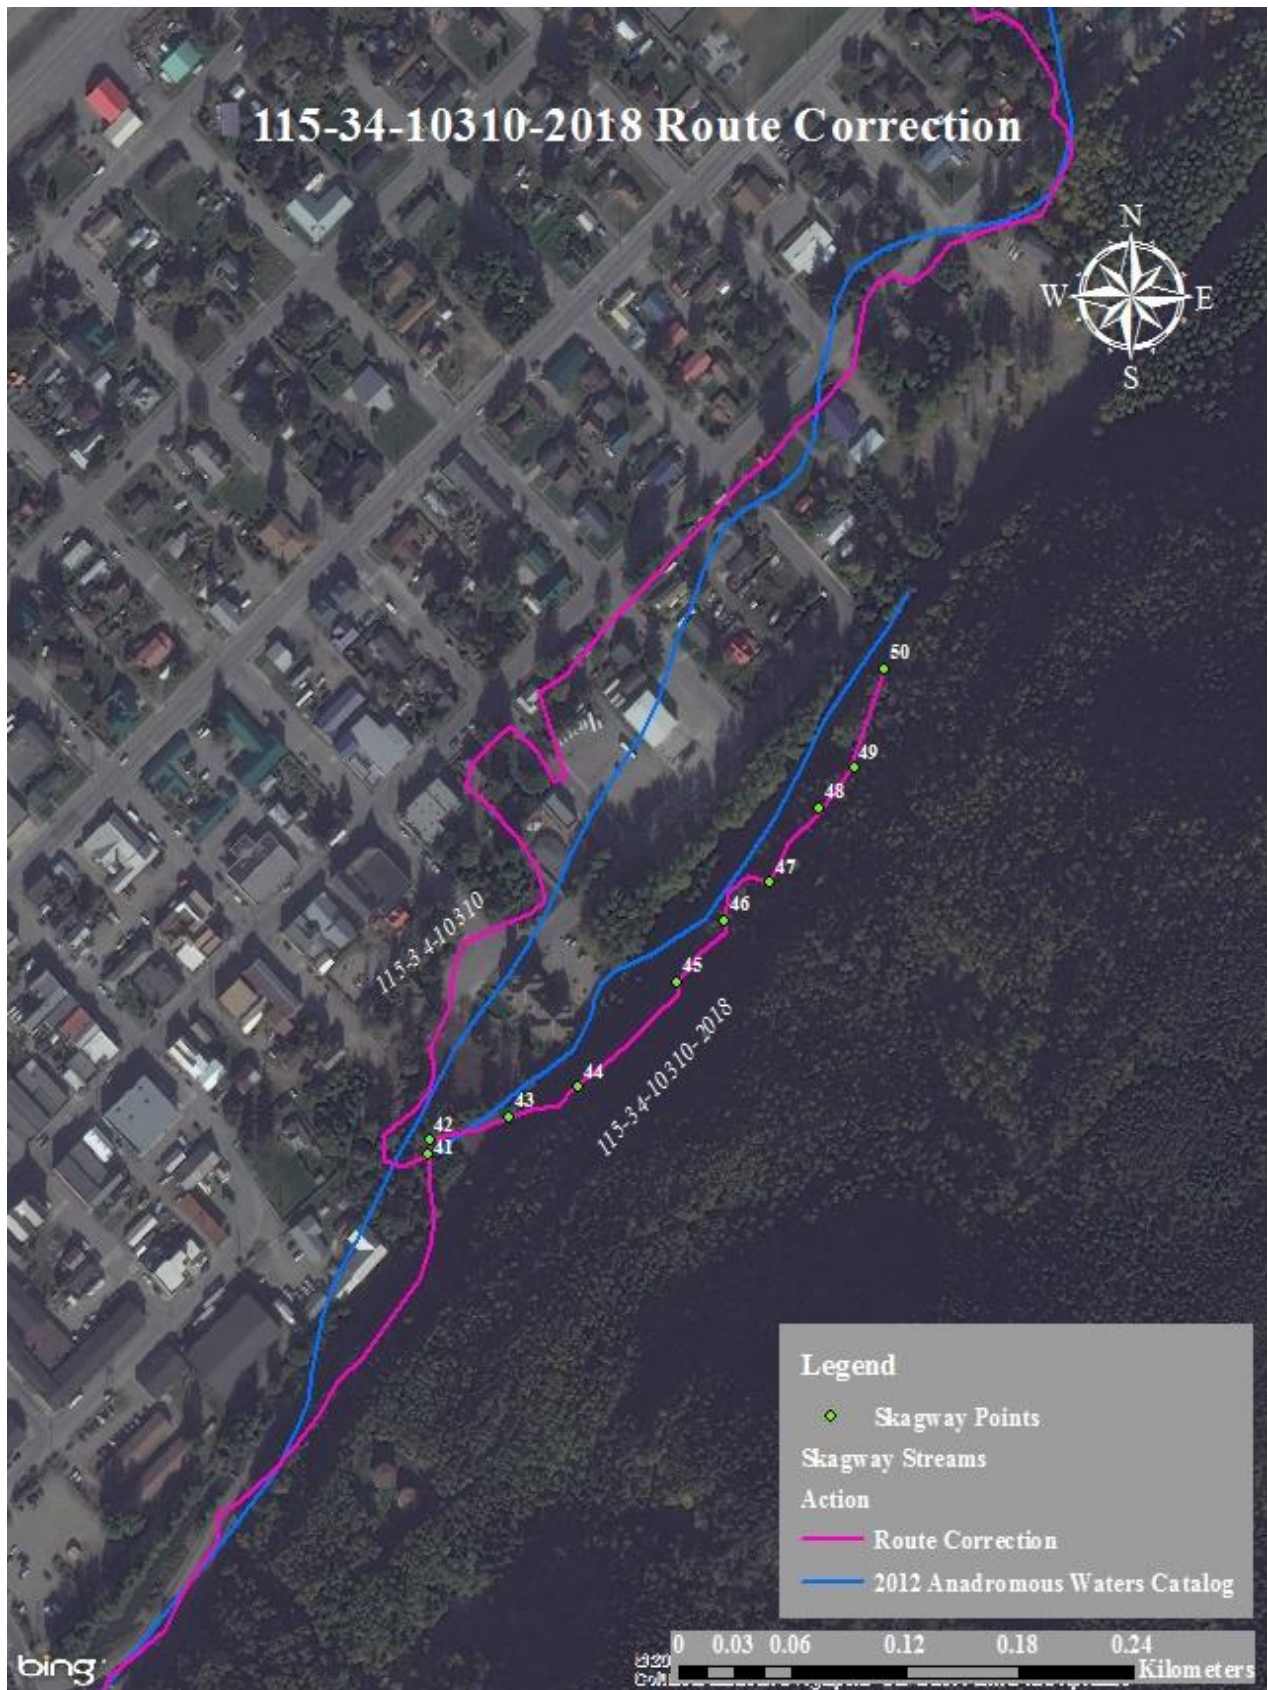
Figure 1.-115-34-10310-2018 route correction map.

**115-34-10310-2018****CORRECTION****Water body name:****Survey date:** 8/28/2012**Water body number:** 115-34-10310-2018**Species & Lifestage:** COsr, DVr**Watershed:** Skagway River**MTR:** C028S059E **Quad:** Skagway B-1**Findings:** We tracked and surveyed this stream and found the stream route differs from what is in the catalog (Table 1).**Recommendations:** Update the stream route in the AWC (Figure 1).**Nomination:** 12-613
