Technical Report No. 21-02

Eklutna River Aquatic Habitat Monitoring, 2017 Through 2020

February 2021

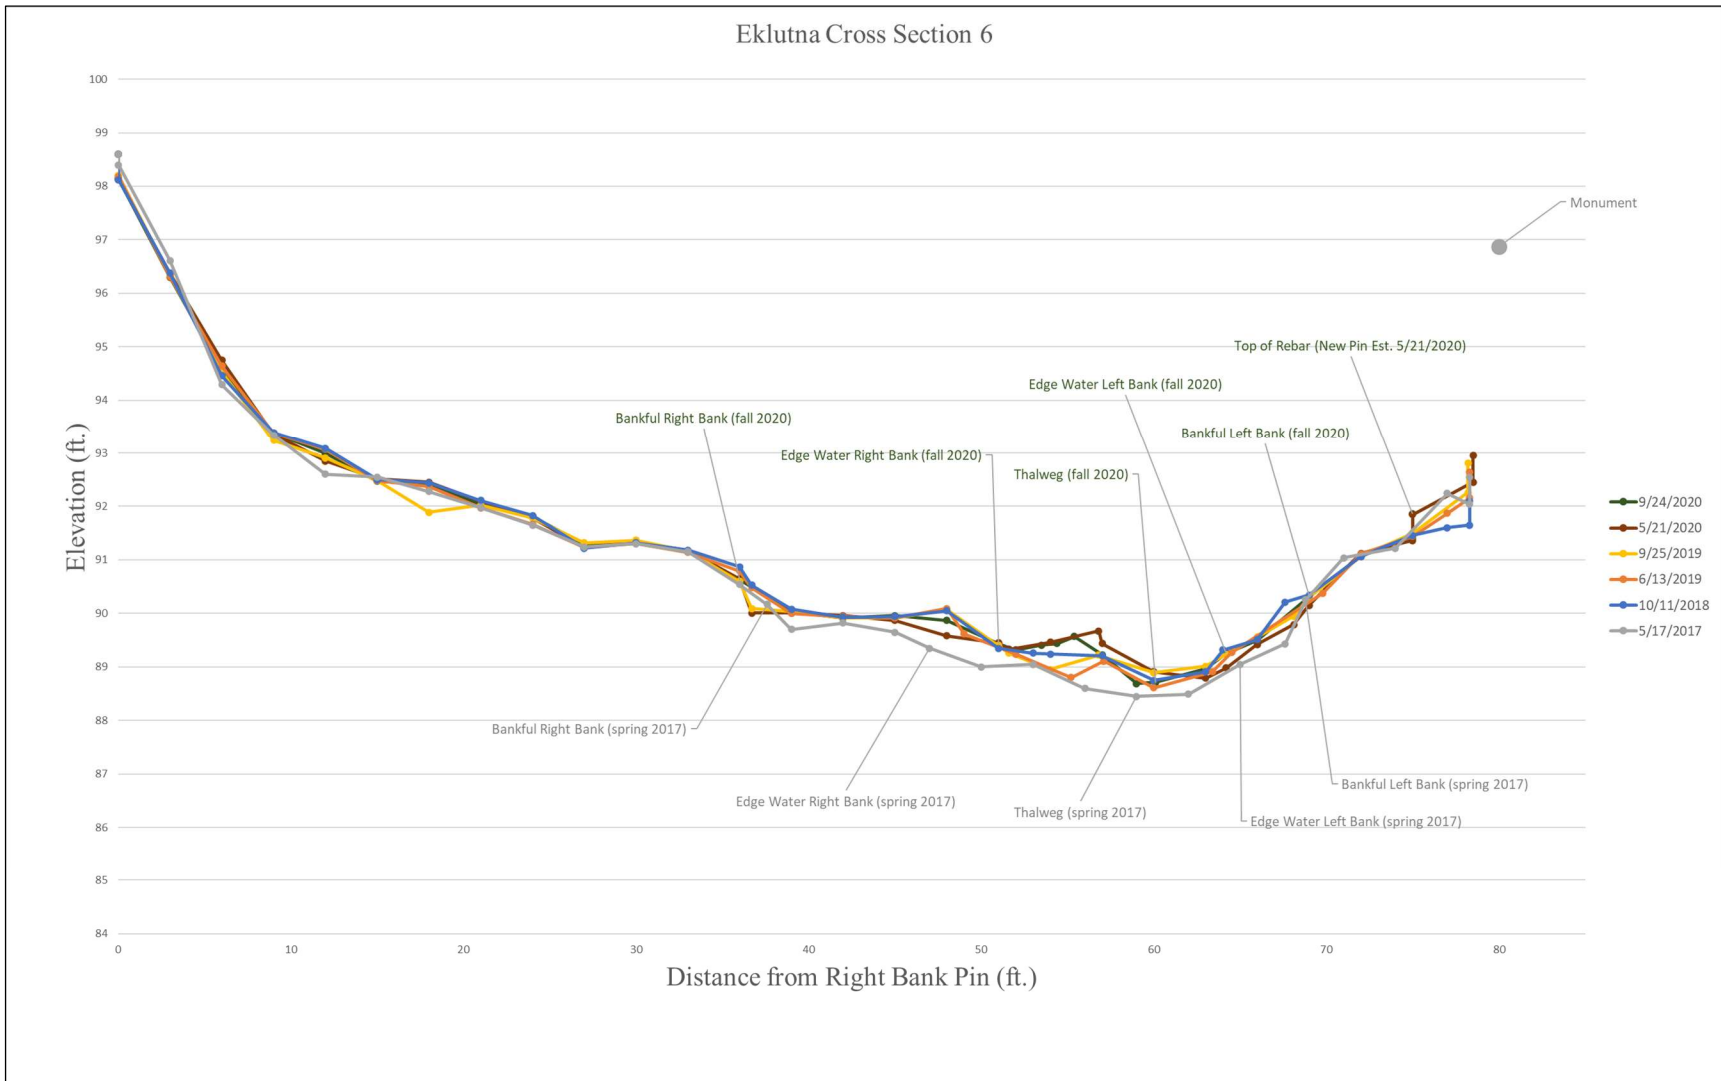
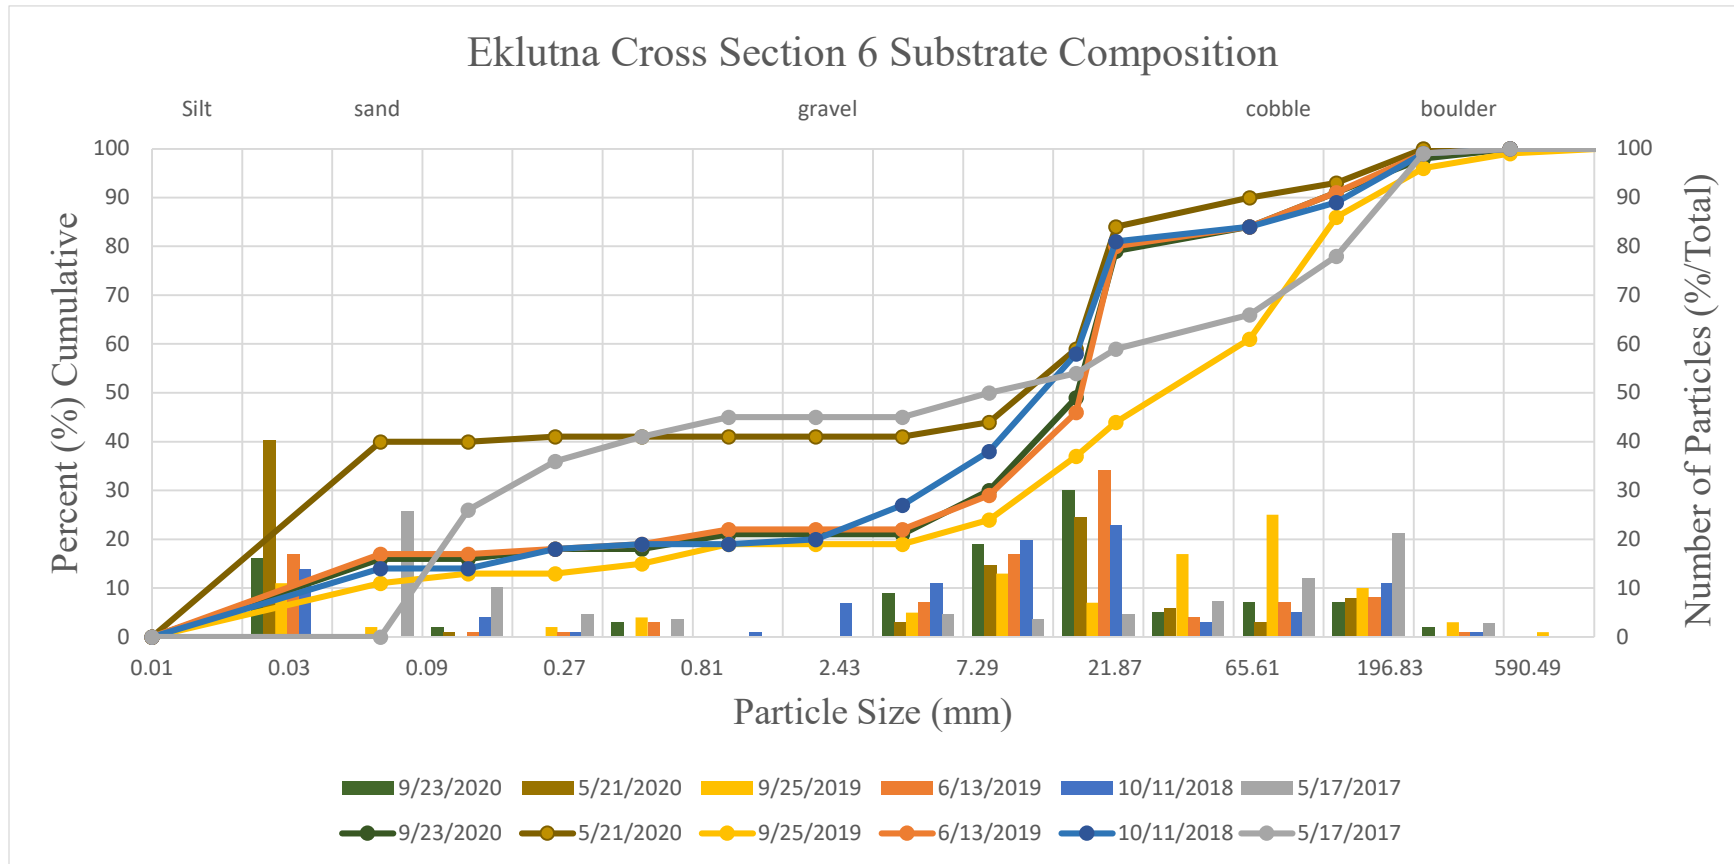
Appendix A1.–Eklutna 6 Channel Geometry and Substrate Composition.

We found that the channel had begun to down-cut into the previously aggraded material by about ¼ foot. Substrate composition became increasingly dominated by *Silts* and *Coarse Gravel*, with the D₅₀ increasing further to *Coarse Gravel* and the D₈₄ decreasing slightly. Embeddedness was noted to have decreased from prior sampling events. Water quality variables generally were non-noteworthy; however, pH was recorded at 8.7. The dissolved oxygen level was recorded to be within expected range (approximately 100% saturation).

The channel had again begun to aggrade nearly to the level observed during the October 2018 visit. Substrate composition was dominated by *Silts* and *Fine Cobble*, while the D₅₀ increased to *Very Coarse Gravel* and the D₈₄ increased to *Small Cobble*. Substrate embeddedness was noted to have continued to decrease from previous sampling events. Water quality variables were not noteworthy, but pH was high at 8.44.

The channel had generally remained stable from 2019 visits, although a mid-channel bar formed by the accumulation of fine gravels and sand likely conveyed downstream from the eroding sediment wedge. The D₅₀ decreased nearly to 2017 levels from *Very Coarse Gravel* to *Medium Gravel* while the D₈₄ similarly decreased from *Small Cobble* to *Coarse Gravel*. Substrate embeddedness was noted to have further decreased. Water quality variables were again not noteworthy, but pH was again high at 8.28 and due to elevated flows, turbidity was elevated at nearly 600 NTU.

The channel morphology was again similar, although D₅₀ increased to previous 2019 recordings of *Coarse Gravel* and D₈₄ similarly returned to *Very Coarse Gravel*. Substrate embeddedness was observed to be similar to 2019 observations. Water quality variables were again similar to previous visits although turbidity decreased to 35 NTU representing the lowest recording for this variable at this site during this study.

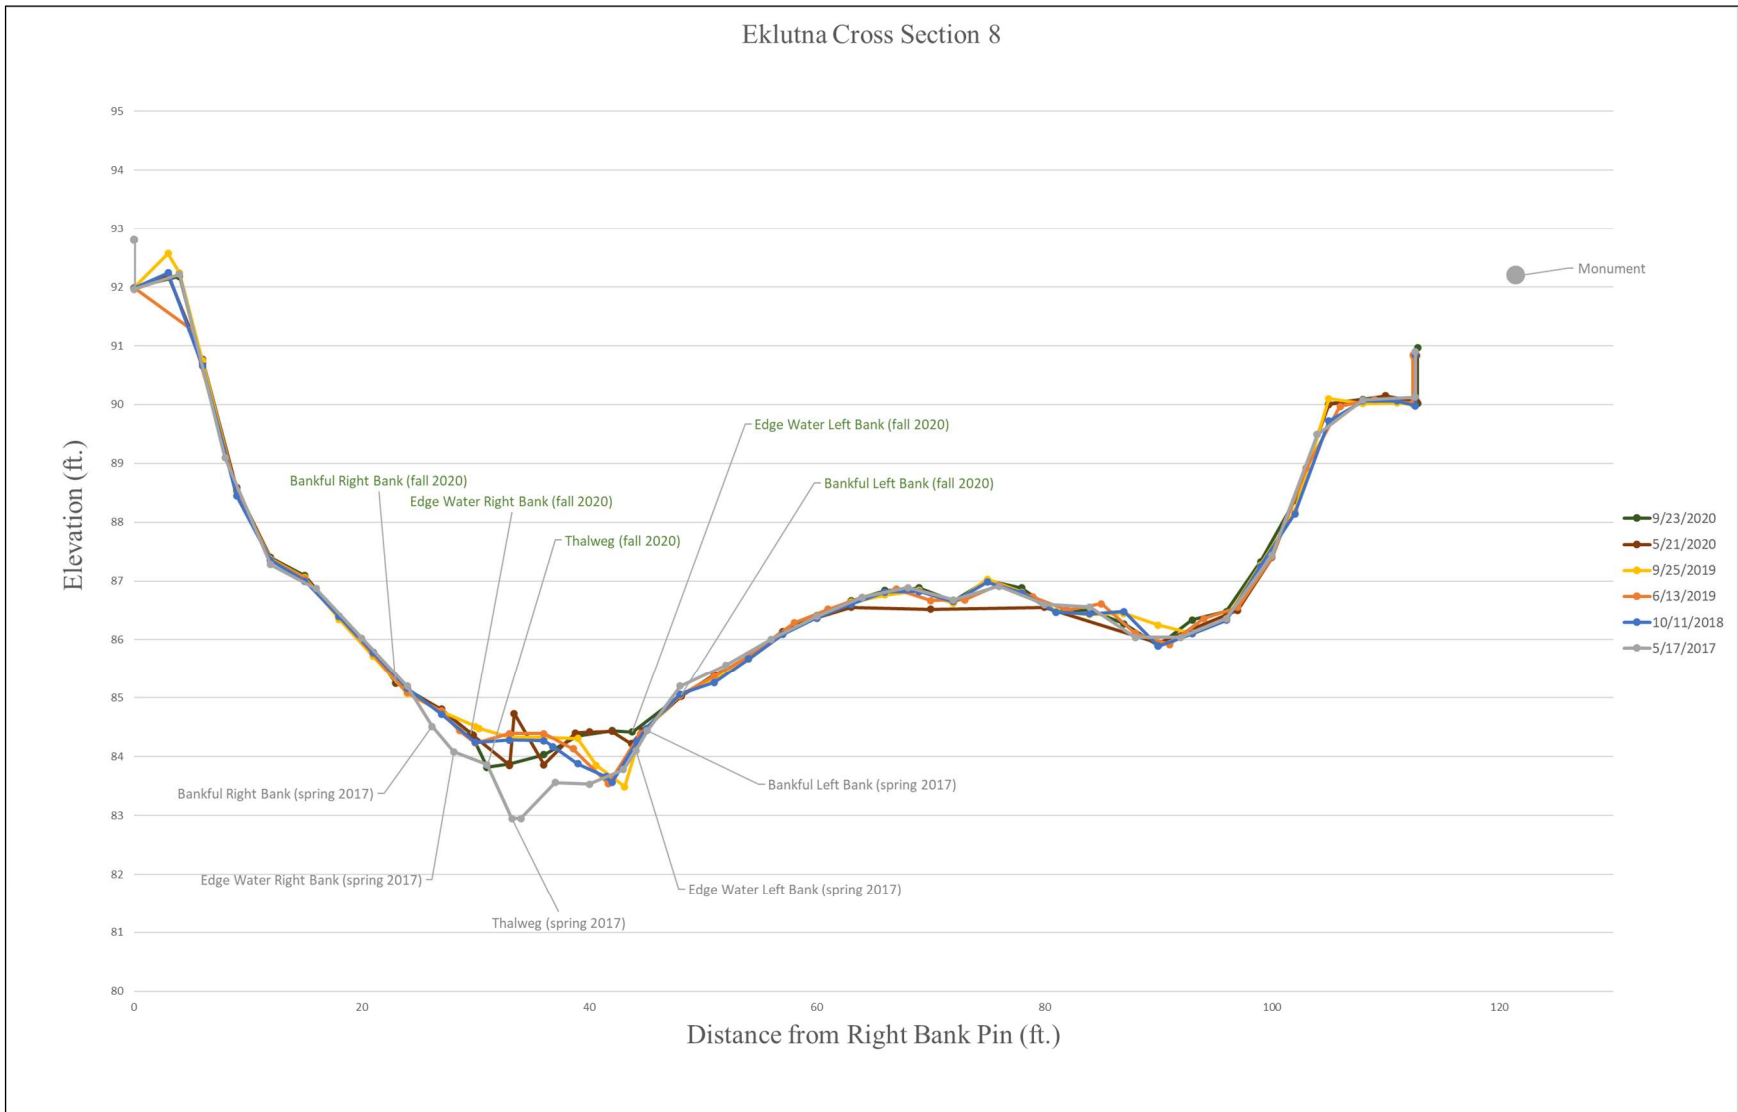
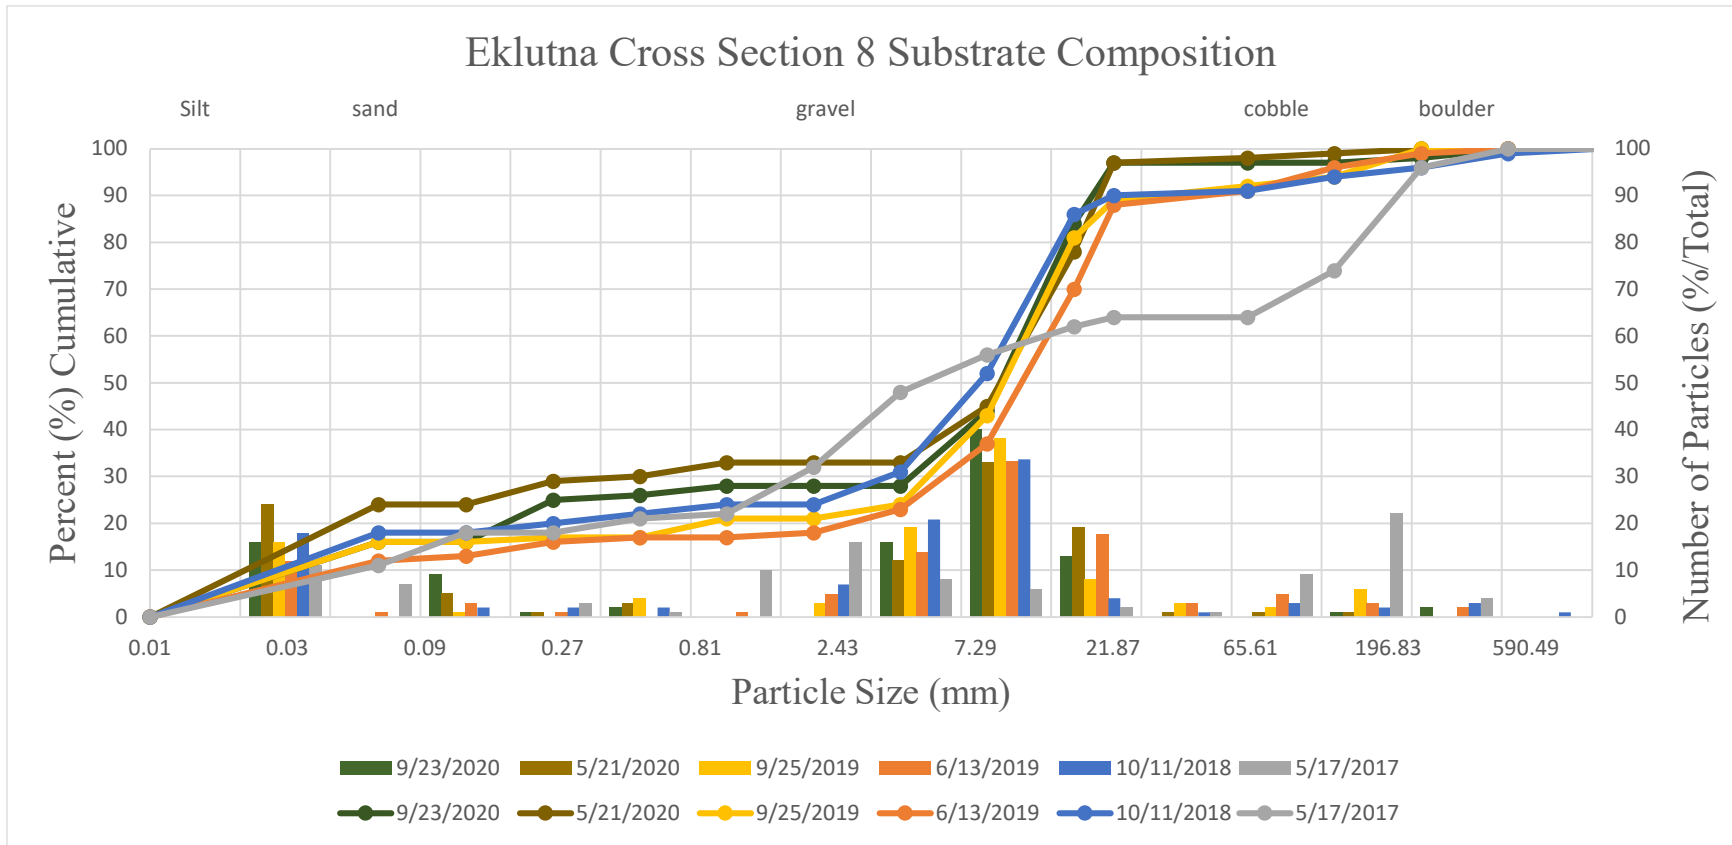
Appendix A2.–Eklutna 8 Channel Geometry and Substrate Composition.

The channel generally had remained stable from 2019 visits, although a mid-channel bar formed by the accumulation of fine gravels and sand likely conveyed downstream from the eroding sediment wedge. Both the D_{50} and D_{84} remained essentially consistent with 2019 measurements. Substrate embeddedness was noted to have further decreased. Water quality variables were again not noteworthy, but pH was again high at 8.3 and due to elevated flows, turbidity was elevated at nearly 500 NTU.

The channel morphology was again similar, while D_{50} and D_{84} measurements also were similar to 2019 measurements. Substrate embeddedness was observed to be similar to 2019 observations.

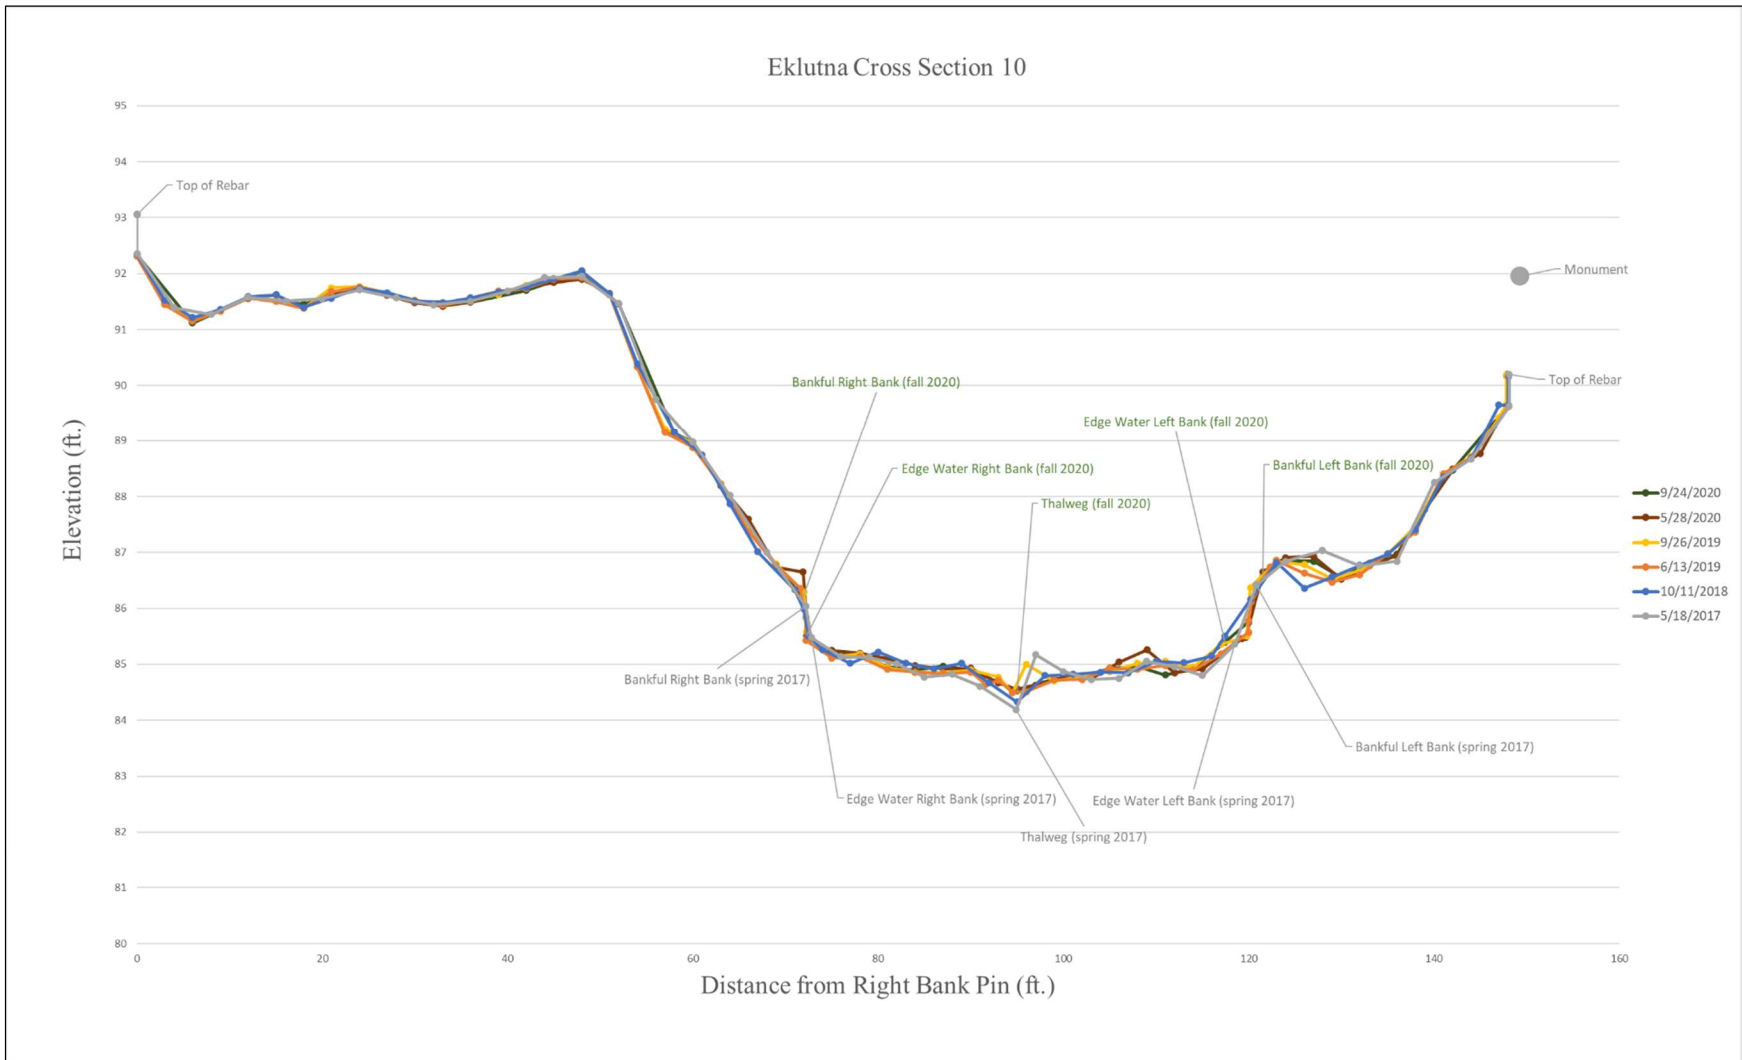
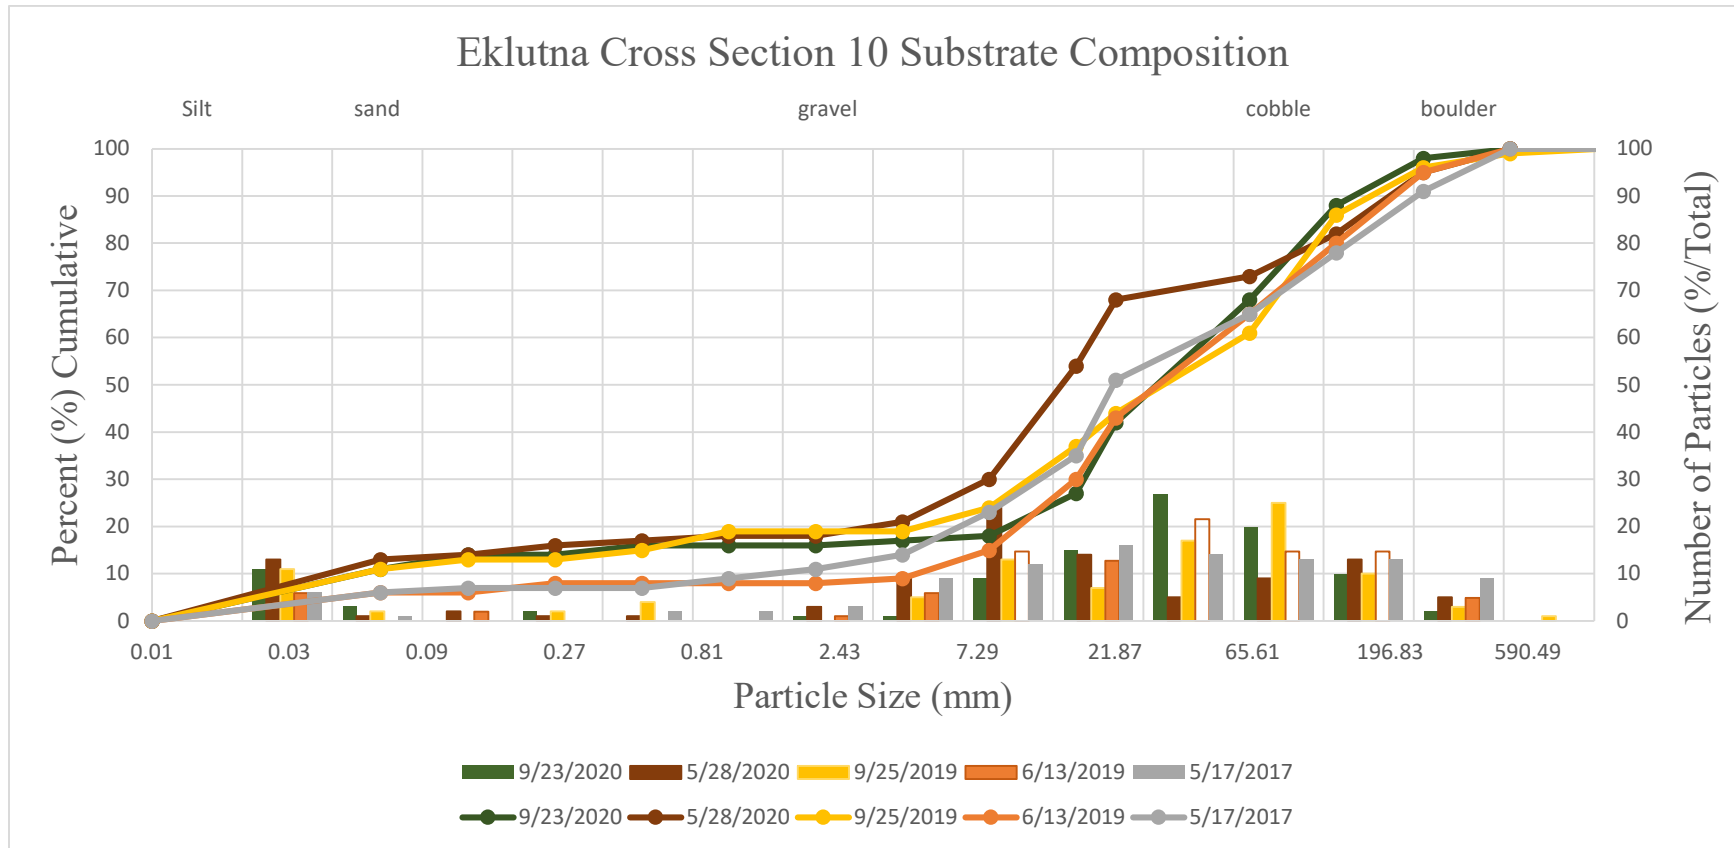
Appendix A3.–Eklutna 10 Channel Geometry and Substrate Composition.

Channel geometry remained very similar to the previous visit. Substrate composition was not recorded due to unsuitable stream conditions. Water quality variables were generally not noteworthy, except that dissolved oxygen readings were abnormally high. This was likely the result of a faulty sensor.

We found channel geometry essentially unchanged. Similarly, substrate composition remained largely unchanged despite a slight decrease in the D_{84} to *Small Cobble*. Water quality variables were similar to previous visits.
