TECHNICAL REPORT NO. 24-02

EKLUTNA RIVER AQUATIC HABITAT MONITORING 2021-2023

Alaska Department of Fish and Game
Habitat Section, Anchorage
333 Raspberry Rd., Anchorage, AK 99518

January 2024

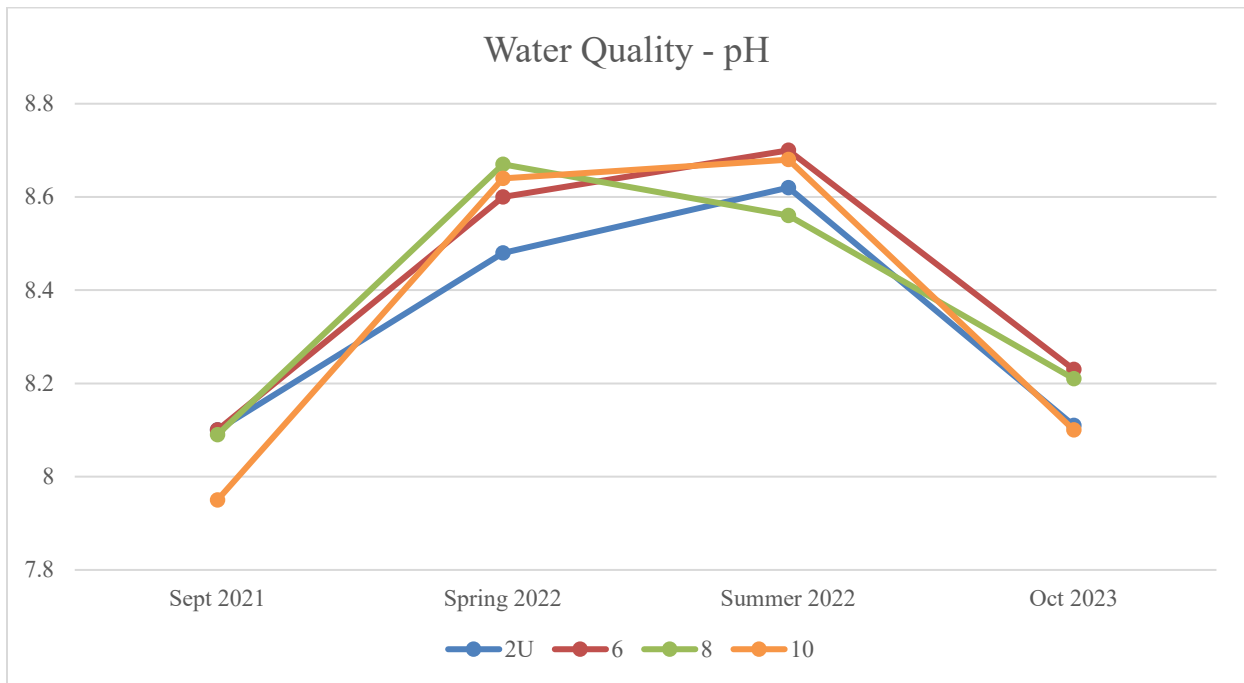
Figure 4.– Water Quality – pH Measurements at Monitoring Sites

At the monitoring site located above the deconstructed lower dam (Eklutna 2U) scouring of the bed was observed compared to the 2017 survey conducted prior to the lower dam deconstruction. There was a slight change in the channel dimensions at this location after the controlled flow releases in 2021. Between 2021 and 2023 there was a slight decrease in the D_{50} particle size after an increase in 2022 while the D_{84} particle size remained categorized as very coarse gravel. Particle sizes and channel dimensions were similar between 2022 and 2023. Water quality at this site were generally un-noteworthy, however pH was consistently high, ranging from 8.10 to 8.62. At monitoring site Eklutna 6 (site just below the deconstructed dam site), the channel aggraded nearly two feet in over half the channel between 2017 and 2023. More sand and gravel sized particles were observed in 2023 as compared to 2017. There was a slight increase in D_{50} substrate size but a slight decrease in D_{84} substrate composition. This is likely the result of the removal of the lower dam and controlled flow releases in the fall of 2021. No changes of note were observed between 2022 and 2023. Water quality at this site was generally un-noteworthy; however, pH was consistently high, ranging from 8.10 to 8.70.

At monitoring site Eklutna 8 (located just upstream from Thunder Bird Creek), the channel has aggraded over a foot between 2017 and 2023. Additional minor changes occurred after the controlled release. At this location it appears that both bed aggradation and subsequent scouring occurred. The overall channel substrate size increased with more gravel and cobbles present in the 2022 and 2023 surveys. Water quality at this site was generally un-noteworthy, but pH was elevated, ranging from 8.09 to 8.56.

All recorded variables from the monitoring site downstream from the Thunder Bird Creek confluence (Eklutna 10) generally remained stable throughout the monitored period. This is likely due to Thunder Bird Creek providing additional flow into this reach that leads to more dynamic bedload transport at the site. The pH levels were elevated however, ranging from 7.95 to 8.68.

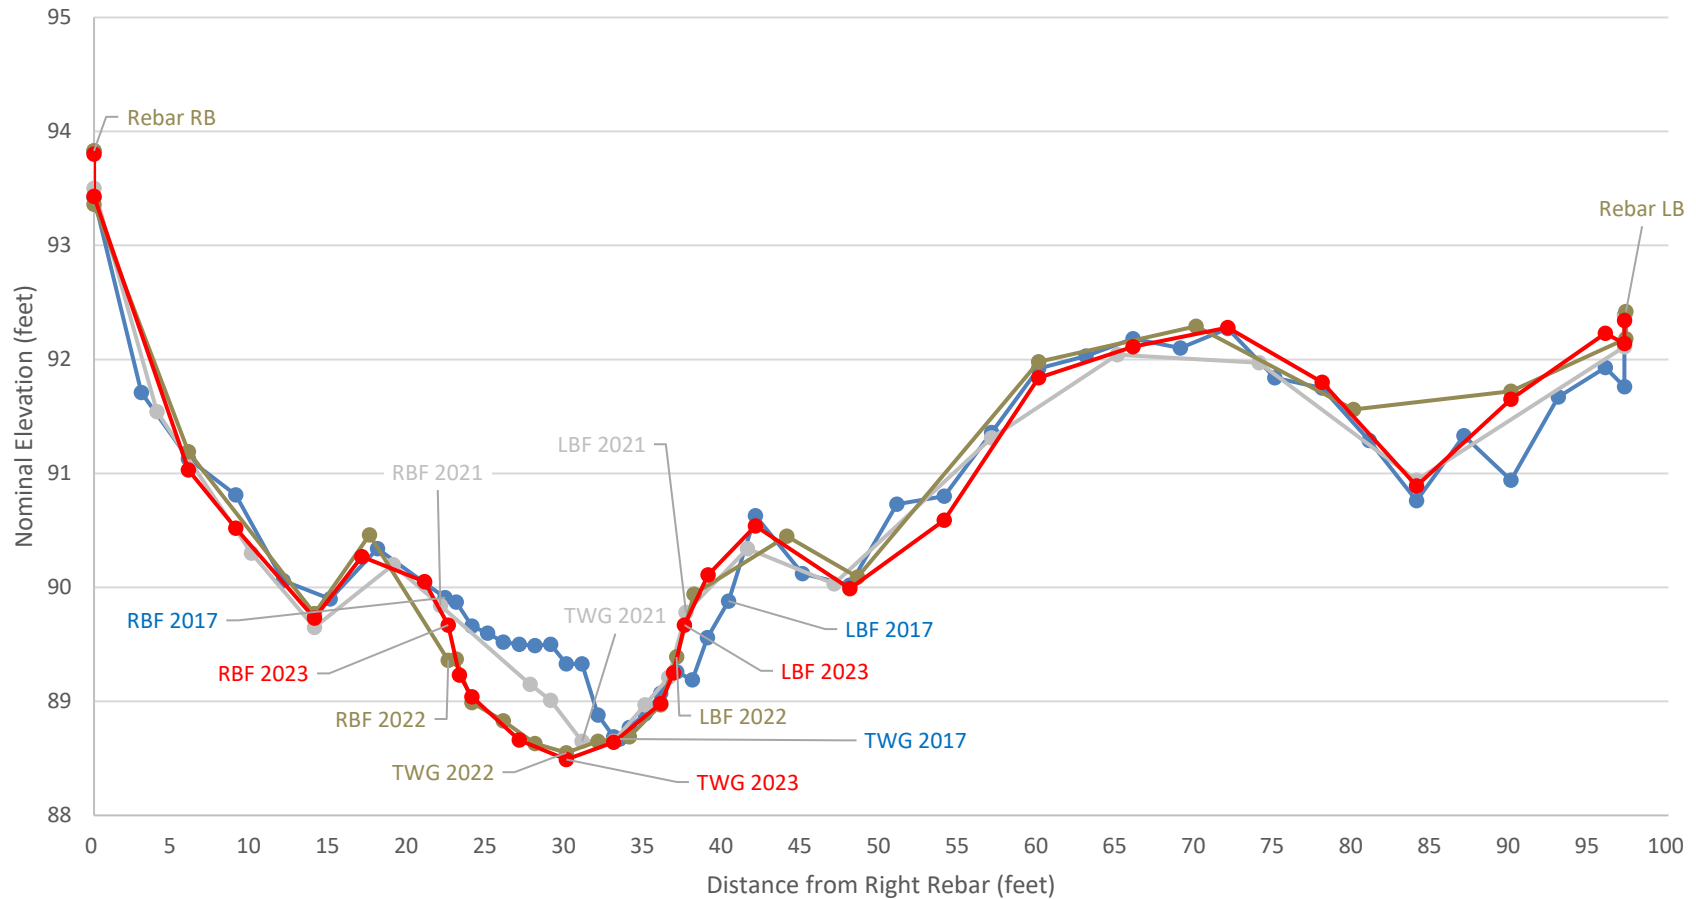
Eklutna Cross Section 2U (above former dam)

Some scour occurred at the monitoring site (2U) upstream from the remaining sediment wedge (former dam impoundment). The main flow channel widened at this site with the bankfull elevation and width slightly decreasing. Overall channel depth (at thalweg) was relatively unchanged. Some aggradation occurred on the streambanks and in a minor side channel that was dry during the

surveys. Changes to the channel at this cross section occurred mostly between 2017 and 2018 when the lower dam was removed and during and/or post controlled flow releases in late 2021.

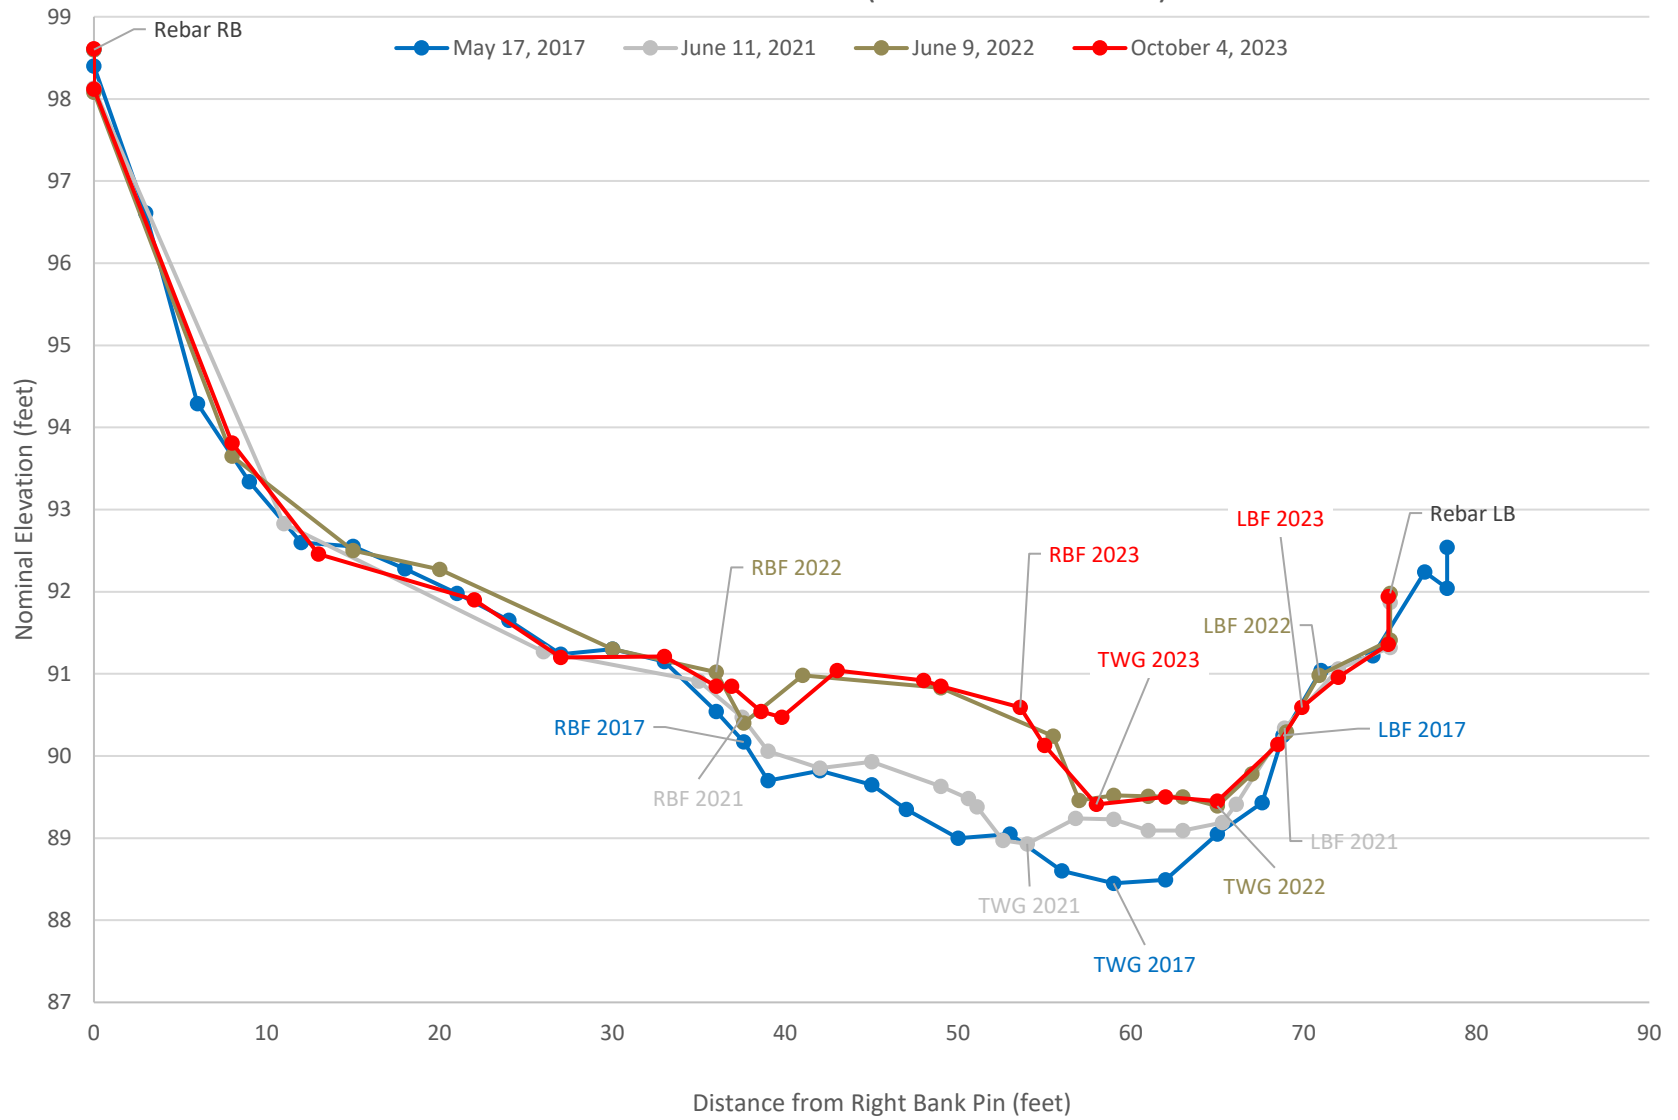
Eklutna Cross Section 6 (below former dam)

This cross section showed the most changes after the lower dam removal in 2018 and after the controlled flow releases. Significant aggradation occurred in the main channel at this monitoring location downstream of the former dam site. About two feet of material aggraded in the main flow channel which caused the bankfull width to decrease and the bankfull elevation to increase. The aggradation pushed the channel to the left bank (looking downstream) and created a side channel on the right bank. Very little changed at this cross section between 2022 and 2023 after returning to a continuous low-flow regime.

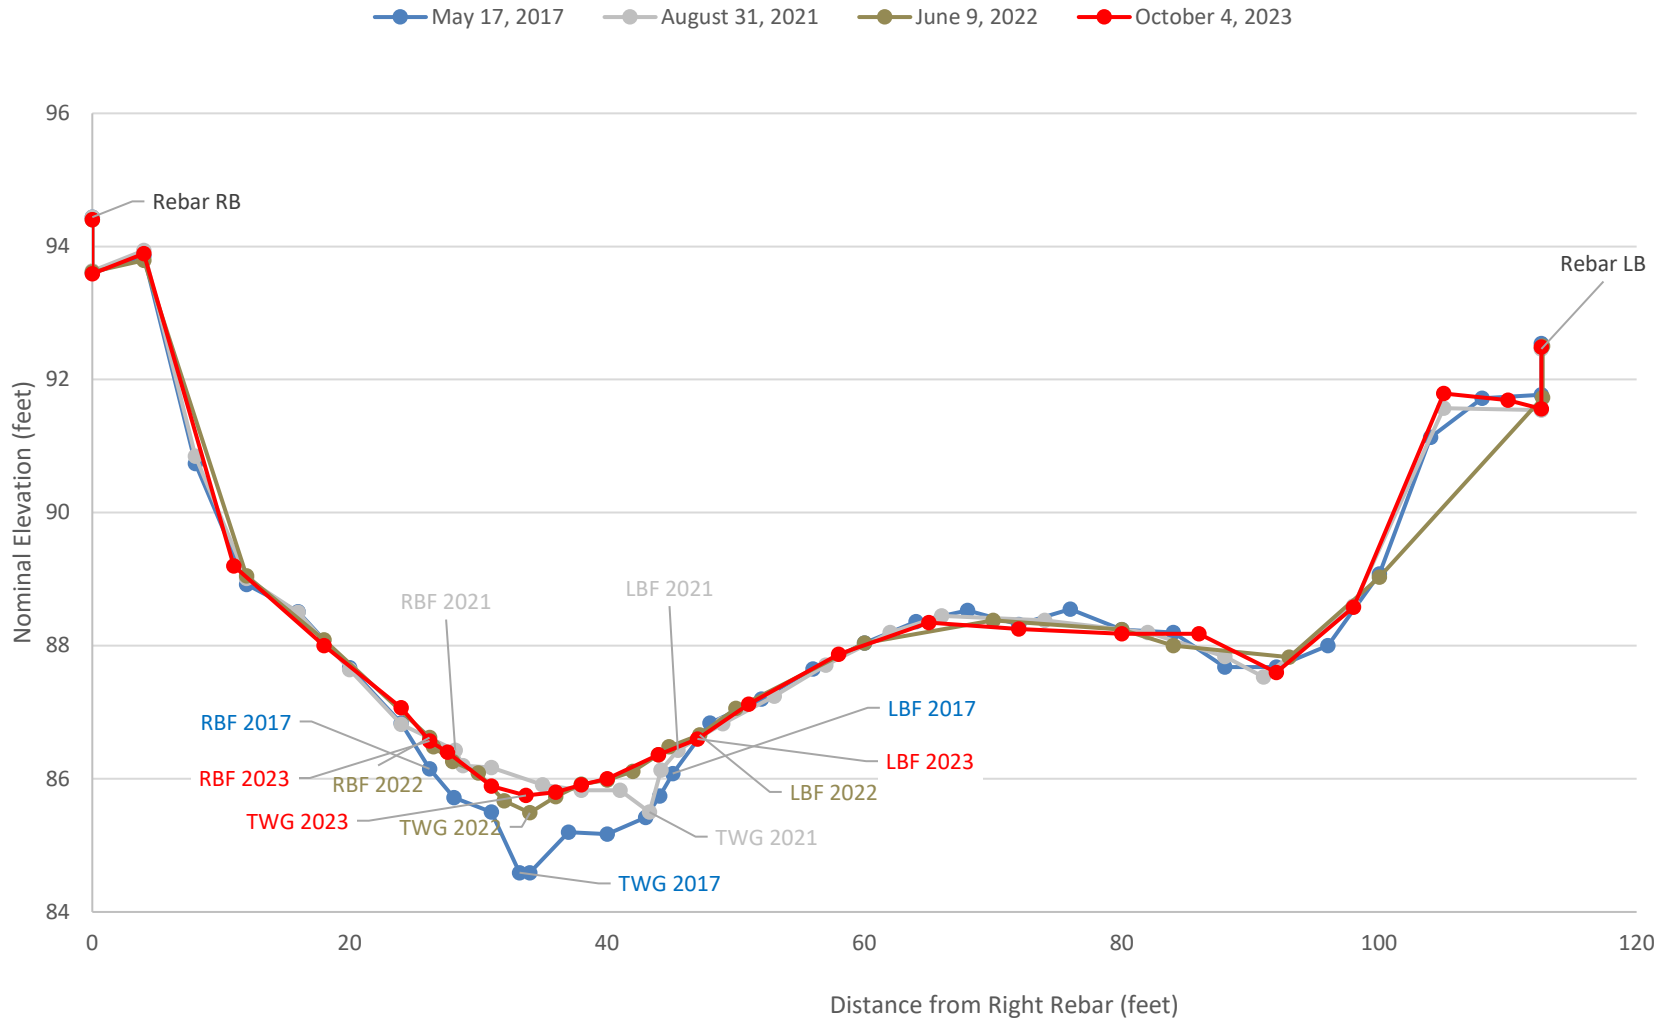
Eklutna Cross Section 8 (below former dam)

The channel cross-section at monitoring site 8 showed about a foot of aggradation between pre- and post-lower dam removal with minor changes observed after the controlled flow releases. Aggradation occurred at the site which increased both the bankfull width (+3.7 feet) and the bankfull elevation (+0.2 feet) between 2021 and 2023. The channel thalweg elevation increased but remained in the same location. Minor aggradation occurred between 2022 and 2023 at this cross section after returning to a continuous low-flow regime.

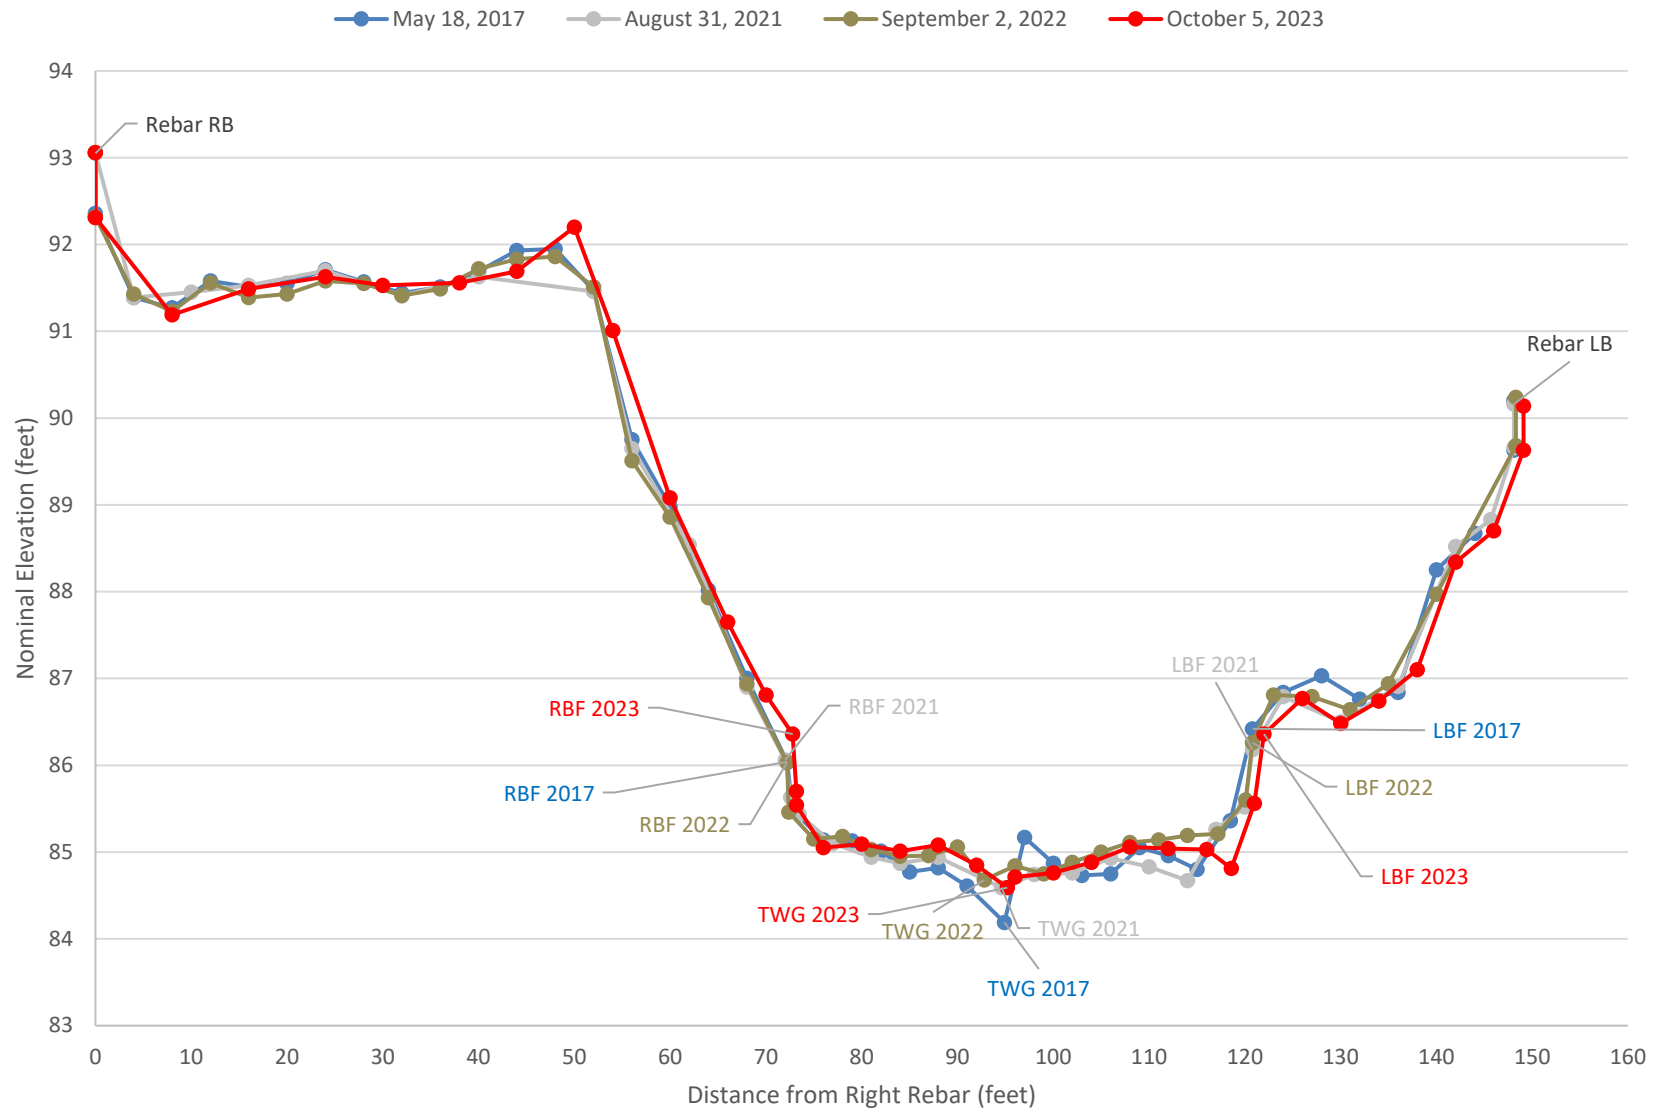
Eklutna Cross Section 10 (below Thunderbird Creek)

The channel cross section at this monitoring location showed very minor changes throughout the monitoring period. There was some aggradation and minor scour after the controlled flow releases, but the bankfull elevation, bankfull width, and thalweg remained relatively unchanged. The aggregation on the left bank scoured out, returning to pre-controlled flow release conditions, between 2022 and 2023.
