State of Alaska
Department of Fish and Game
Division of Sport Fish

Nomination Form
Anadromous Waters Catalog & Atlas

Nomination # : 24-008

**Solomon Environmental Baseline
Technical Assistance**

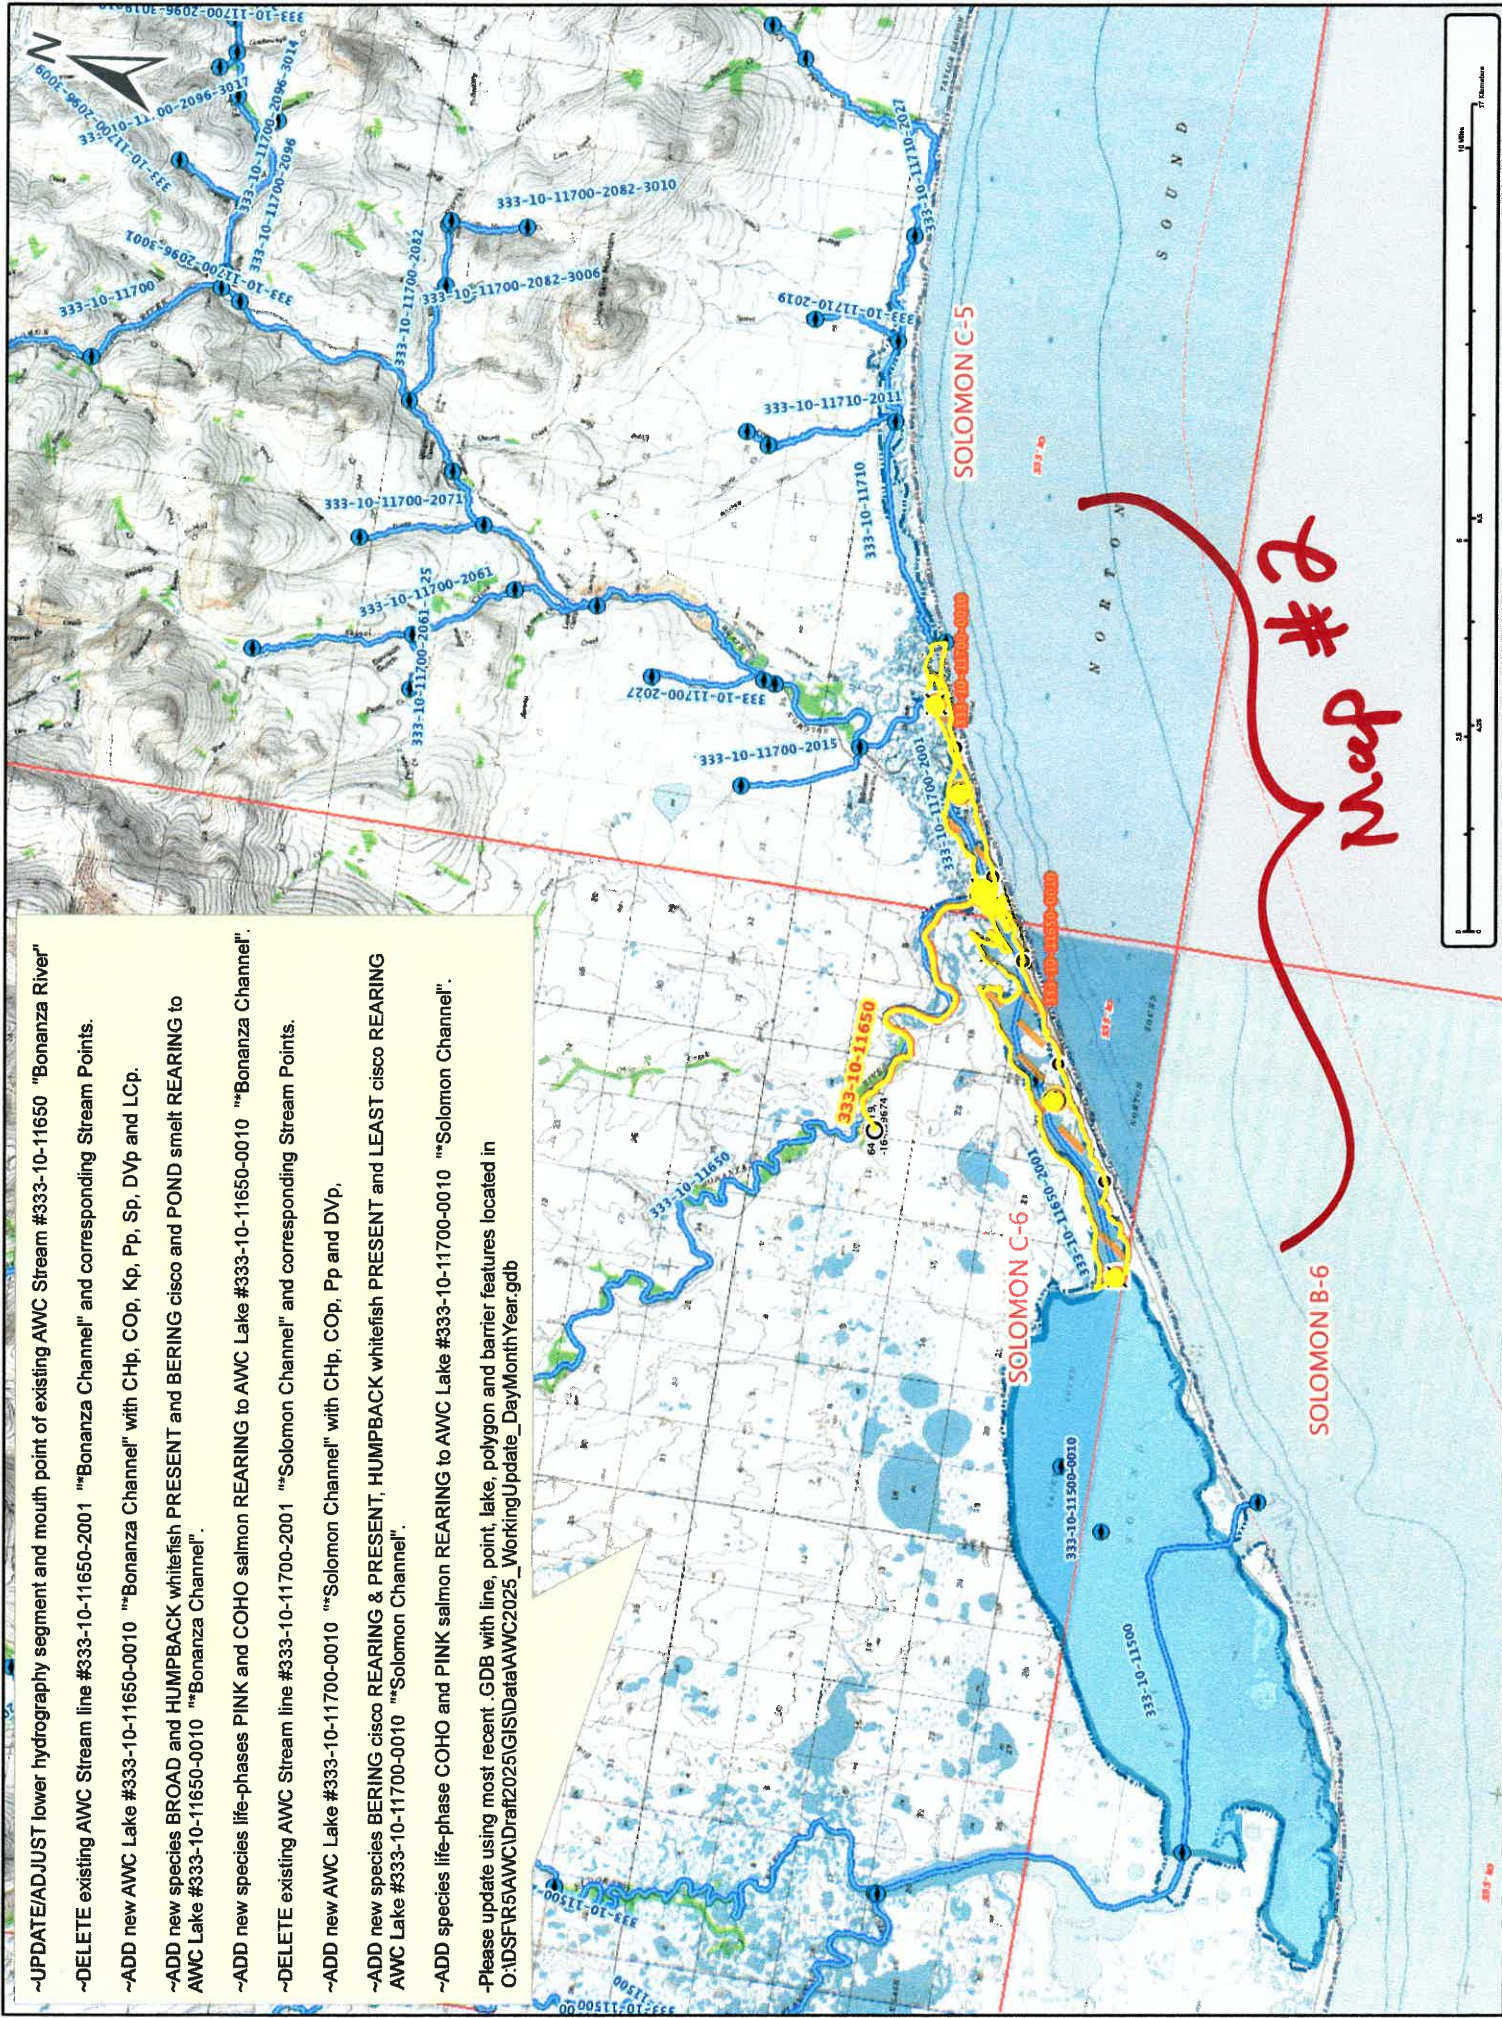
~UPDATE/ADJUST lower hydrography segment and mouth point of existing AWC Stream #333-10-11650 "Bonanza River"

~DELETE existing AWC Stream line #333-10-11650-2001 "Bonanza Channel" and corresponding Stream Points.

~ADD species life-phase COHO and PINK salmon REARING to AWC Lake #333-10-11700-0010 "Solomon Channel".

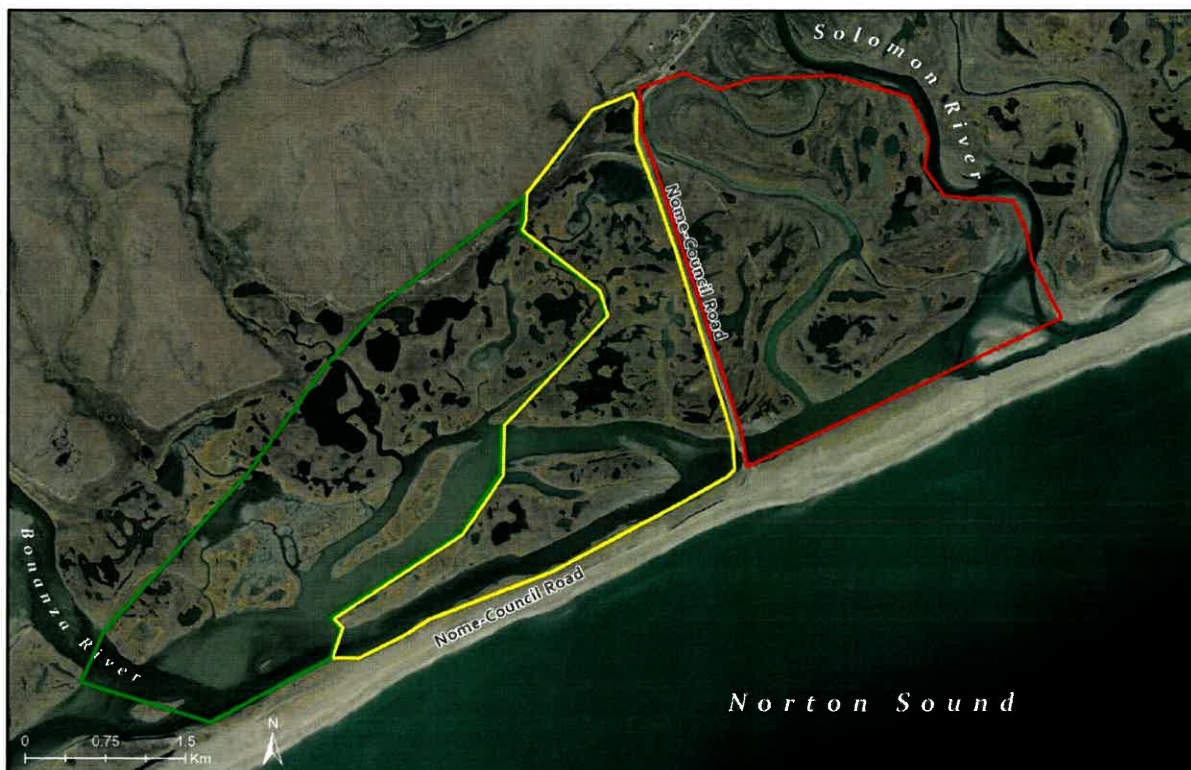
Figure 8. Waterfowl survey areas in eastern Safety Sound.

Three survey areas were coded as area 1 (green), area 2 (yellow), and area 3 (red). Boundaries of these three survey areas were chosen to minimize overlap and mitigate for accidental recounting.

Waterfowl surveys were conducted throughout the summer and fall field season in three areas along Safety Sound (Figure 8). Boundaries of survey areas were selected to minimize potential overlap of species observed and mitigate for accidental recounting of individuals. During each survey, counts of each species were recorded within each area. Though our surveys focused on waterfowl, the presence of other avian taxa (i.e., gulls, loons, ravens) within the area were recorded. Surveys were conducted using a combination of 10x42 binoculars and a 20-60X spotting scope on a tripod.

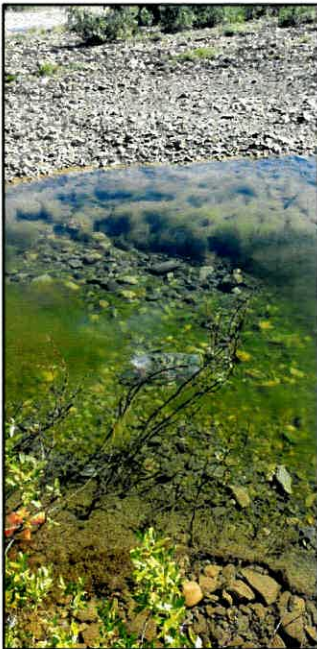
Trap 12. Deep pool off the mainstem of the Solomon River, spring fed at 7°C (colder than mainstem).
