Alaska Department of Fish and Game

Habitat Section
Southeast Region

114-31-10100-2020

ADDITION

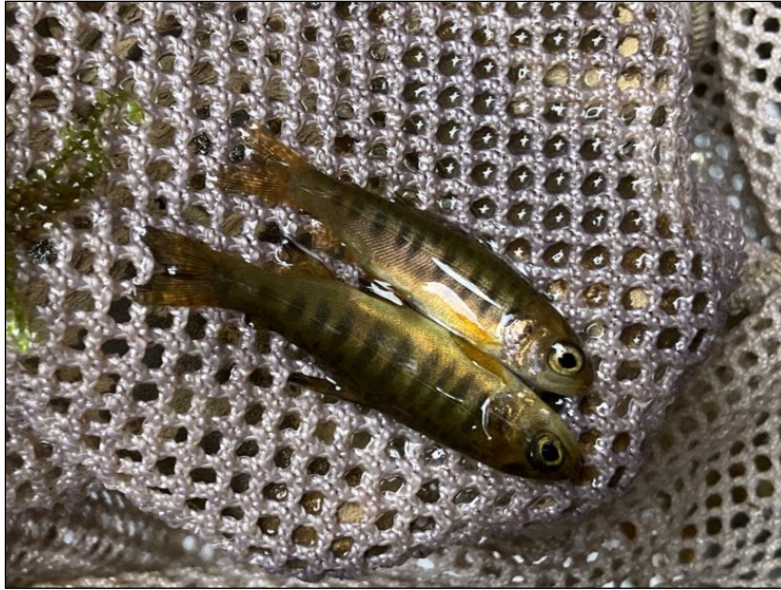
Figure 1.—Juvenile coho salmon captured at waypoint 1581.

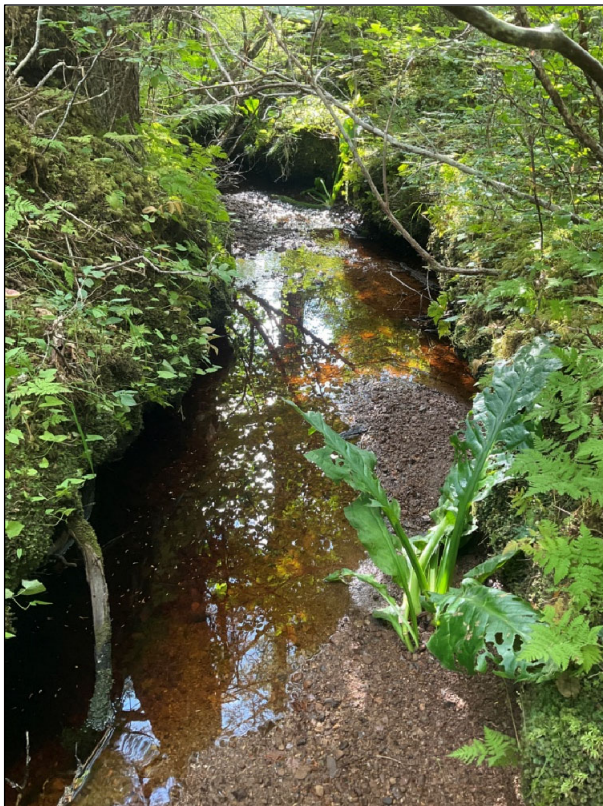
Findings: We surveyed this cataloged stream using a backpack electrofisher and GPS. We captured juvenile coho salmon, Dolly Varden, and cutthroat trout. The tributary stream flows through a series of small rootwad and woody debris jams and has a reach of low-gradient channel with spawning substrate (Table 1; Figures 1–3).

Figure 2.—Upstream view of stream No. 114-31-10100-2020 at waypoint 1585.
