Alaska Department of Fish and Game

Habitat Section
Southeast Region

114-31-10130-2022-3003-4007-5300

ADDITION

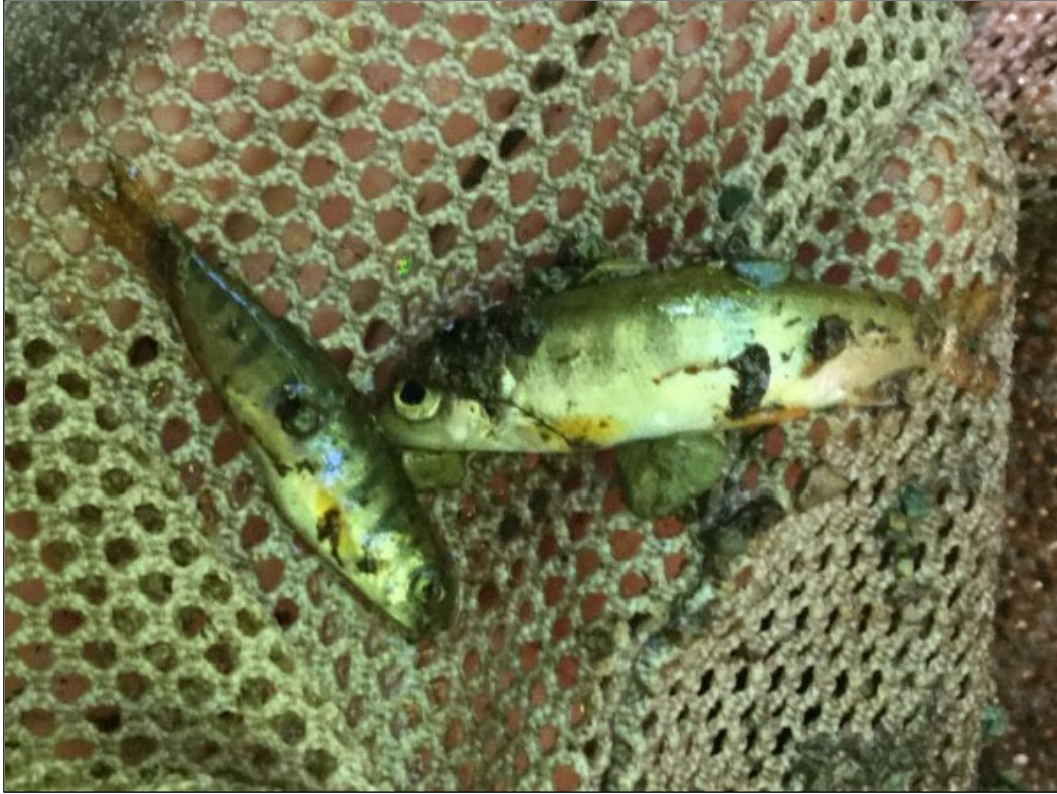
Figure 1.—Juvenile coho salmon captured at waypoint 869.

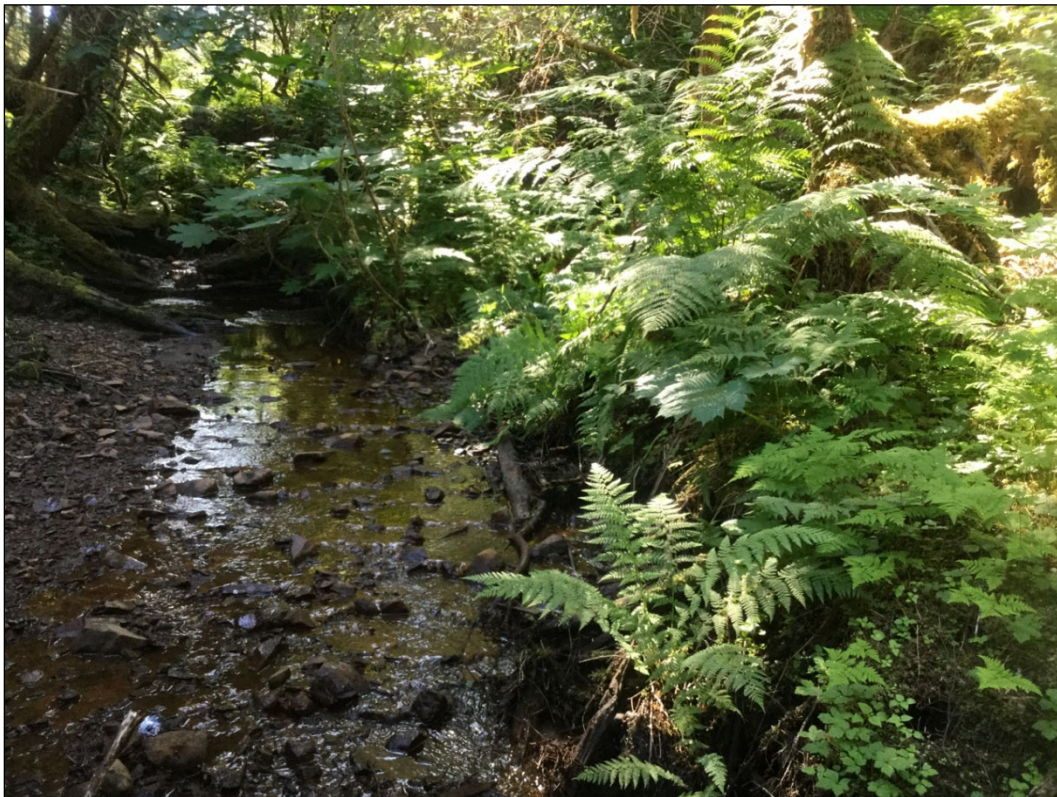
Figure 2.—Channel at waypoint 868.

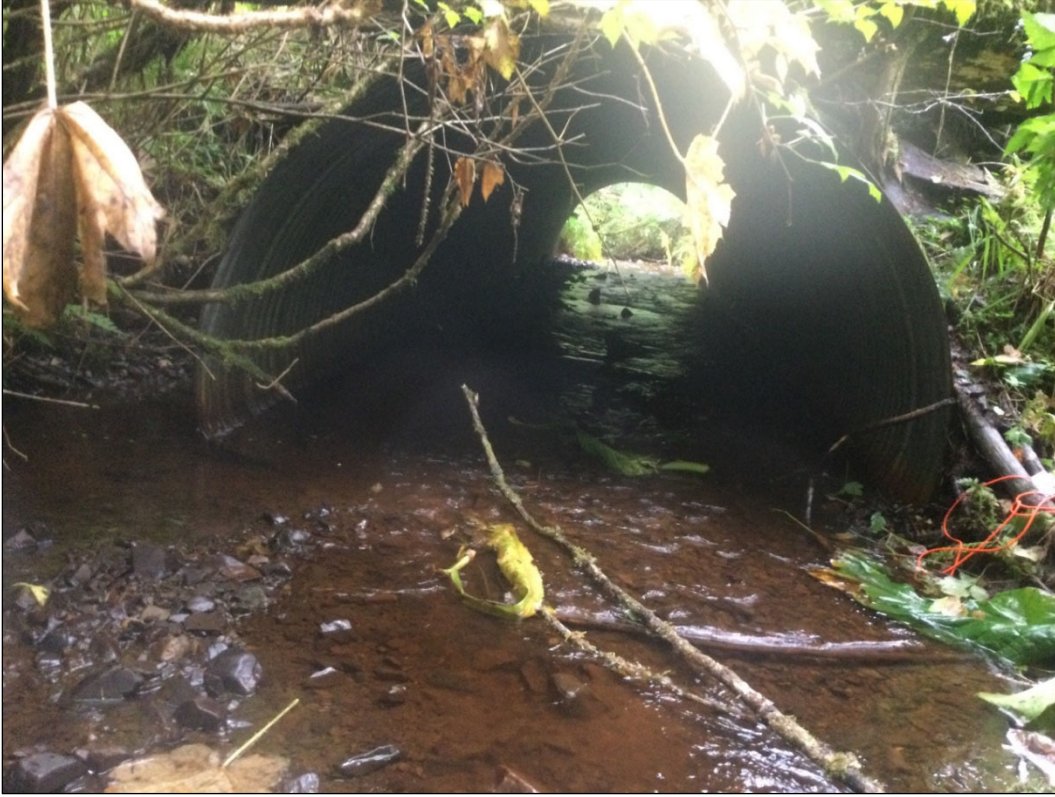
2382	57.946235	-135.397423	Minnow trap set upstream of culvert. 7' squash CMP.	8-10	Large Gravel Small Gravel	Cut Banks	1-2	MT	2 CO 3 CT

Figure 3.—Culvert inlet at waypoint 2382.

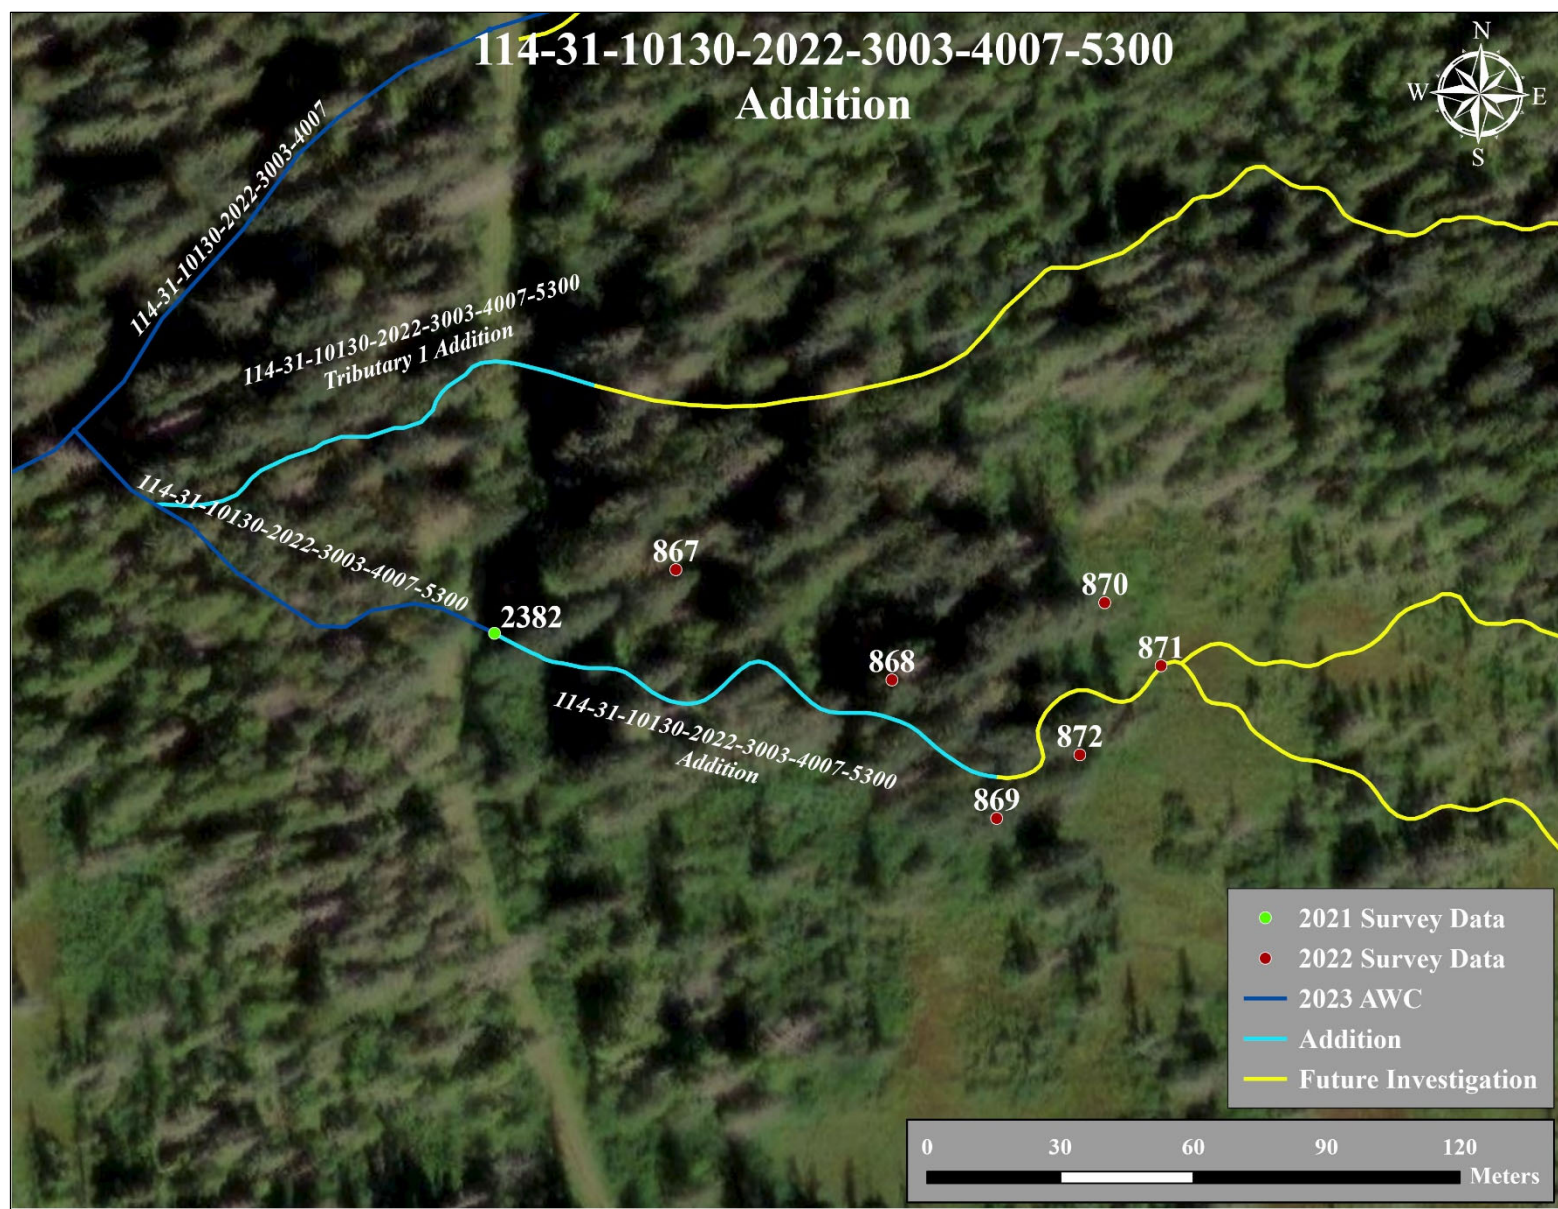
Figure 4.—Stream No. 114-31-10130-2022-3003-4007-5300 addition map.

Recommendations: Extend upper extent of Stream No. 114-31-10130-2022-3003-4007-5300 in the anadromous waters catalog (Figure 4).
