Alaska Department of Fish and Game

114-27-10300 Tributary 6

ADDITION

Survey date: 6/15/2022

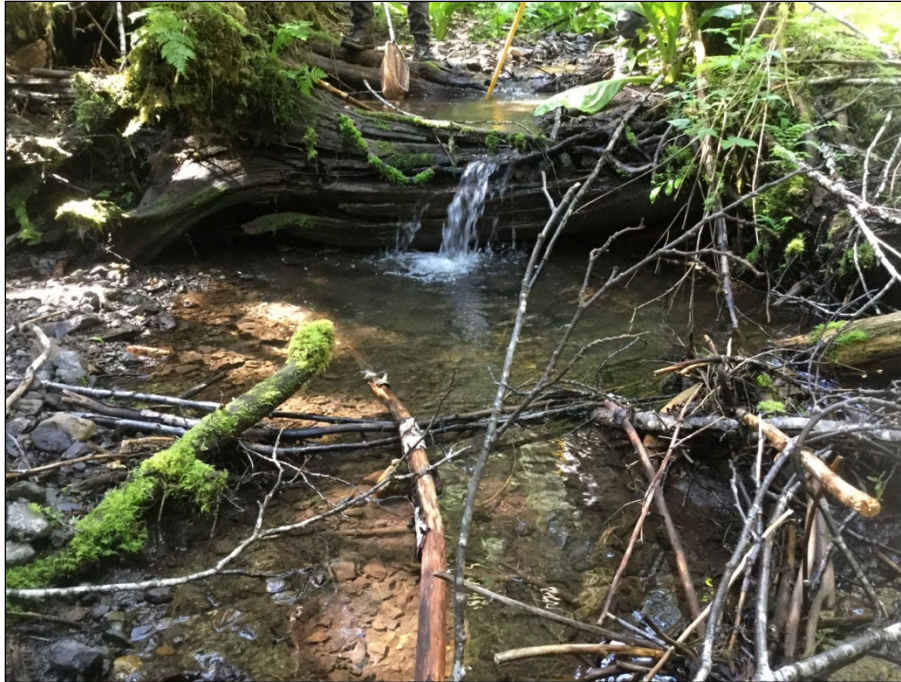
Figure 1.–Channel with log jam at waypoint 771.

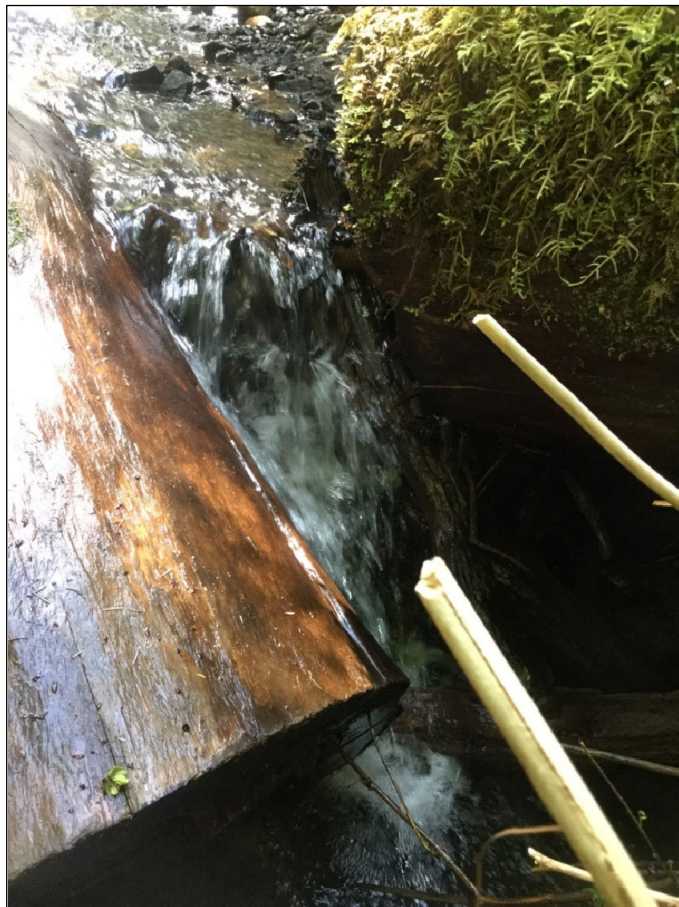
Findings: We surveyed this uncataloged stream using a backpack electrofisher and GPS. We captured juvenile coho salmon, Dolly Varden, and cutthroat trout. Pictures of juvenile coho salmon were not obtained; however, fish identification was verified by a Habitat Biologist. The tributary stream flows over a 3-to-4 ft tall falls and through a gravel-dominated channel (Table 1; Figures 1, 2).

Figure 2.–Falls at waypoint 773.

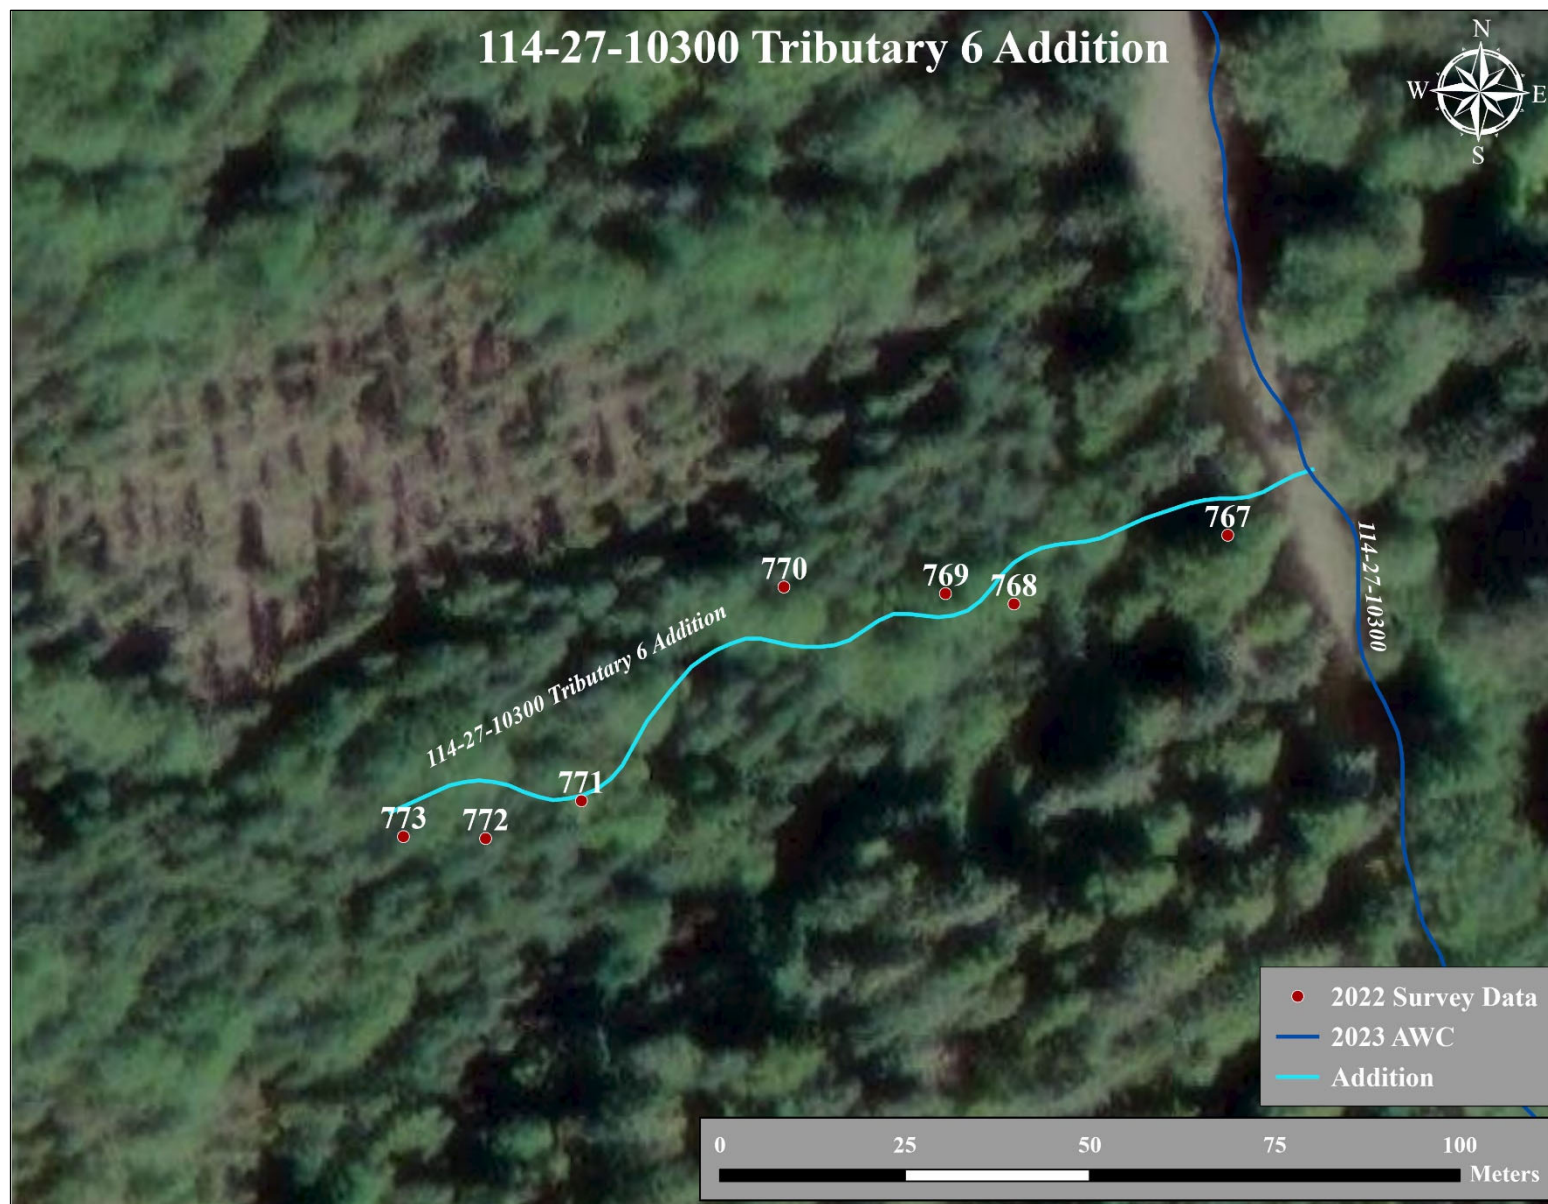
Figure 3.—114-27-10300 tributary 6 addition map.

Recommendations: Add this uncataloged stream to the anadromous waters catalog for rearing coho salmon (Figure 3).
