Alaska Department of Fish and Game

Habitat Section
Southeast Region

114-34-10100 Tributary 8

ADDITION

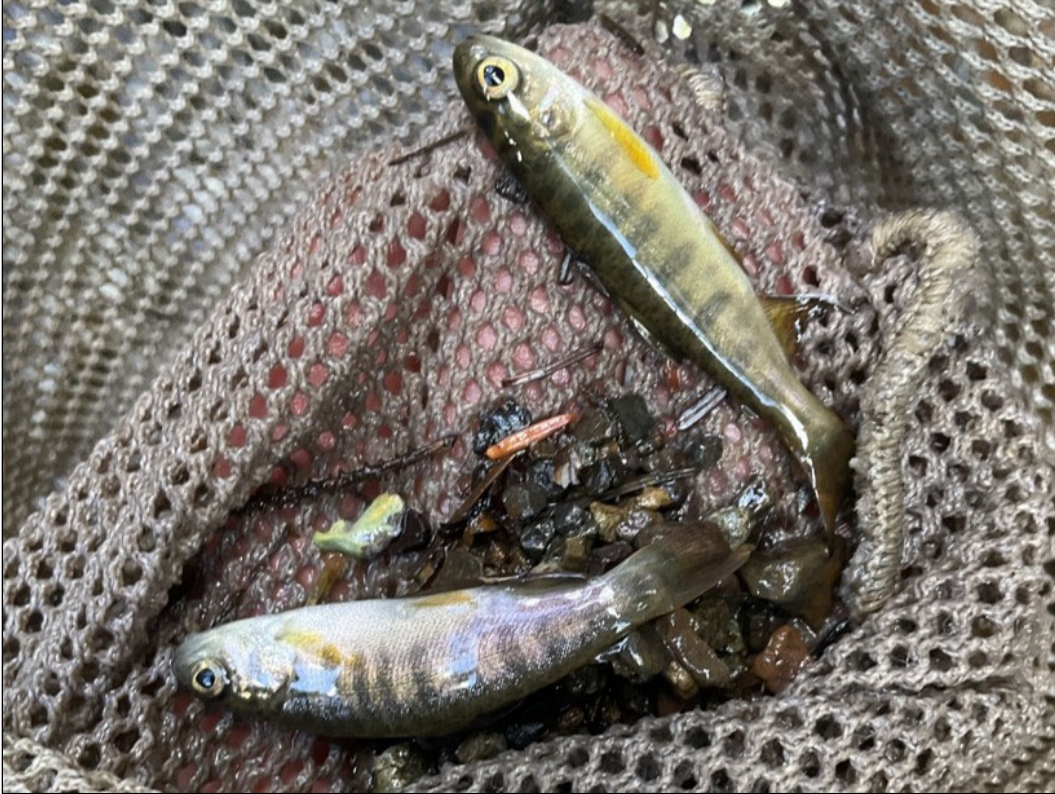
Figure 1.—Juvenile coho salmon captured at waypoint 1870.

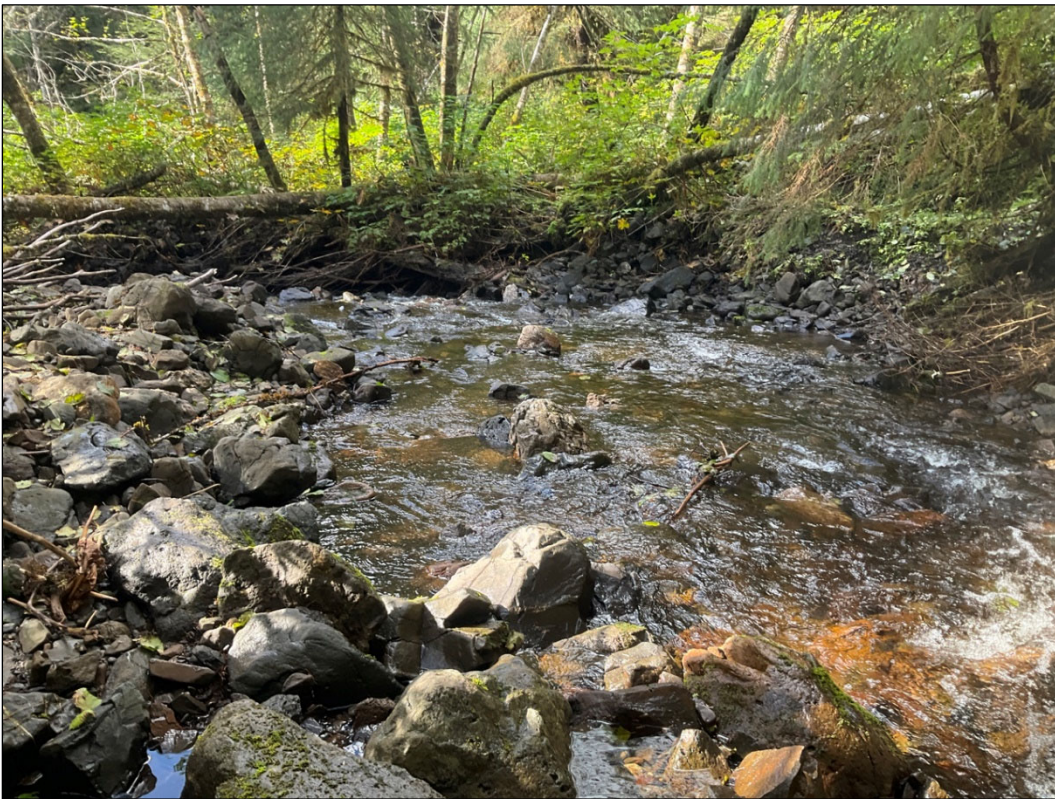
Figure 2.—Channel at waypoint 1871.

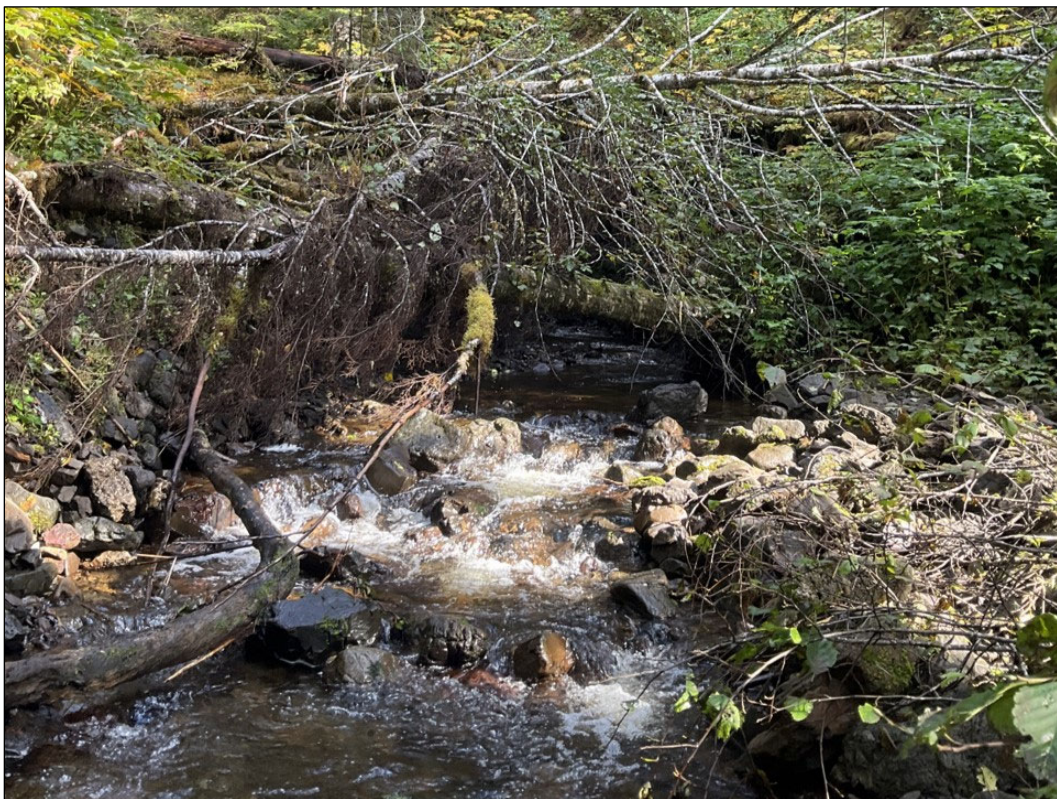
1873	58.113545	-135.597689	Gradient increases substantially (12%+) upstream. Becoming much less navigable due to steep incised channels and large amount of tree-fall. Actual barrier not located but likely near extent of anadromy.	10-12	Cobble Large Gravel		6-8	Not Fished

Figure 4.—Channel at waypoint 1873.
