Alaska Department of Fish and Game

Habitat Section
Southeast Region

112-12-10340

CORRECTION

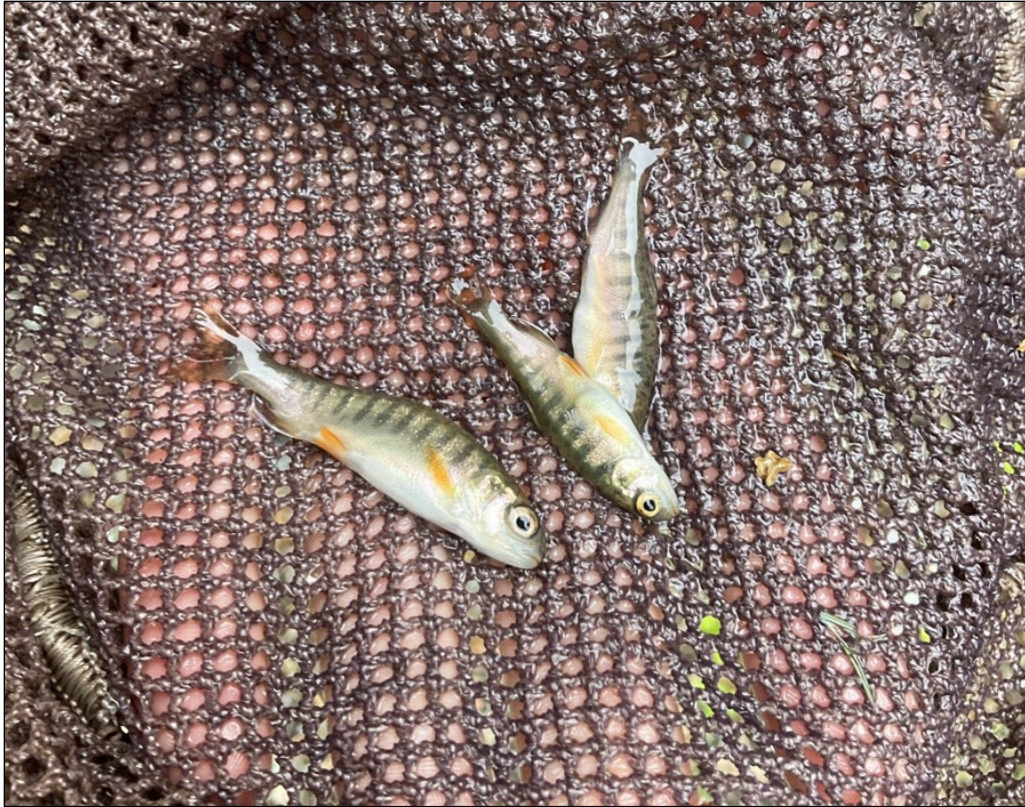
Figure 1.–Juvenile coho captured at waypoint 1399.

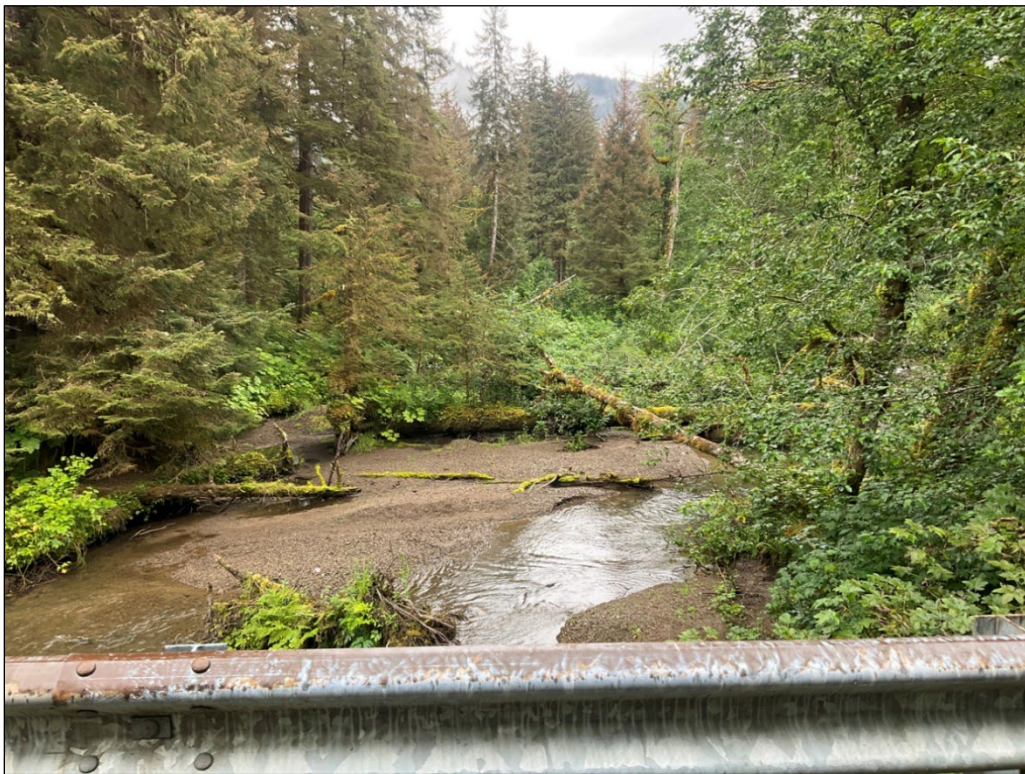
Findings: We surveyed a road crossing and tributaries of this cataloged stream using a backpack electrofisher and GPS. We captured juvenile coho salmon, visually identified spawning pink salmon, and found that the stream path is incorrectly mapped (Table 1; Figure 1). The stream channel is greater than 50ft wide, forested, and has spawning substrate throughout the surveyed reach (Figure 2).

Figure 2.–Bridge at waypoint 1484 facing upstream.
