Alaska Department of Fish and Game

112-12-10340-2004 Tributary 1

ADDITION

Survey date: 8/16/2022

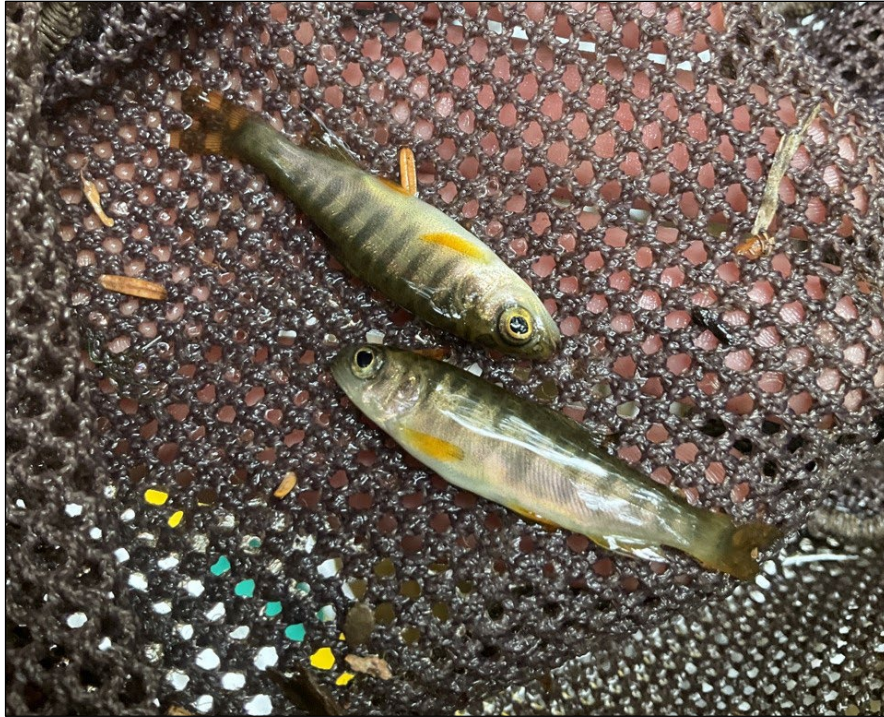
Findings: We surveyed this uncataloged stream using a backpack electrofisher and GPS and captured juvenile coho salmon (Figure 1). The stream channel is forested and low gradient (Table 1; Figures 2, 3). The survey ended due to time constraints; fish habitat continues upstream.

Figure 1.—Juvenile coho salmon captured at waypoint 1397.

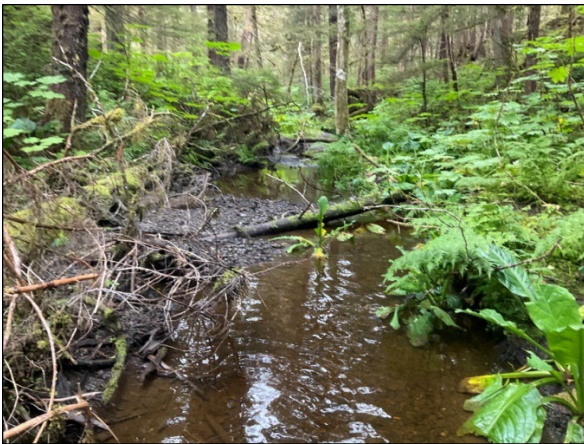
Figure 2.—Channel at waypoint 1397.

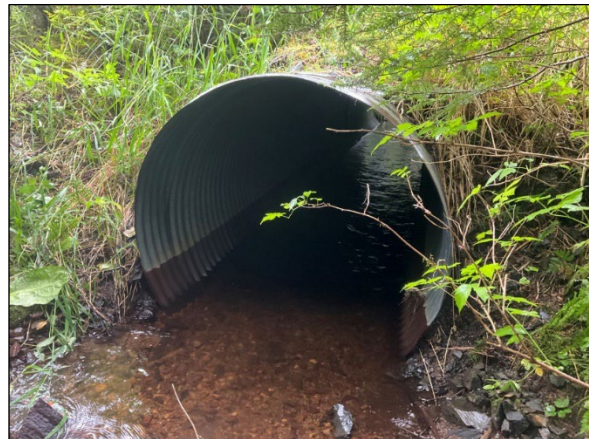
Figure 3.—Culvert and spawning pink salmon at waypoint 1371.
