115-10-10420

Species/Waters Addition / Route Correction

Species & Lifestage Observed: DVp, CO_r, Pp

Observation Date: 05/15/2024

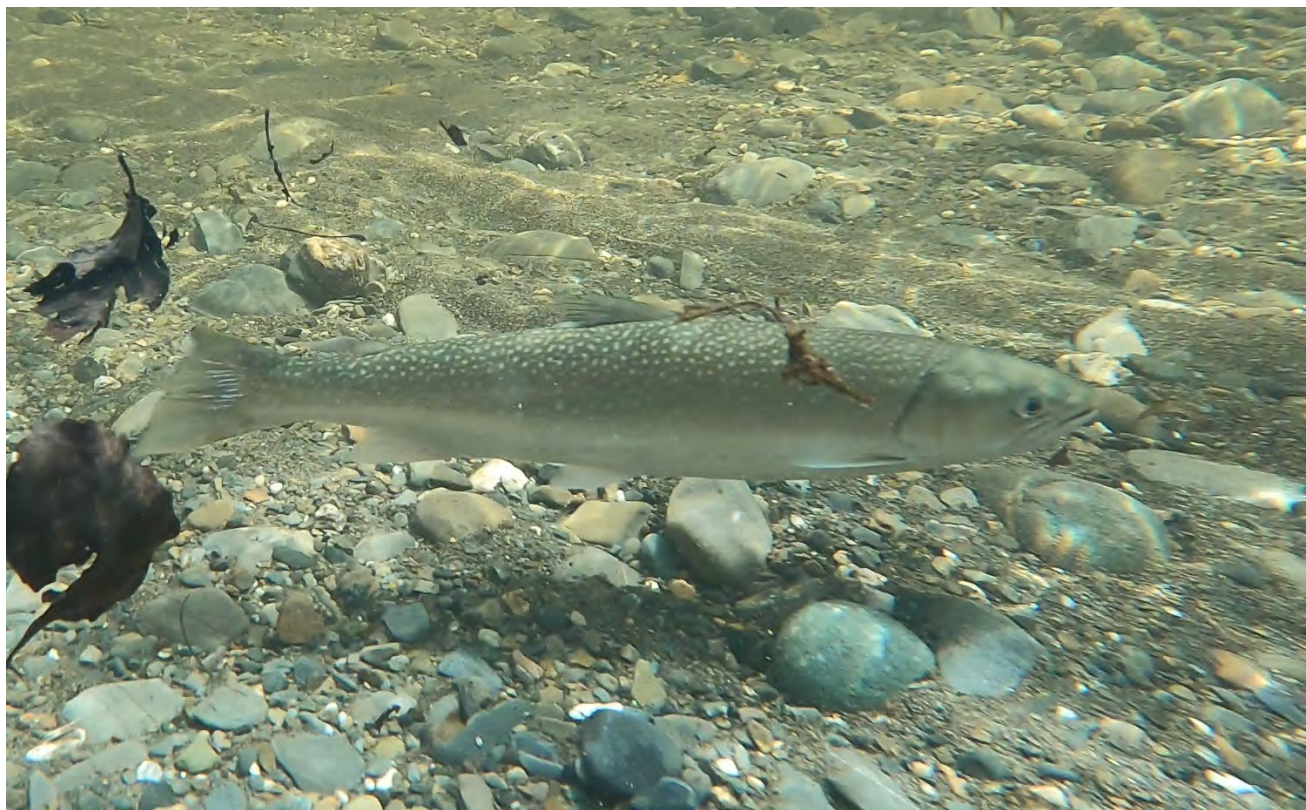
Figure 1.- One of two Dolly Varden char from waypoint 2. Size and appearance of both fish strongly suggest anadromy in recent life history.

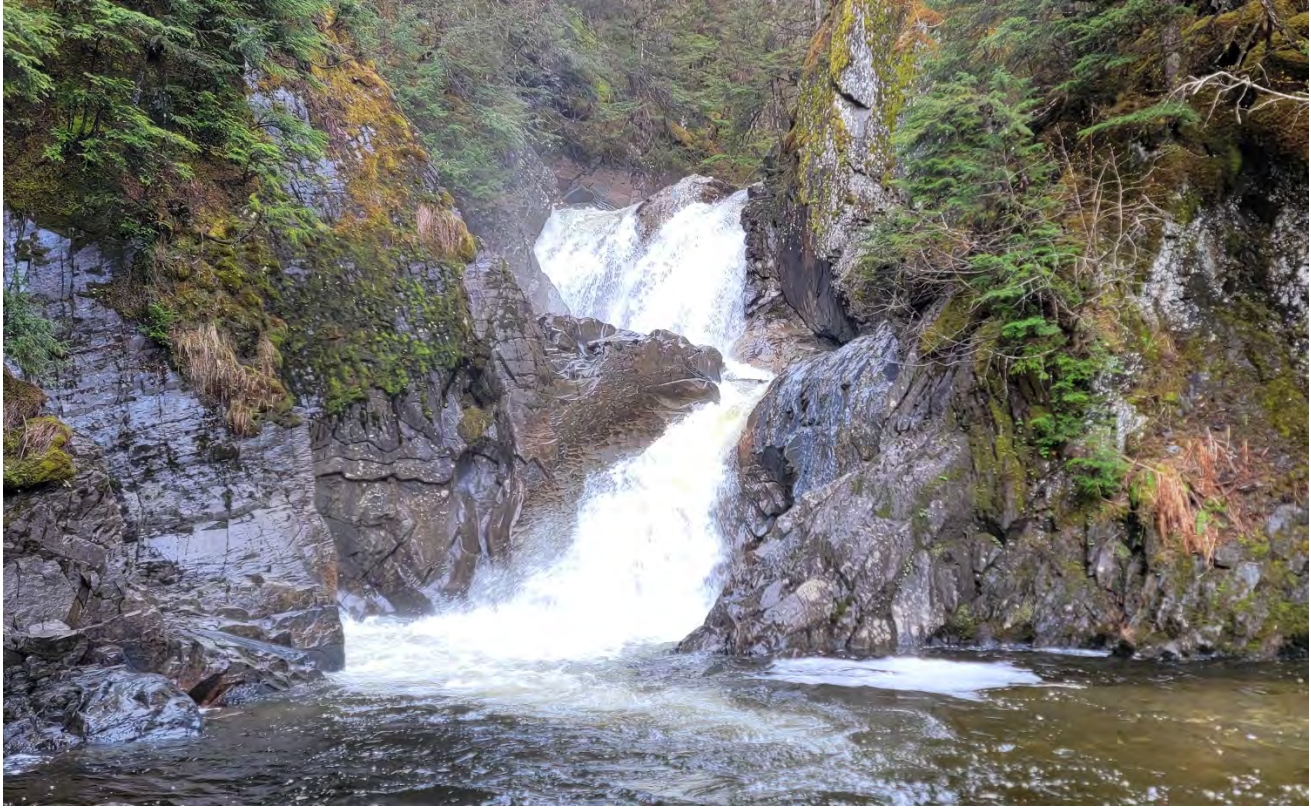
Figure 2.- 13.6m probable barrier to anadromy at waypoint 3.

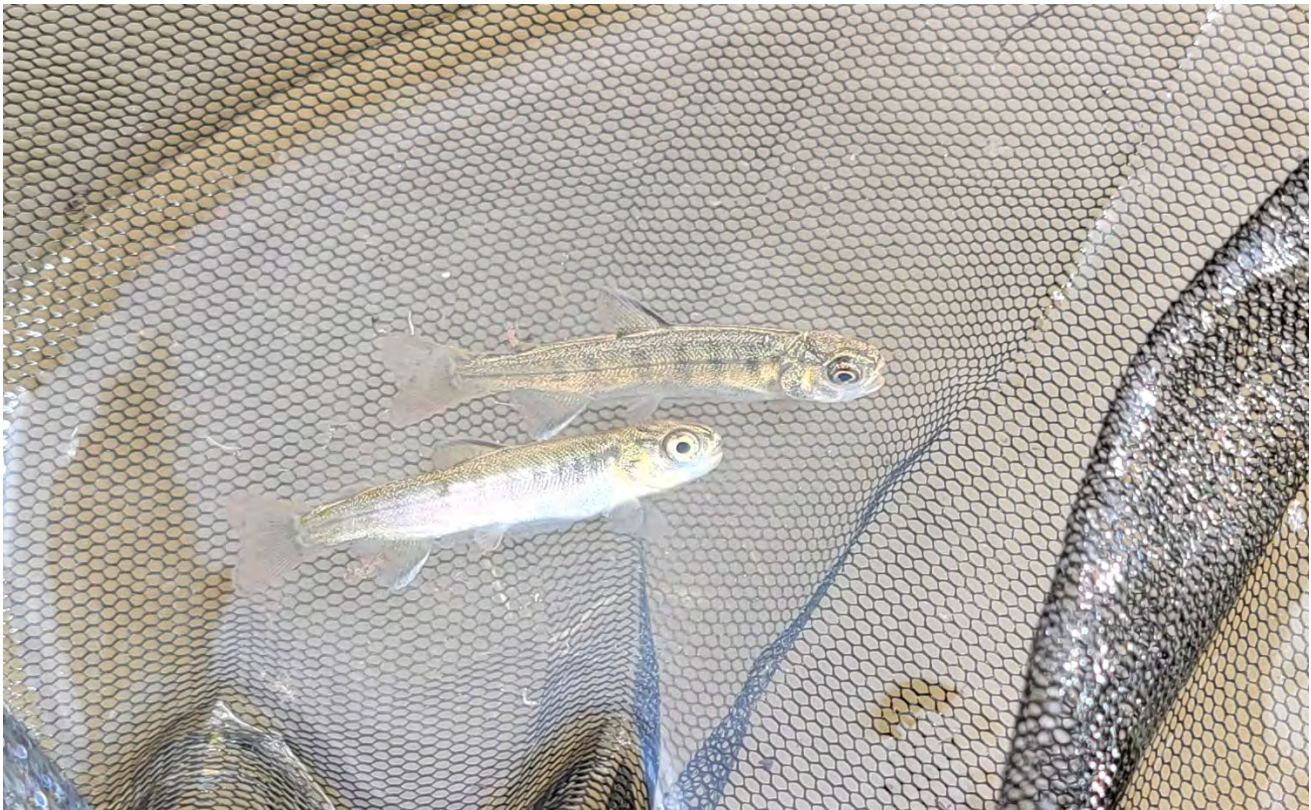
Figure 3.- Juvenile coho salmon captured in a previously unlisted tributary at waypoint 5.

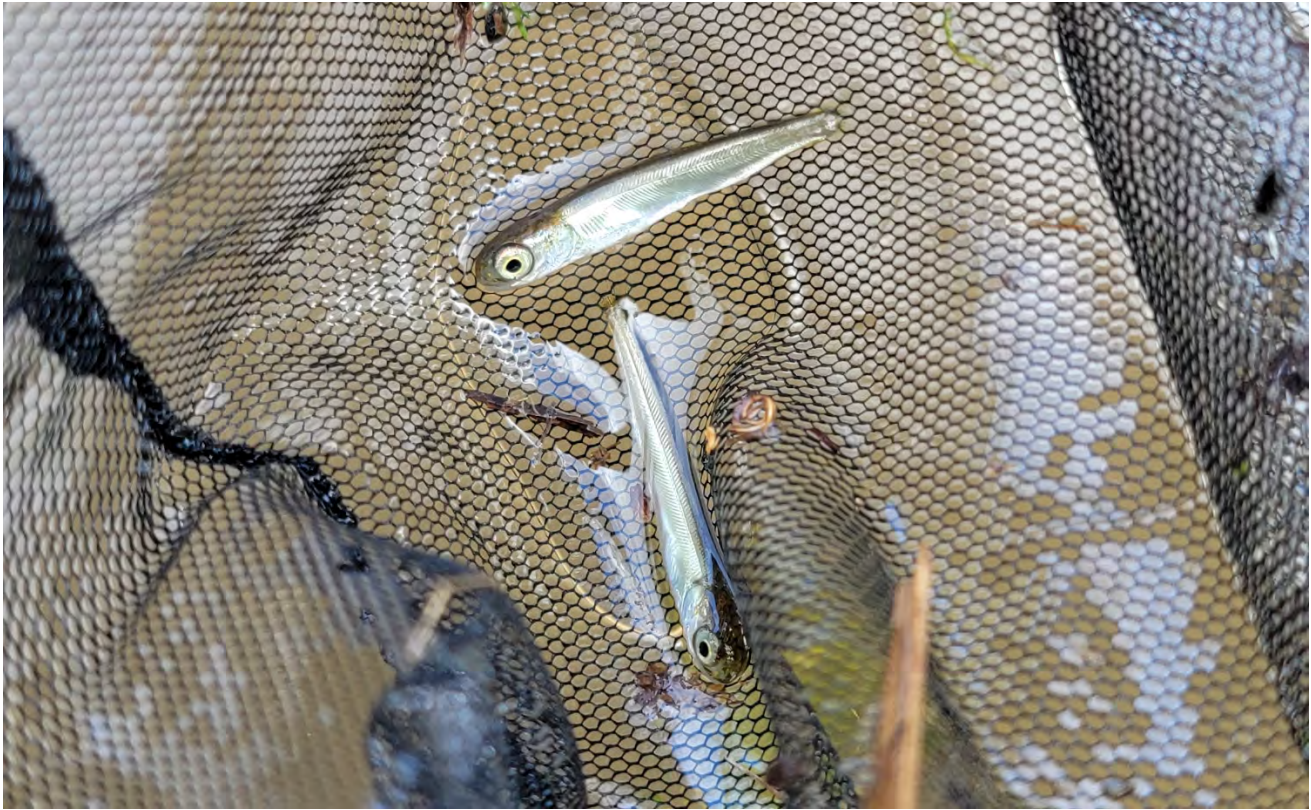
Figure 4.- Juvenile pink salmon captured in a previously unlisted tributary at waypoint 5.

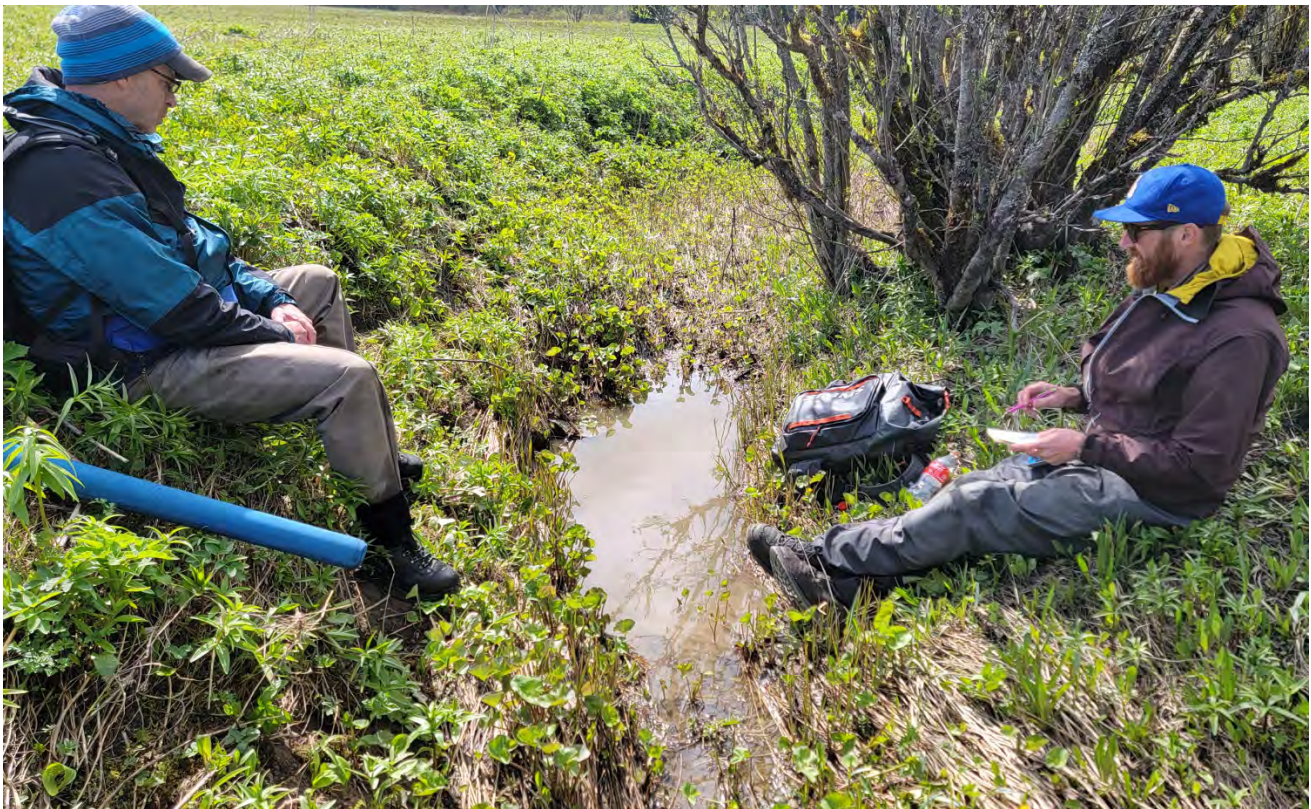
Figure 5.- Looking upstream at waypoint 5 showing emergence of flow at this water level and "dry" surface channel upstream.

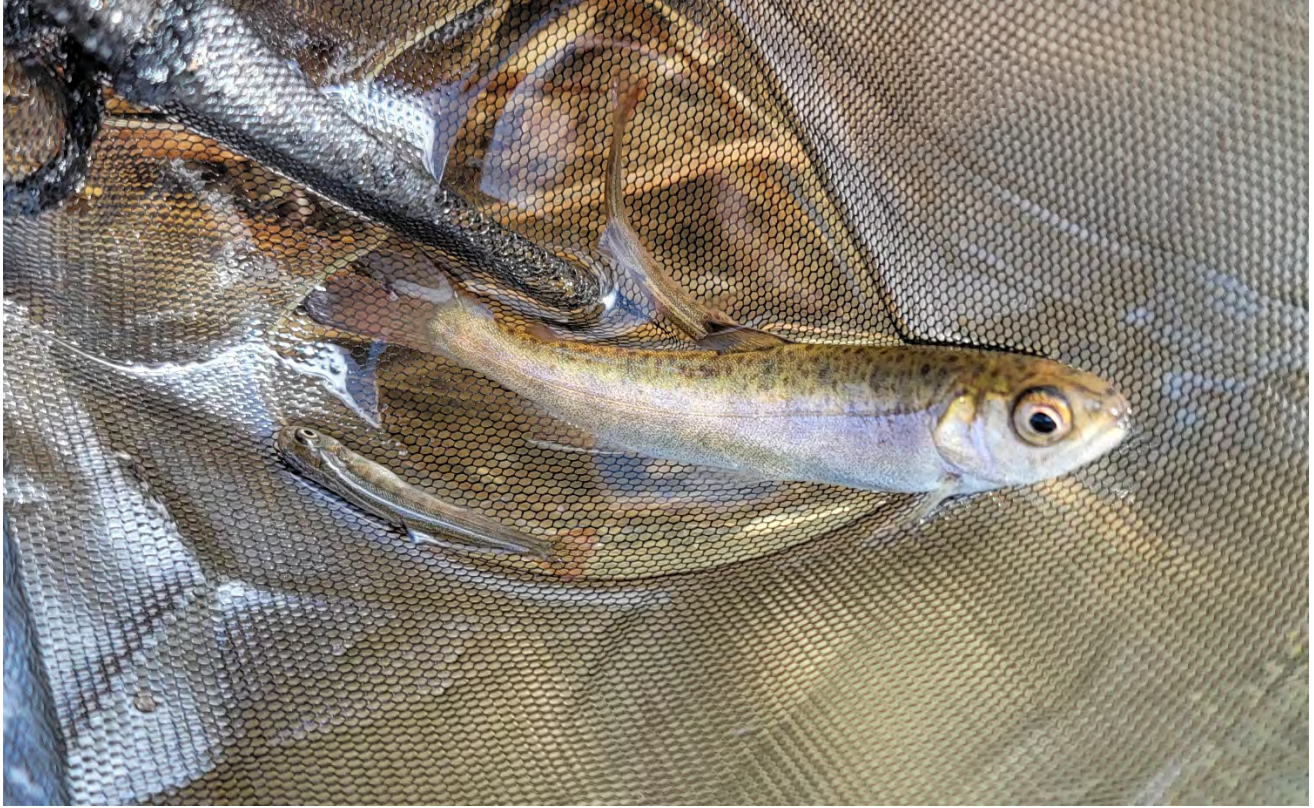
Figure 6.- Three juvenile coho salmon (Two YoY and one age 1+) captured in a previously unlisted tributary at waypoint 7.

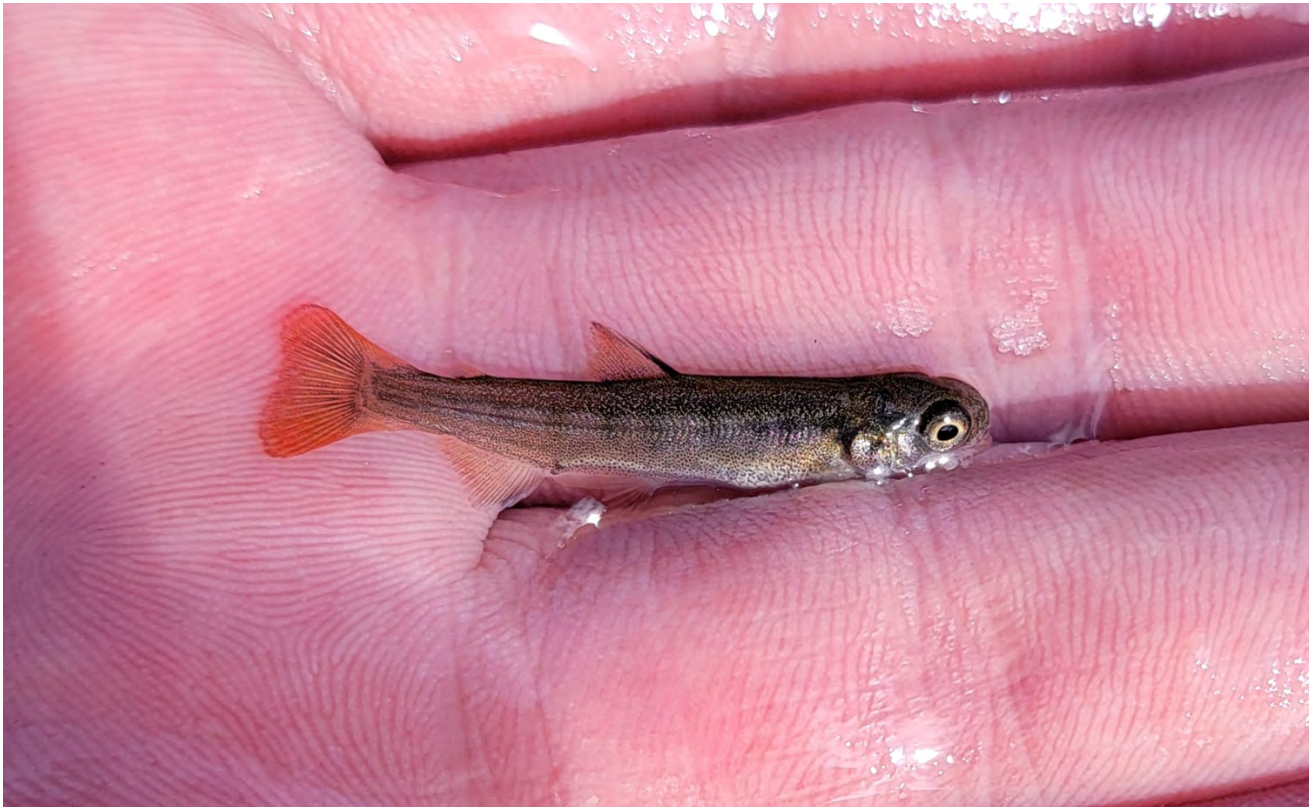
Figure 7.- Closeup of coho YOY captured at waypoint 7.

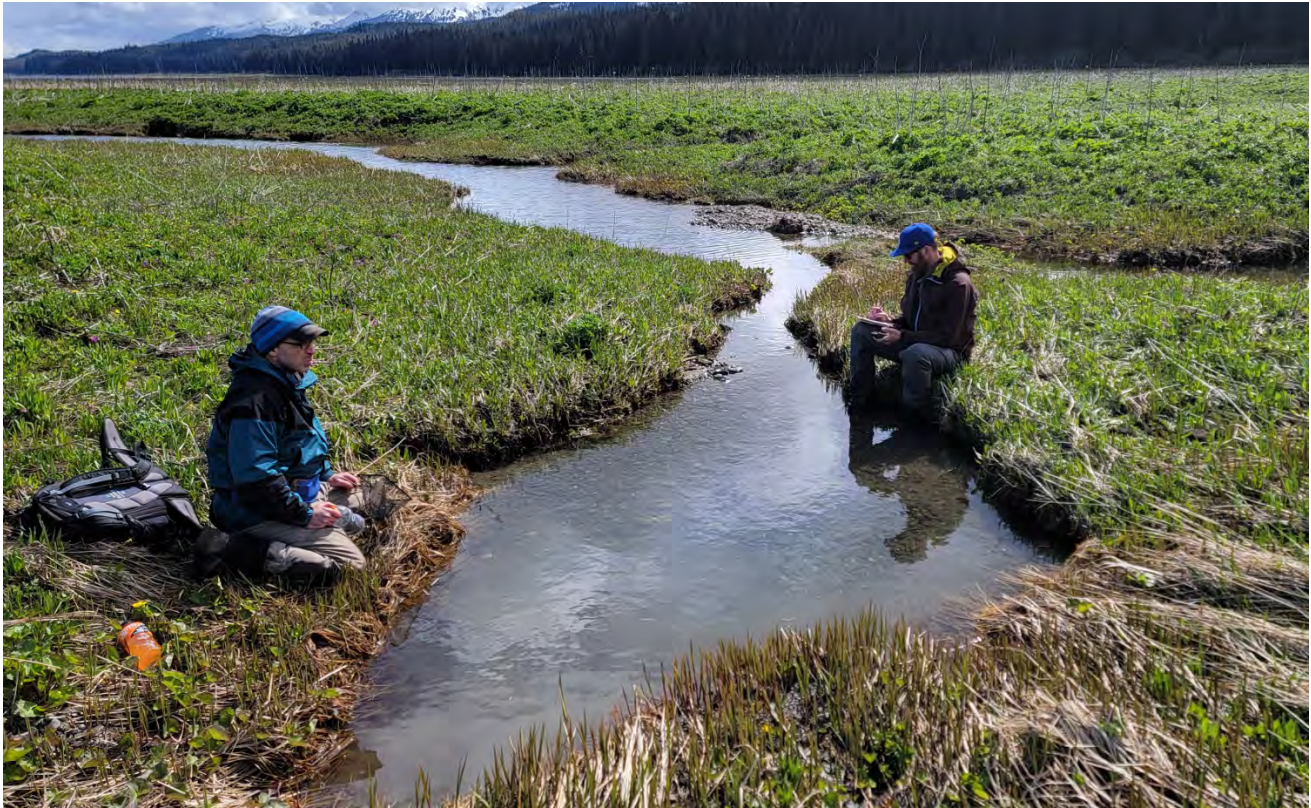
Figure 8.- Looking downstream from waypoint 7 showing off-channel pool where fish were captured as well as stream channel and general characteristics.

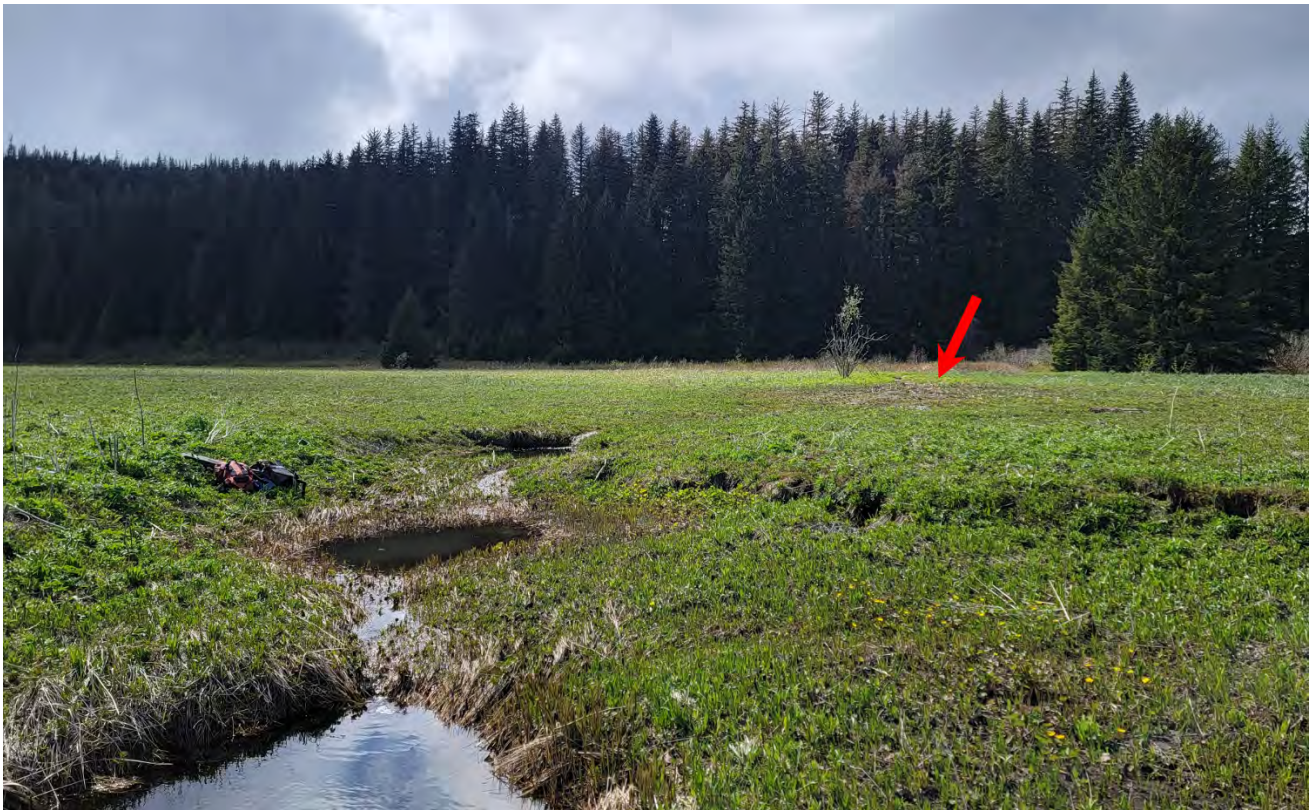
Figure 9.- Looking upstream in main channel at pools and grass steps from near waypoint 7. Red arrow indicates stream emergence from seep.

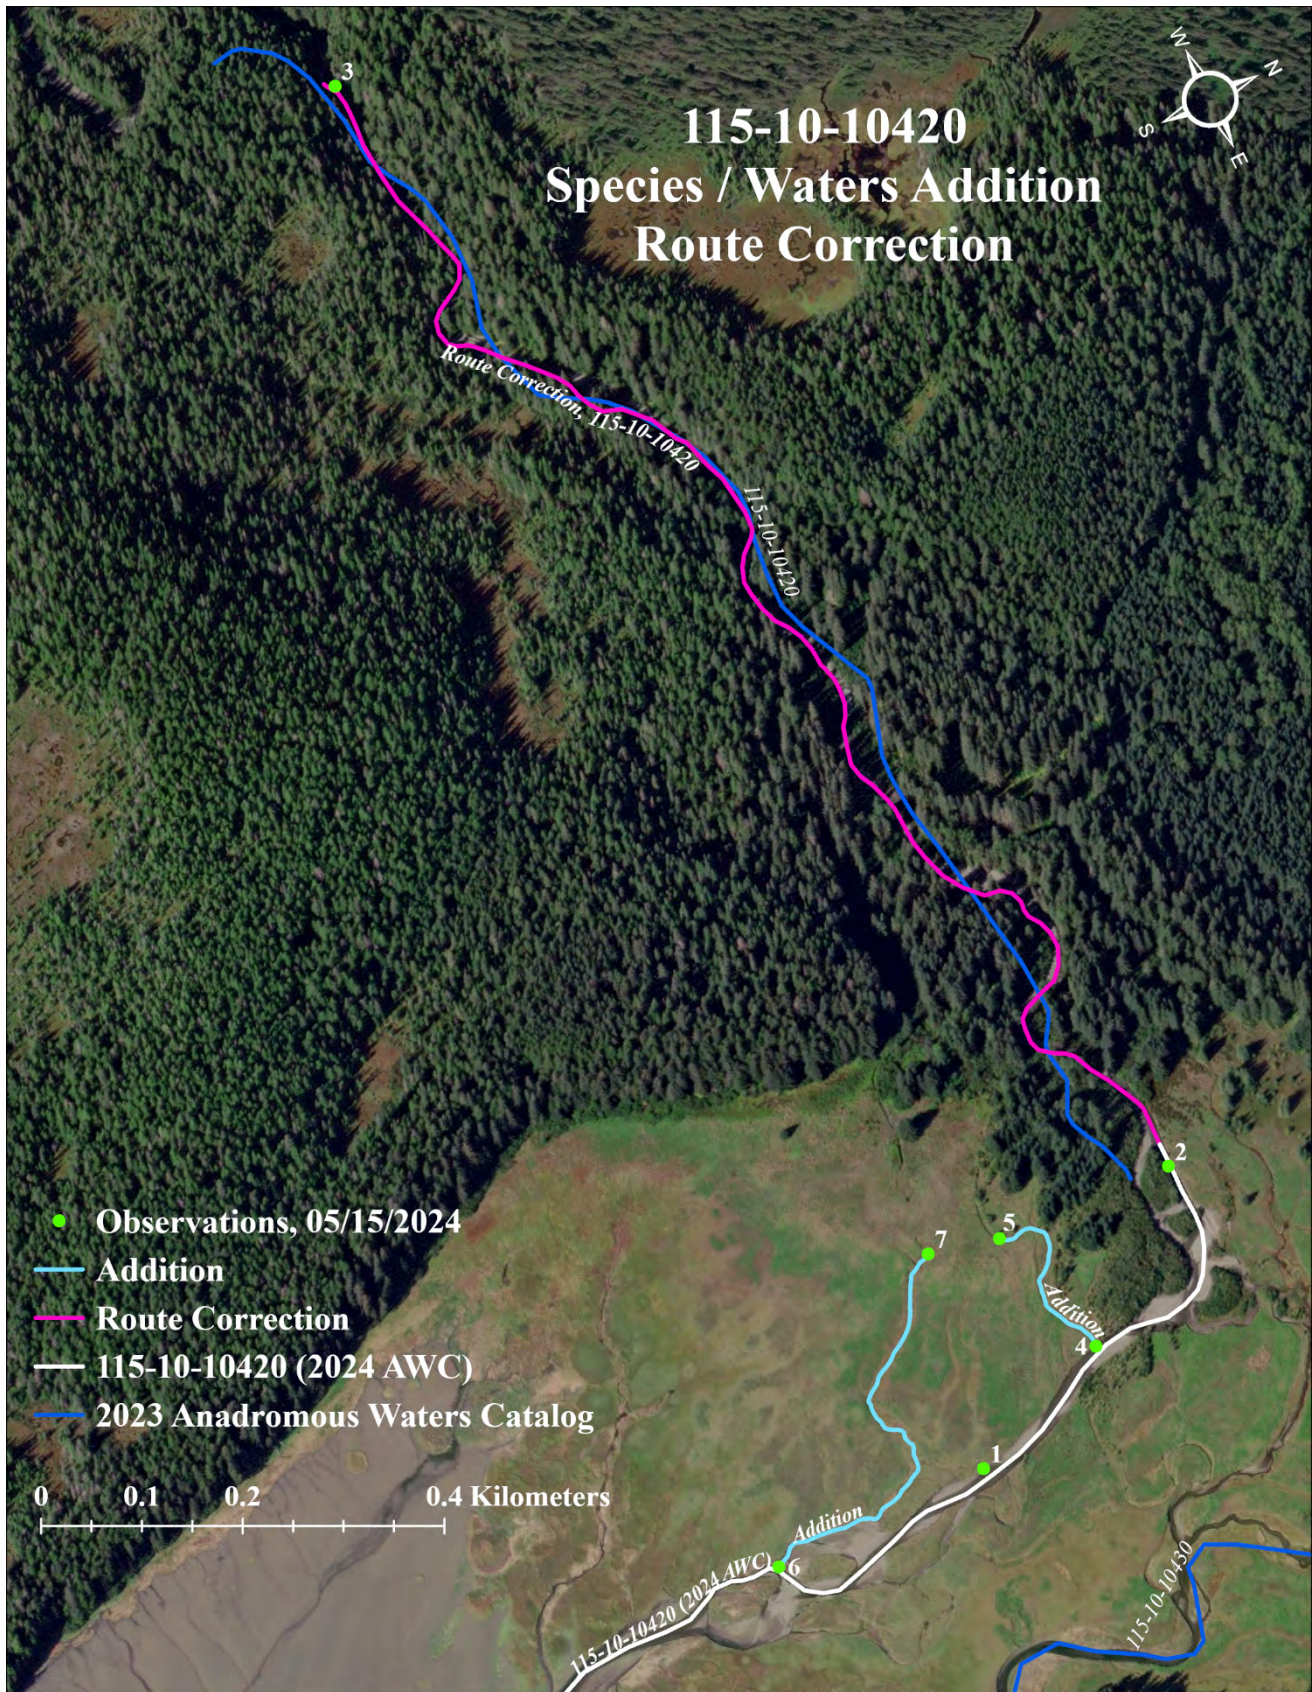
Figure 10.- A map of 115-10-10420 showing observation locations, waters additions, and route correction.
