Canyon Lake

247-41-10200-2053-3205-4069

10/9/2024

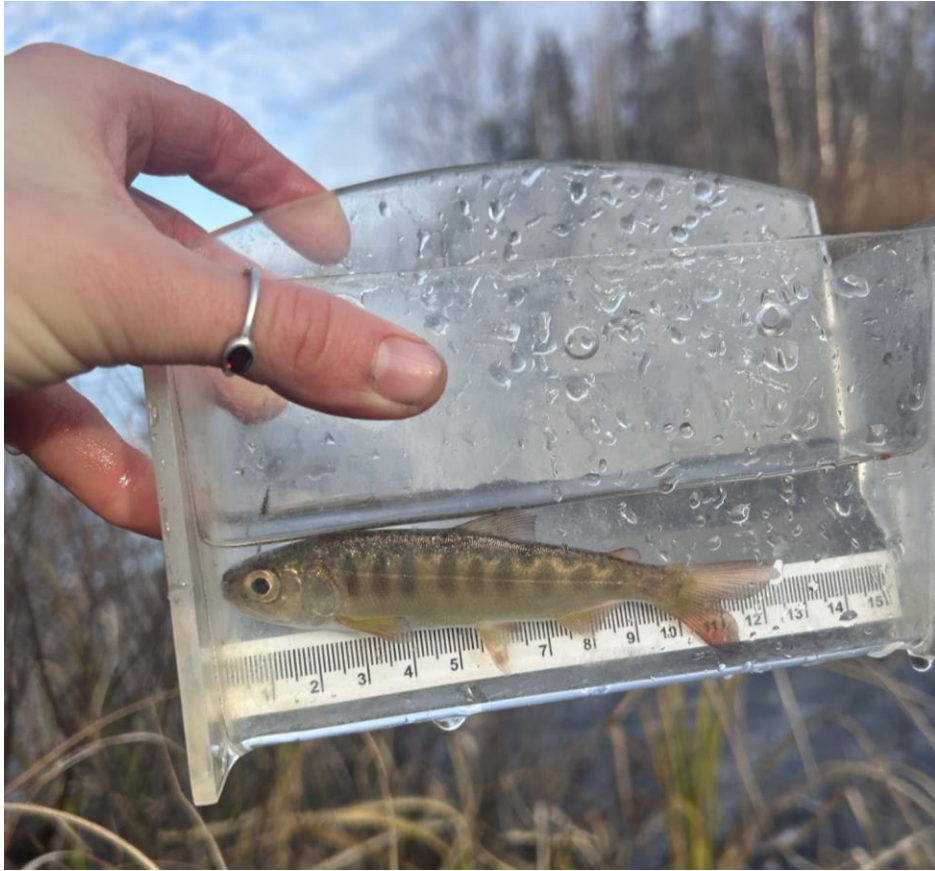
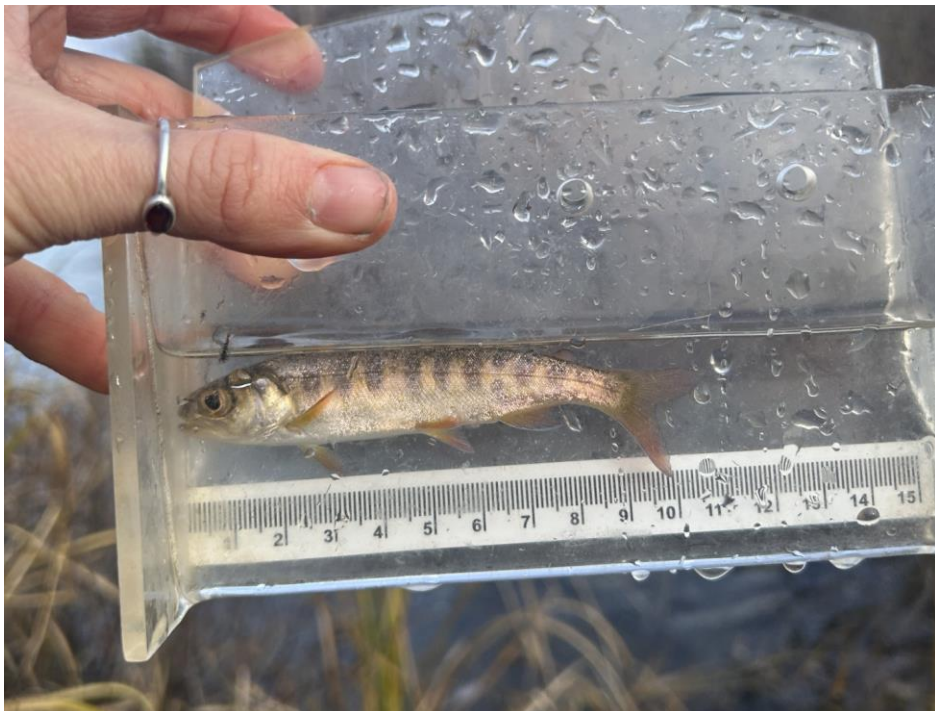
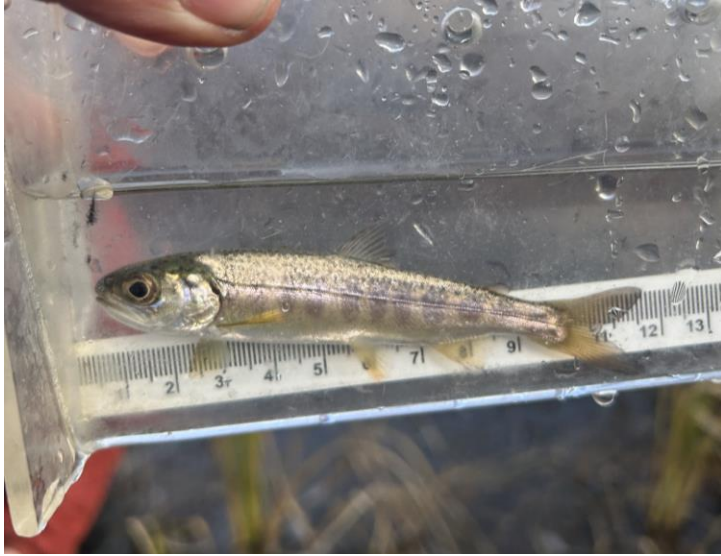
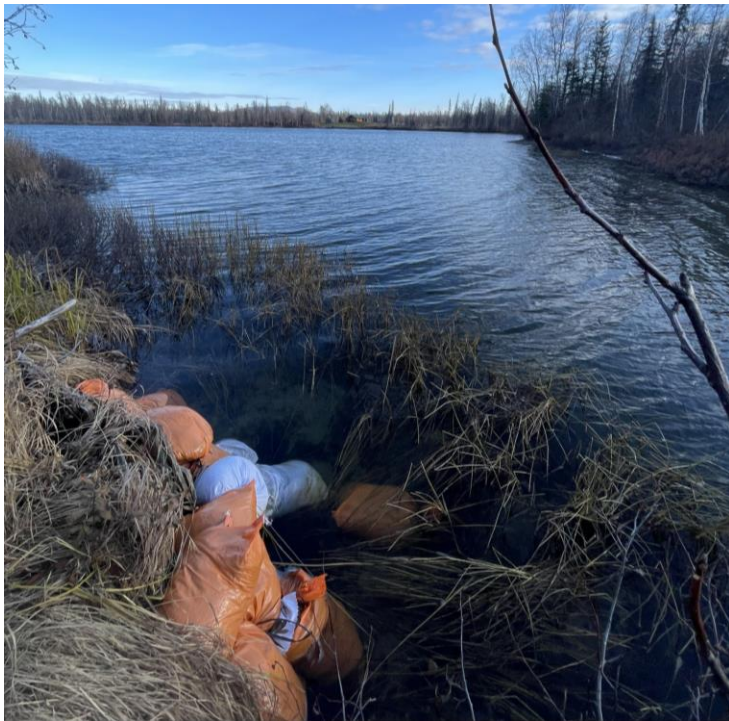
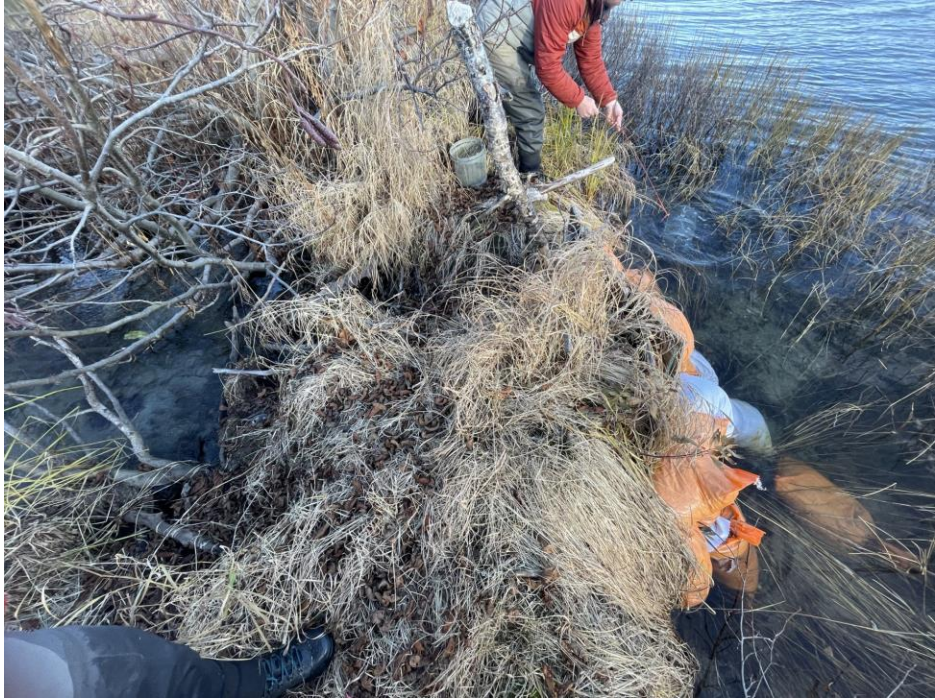
Datasheet: Coho smolt captured in two minnow traps in Canyon Lake, within lake and near outlet. Lake residents had constructed a dam at outlet, but water was visibly flowing underneath dam. Dam does not appear to be a passage barrier for adult salmon due to the presence of coho smolt within the lake, but could be a barrier to juvenile fish. Two traps were set in the lake body, approximately 10 m apart. One trap (61.894510, -151.614834) captured 12 coho, and the other (61.894532, -151.614982) captured 7 coho and 1 three-spine stickleback. In total, 19 juvenile coho were captured.

Photos: Coho smolt captured in minnow traps set in Canyon Lake, near outlet but in lake. Residents constructed sandbag dam at outflow, traps were set above dam in lake.

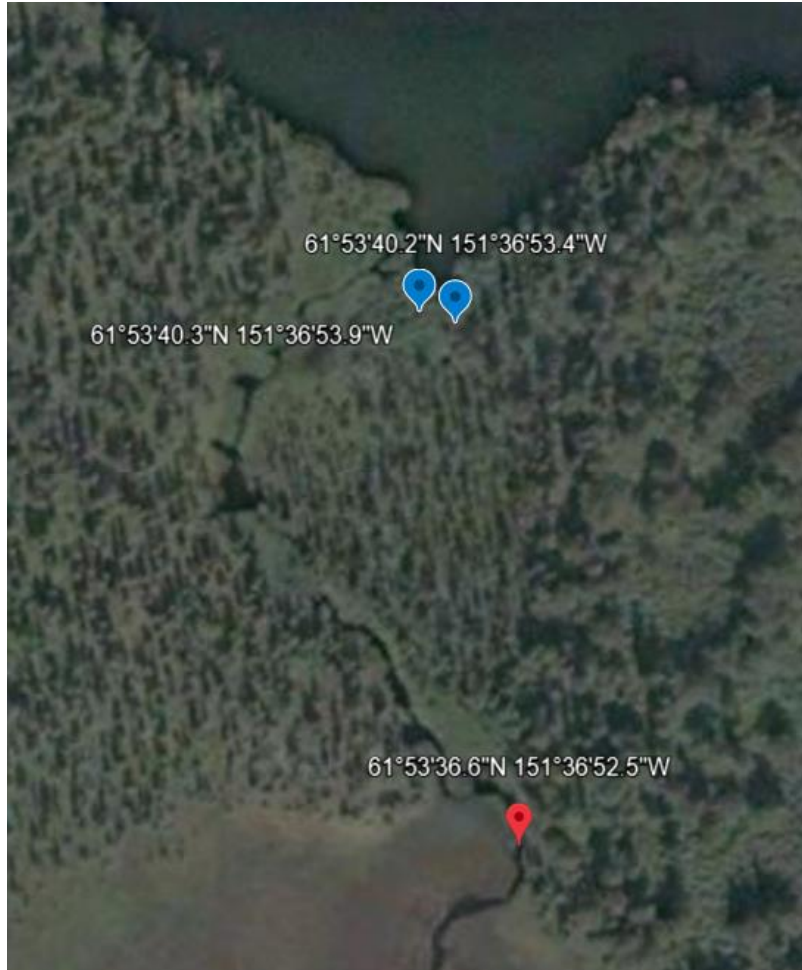
Map: Blue point are sites of minnow traps in Canyon Lake. Lower red point is site of minnow traps set on 8/14/2024 (pending AWC nomination 24-826). Two traps set on this visit were set in the lake proper, demonstrated in above photos picturing the sandbag dam structure. Lake boundary appears to have expanded from previous aerial imagery.
