Appendix: Excursion Inlet

Guide to direct fieldwork for cataloging anadromous water bodies in Southeast Alaska

EXCURSION INLET SURVEYS

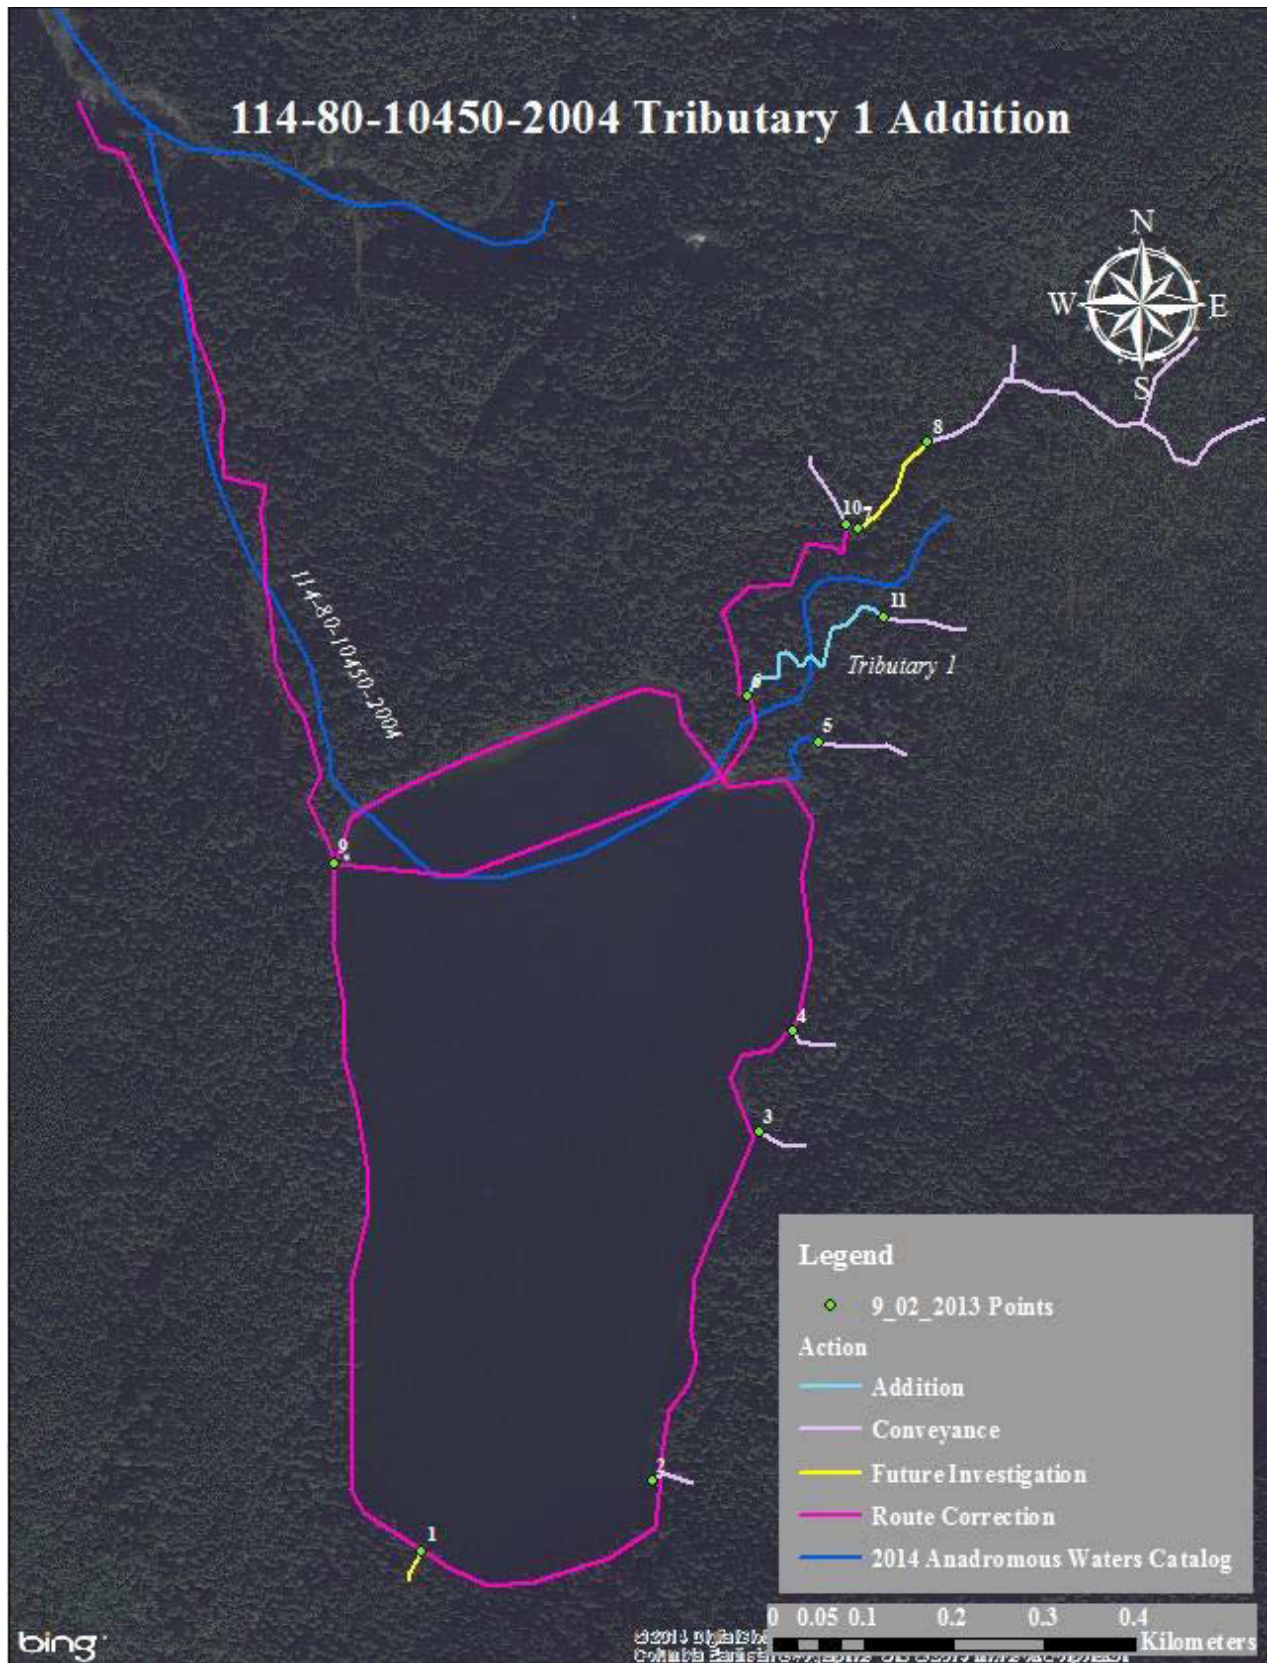
Figure 1.-114-80-10450-2004-3008 addition map, labeled Tributary 1 on map.

114-80-10450-2004-3008**ADDITION****Water body name:****Survey date:** 9/2/2013**Water body number:** 114-80-10450-2004-3008**Species & Lifestage:** Ss**Watershed:** Excursion River-Frontal Icy Strait**MTR:** C040S060E **Quad:** Juneau B-5**Findings:** I observed 15 spawning sockeye in an uncataloged tributary to Neva Creek (Table 1, Figure 1).**Recommendations:** Add stream and spawning sockeye to the Anadromous Waters Catalog.**Nomination:** 15-504
