Appendix: Ketchikan

Guide to direct fieldwork for cataloging anadromous water bodies in Southeast Alaska

KETCHIKAN SURVEYS

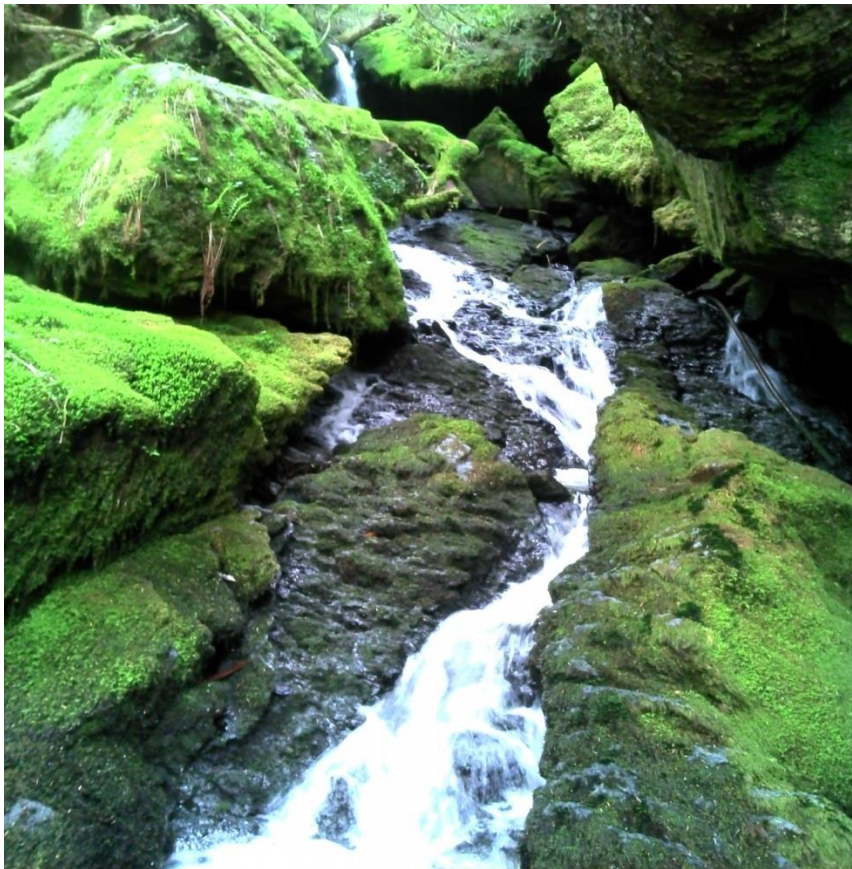
Findings: We surveyed this stream using a backpack electrofisher and a GPS (Table 1). We ended the survey at a cascade waterfall that is a barrier to fish passage (Figure 1). The stream's cataloged route differs from the field verified route.

Figure 1.–Lower portion of the bedrock cascade barrier on Herring Cove Creek.

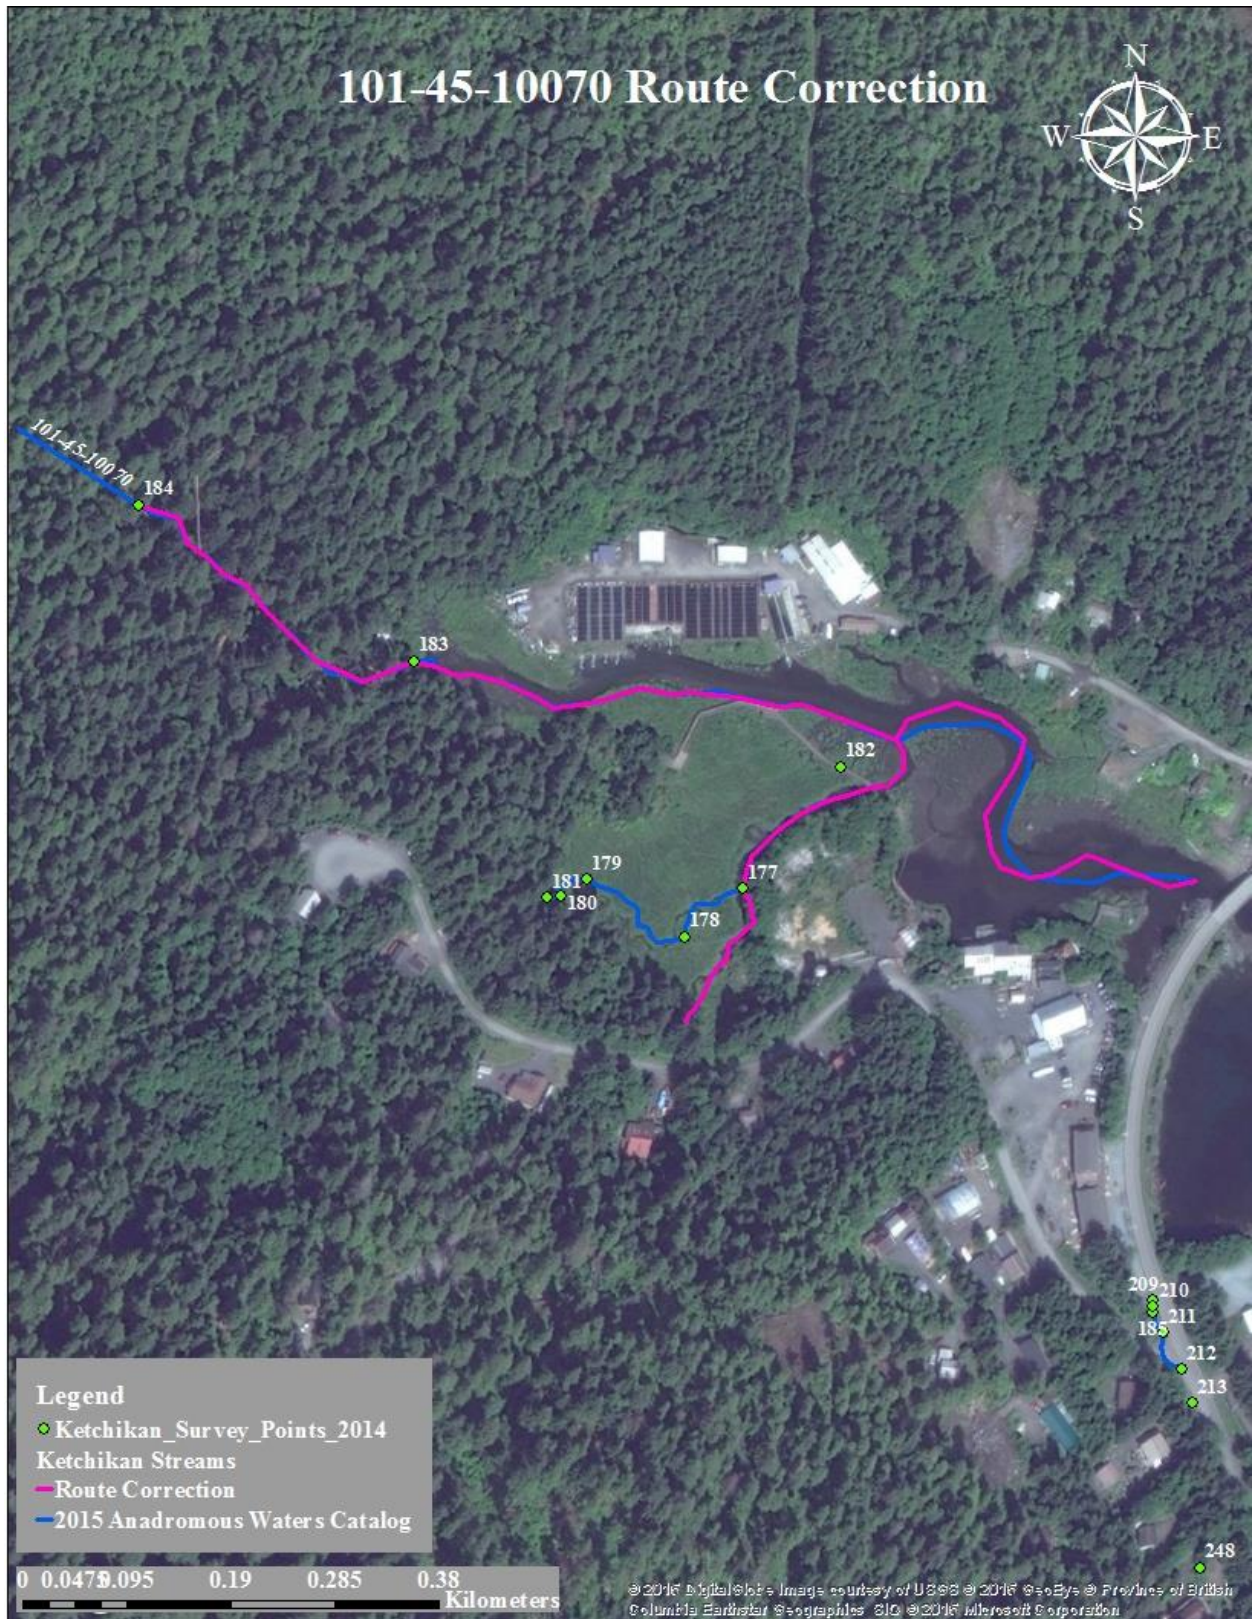
Figure 2.—101-47-10070 route correction map.

Recommendations: Update this stream's course to reflect the field verified route (Figure 2).

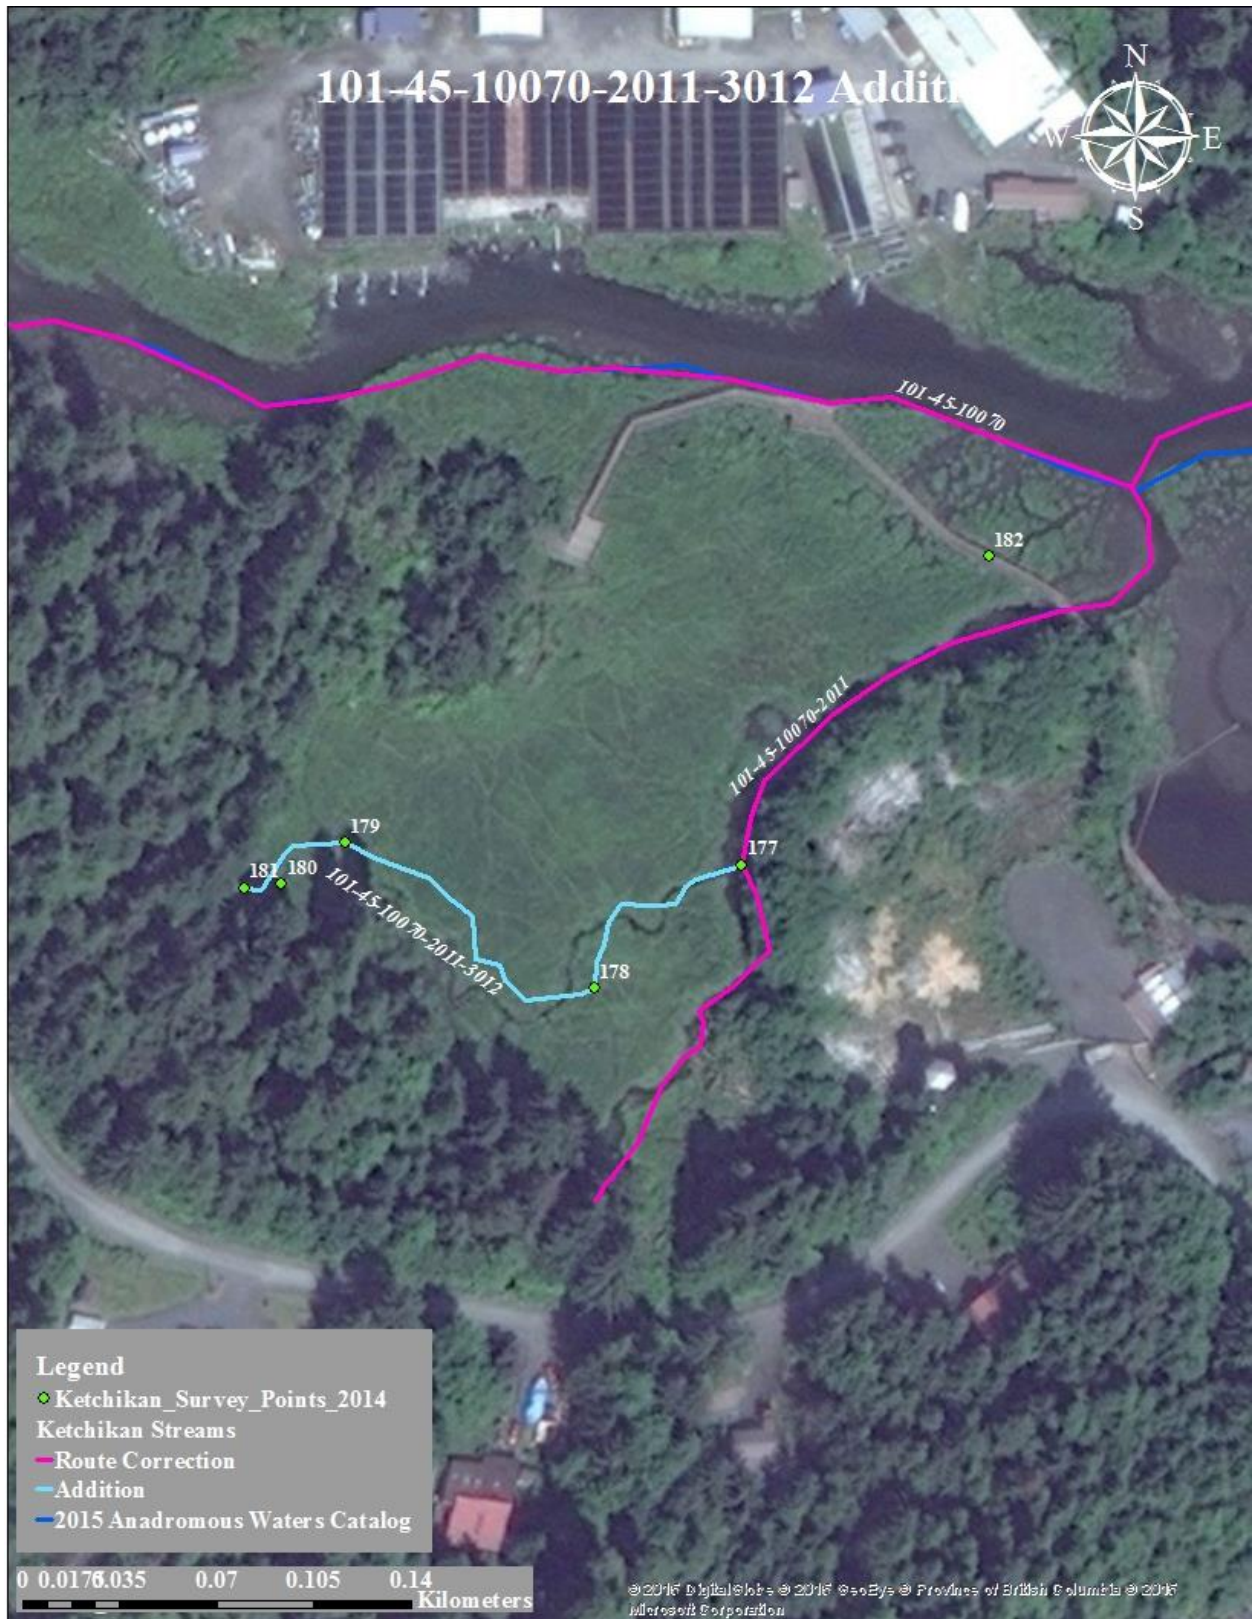
Figure 1.-101-45-10070-2011-3012 addition map.

101-45-10070-2011-3012**ADDITION****Water body name:****Survey date:** 5/7/2014**Water body number:** 101-45-10070-2011-3012**Species & Lifestage:** CO**Watershed:** Carroll Inlet-Frontal Revillagigedo Channel**MTR:** C075S091E **Quad:** Ketchikan B-5**Findings:** We surveyed stream number 101-45-10070-2011-3012 using a backpack electrofisher and a GPS (Table 1). This stream provides rearing habitat for rearing coho salmon.**Recommendations:** Add this stream to the AWC (Figure 1).**Nomination:** 14-623

Waypoint	Latitude	Longitude	Notes	Sample Effort	Sample Results
177	55.3266	-131.5292	High tide mark, tributary entering on river left.		
178	55.3263	-131.5297		HN	2 CO
179	55.3266	-131.5305		EF	3 CO
180	55.3265	-131.5307	Seep that is providing half of the flow entering on river right. Only 10' long so not tracking.		
181	55.3265	-131.5308	Calling it the top. Water is seeping out of th ground.

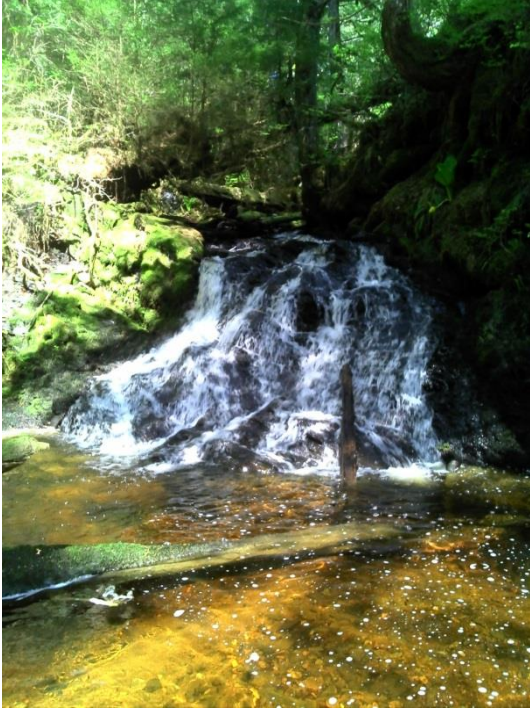
Findings: We surveyed Adams Creek using minnow traps and a GPS (Table 1). This creek is substantially shorter than currently cataloged. The anadromous reach terminates in a 15' falls and bedrock chute (Figures 1, 2). There is a 2.5' pool at the base that provides good spawning gravel, but no upstream migration is possible.

Figure 1.—Cascade barrier on Adams Creek.

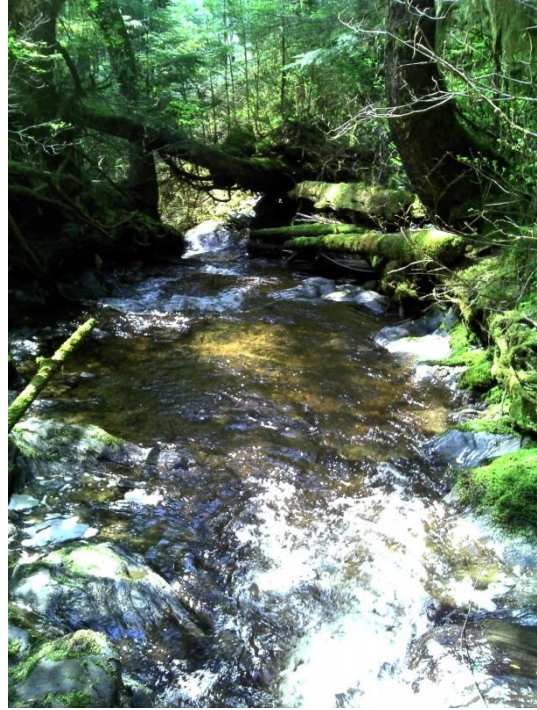
Figure 2.—Bedrock reach above cascade on Adams Creek.

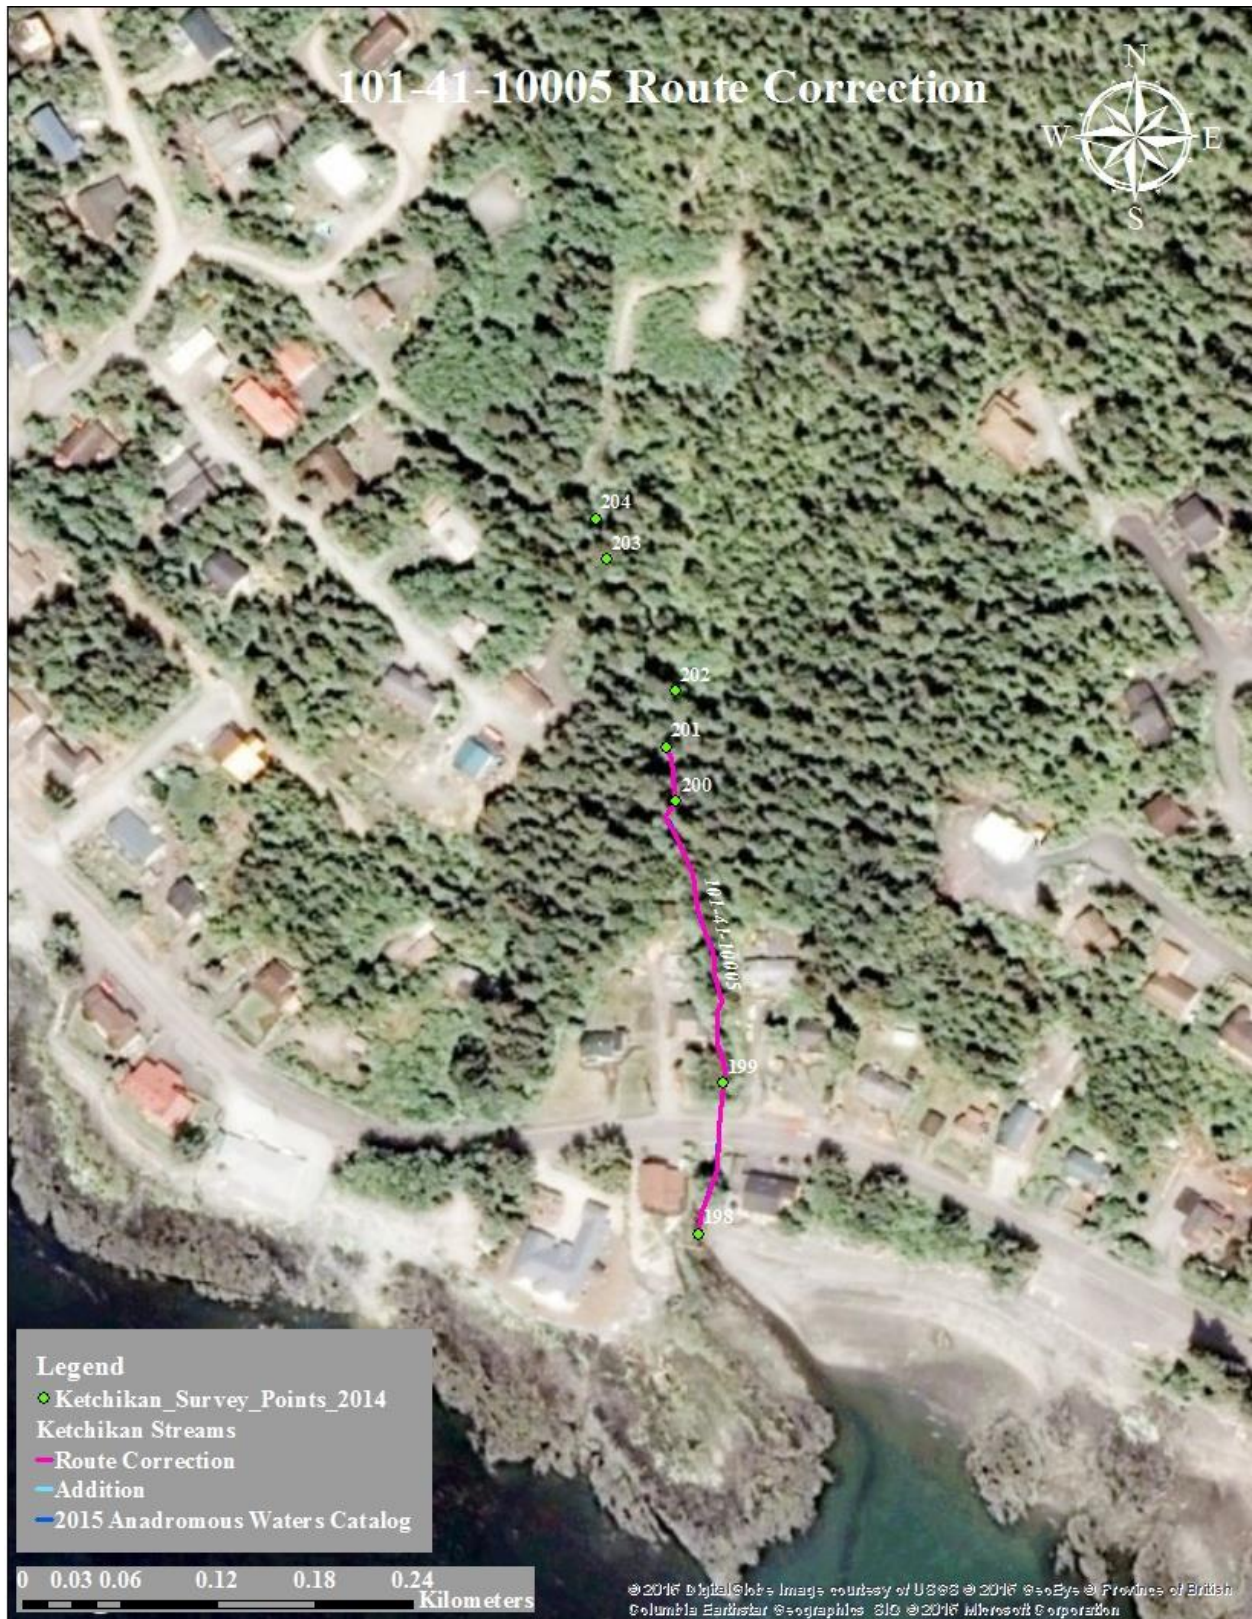
Figure 3.—101-41-10005 route correction map.

Recommendations: Update the route of this stream to reflect the field verified upper extent of anadromy (Figure 3).

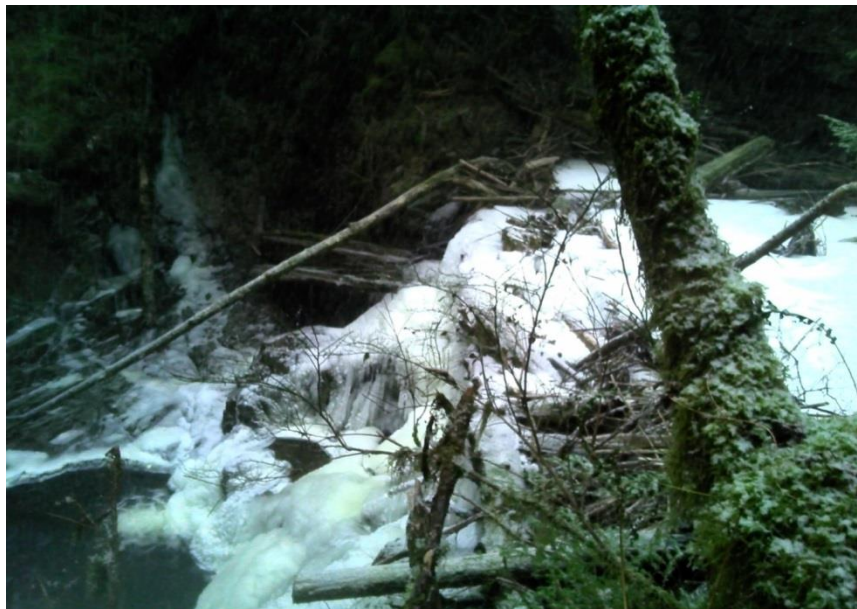
Findings: We conducted a foot survey of Whipple Creek (Table 1). This stream's anadromous reach ends at a 24' falls (Figure 1).

Figure 1.-Barrier Falls on Whipple Creek.

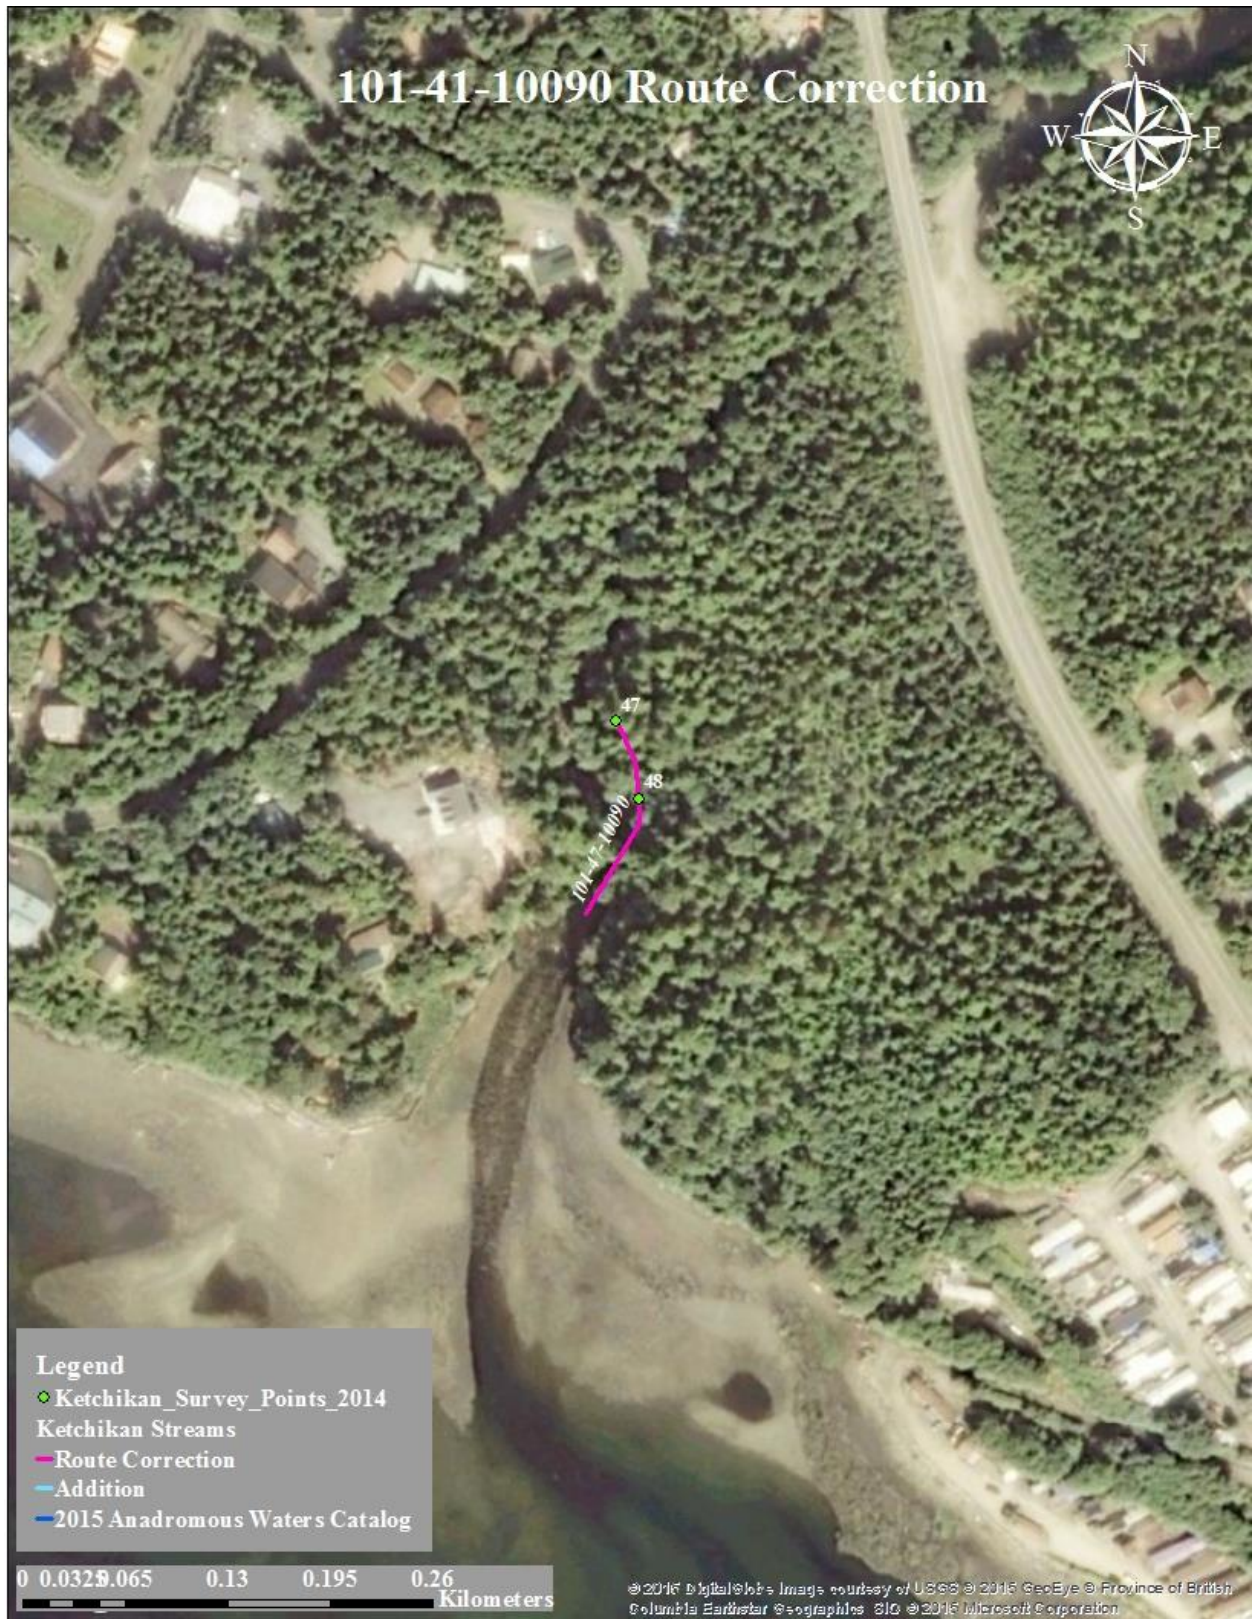
Figure 2.—101-47-10090 route correction map.

Recommendations: Please update this stream's mapped course to reflect the field-verified route (Figure 2). Additionally, there are no nominations indicating coho present for this stream, and the pink salmon were only observed in the intertidal.

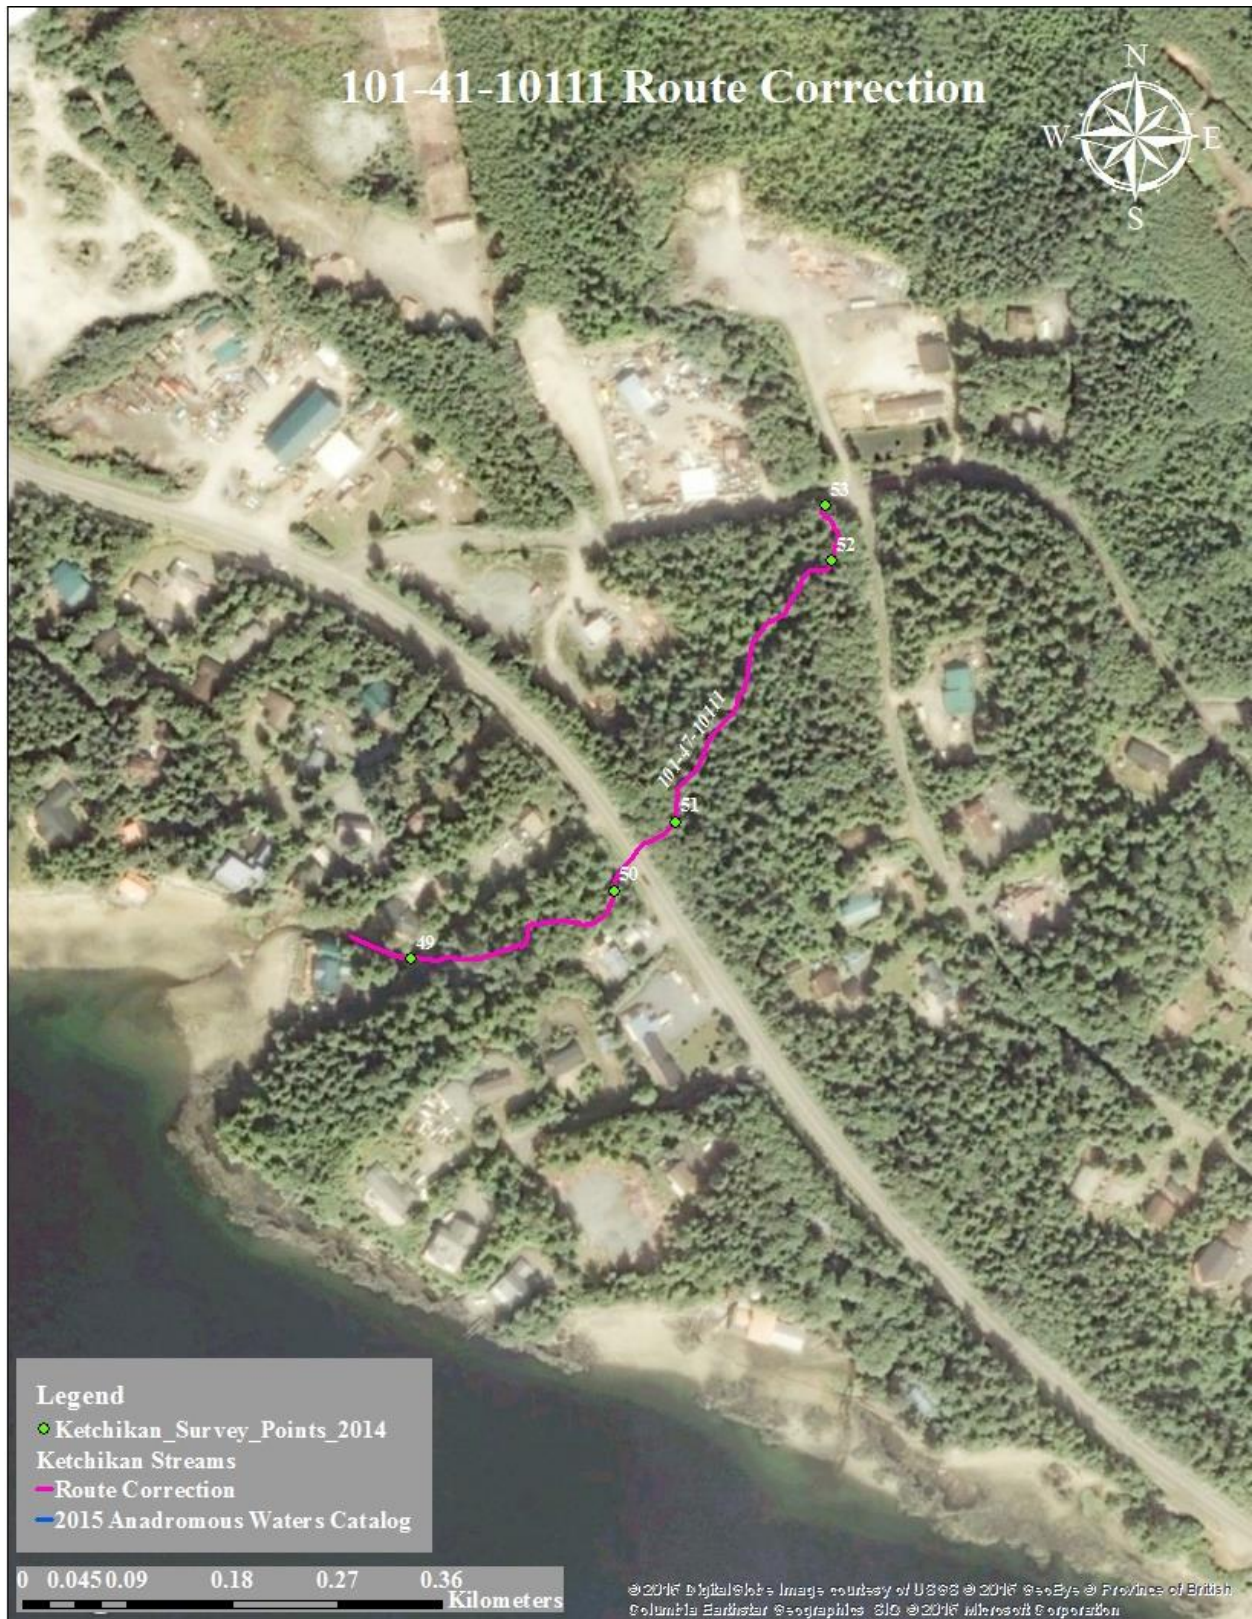
Findings: We conducted a foot survey of this stream using a GPS (Table 1). This stream's actual course differs from that illustrated in the AWC. The stream's anadromous reach ends at a perched culvert.

Figure 1.-101-47-10111 route correction map.

Recommendations: Update this stream's mapped route to reflect the field verified course (Figure 1).

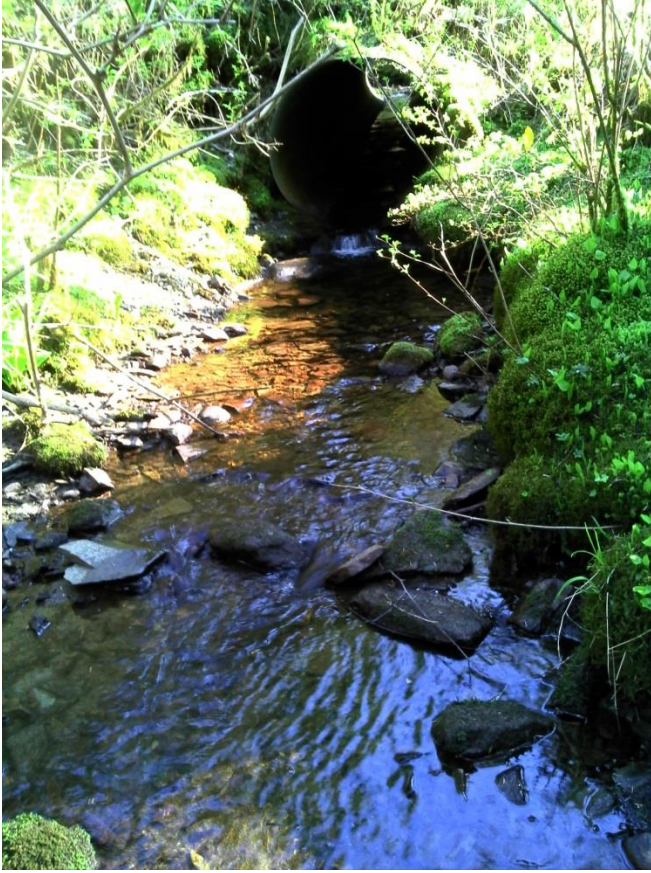
Figure 1.–Culvert crossing on 101-47-10145.

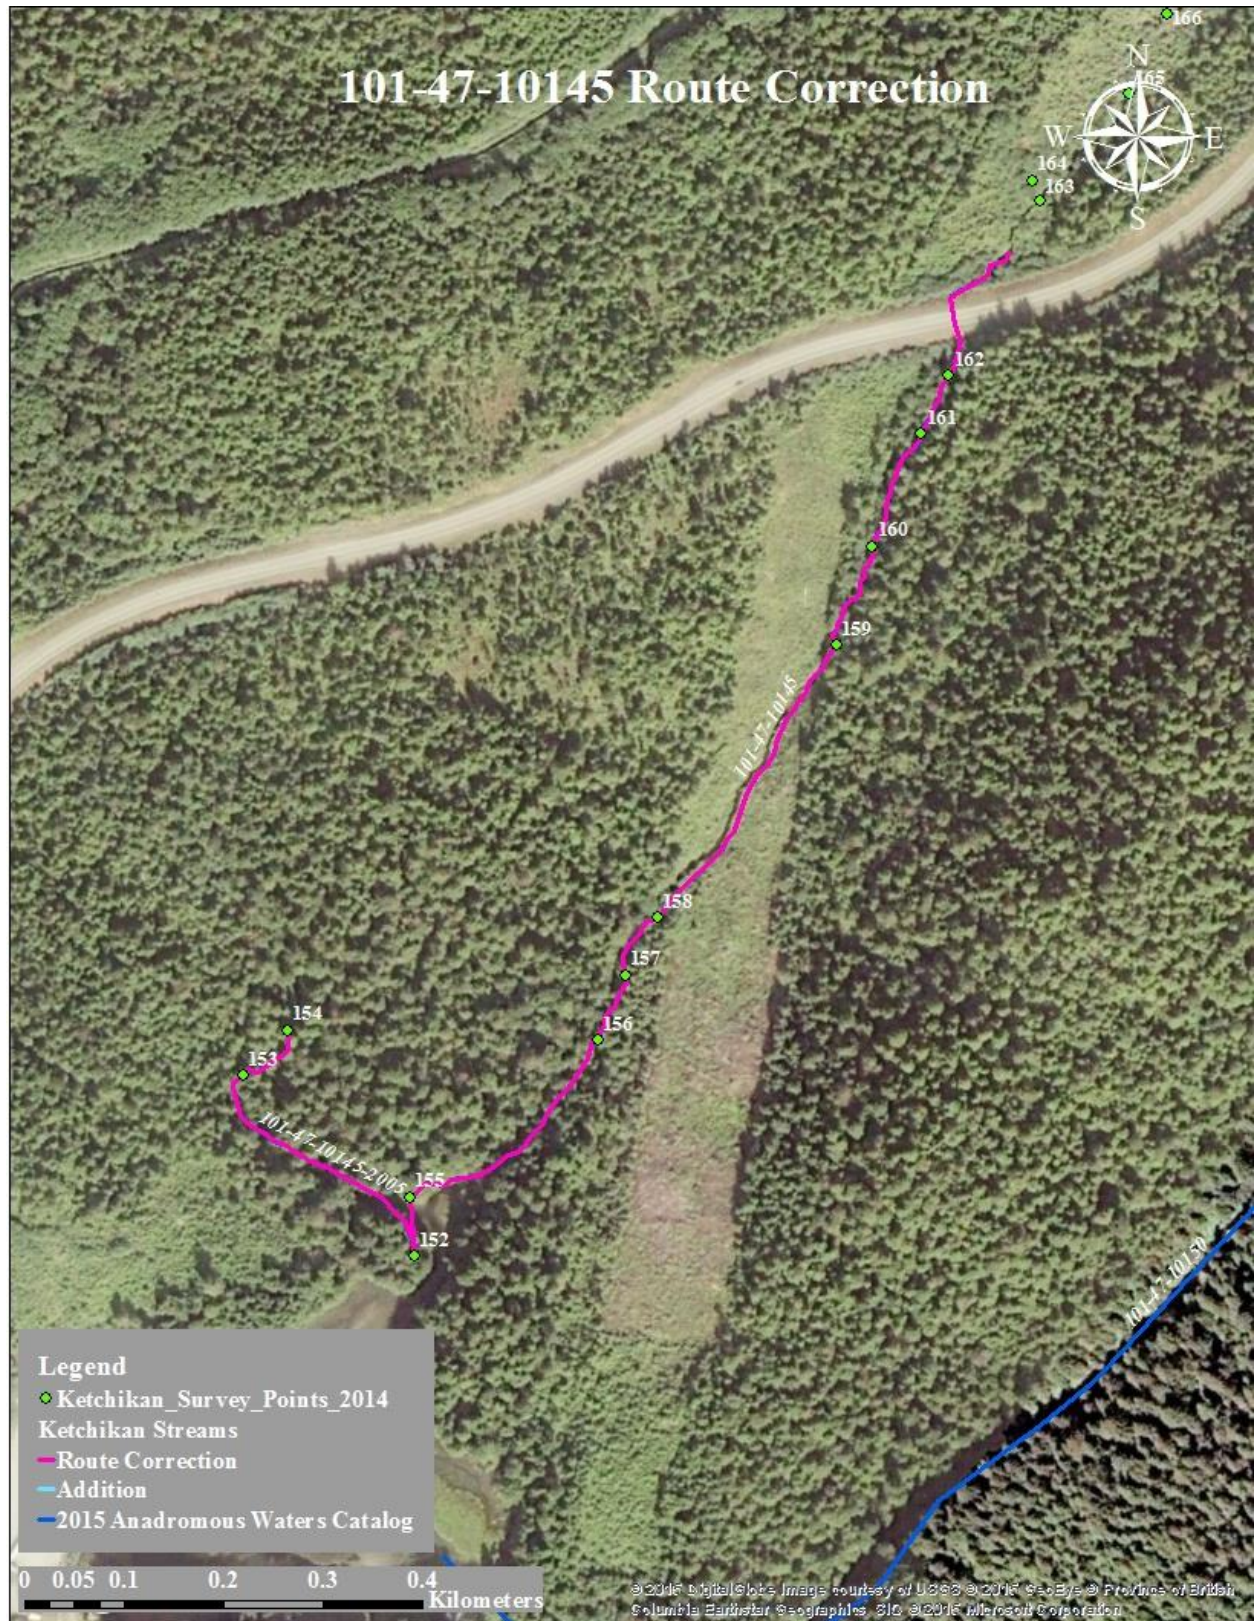
Figure 2.—101-47-10145 route correction map.

101-47-10145**CORRECTION****Water body name:****Survey date:** 5/7/2014**Water body number:** 101-47-10145**Species & Lifestage:** COsr,Ps**Watershed:** Carlanna Creek-Frontal Tongass Narrows**MTR:** C074S090E **Quad:** Ketchikan B-6**Findings:** We surveyed this stream using a backpack electrofisher and GPS (Table 1). This stream goes through a very nice culvert that provides easy fish passage (Figure 1). The actual course of this stream differs from that currently cataloged, but the upper extent remains the same.**Recommendations:** Update this stream's route to reflect the field verified course (Figure 2).**Nomination:** 14-256

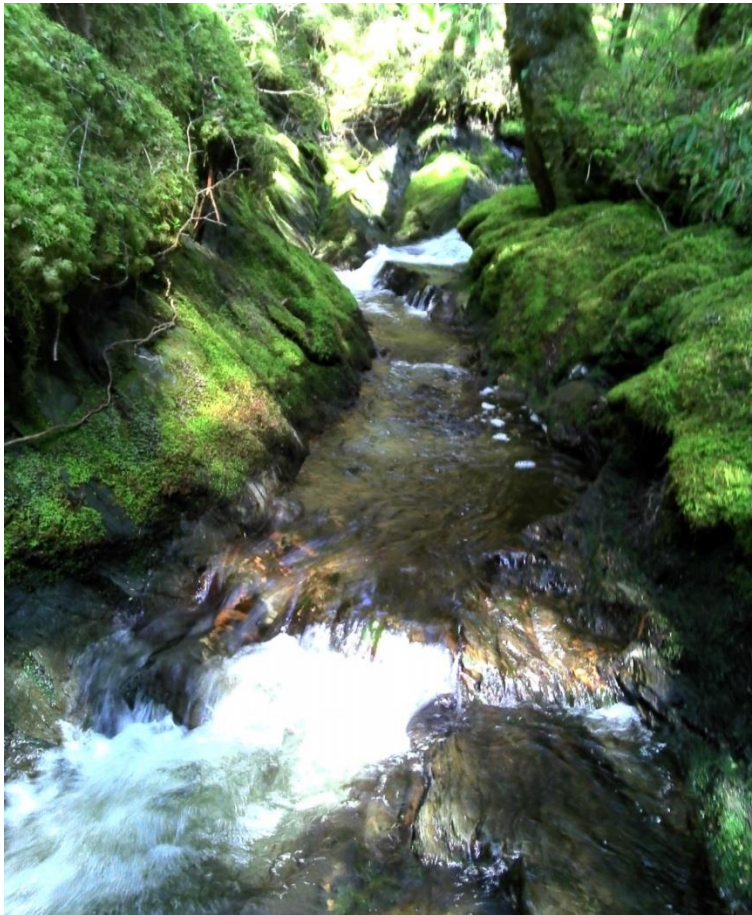
Findings: We surveyed this stream using a backpack electrofisher and a GPS (Table 1). We end the survey at a bedrock chute that is about 300' long (Figure 1). This stream's actual route differs from that in the AWC.

Figure 1.–Portion of bedrock reach on 101-47-10145-2005.

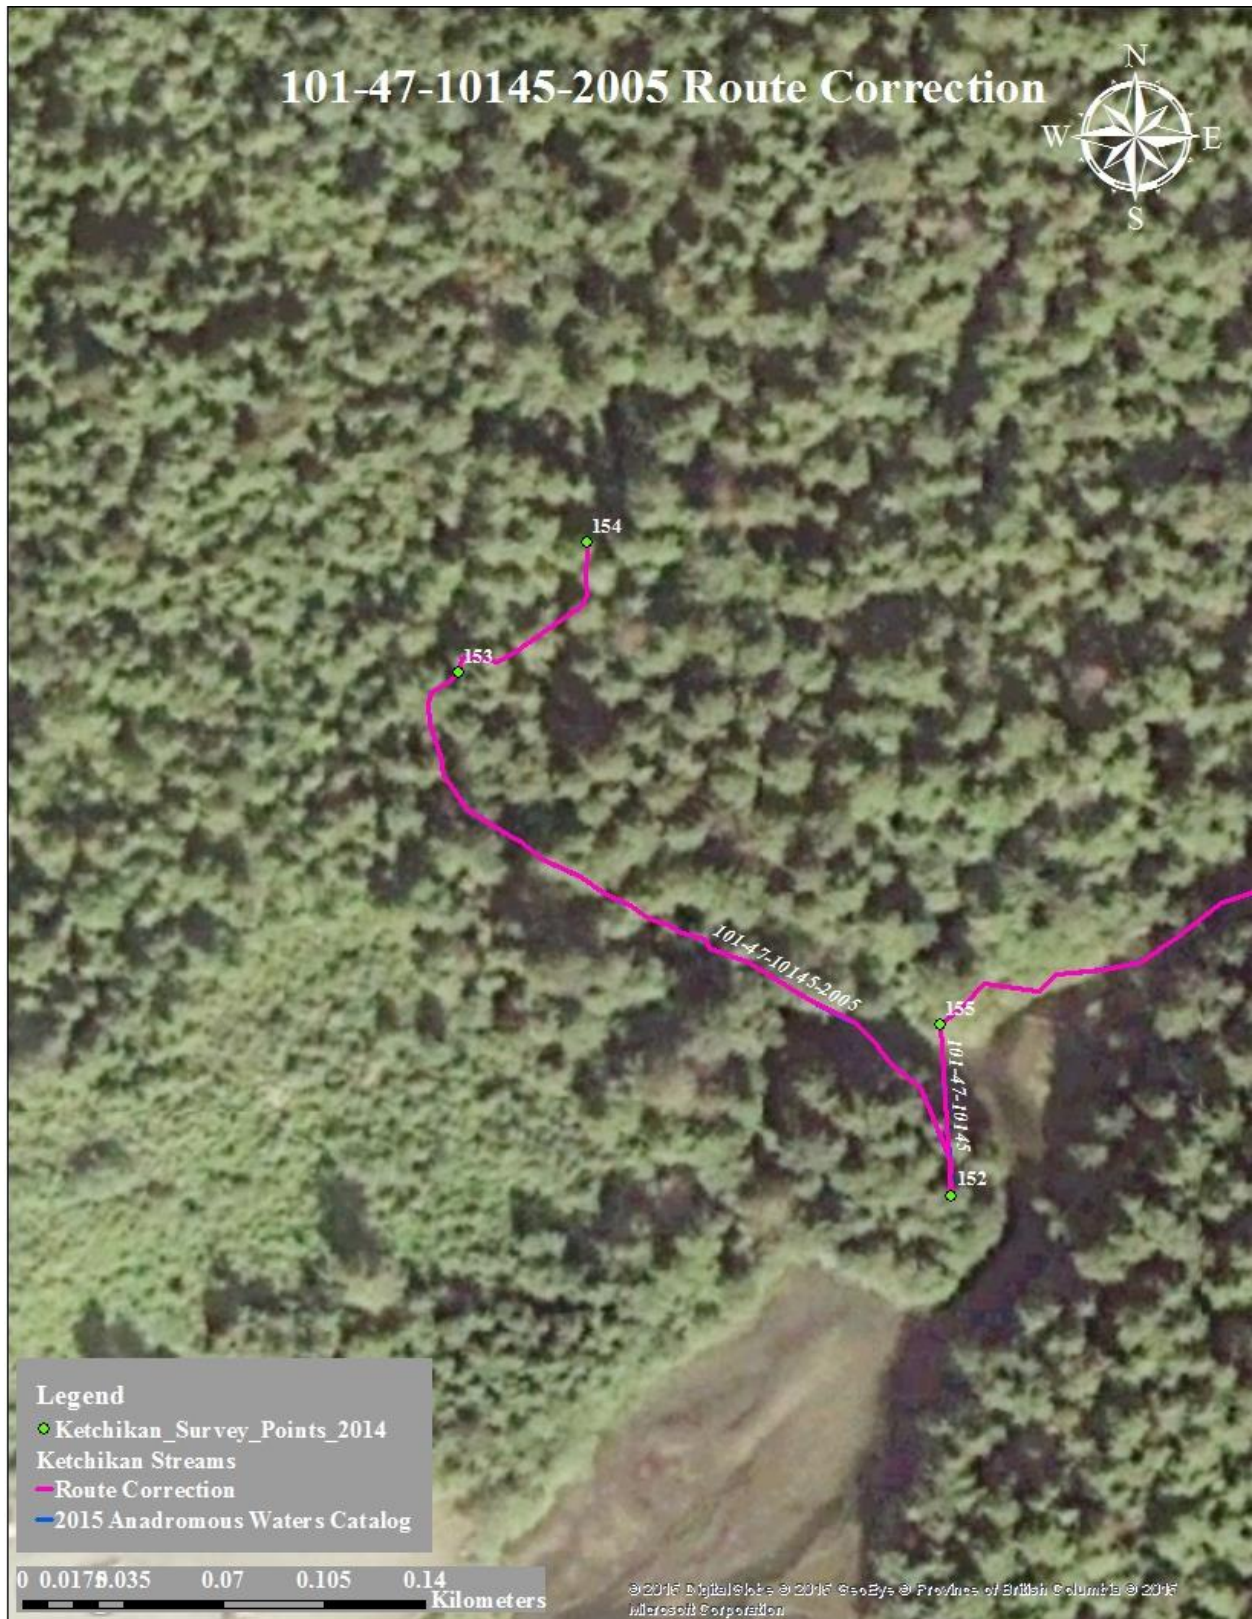
Figure 2.—101-47-10145-2005 route correction map.

Recommendations: Update this stream's course to reflect the field verified route in the AWC (Figure 2).

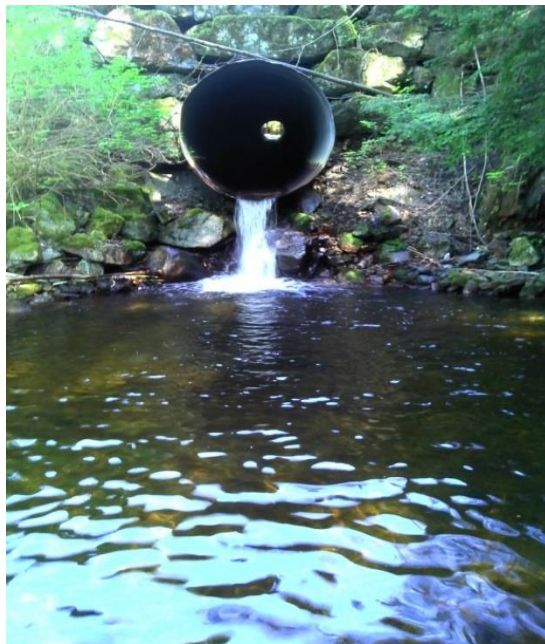
Findings: We surveyed this stream using a minnow trap and a GPS (Table 1). We ended the survey at a perched culvert that had a very deep and large pool at base (Figure 1). The culvert is long enough to impede fish passage. The stream's actual route differs significantly from the currently cataloged route.

Figure 1.–Hoadley Creek barrier culvert.

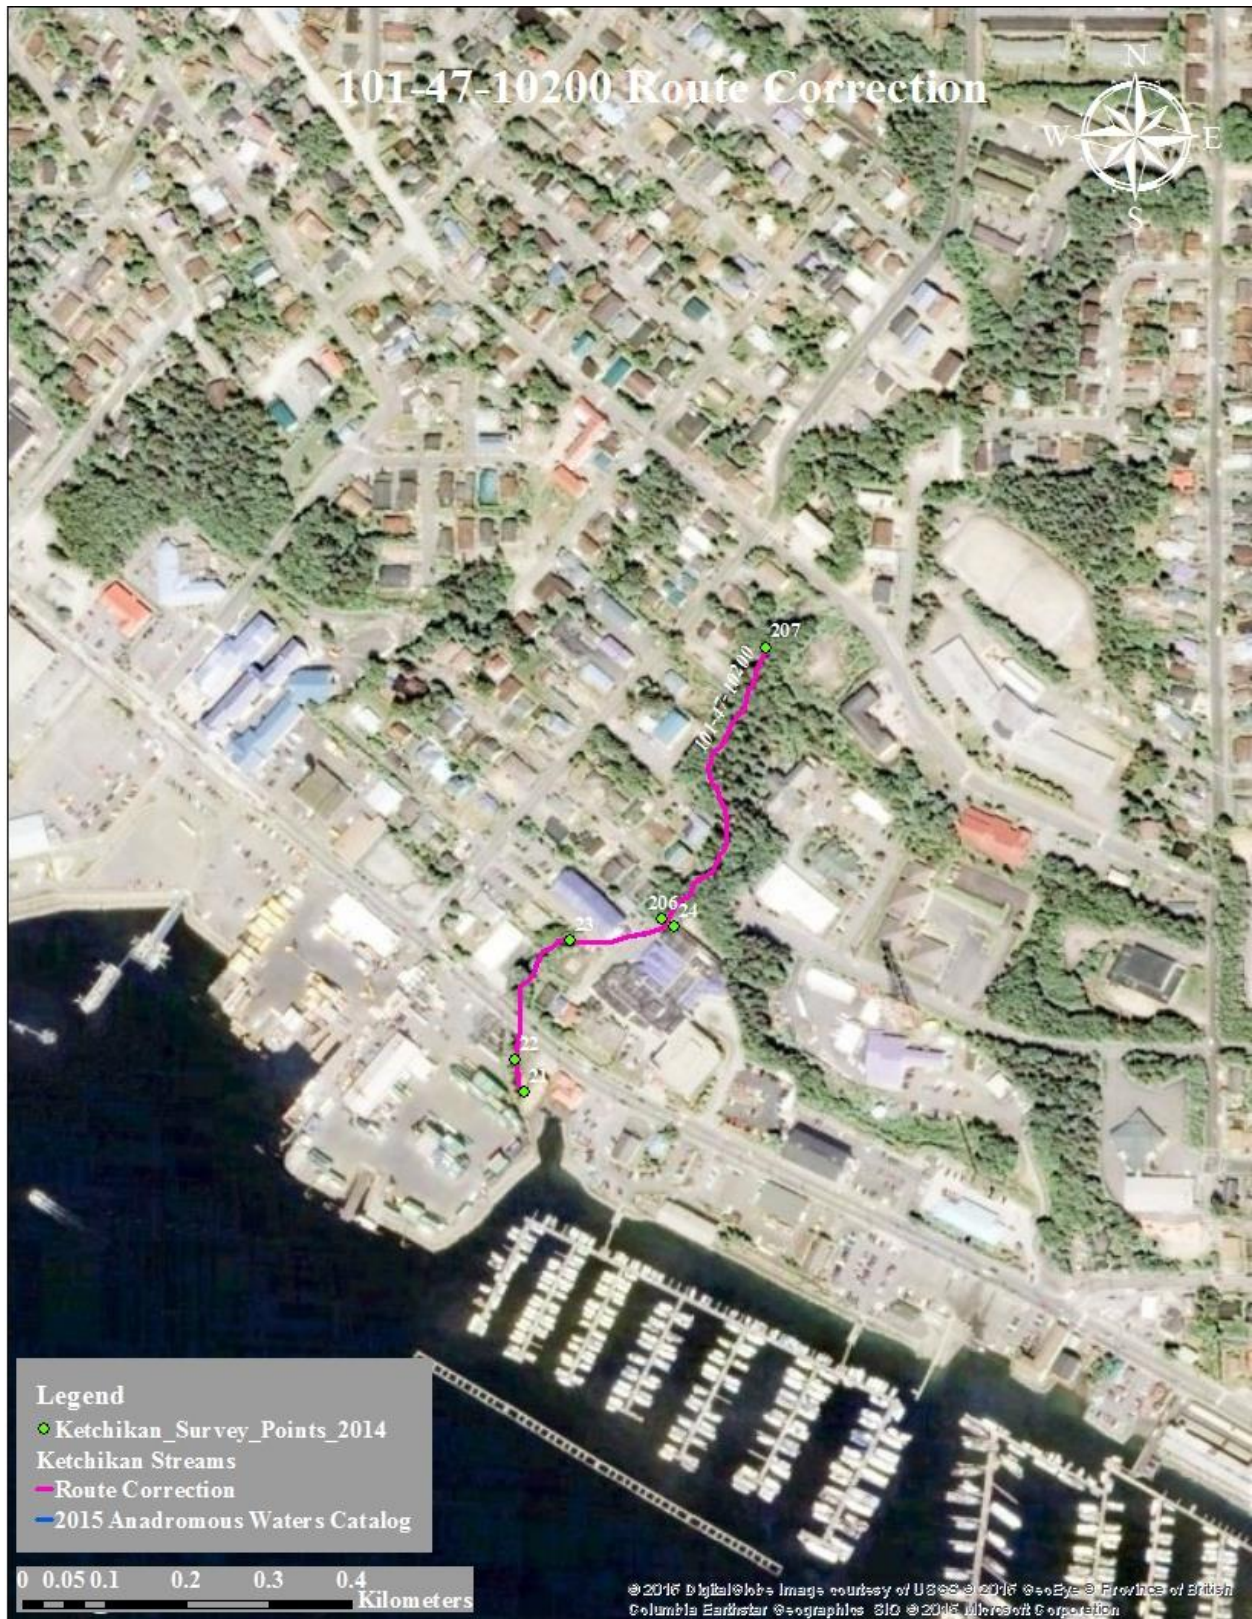
Figure 2.—101-47-10200 route correction map.

Recommendations: Update this stream's course to reflect the field verified route (Figure 2).

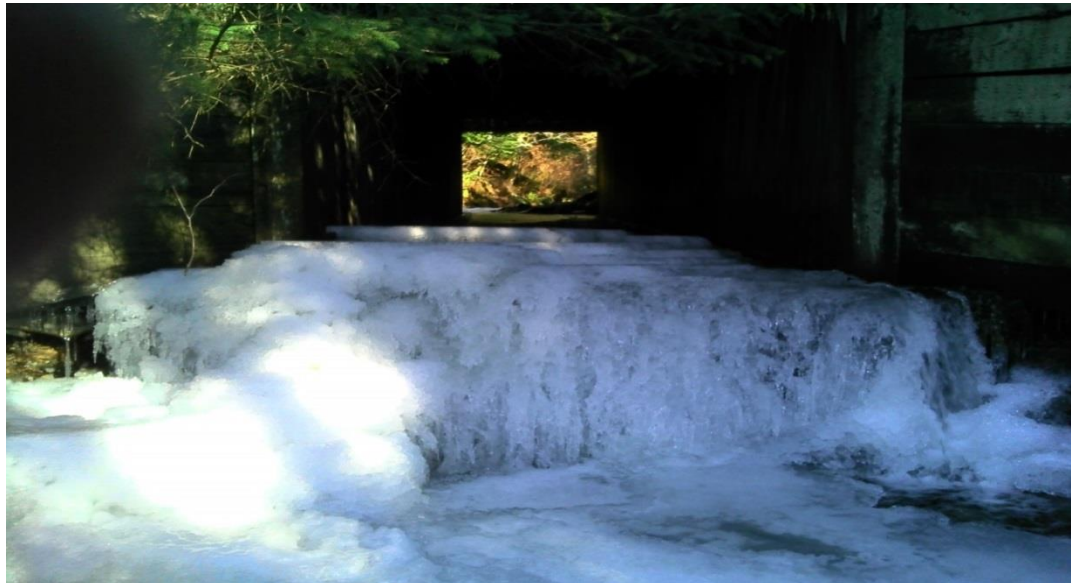
Figure 1.–101-47-10300 culvert barrier in the winter.
