Appendix: Ketchikan

Guide to direct fieldwork for cataloging anadromous water bodies in Southeast Alaska

KETCHIKAN SURVEYS

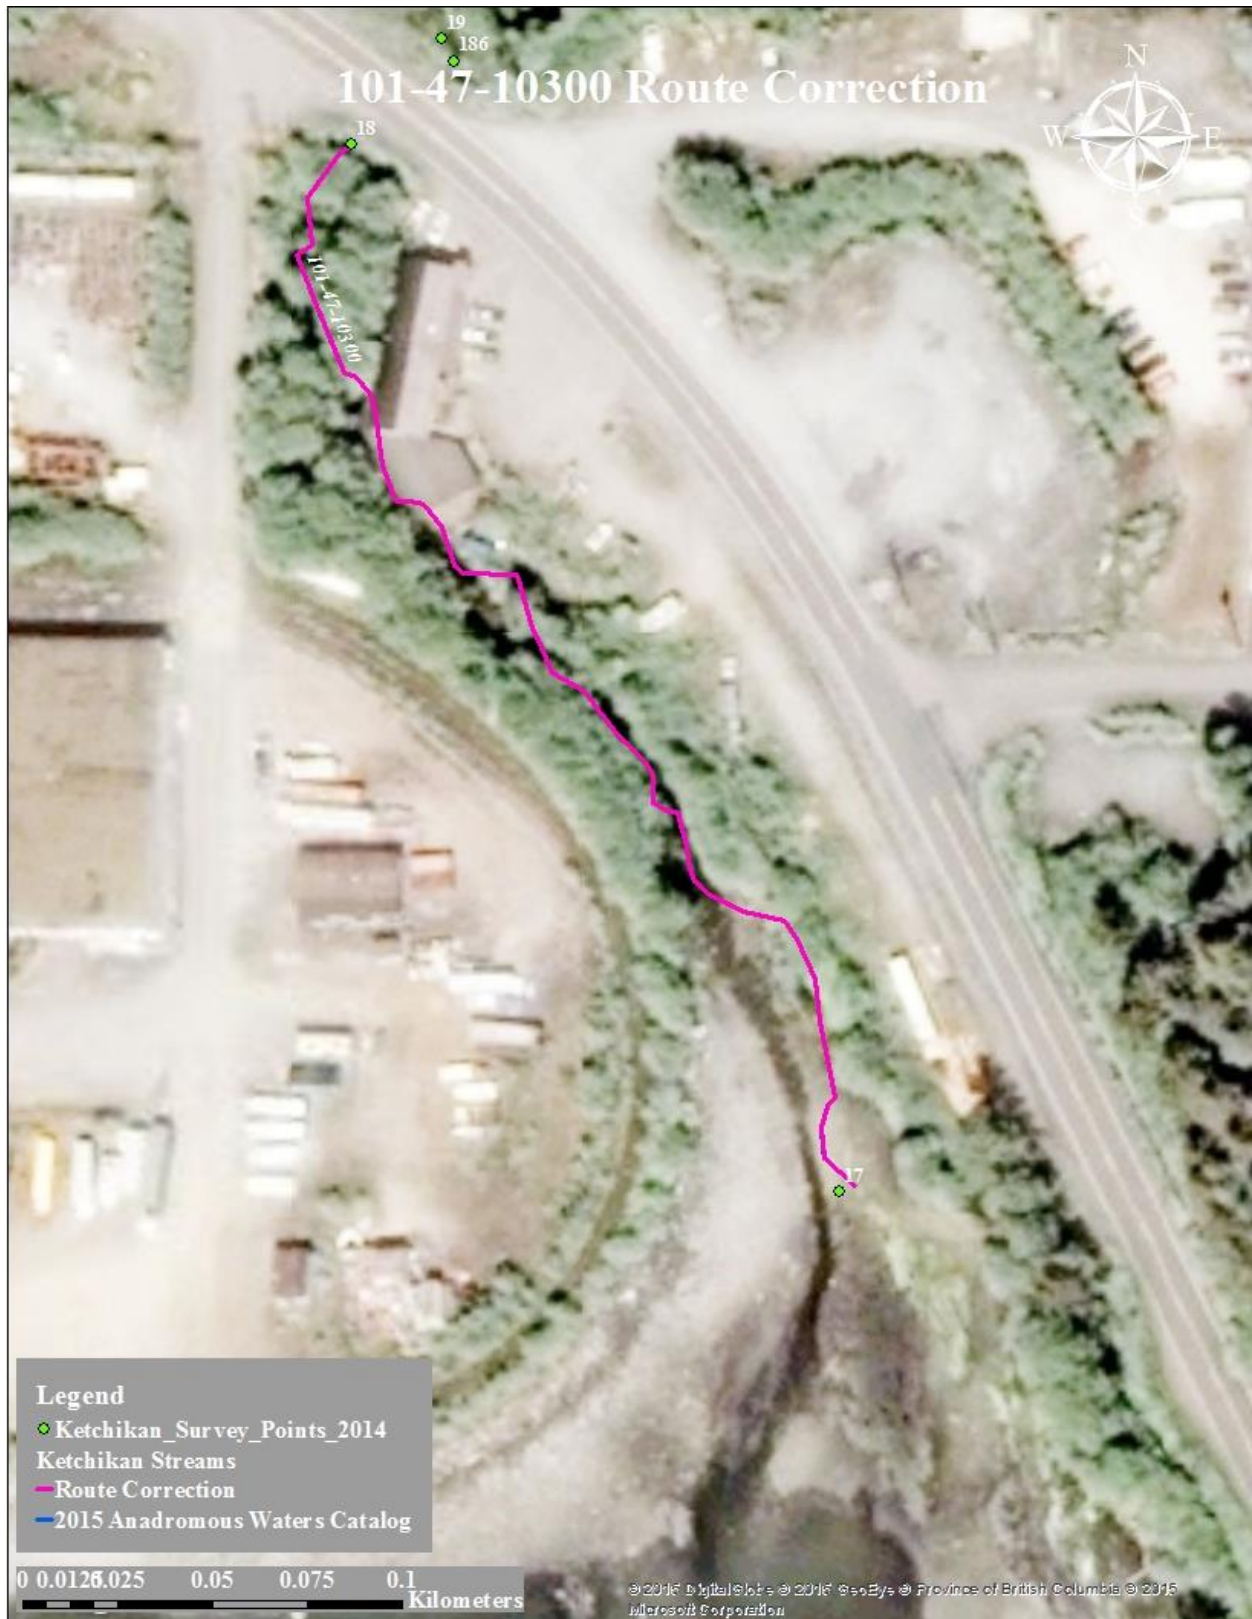
Figure 2.—101-47-10300 route correction map.

Recommendations: Adjust the upper limit of anadromy to reflect the field verified route (Figure 2).

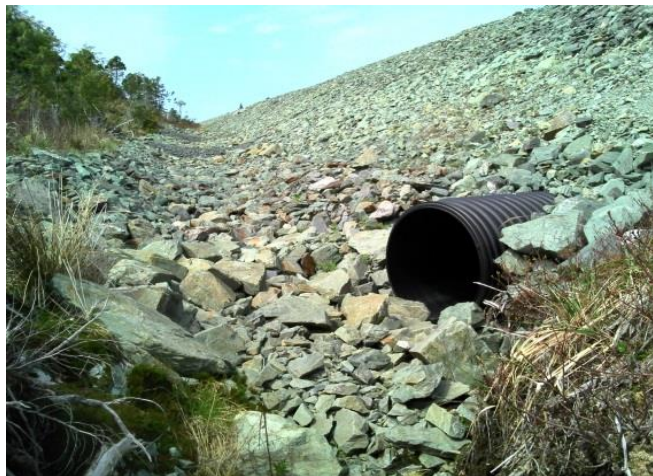
Findings: We conducted a survey of this stream and visually observed rearing coho salmon (Table 1). This creek's upper limit and route differs from that illustrated in the Catalog. The upper limit has been filled to accommodate the Gravina Island Highway (Figures 1, 2).

Figure 1.–Filled upper limit on Stensland tributary.

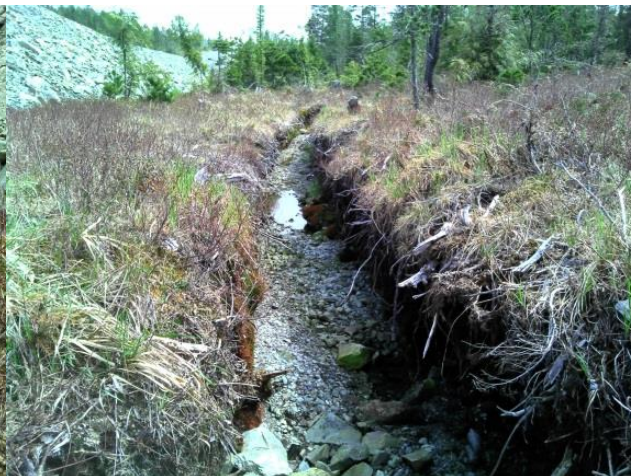
Figure 2.–Looking downstream at intermittent pools on Stensland tributary.

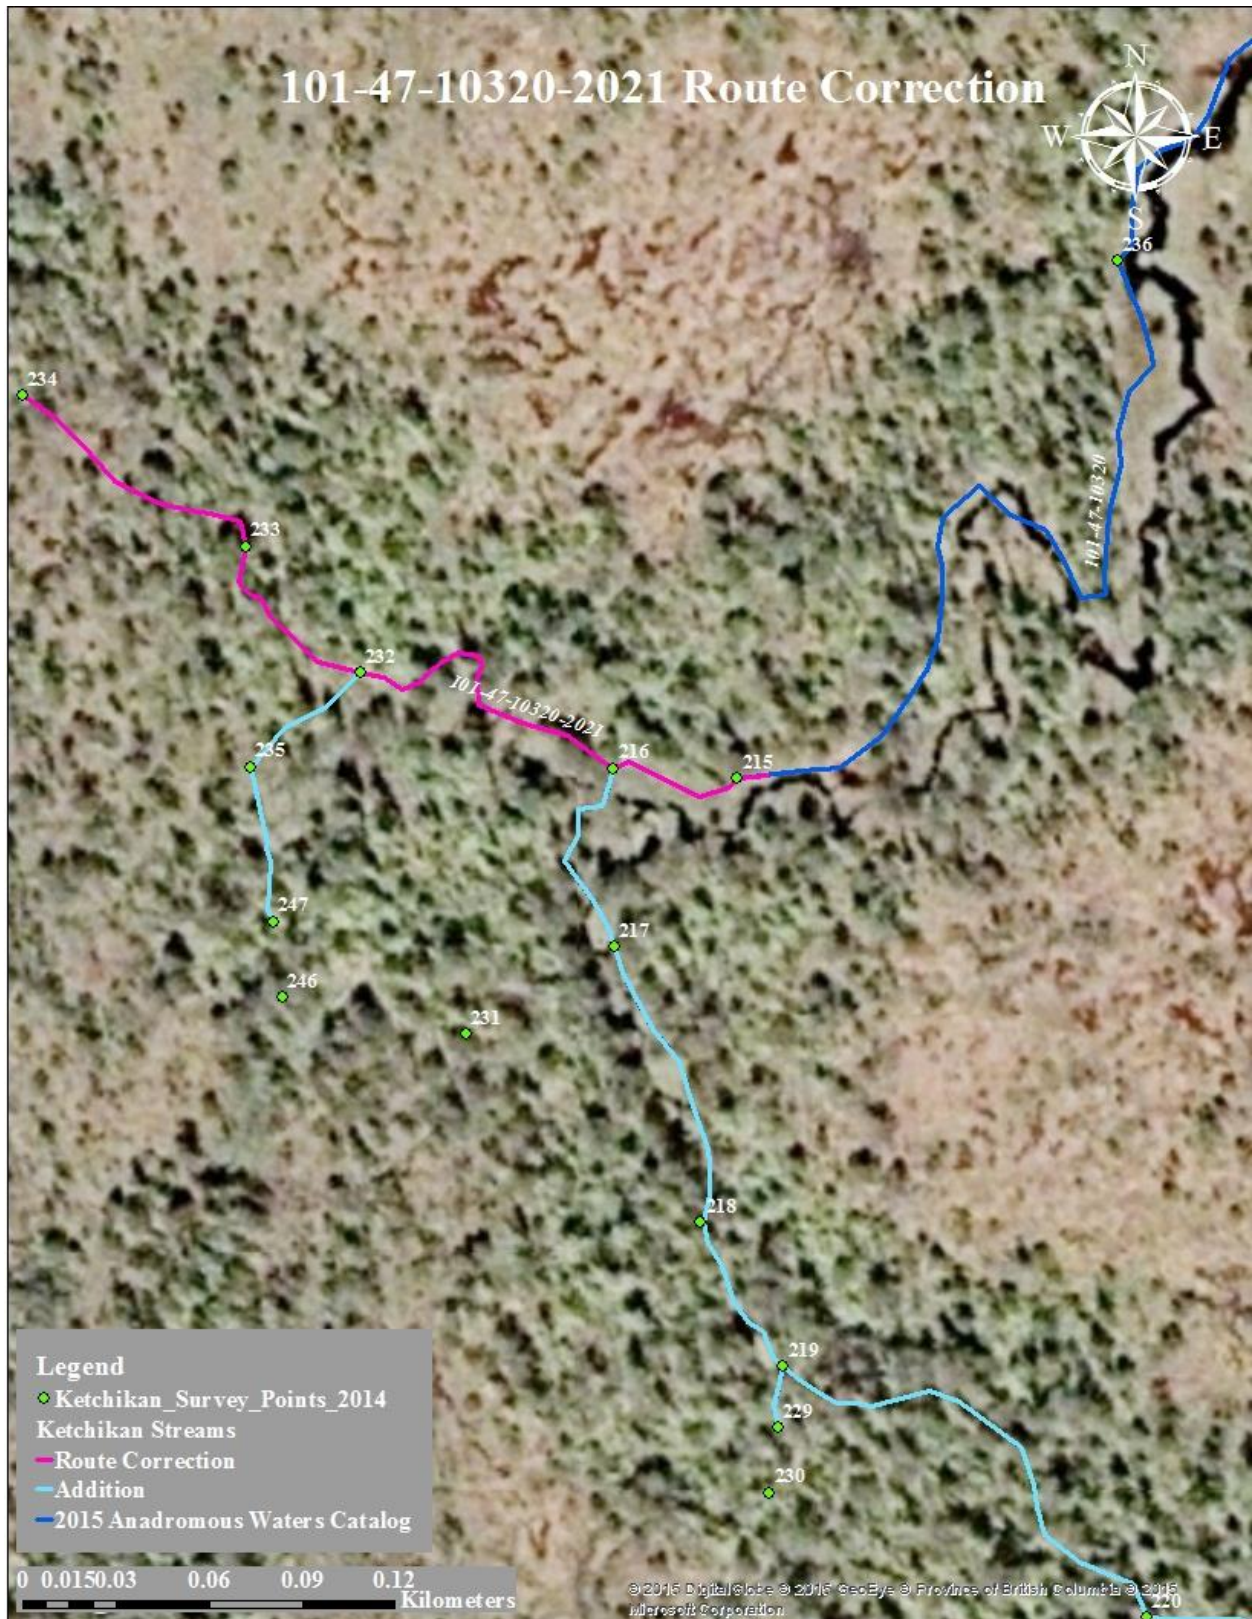
Figure 3.-101-47-10320-2021 route correction map.

Recommendations: Update this stream to accurately reflect the field verified route, from waypoint 215 to 234 (Figure 3).

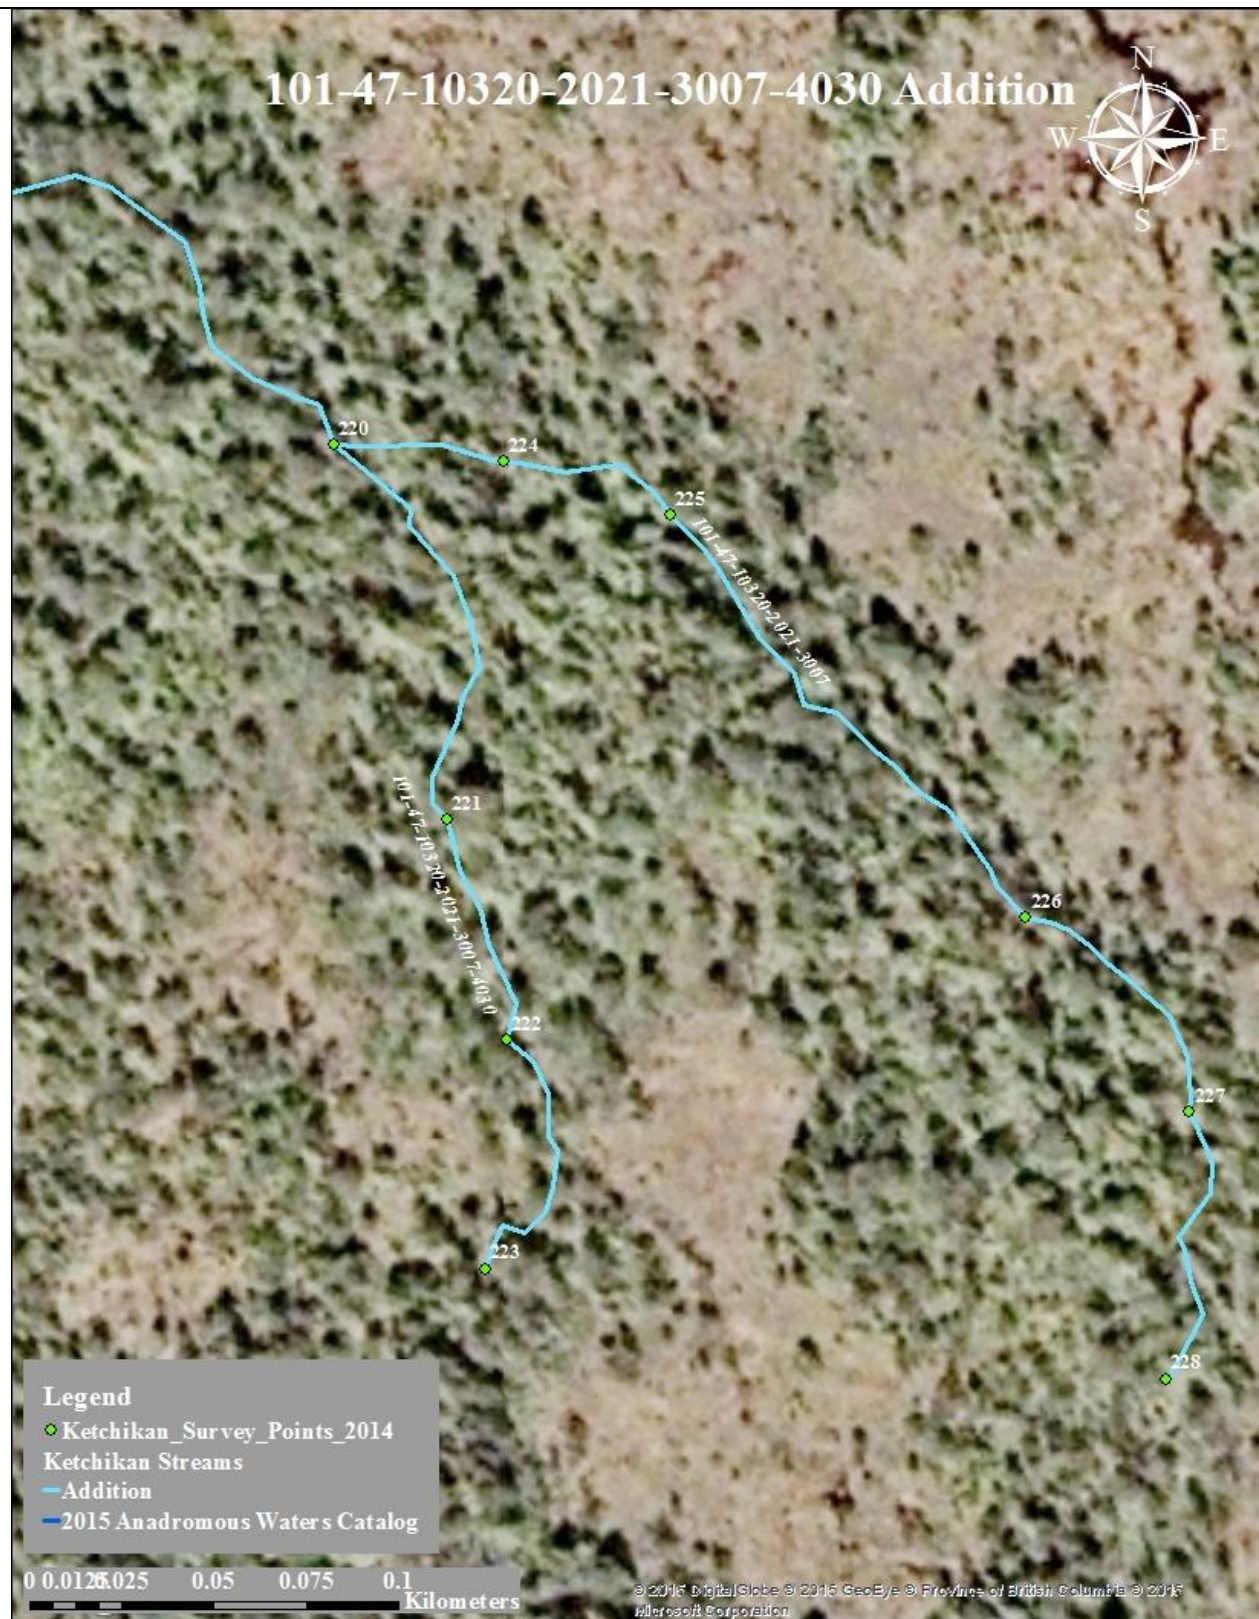
Figure 1.-101-47-10320-2021-3007-4030 addition map.

Waypoint	Latitude	Longitude	Notes	Sample Effort	Sample Results
220	55.3180	-131.6695	Trib entering RR. Coho young are visible throughout this area. Huge rearing habitat.	HN	5 CO
221	55.3175	-131.6692	stream is just a little bedrock chute at this point.	VI	Multi CO
222	55.3172	-131.6691		HN	3 CO 130mm
223	55.3169	-131.6691	Water flows are very low, have a couple of pools but water is barely flowing over rocks.

Recommendations: Please add this stream to the AWC (Figure 1).

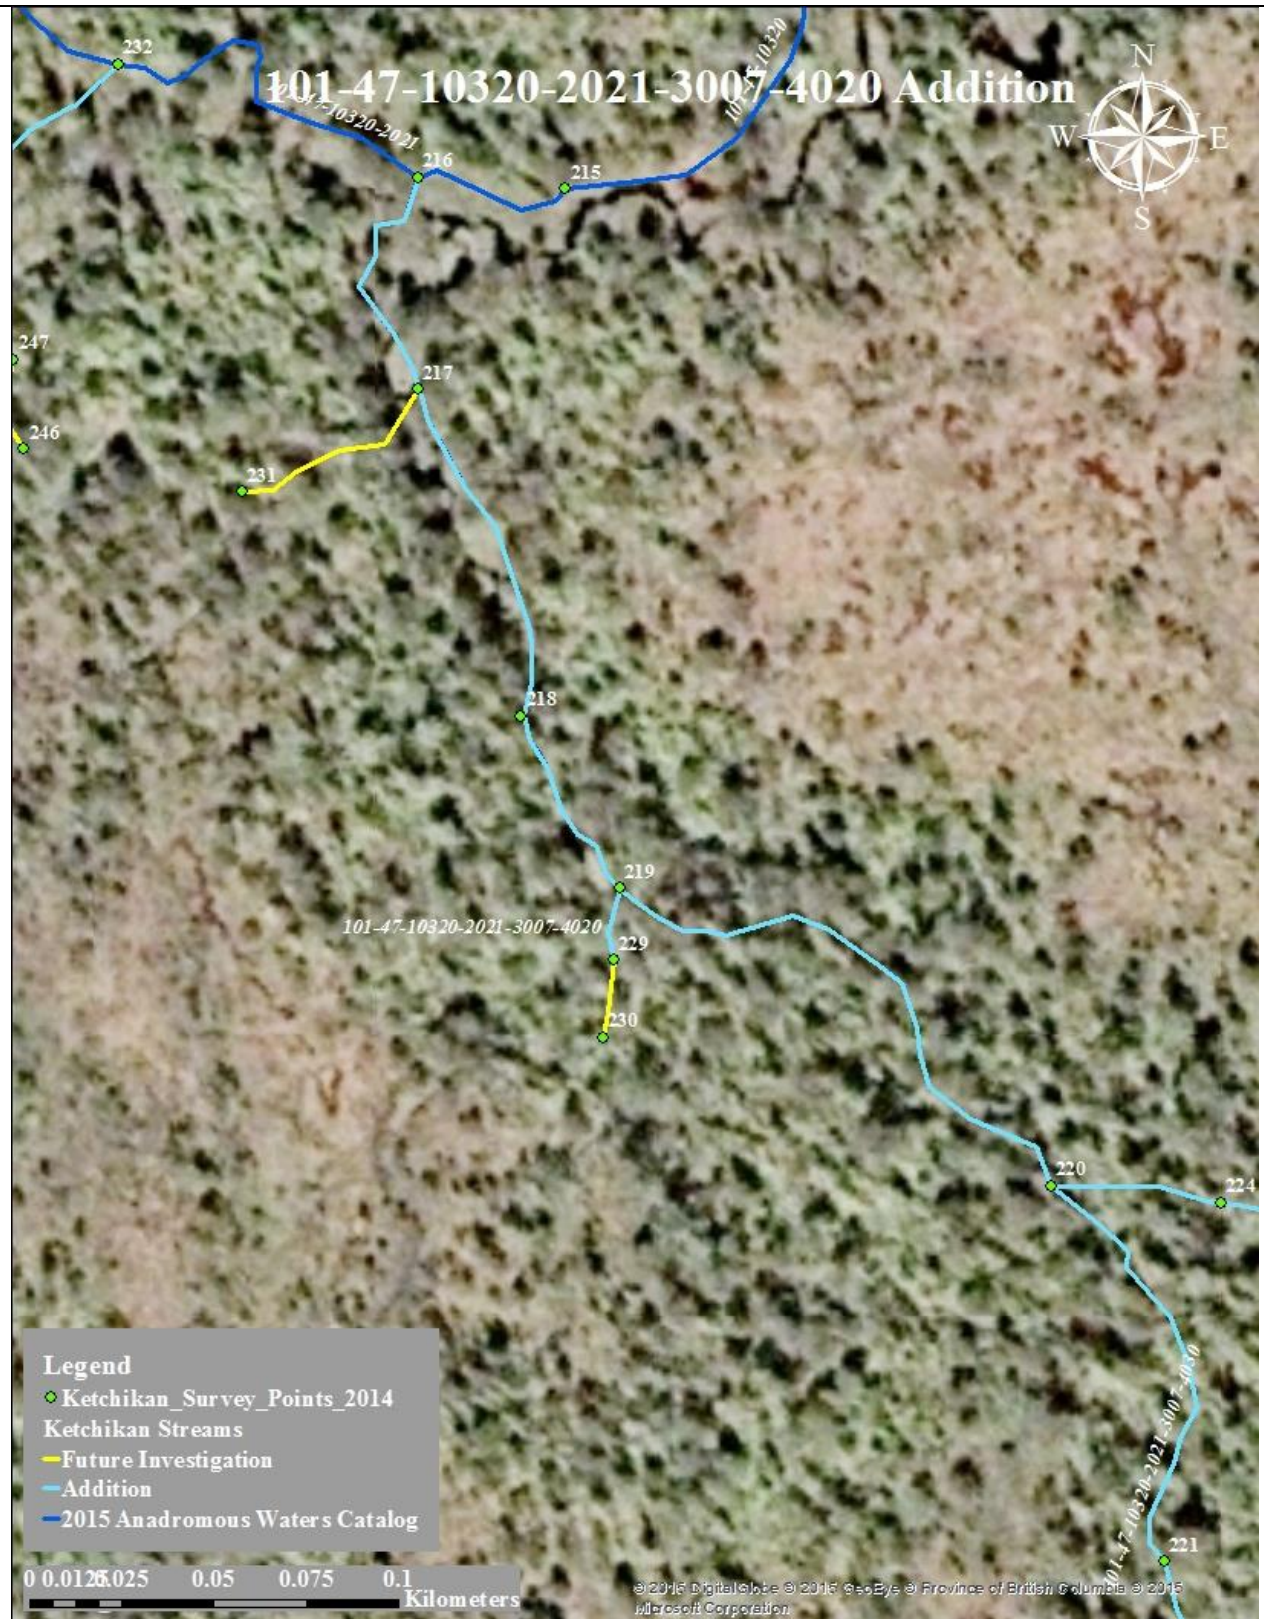
Figure 1.-101-47-10320-2021-3007-4020 addition map.

101-47-10320-2021-3007-4020**ADDITION****Water body name:****Survey date:** 5/8/2014**Water body number:** 101-47-10320-2021-3007-4020**Species & Lifestage:** CO**Watershed:** Carlanna Creek-Frontal Tongass Narrows**MTR:** C075S090E **Quad:** Ketchikan B-6**Findings:** We surveyed this tributary using a minnow trap and were also able to visual identify rearing coho salmon (Table 1). This small tributary provides excellent rearing habitat for juvenile coho salmon, and were observed throughout.**Recommendations:** Add this stream to the AWC (Figure 1).**Nomination:** 14-591

Waypoint	Latitude	Longitude	Notes	Sample Effort	Sample Results
219	55.3184	-131.6705	Small tributary on river left.		
229	55.3183	-131.6706		VL	4 CO
230	55.3182	-131.6706	Water becomes a seepy trickle.	MT	No Fish

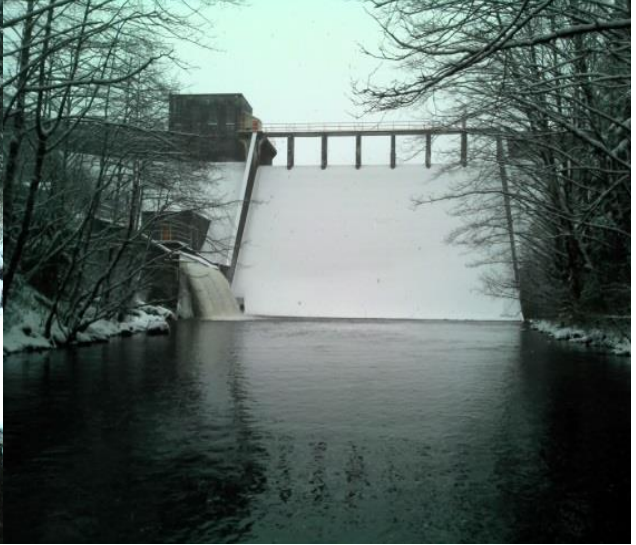
77	55.4335	-131.6748	Inlet to side channel that ends at WPT 76		
78	55.4317	-131.6723	End of Ward Creek at the dam. No fish passage. Obviously.

Figure 2.—Dam on Ward Creek.

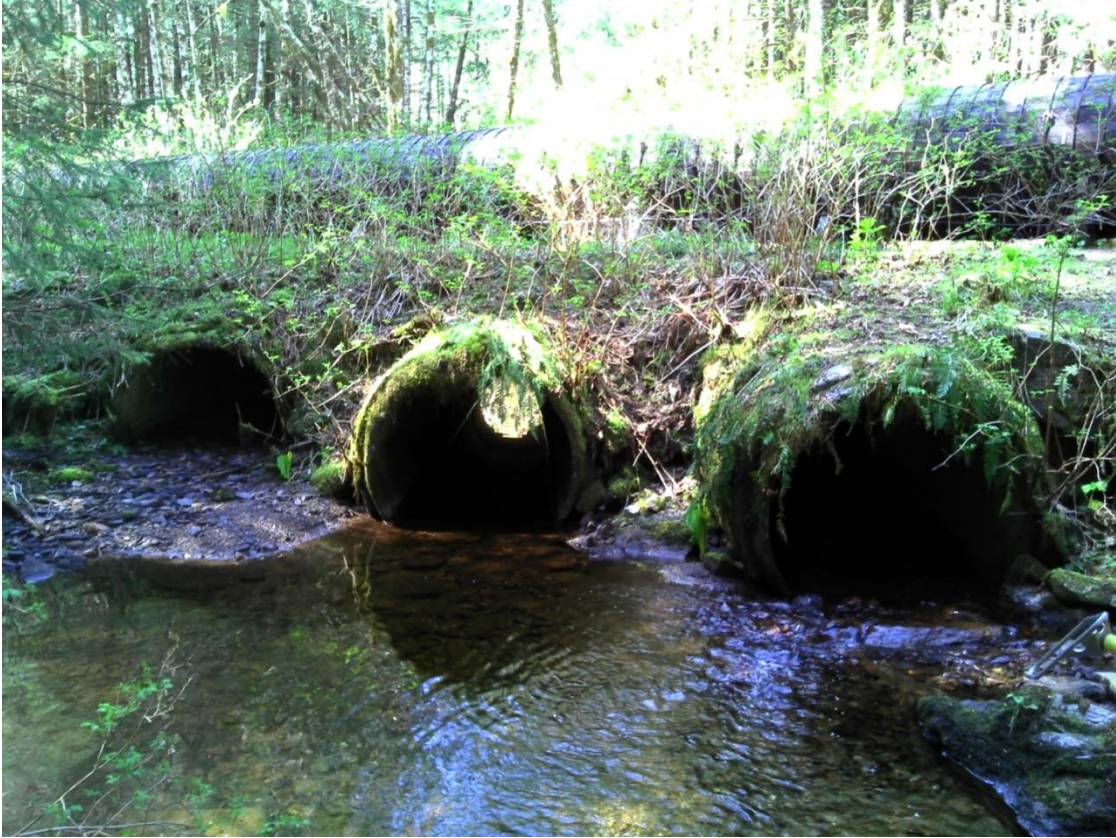
Figure 1.—Battery of three culverts under the Connell Lake penstock.

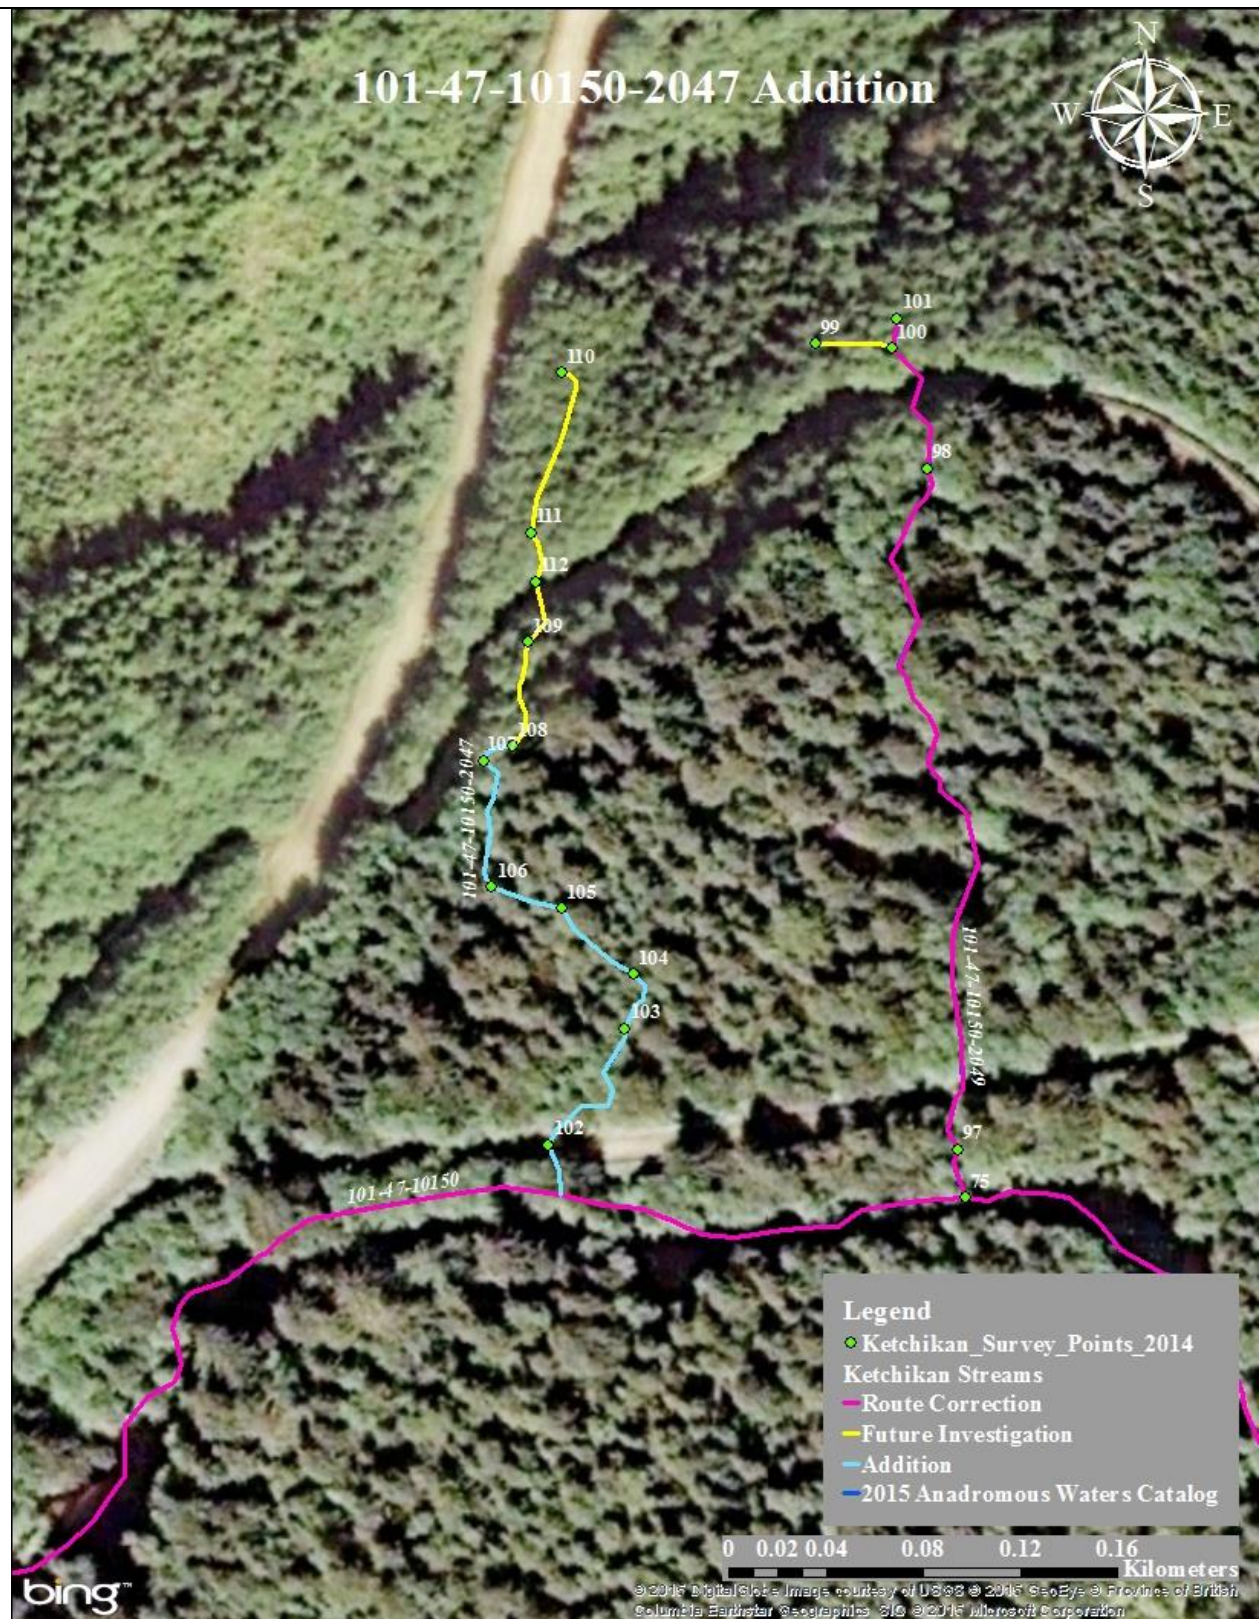
Figure 1.-101-47-10150-2047 addition map.

101-47-10150-2047**ADDITION****Water body name:****Survey date:** 5/7/2014**Water body number:** 101-47-10150-2047**Species & Lifestage:** CO**Watershed:** Carlanna Creek-Frontal Tongass Narrows**MTR:** C070S094E **Quad:** Ketchikan B-6**Findings:** We surveyed this stream using a backpack electrofisher and a GPS (Table 1). This tributary to Ward Creek provides great rearing habitat for juvenile coho salmon.**Recommendations:** Add this stream to the AWC (Figure 1).**Nomination:** 14-597

Waypoint	Latitude	Longitude	Notes	Sample Effort	Sample Results
102	55.4338	-131.6809	Outlet of tiny tributary into Ward Creek. Conveyance stream.		
103	55.4340	-131.6806	2 CO in slow water undercut bank.	EF	2 CO
104	55.4341	-131.6806	Captured in pool below riffle.	EF	2 CO
105	55.4342	-131.6808	Calm shallow pool.	EF	2 CO
106	55.4343	-131.6811	Rooty log jam pool.	EF	2 CO
107	55.4346	-131.6811	Pool below a small bedrock cascade.	EF	1 CO
108	55.4346	-131.6810	Below debris jam.	EF	2 CO
109	55.4348	-131.6810	Below debris jam and culvert.	EF	1 CO
110	55.4354	-131.6808	Top of creek. Flows from steep culvert onto huge sharp boulders. Not friendly to any living thing.

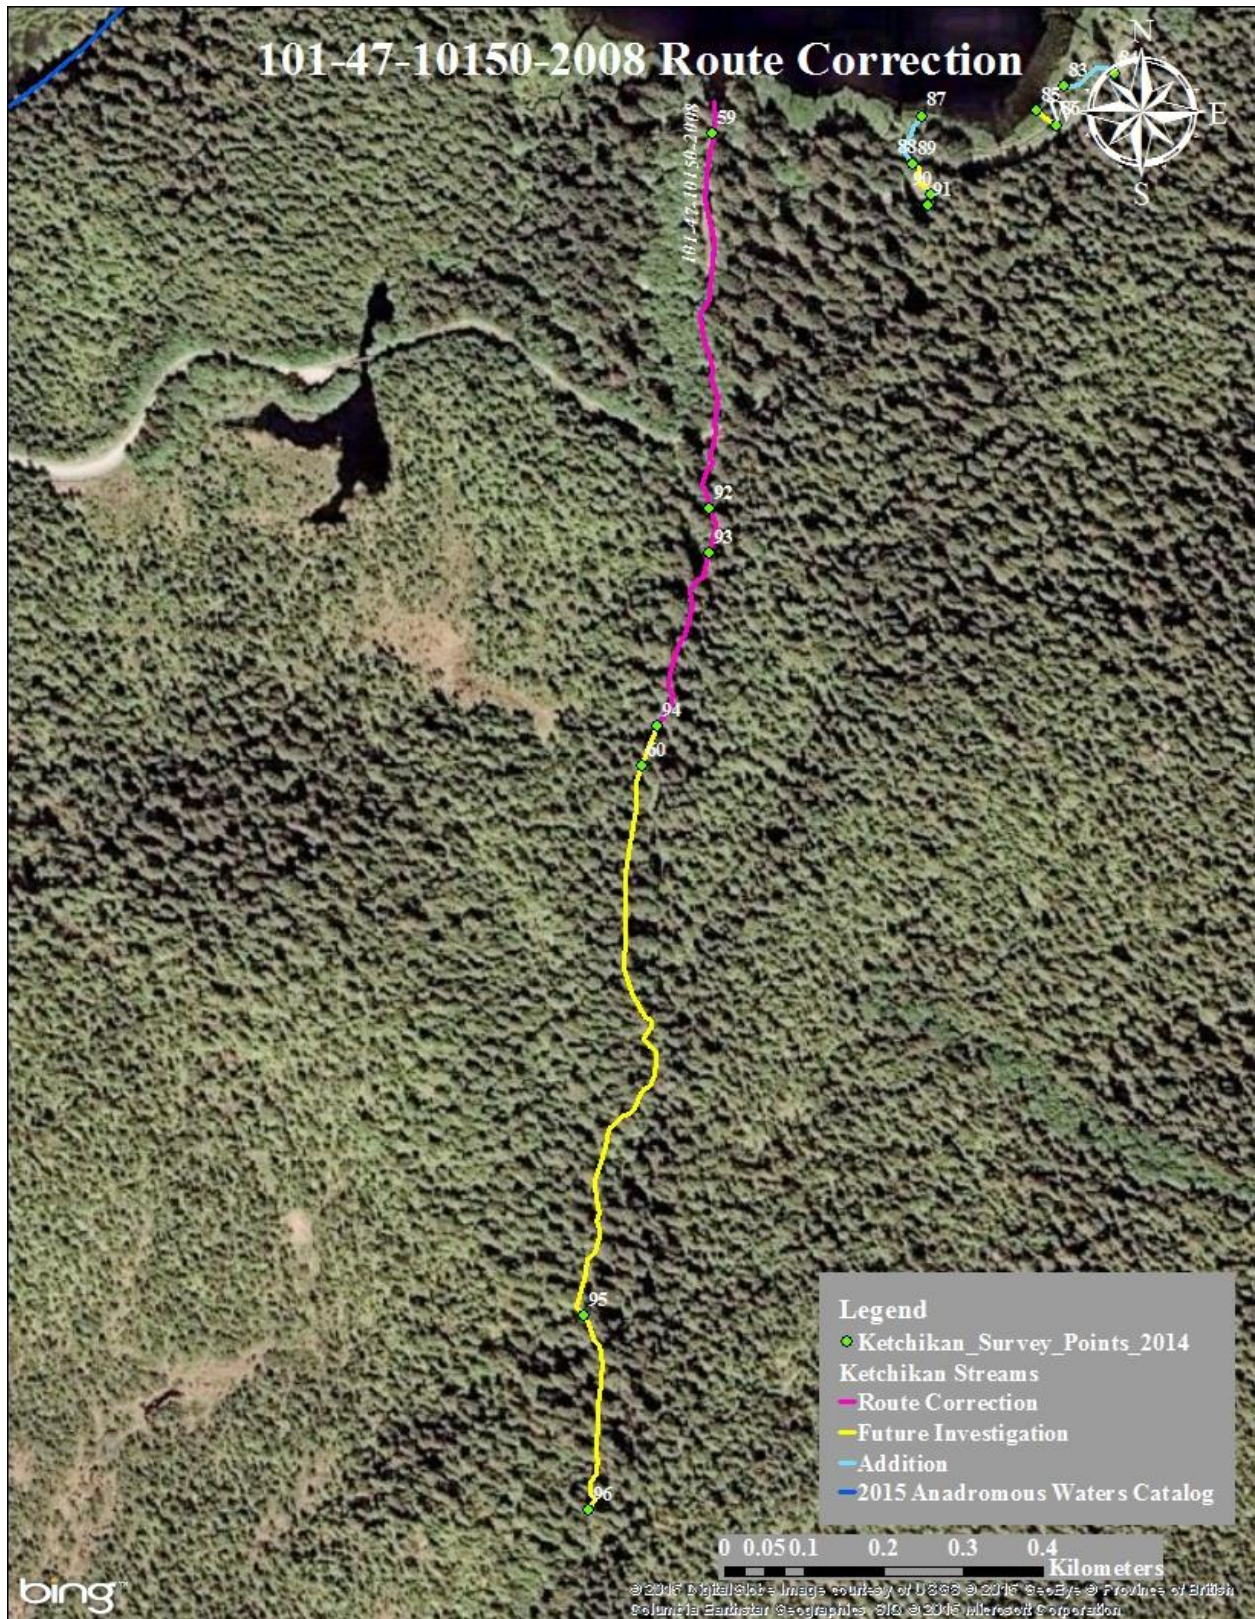
Findings: We surveyed this stream using a backpack electrofisher and a GPS (Table 1). We switched to a spawning survey after we found adult steelhead spawning in the stream. This creek's upper limit needs to be extended, because spawning steelhead were visually identified past the cataloged portion.

Figure 1.-101-47-10150-2008 route correction map.

Recommendations: Extend the upper portion of this creek to reflect upper most pair of spawning steelhead (Figure 1).

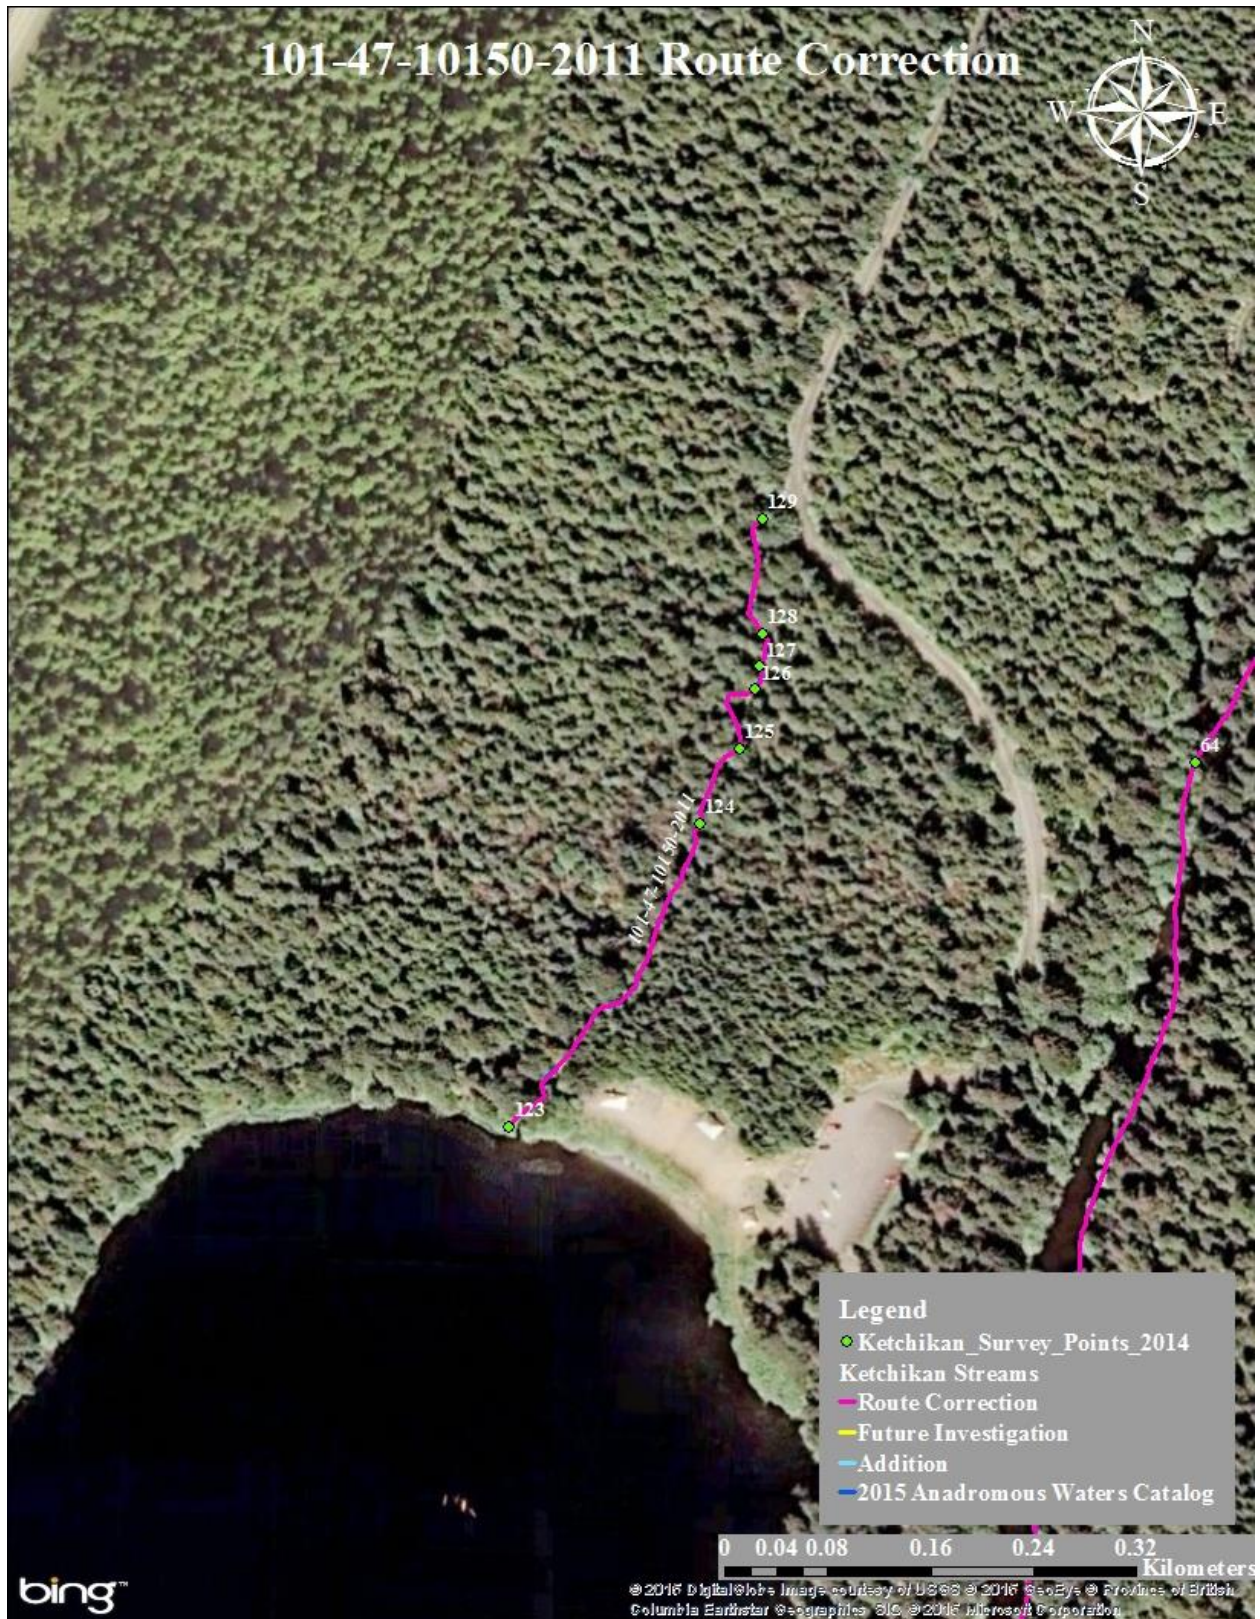
Figure 1.-101-47-10150-2011 route correction map.

101-47-10150-2011**CORRECTION****Water body name:****Survey date:** 5/6/2014**Water body number:** 101-47-10150-2011**Species & Lifestage:** COsr**Watershed:** Carlanna Creek-Frontal Tongass Narrows**MTR:** C074S090E **Quad:** Ketchikan B-6**Findings:** We surveyed this stream using a backpack electrofisher and a GPS (Table 1). This stream's actual course differs from that illustrated in the AWC.**Recommendations:** Update this stream's course to reflect the field verified route (Figure 1).**Nomination:** 14-612

Waypoint	Latitude	Longitude	Notes	Sample Effort	Sample Results
123	55.4147	-131.6988	Mouth of small trib into Ward Creek.		
124	55.4159	-131.6975	Enjoying the sunny day.	VI	CO
125	55.4162	-131.6972	Young of the year.	EF	2 CO
126	55.4164	-131.6971		EF	1 RT
127	55.4165	-131.6971		EF	1 CT
128	55.4166	-131.6970	Also found a huge dorsal fin from a trout.	EF	1 CT
129	55.4171	-131.6970	Top of creek where it hits the road. No coho, only cuts and dollies. A huge, tightly packed mangle of debris here.

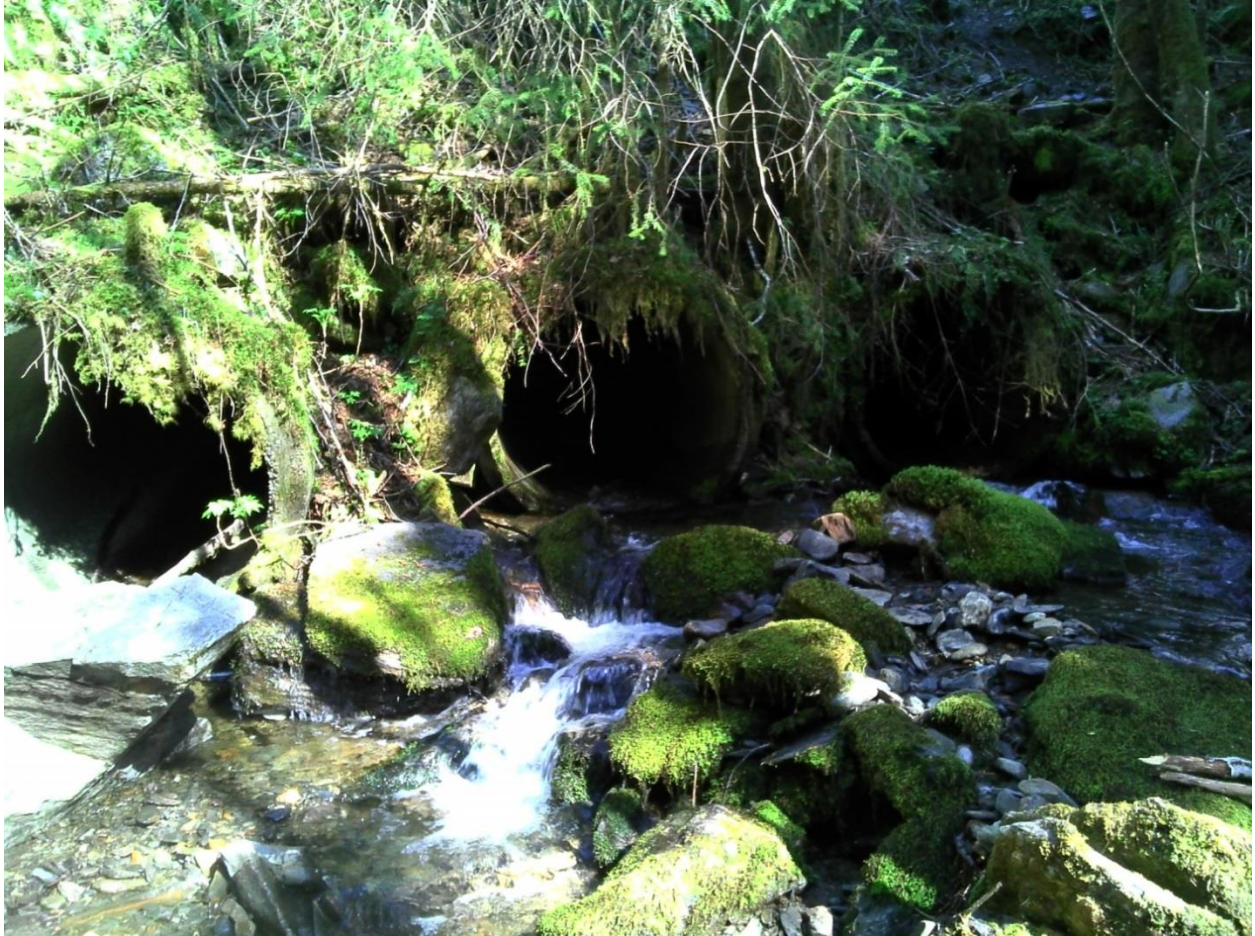
Figure 1.—Battery of 3 concrete culverts on 101-47-10150-2035.

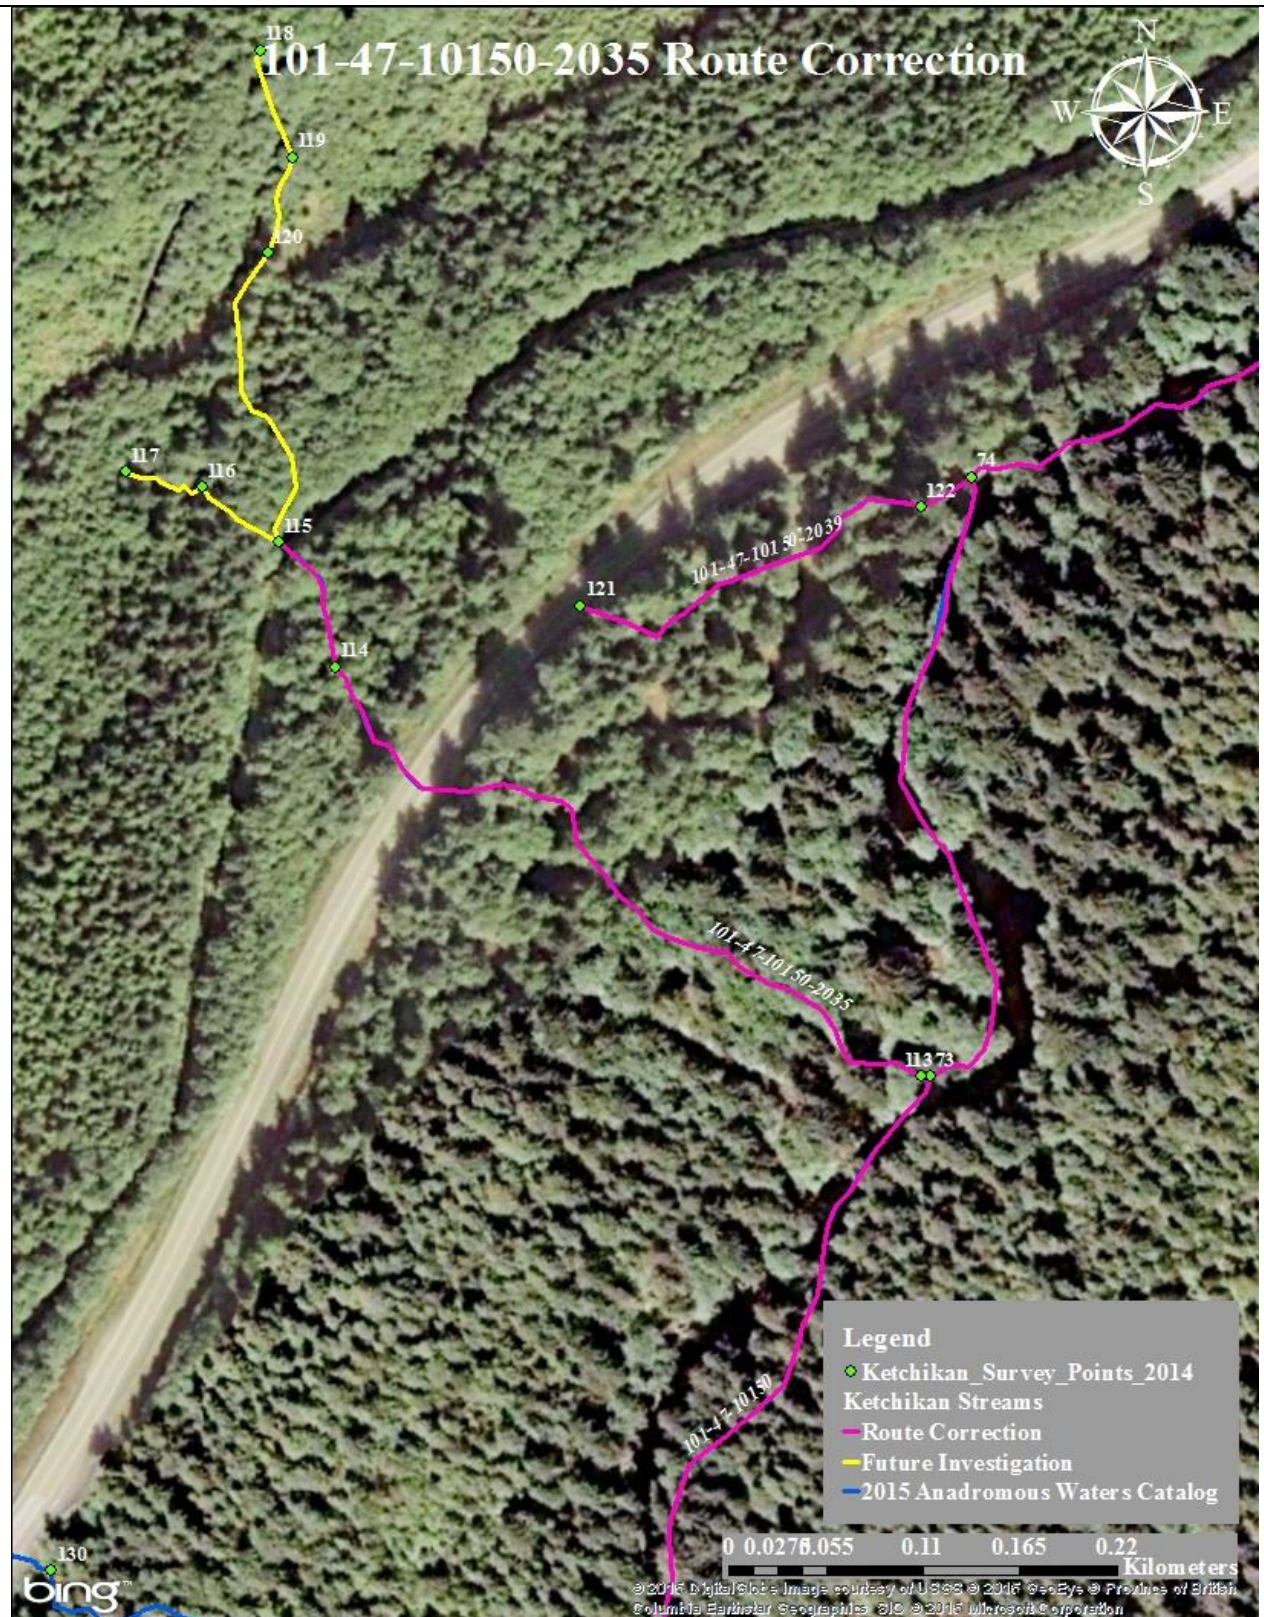
Figure 2.—101-47-10150-2035 route correction map.

Recommendations: Update this stream to reflect the field verified route and upper limit (Figure 2).

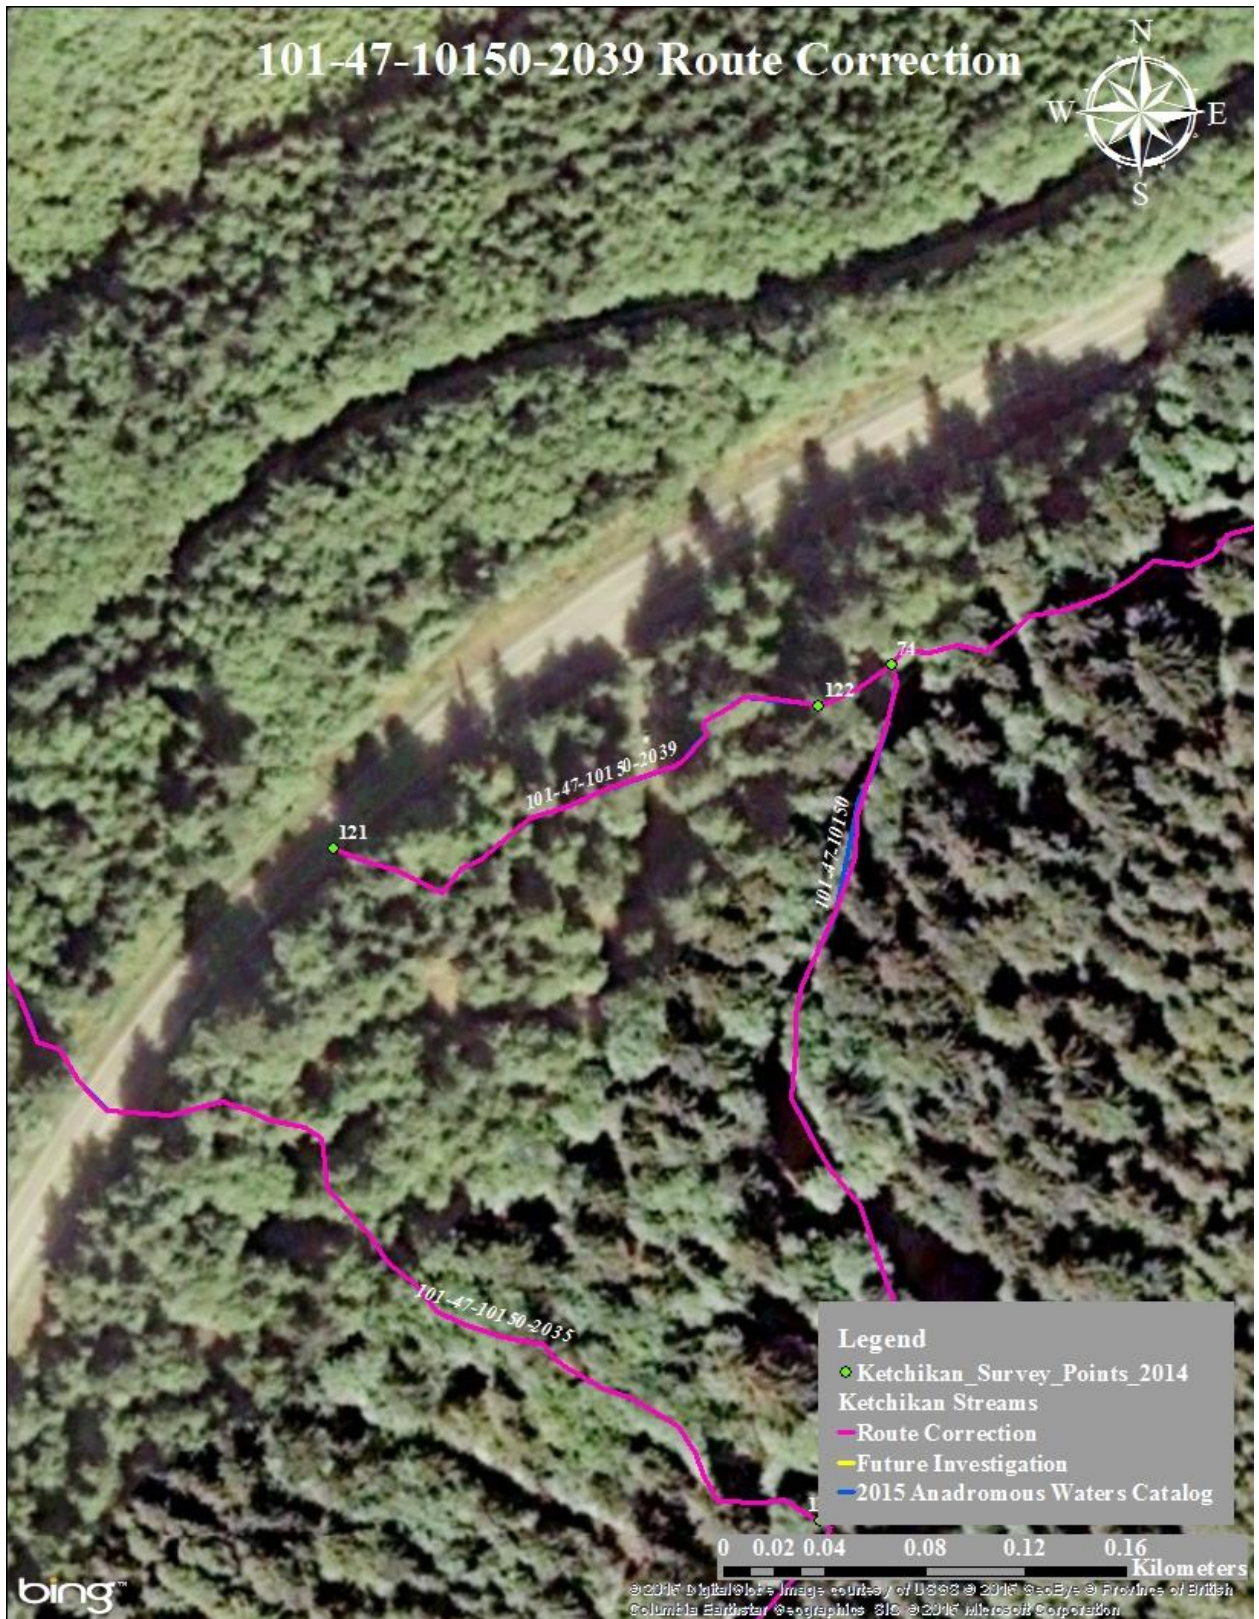
Figure 1.-101-47-10150-2039 route correction map.

101-47-10150-2039**CORRECTION****Water body name:****Survey date:** 5/6/2014**Water body number:** 101-47-10150-2039**Species & Lifestage:** CO**Watershed:** Carlanna Creek-Frontal Tongass Narrows**MTR:** C074S090E **Quad:** Ketchikan B-6**Findings:** We surveyed this tributary using a handnet, visual identification, and a GPS (Table 1). This tributary's actual course differs from that illustrated in the AWC.**Recommendations:** Update this stream's mapped course to reflect the field verified route (Figure 1).**Nomination:** 14-613

Waypoint	Latitude	Longitude	Notes	Sample Effort	Sample Results
74	55.4323	-131.6851	Tributary on river right.		
221	55.3175	-131.6692	Stream is going through a little bedrock chute at this point. Captured multiple rearing coho salmon.	VL	CO
222	55.3172	-131.6691	Handnetted 2 CO about 130mm.	HN	3 CO
