Appendix: Ketchikan

Guide to direct fieldwork for cataloging anadromous water bodies in Southeast Alaska

KETCHIKAN SURVEYS

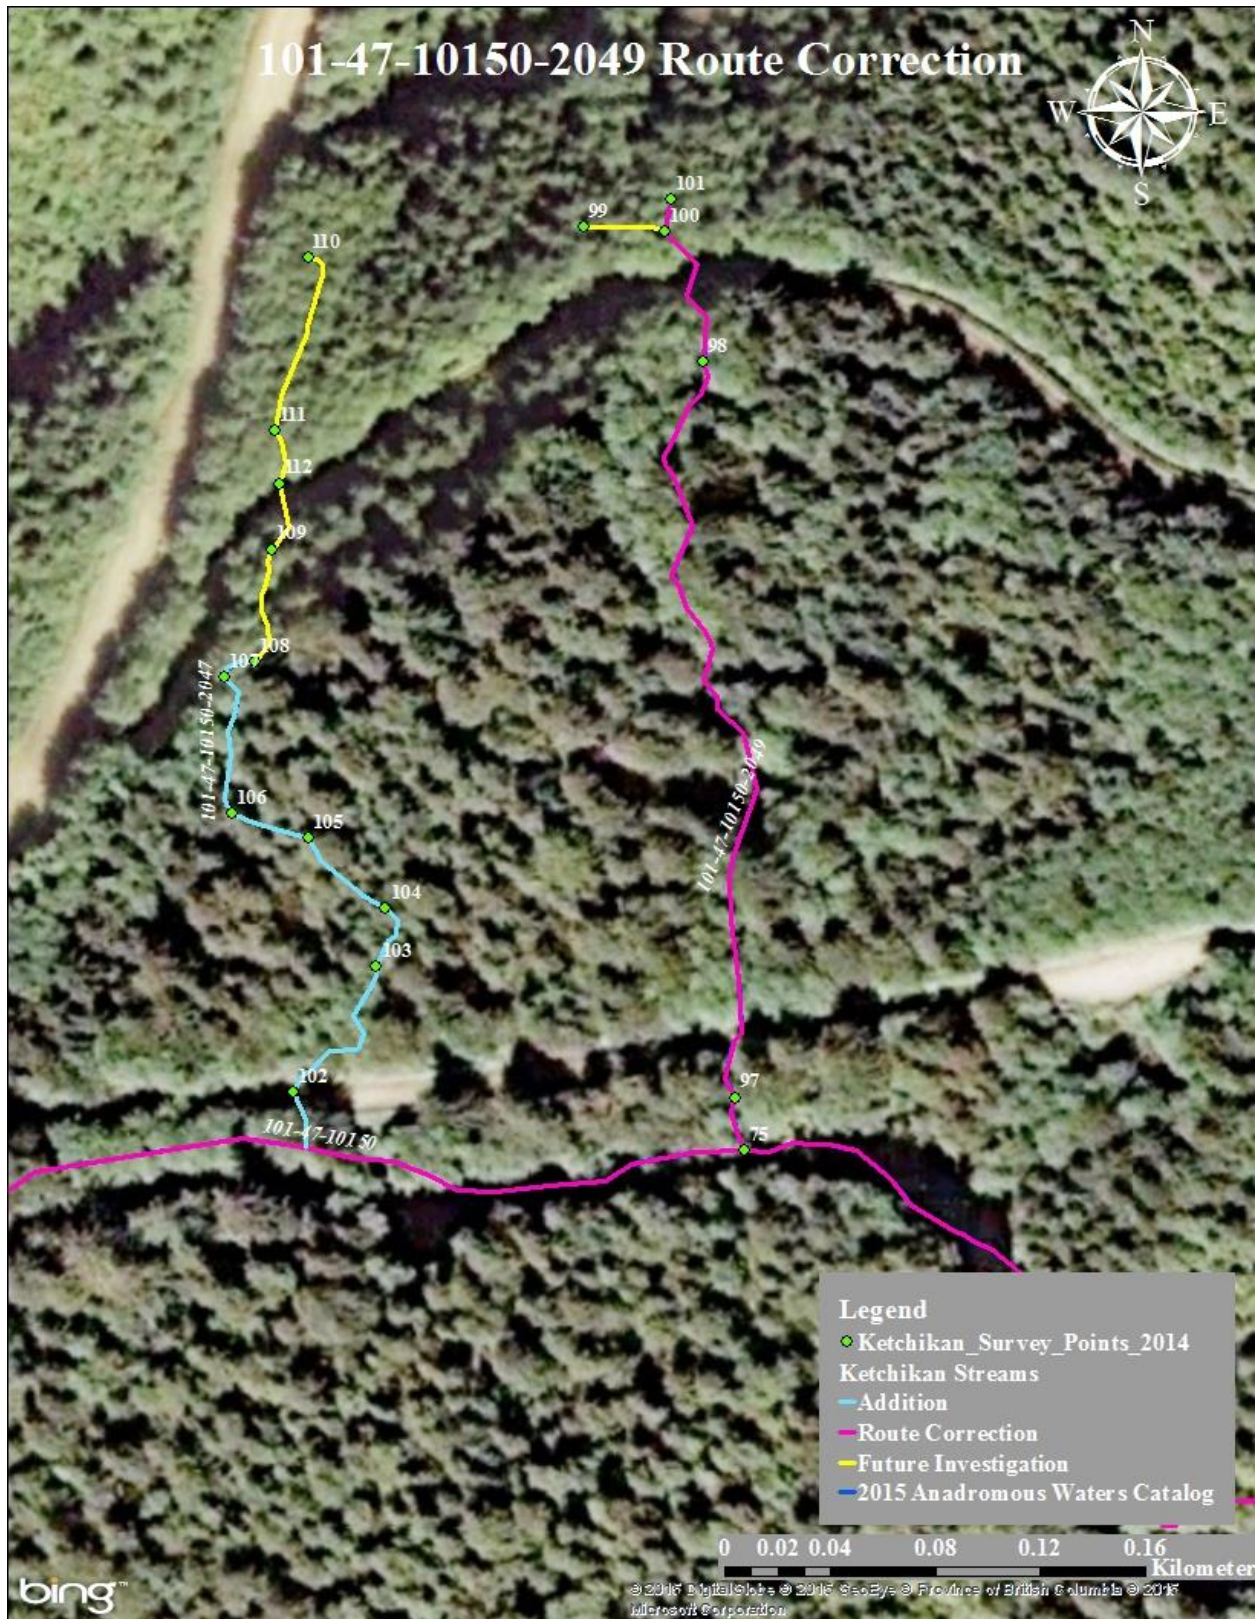
Figure 1.-101-47-10150-2049 route correction map.

101-47-10150-2049**CORRECTION****Water body name:****Survey date:** 5/6/2014**Water body number:** 101-47-10150-2049**Species & Lifestage:** COsr**Watershed:** Carlanna Creek-Frontal Tongass Narrows**MTR:** C074S090E **Quad:** Ketchikan B-6**Findings:** We surveyed this stream using a backpack electrofisher and a GPS (Table 1). Fish passage on this stream ends at a series of badly mangled culverts. Sampling efforts above the barrier only yielded Dolly Varden.**Recommendations:** Update the stream course to reflect the field verified route (Figure 1).**Nomination:** 14-614

Waypoint	Latitude	Longitude	Notes	Sample Effort	Sample Results
75	55.4336	-131.6793	Tributary on river right.		
97	55.4337	-131.6794	Begin tracking first tributary downstream from Connell Lake dam.		
98	55.4352	-131.6795	Huge old concrete culverts, likely a barrier as they are broken in two places and are a jumbled mess.		
99	55.4354	-131.6799	Sampling above culvert barrier. DVs only. This stream forks.	EF	DV
100	55.4354	-131.6796	Stream forks at a double culvert.		
101	55.4355	-131.6796	Sampled above double culverts.	EF	1 DV, 1 RT

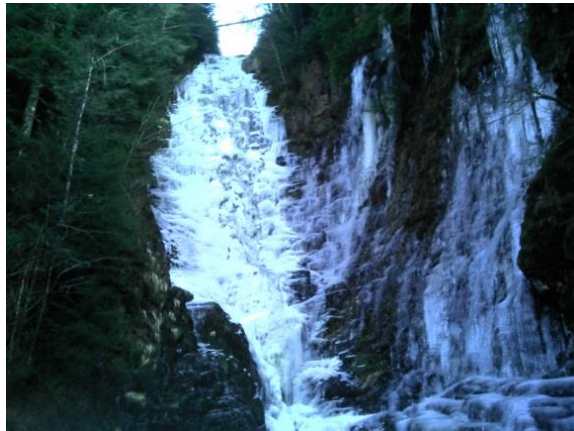
Findings: We conducted a foot survey of Carlanna Creek using a GPS (Table 1). Upon walking the entirety of this creek, we found several places where fish passage could be restricted and that the upper limit is a waterfall approximately 80 feet tall (Figures 1, 2). Anadromy most certainly does not extend to the lake as currently cataloged.

Figure 1.—Waterfall barrier on Carlanna Creek.

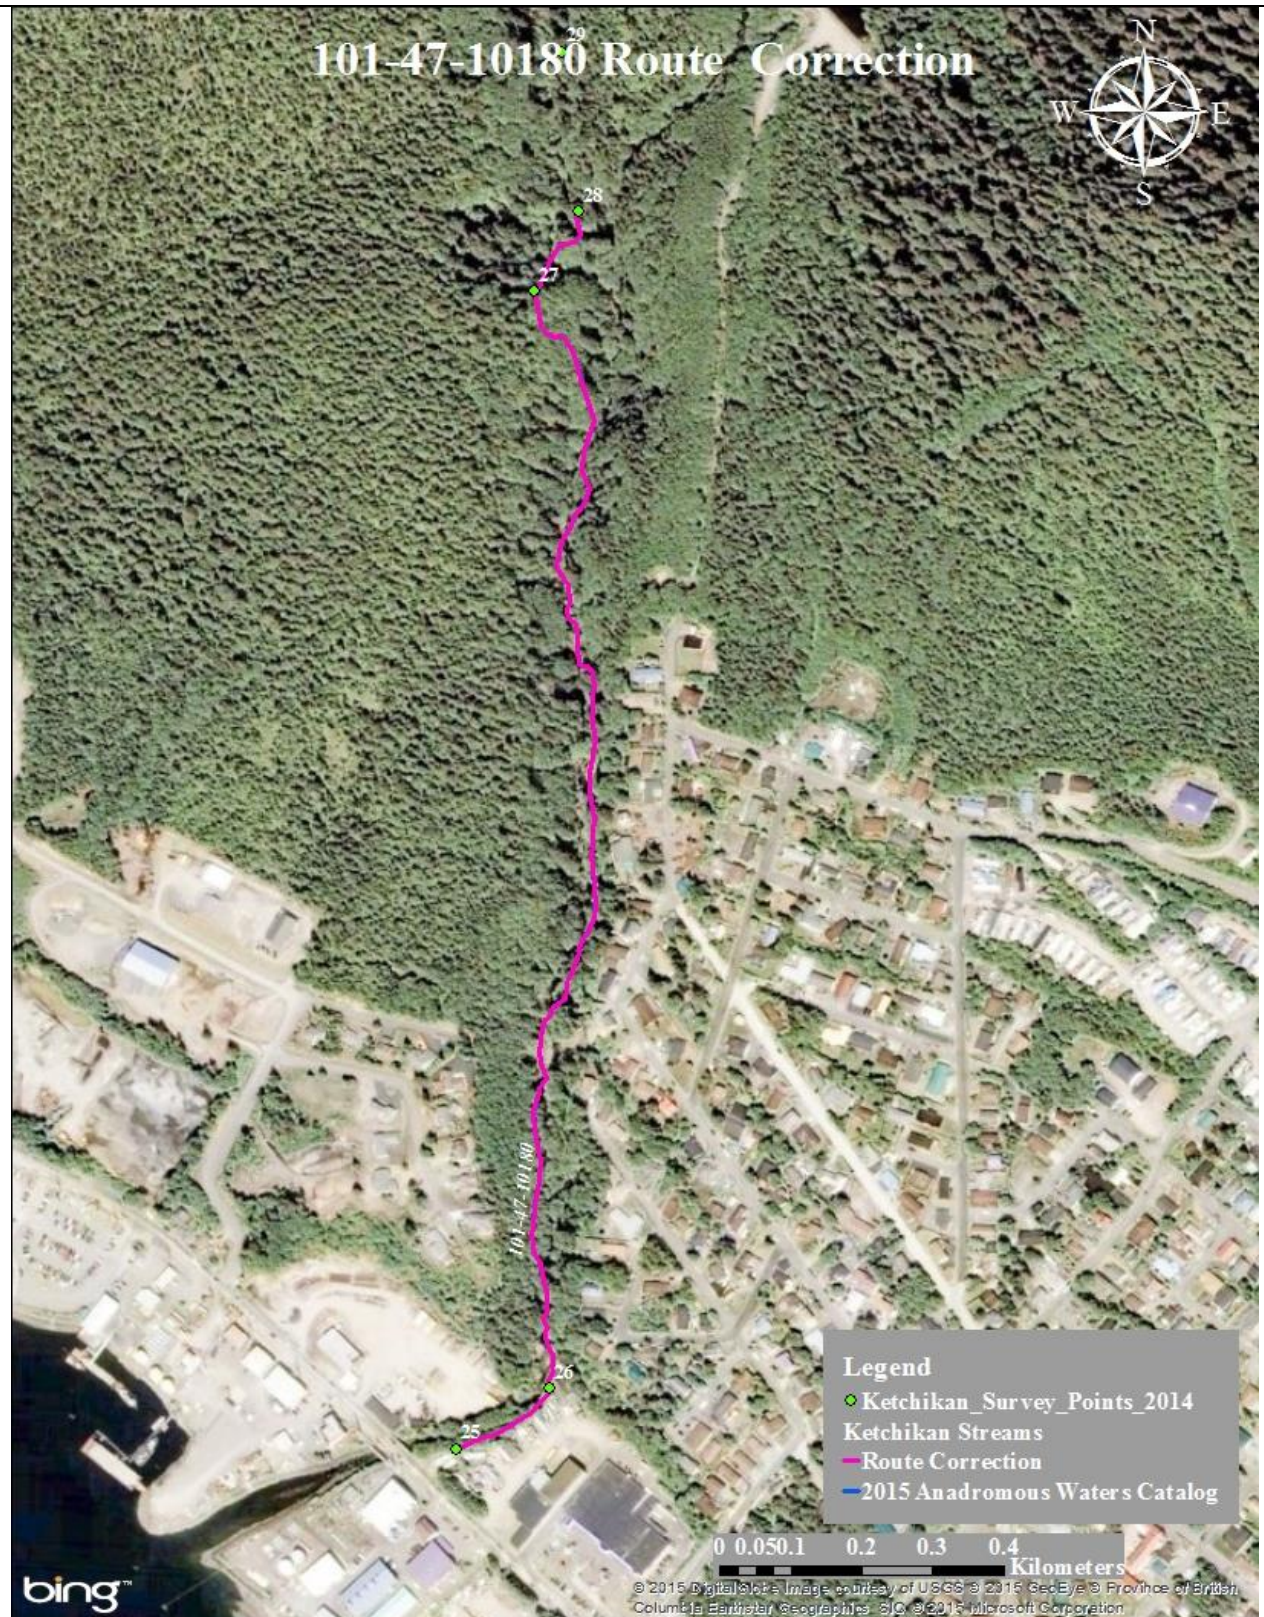
Figure 3.—101-47-10180 route correction map.

Recommendations: Update the route of this creek to reflect the field verified upper extent at waypoint 28 (Figure 3).

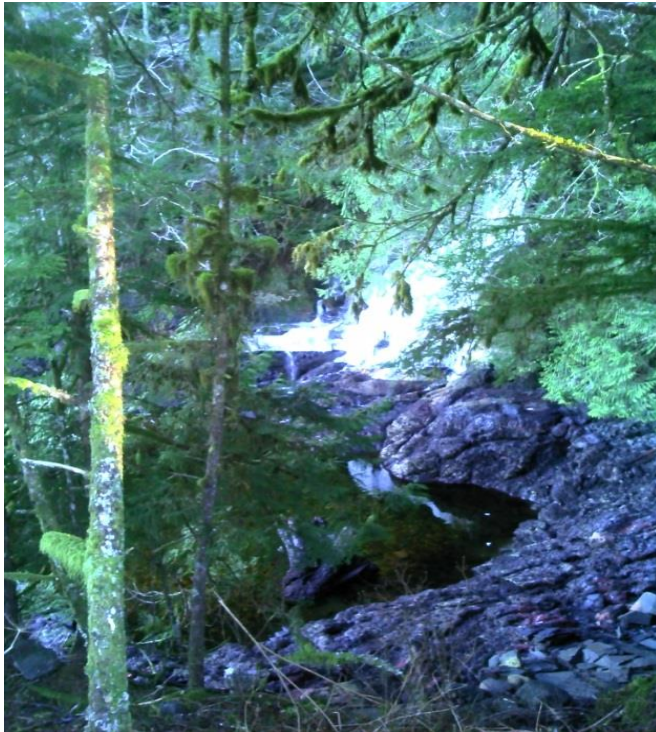
Figure 1.—Waterfall barrier at tideline on Second Waterfall Creek.

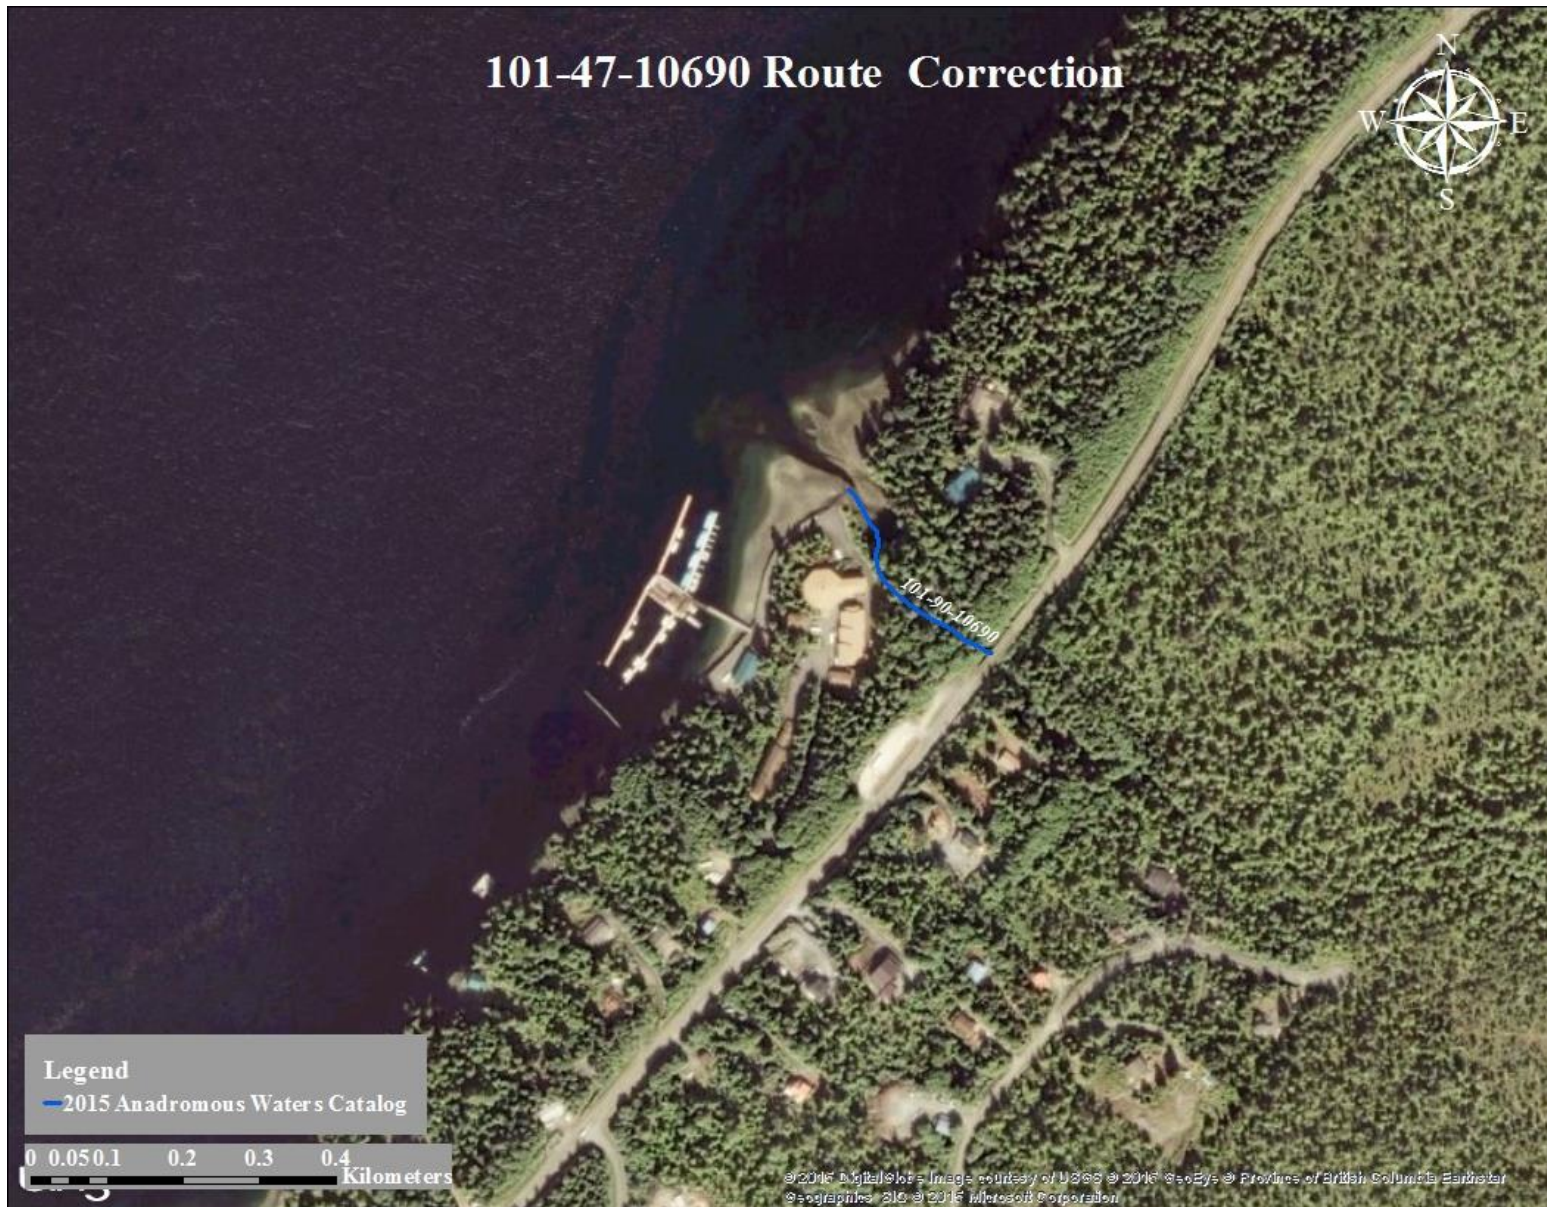
Figure 2.—101-90-10690 correction map.

Recommendations: Remove this stream from the AWC (Figure 2). Note: as of 2015, this stream has been shortened to the road, not delisted, as it is an index stream.

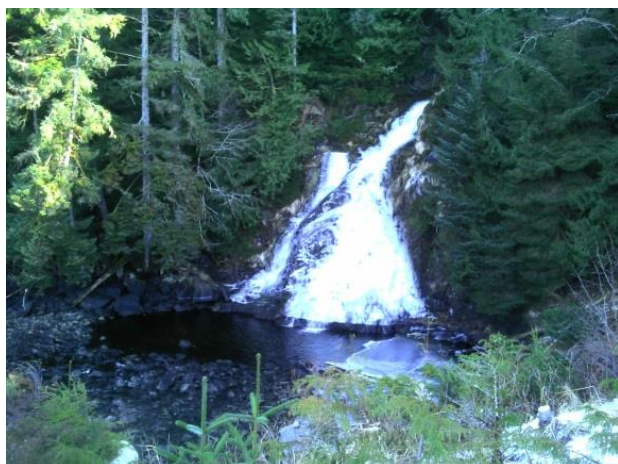
Figure 1.—Waterfall barrier at tideline on First Waterfall Creek.

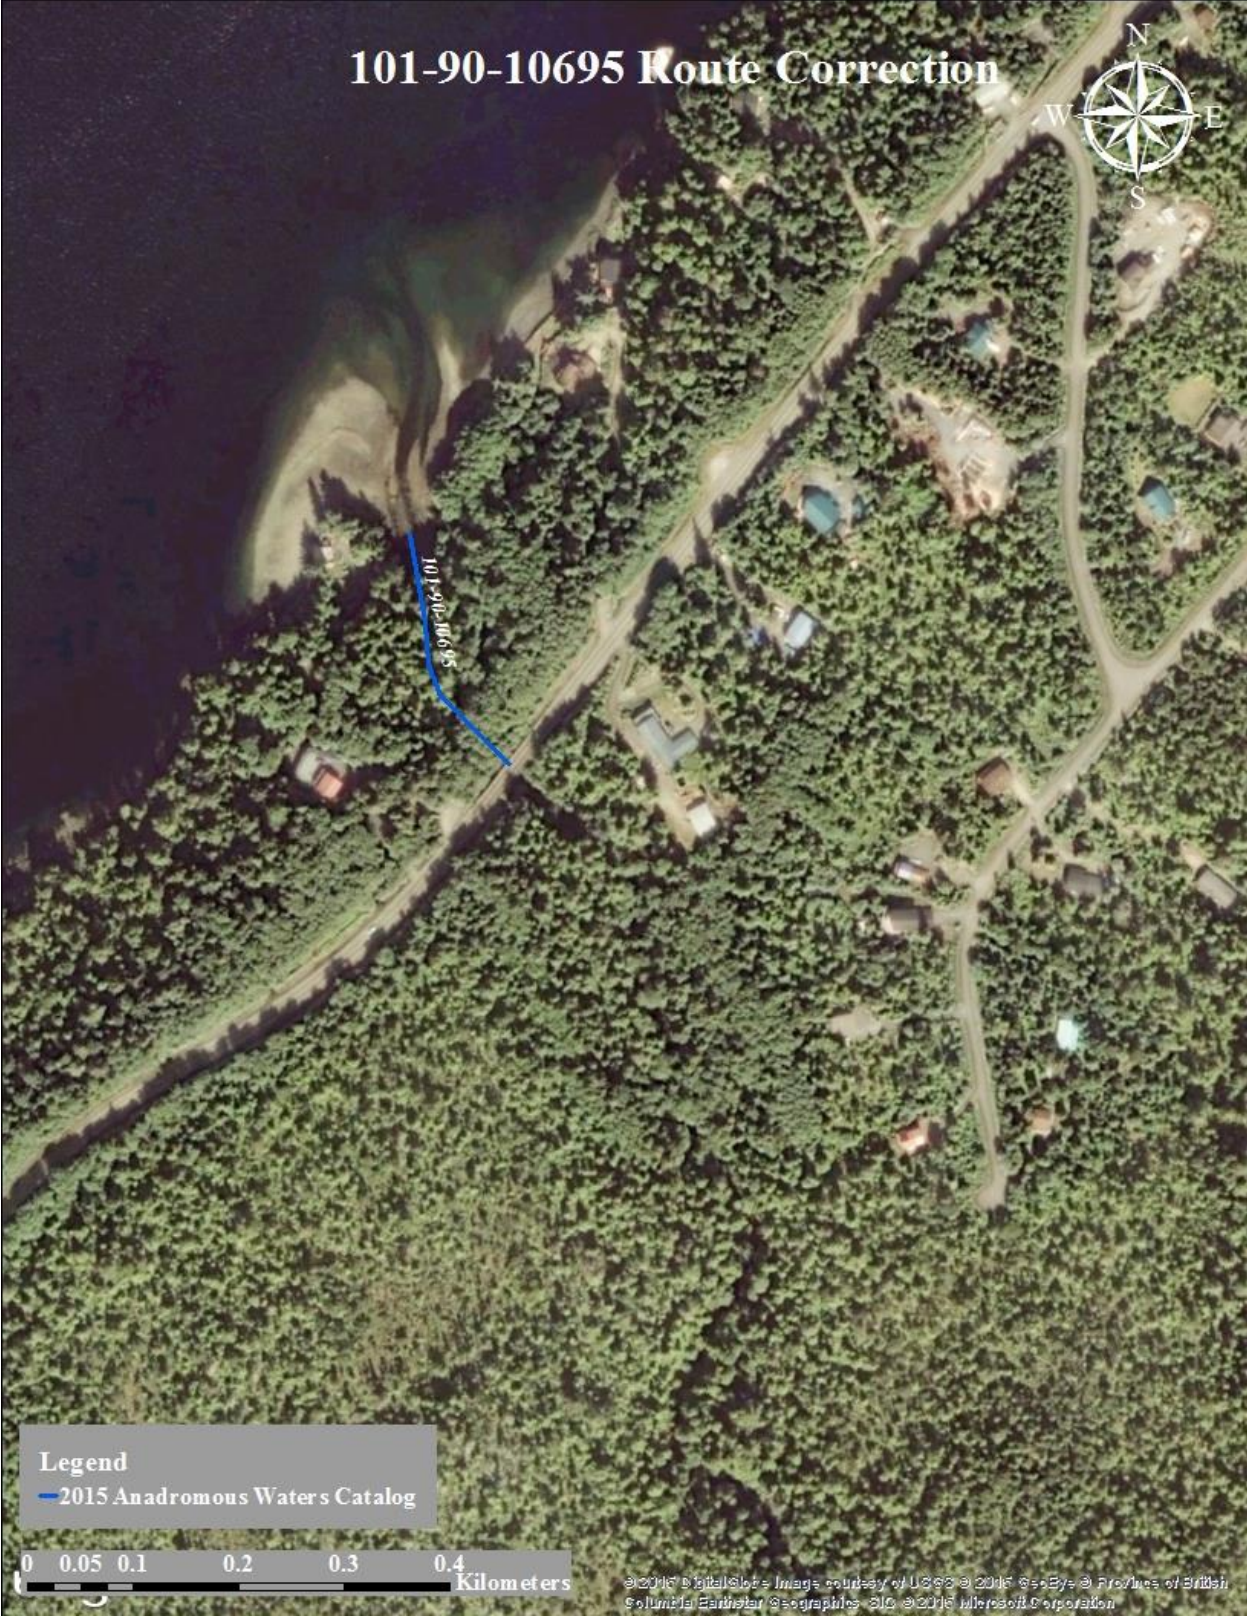
Figure 3.-101-90-10695 correction map.

Recommendations: Remove this stream from the AWC (Figure 3). Note: as of 2015, this stream has been shortened to the road, not removed, as it is an index stream.

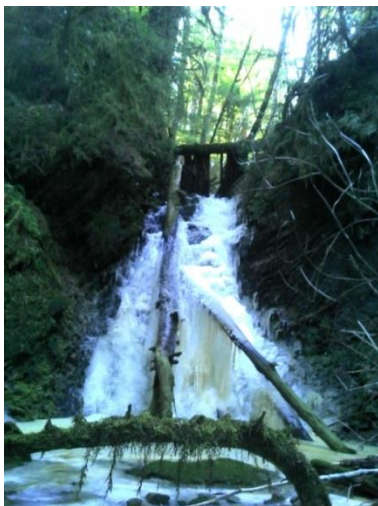
Figure 1.—Barrier falls on 1st Waterfall Creek.

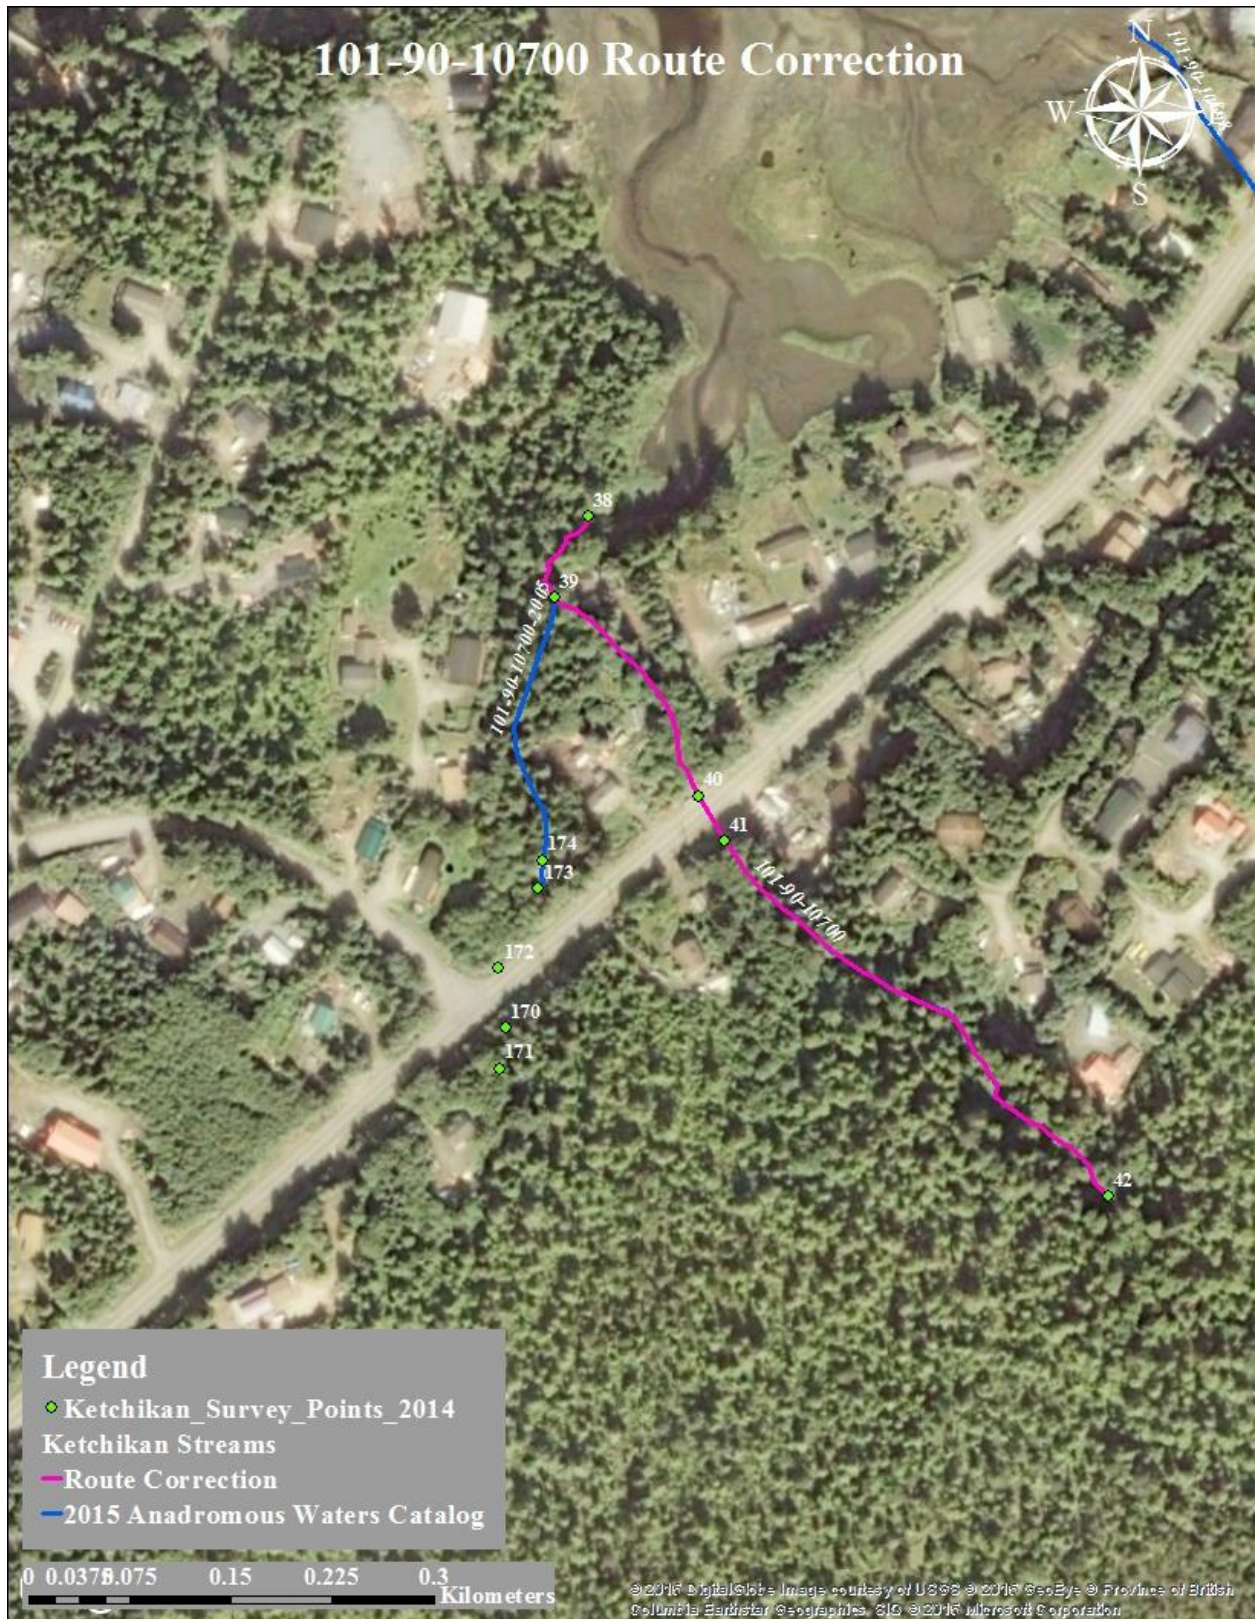
Figure 2.—101-90-10700 route correction map.

Recommendations: Please update this stream's route to reflect the field verified route, and add COr to the AWC database (Figure 2).

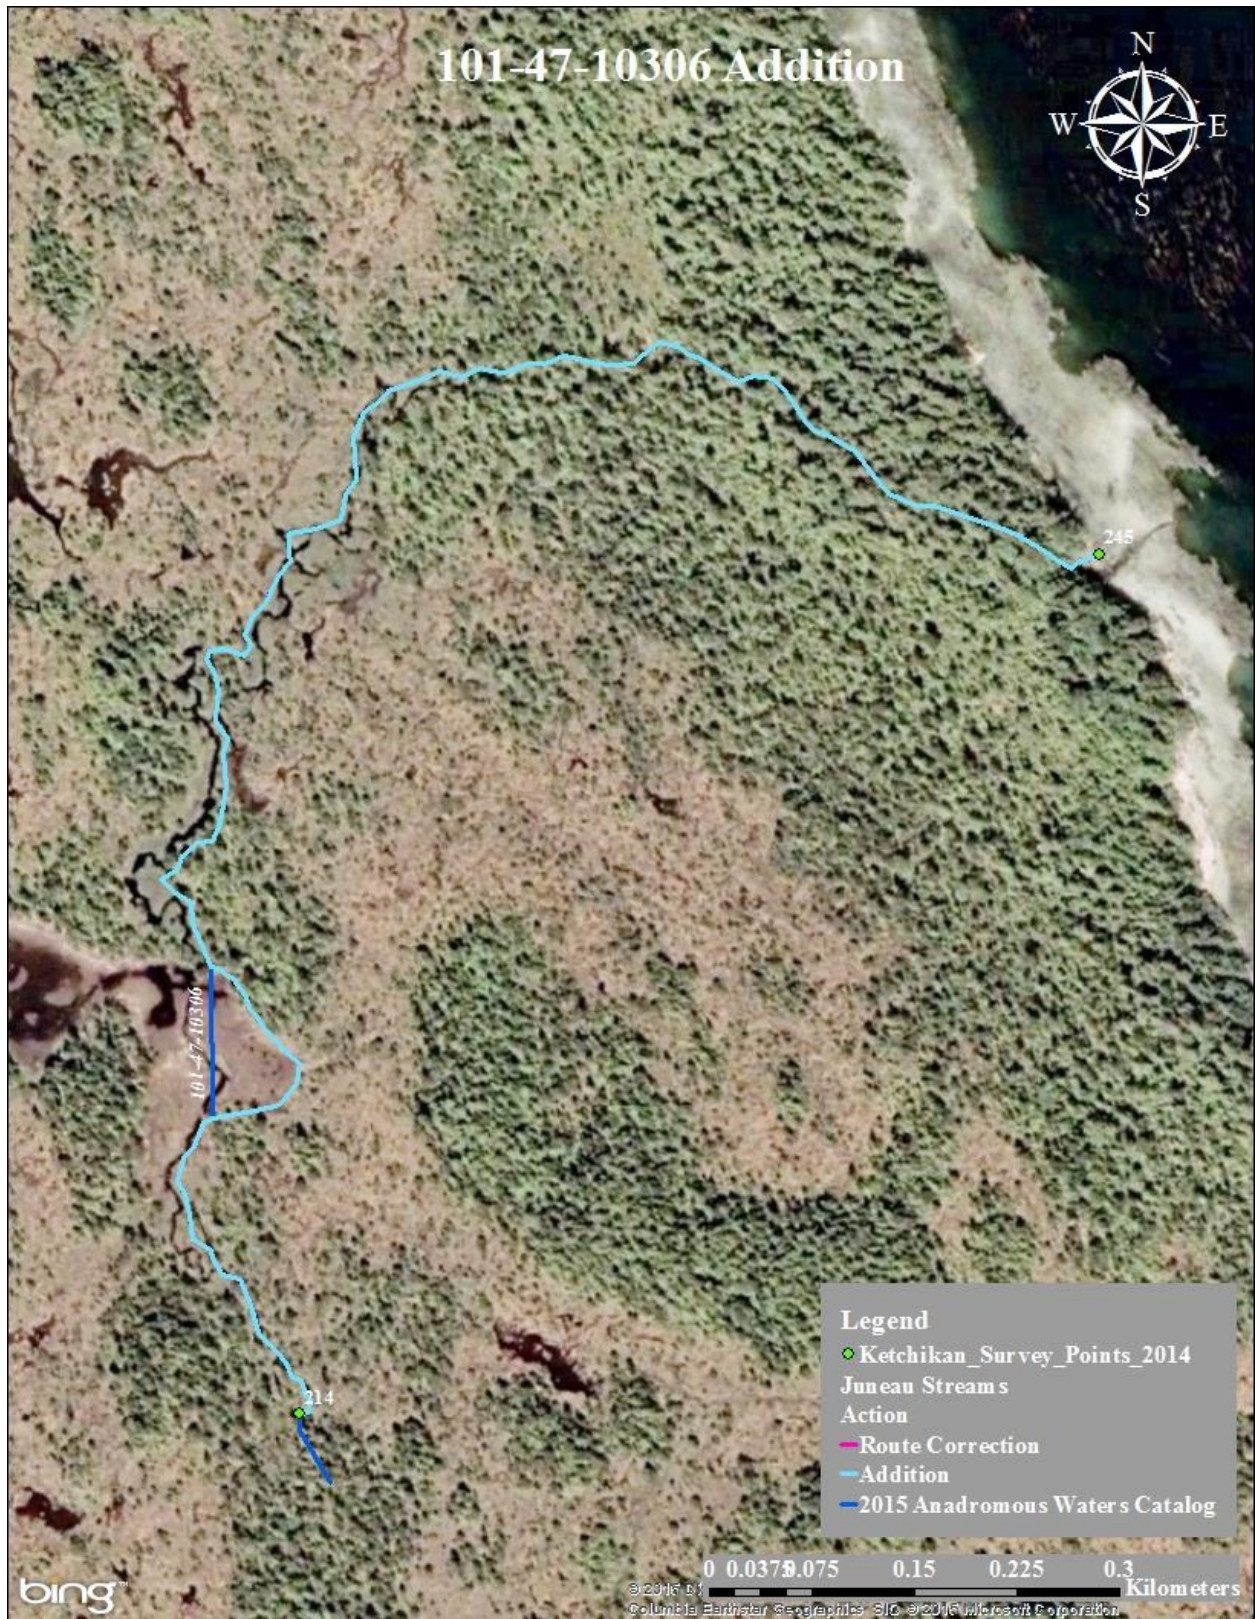
Figure 1.- 101-47-10306 addition map.

Waypoint	Latitude	Longitude	Notes	Sample Effort	Sample Results
245	55.3179	-131.6506	Outlet of uncataloged stream.		
214	55.3147	-131.6558	Set minnow trap near outlet of culvert under Airport road.	MT	14 CO

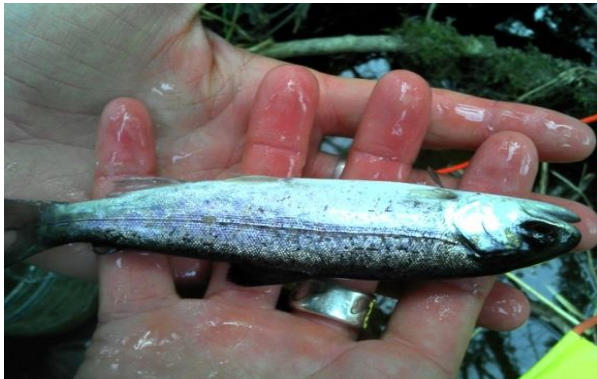
Waypoint	Latitude	Longitude	Notes	Sample Effort	Sample Results
209	55.3246	-131.5258	This is the lowest point of ditch creek on Herring Cove. Was filled in with large rocks for road expansion.		
210	55.3246	-131.5258	WPT 185 trap results.	MT	3 CO
211	55.3245	-131.5257	Culvert under Wood Drive.		
212	55.3243	-131.5256	Culvert under private driveway.		
213	55.3242	-131.5255		MT	11 CO
248	55.3234	-131.5254

Figure 1.–Coho captured in Herring Cove ditch.

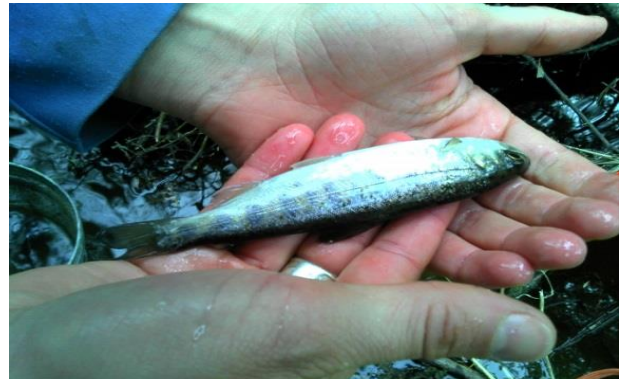
Figure 2.–Coho captured in Herring Cove ditch.
