Appendix: Lynn Canal

Guide to direct fieldwork for cataloging anadromous water bodies in Southeast Alaska

LYNN CANAL SURVEYS

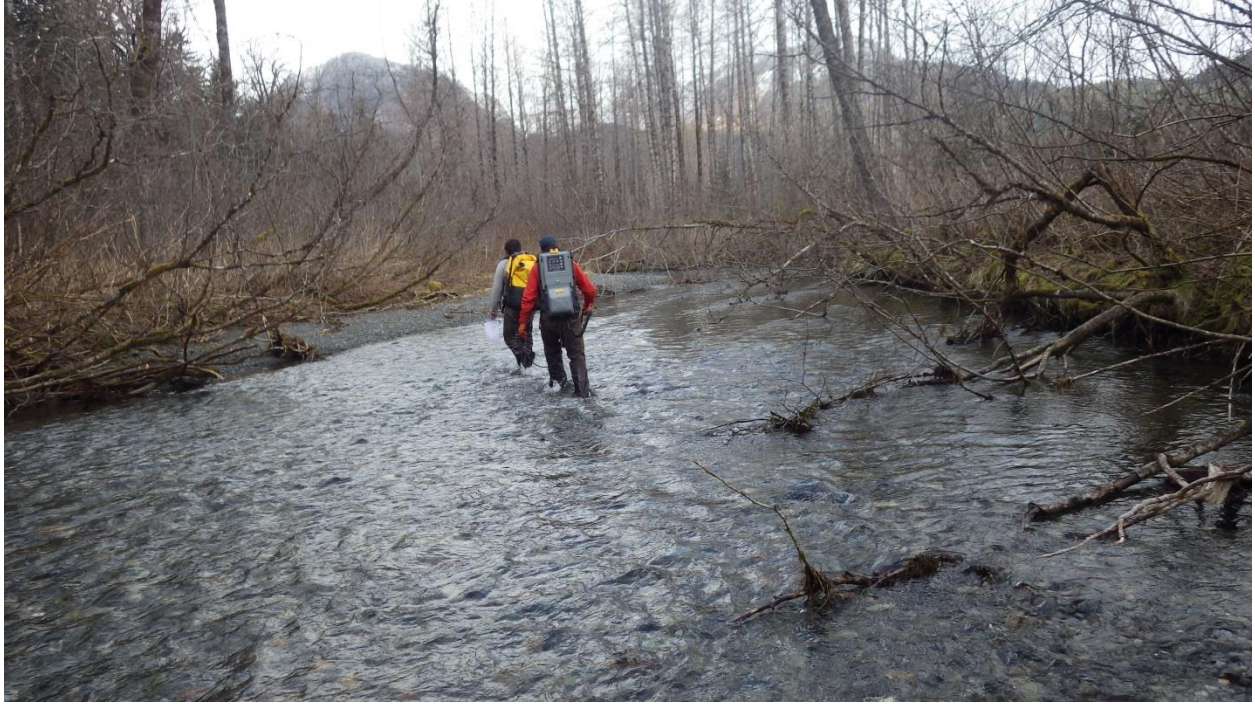
Figure 1.—Biologists sampling 115-10-10800-2005 in the Endicott River watershed.

Findings: We sampled with a GPS and a backpack electrofisher (Table 1). This is a beautiful tributary to the Endicott River (Figure 1). It provides excellent spawning habitat in the cobble substrate and crystal clear water. The river is about 15 feet wide and 2 feet deep with pools and backwaters for juvenile fish to hide. The anadromous reach ends at a long cascading waterfall (Figure 2). We captured chum salmon outmigrants throughout the stream (Figure 3).

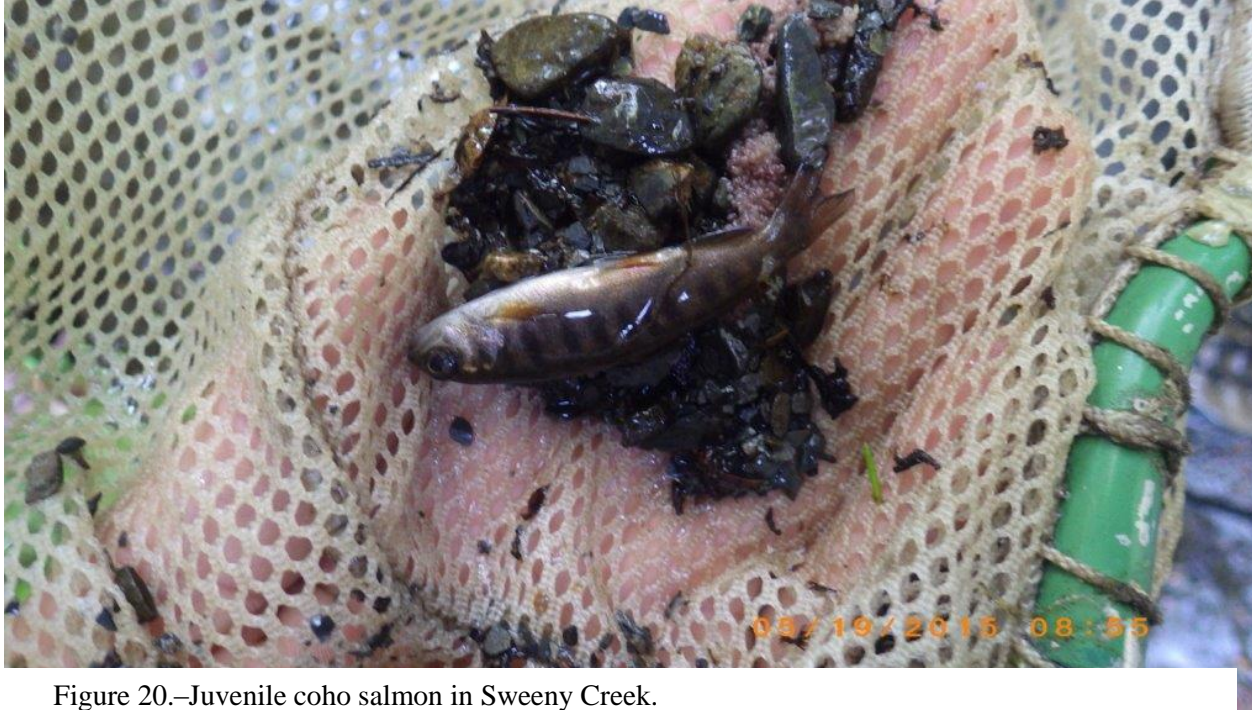
Figure 20.—Juvenile coho salmon in Sweeny Creek.

Findings: We sampled Sweeny Creek with a backpack a backpack electrofisher and GPS (Table 1). We documented steelhead spawning at waypoint 52 and juvenile coho rearing to waypoint 36 (Figure 1). We did not encounter a definitive barrier, but we did not capture anadromous fish above waypoint 52 (Figure 2). Therefore, we will sample at higher flows to confirm upper extent.

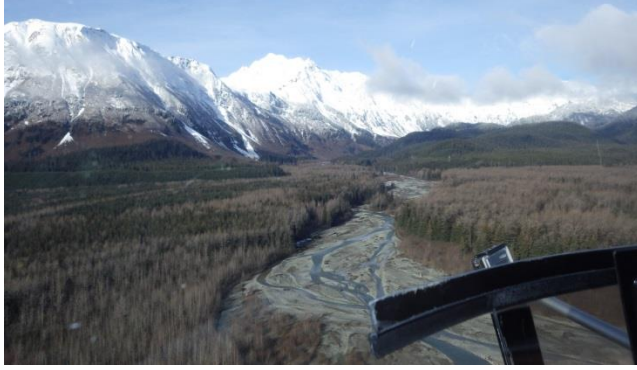
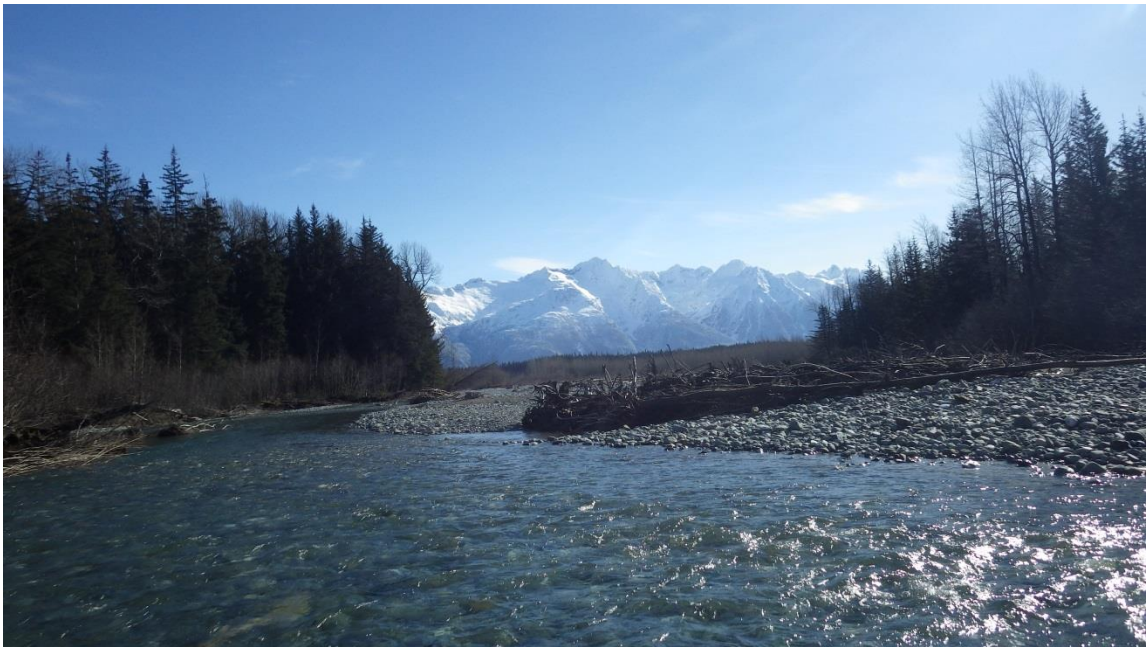
Findings: We found coho rearing in tributaries to this stream (Table 1), therefore the mainstem should be cataloged for coho rearing to waypoint 168, where a tributary enters the river mainstem (Figures 1, 2, 3). Additionally, the actual route of the stream no longer matches the mapped route. This needs to be re-digitized.

Figure 23.—Beaver complex on Sullivan River.

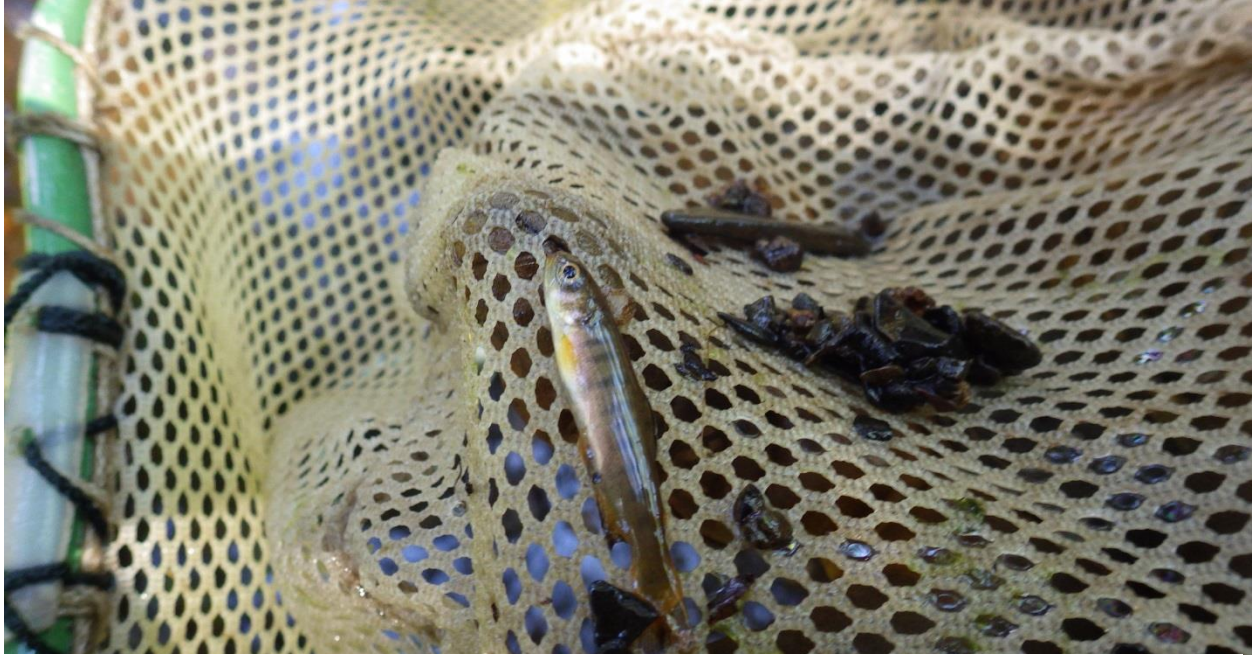
Figure 30.–Juvenile coho salmon in 115-10-10200-2005.

Findings: We sampled this stream with a backpack a backpack electrofisher and GPS (Table 1). We documented juvenile coho salmon rearing up to waypoint 72 (Figure 1). Fish habitat likely extends past waypoint 72, however due to low water we could not sample further (Figure 2). We will sample again at higher flows.
