Appendix: Sitka

Guide to direct fieldwork for cataloging anadromous water bodies in Southeast Alaska

SITKA SURVEYS

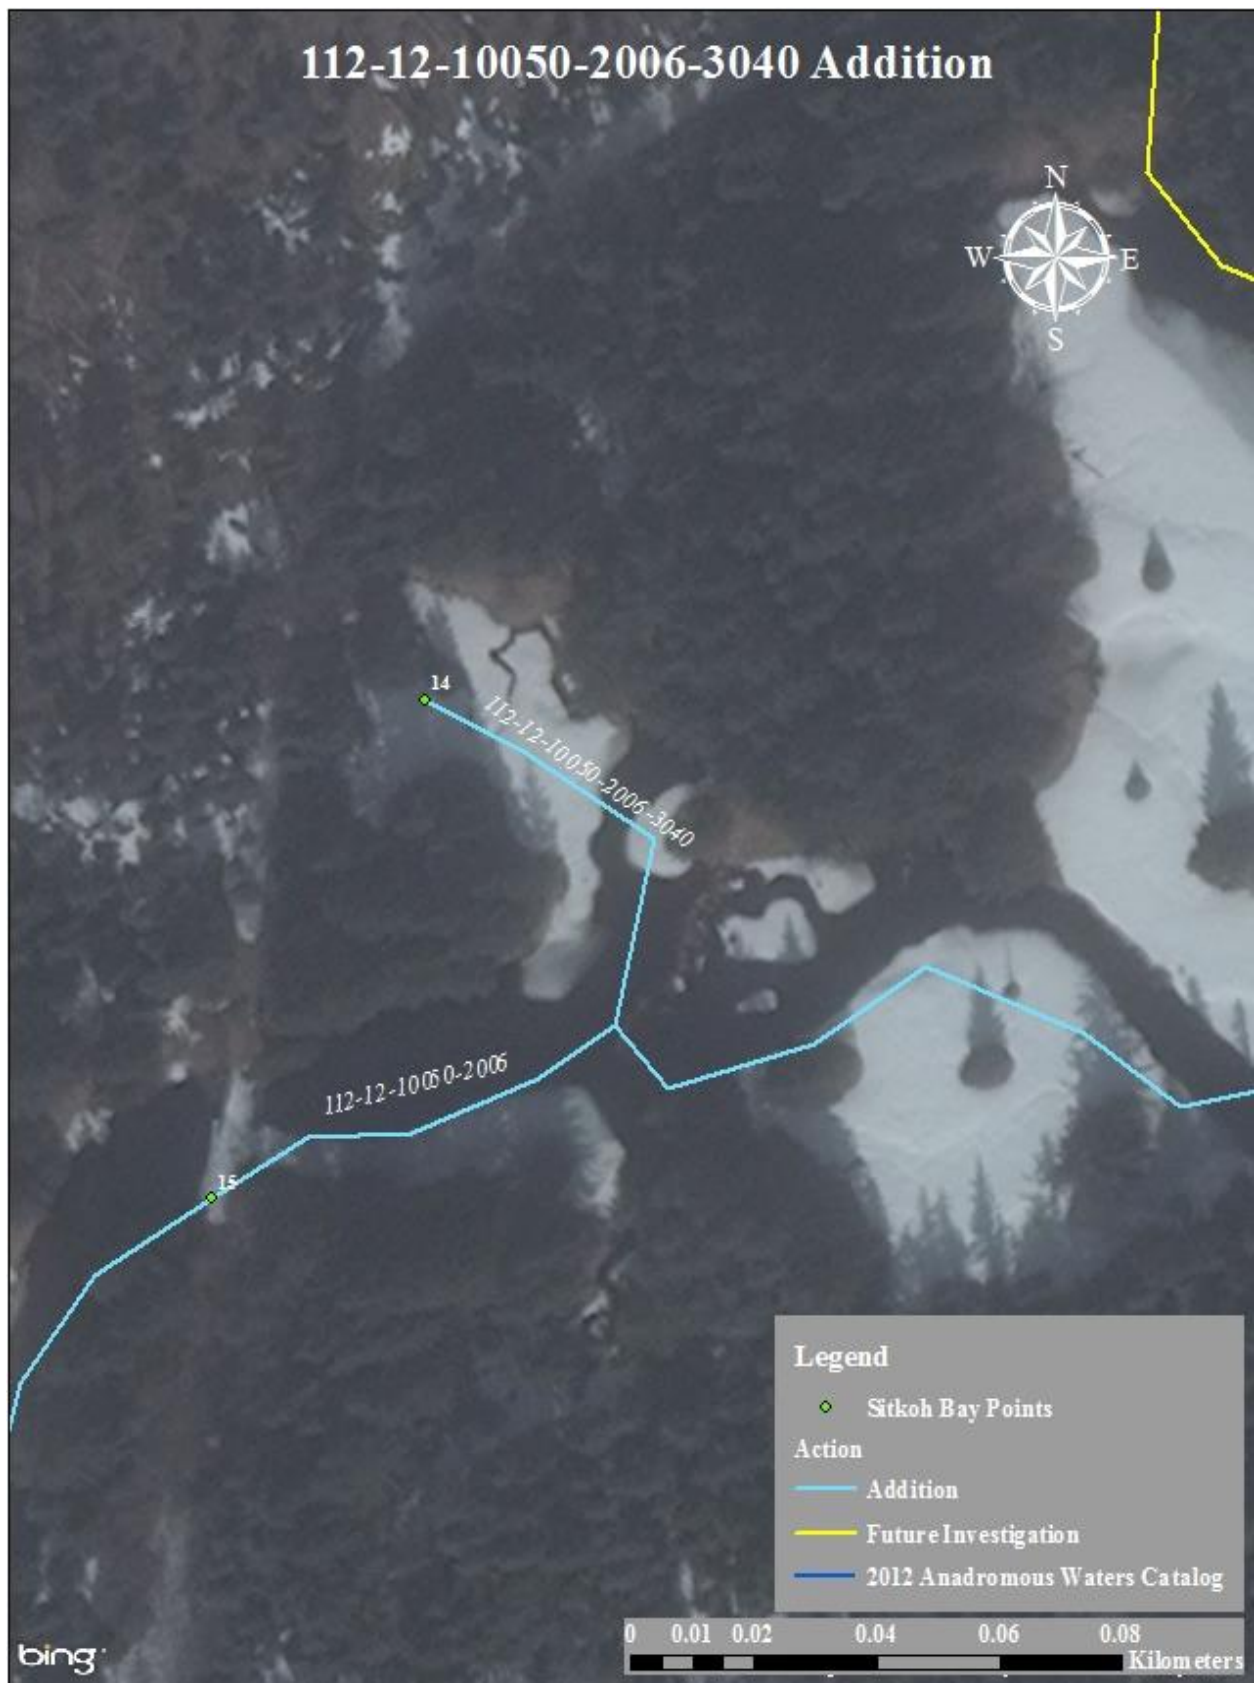
Figure 1.—112-12-10050-2006-3040 addition map.

Recommendations: Add stream and rearing coho salmon to the AWC (Figure 1).

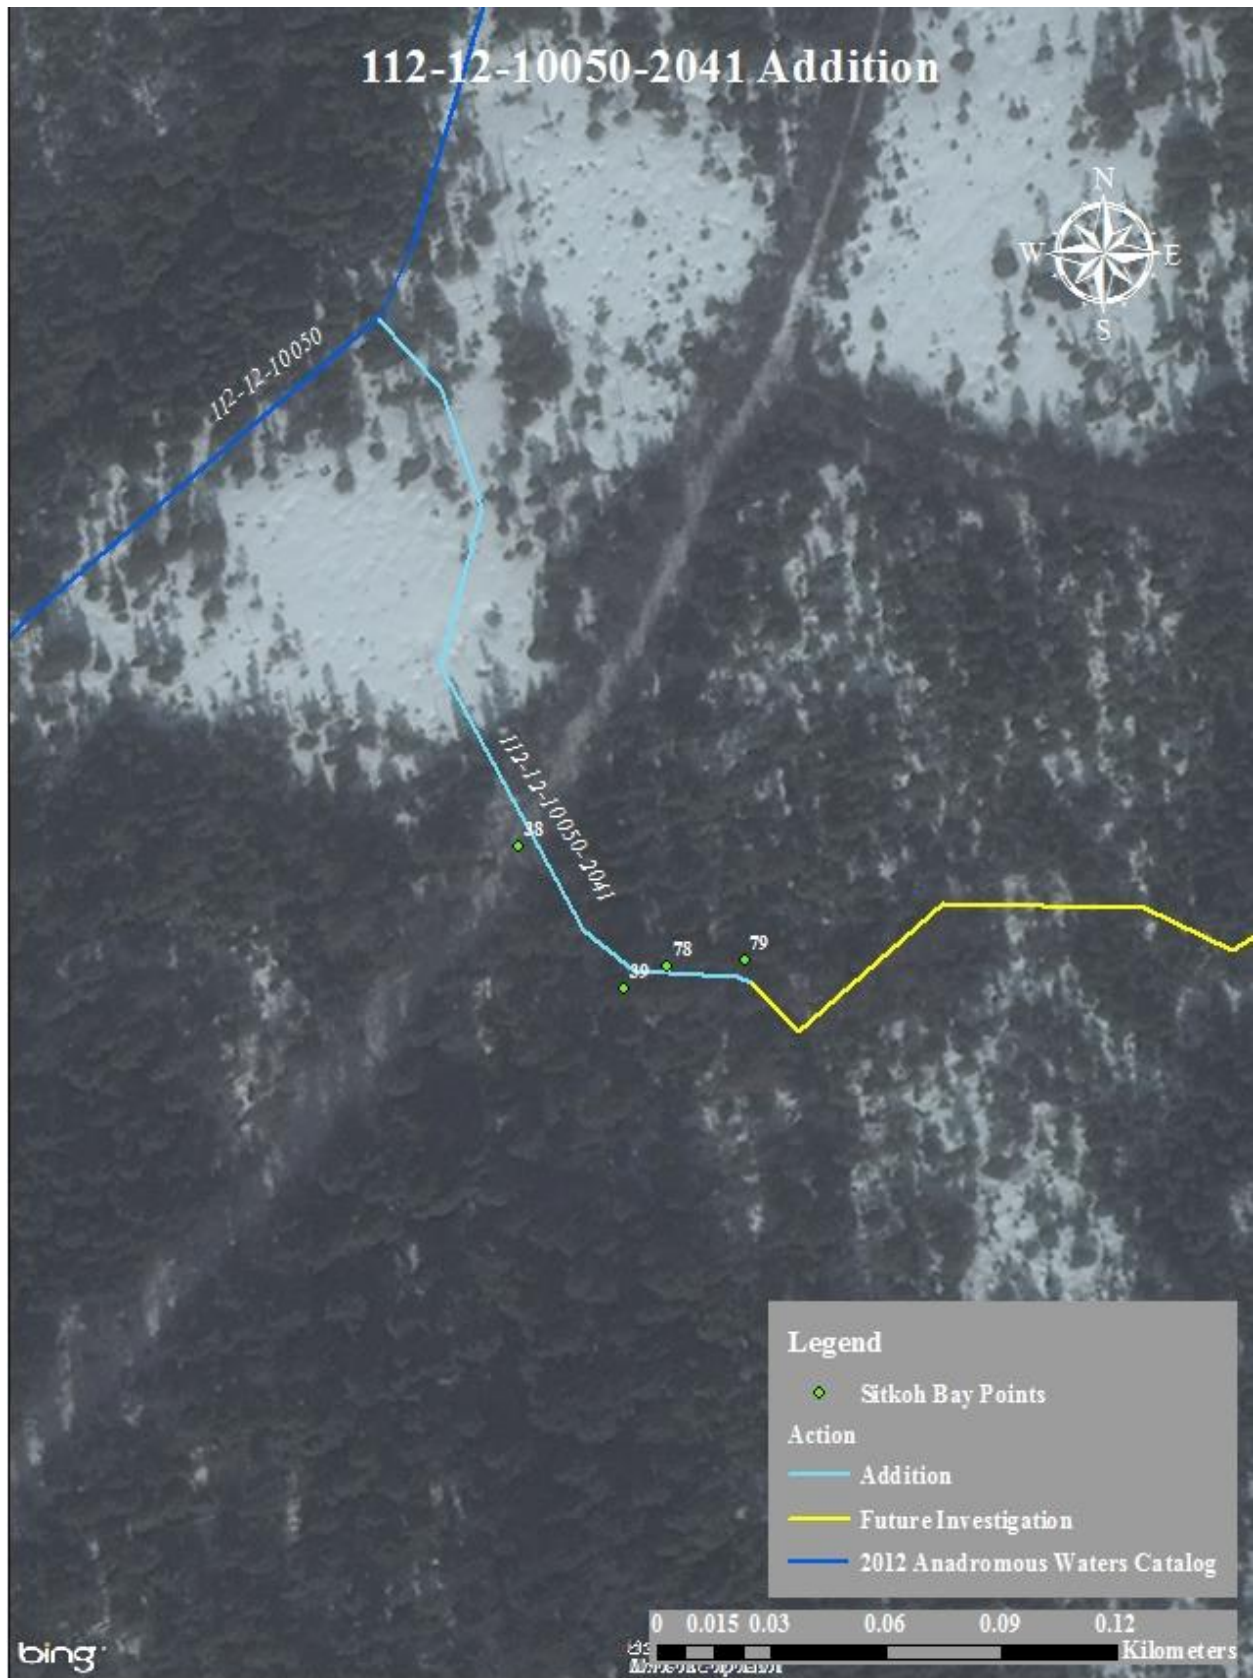
Figure 1.—112-12-10050-2041 addition map.

112-12-10050-2041**ADDITION****Water body name:****Survey date:** 4/17/2012**Water body number:** 112-12-10050-2041**Species & Lifestage:** CO**Watershed:** Kook Creek-Frontal Chatham Strait**MTR:** C050S066E **Quad:** Sitka C-3**Findings:** I surveyed this stream using a backpack electrofisher and GPS (Table 1). I captured rearing coho salmon, Dolly Varden char, and cutthroat trout.**Recommendations:** Add stream and rearing coho salmon to the AWC (Figure 1).**Nomination:** 12-557

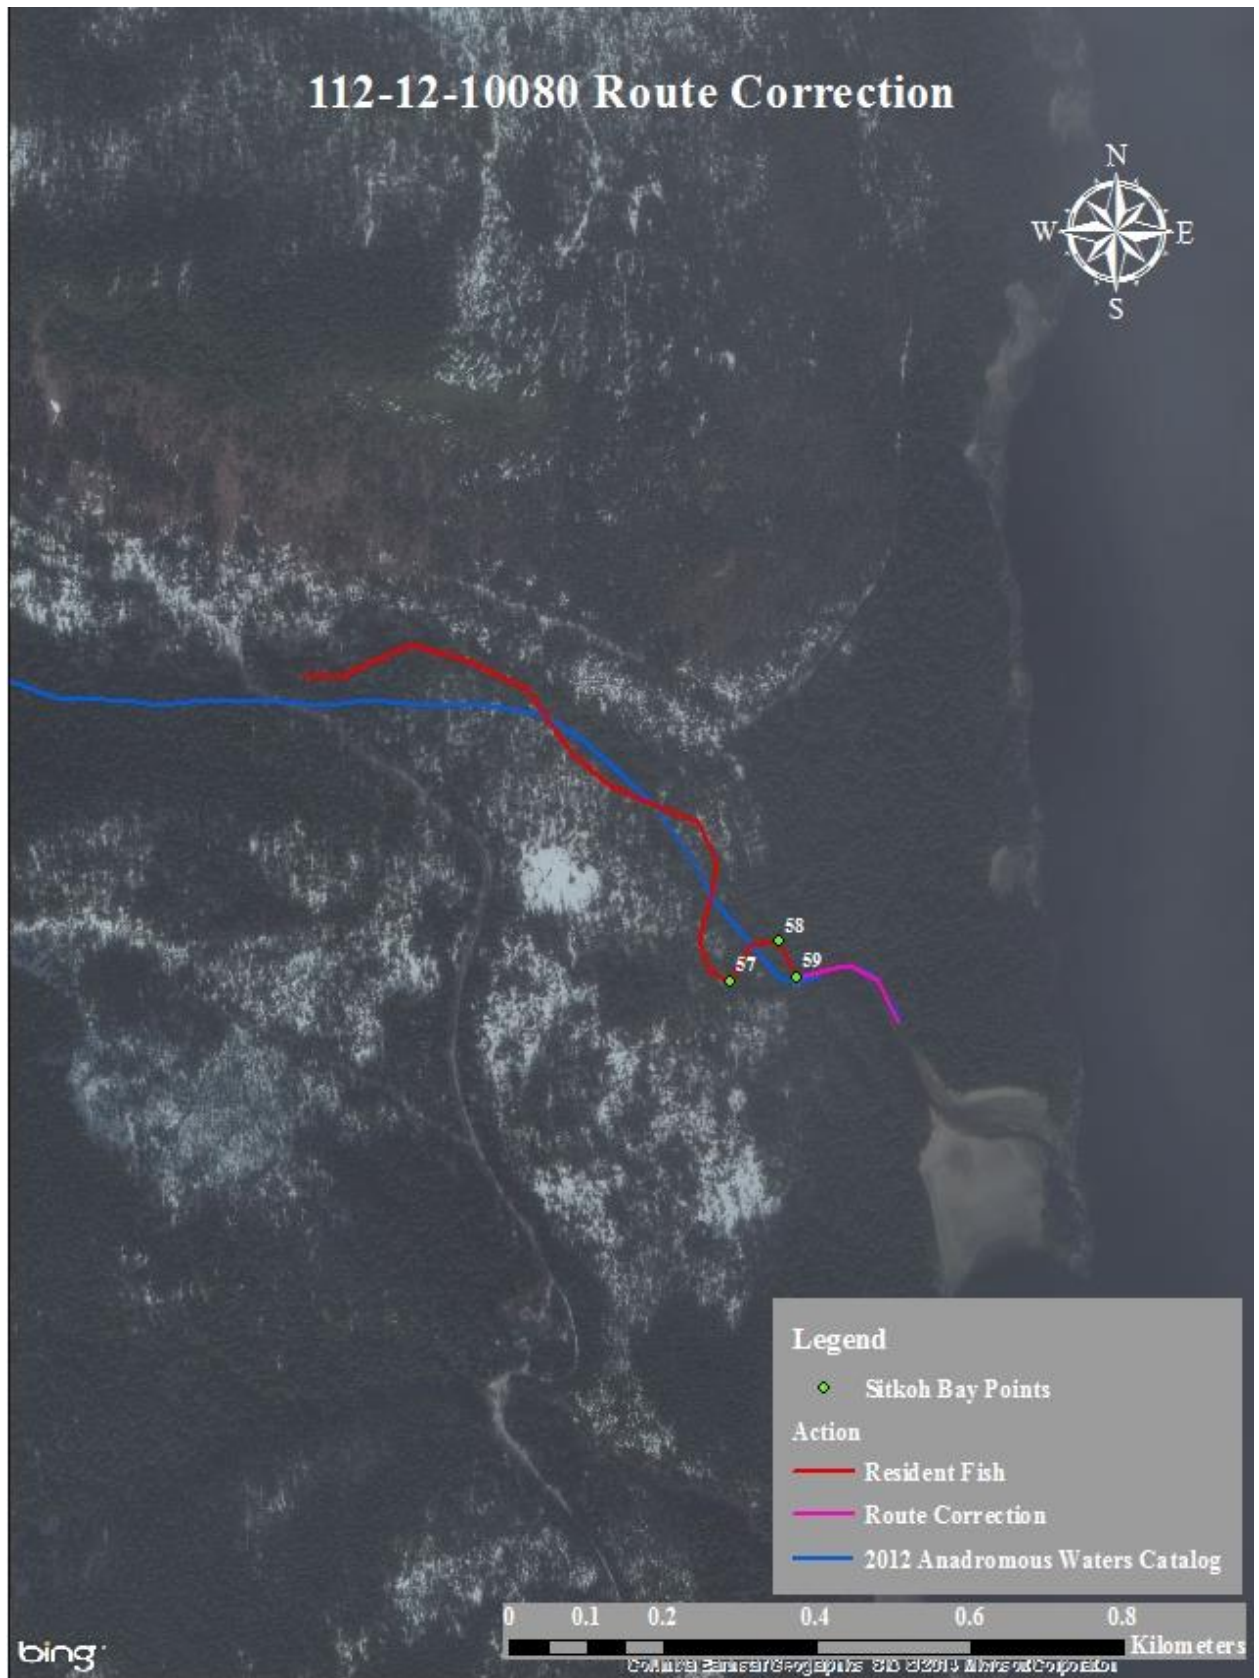
Figure 1.—112-12-10080 route correction map.

Recommendations: Shorten the existing route in the AWC (Figure 1).

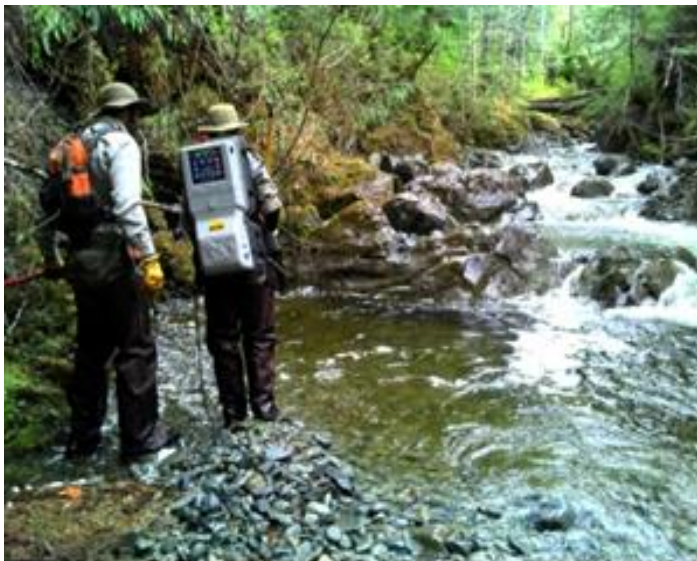
Findings: We walked this stream over the course of several days and found it to be more sinuous and meandering than the catalog illustrates (Table 1). The stream has very nice spawning habitat and pools for fish to rest in (Figure 1). The upper limit needs to be shortened to the waypoint provided as there is a waterfall barrier that prevents fish passage at all flows.

Figure 1.–Gordon Willson-Naranjo and Tess Quinn surveying Starrigavan Creek.

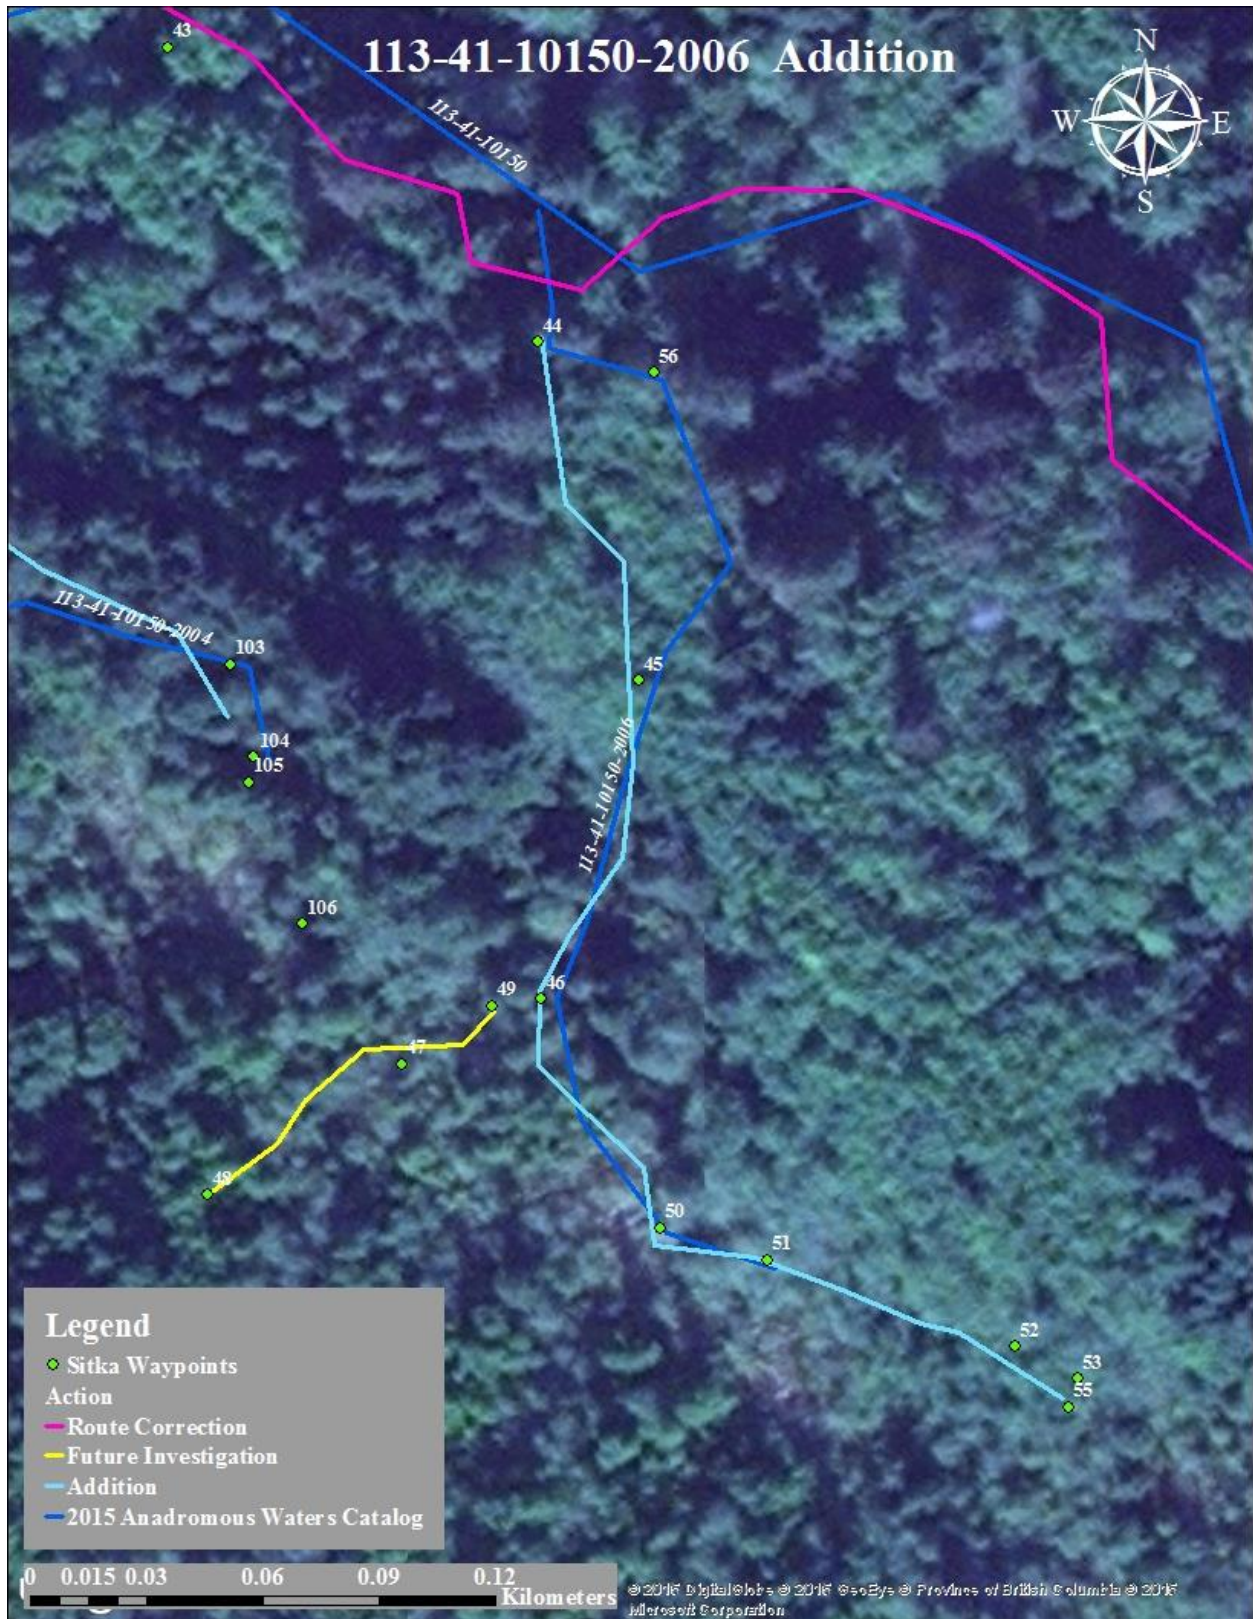
Figure 2.—113-41-10150-2006 addition map.

Findings: We surveyed this stream using a backpack electrofisher and GPS (Table 1). During sampling and tracking of the stream, coho salmon were captured and observed at points along the entire length (Figure 1). Upper and lower limits of fish presence are from waypoint 44 to waypoint 52.

Recommendations: Add stream to the AWC (Figure 2).

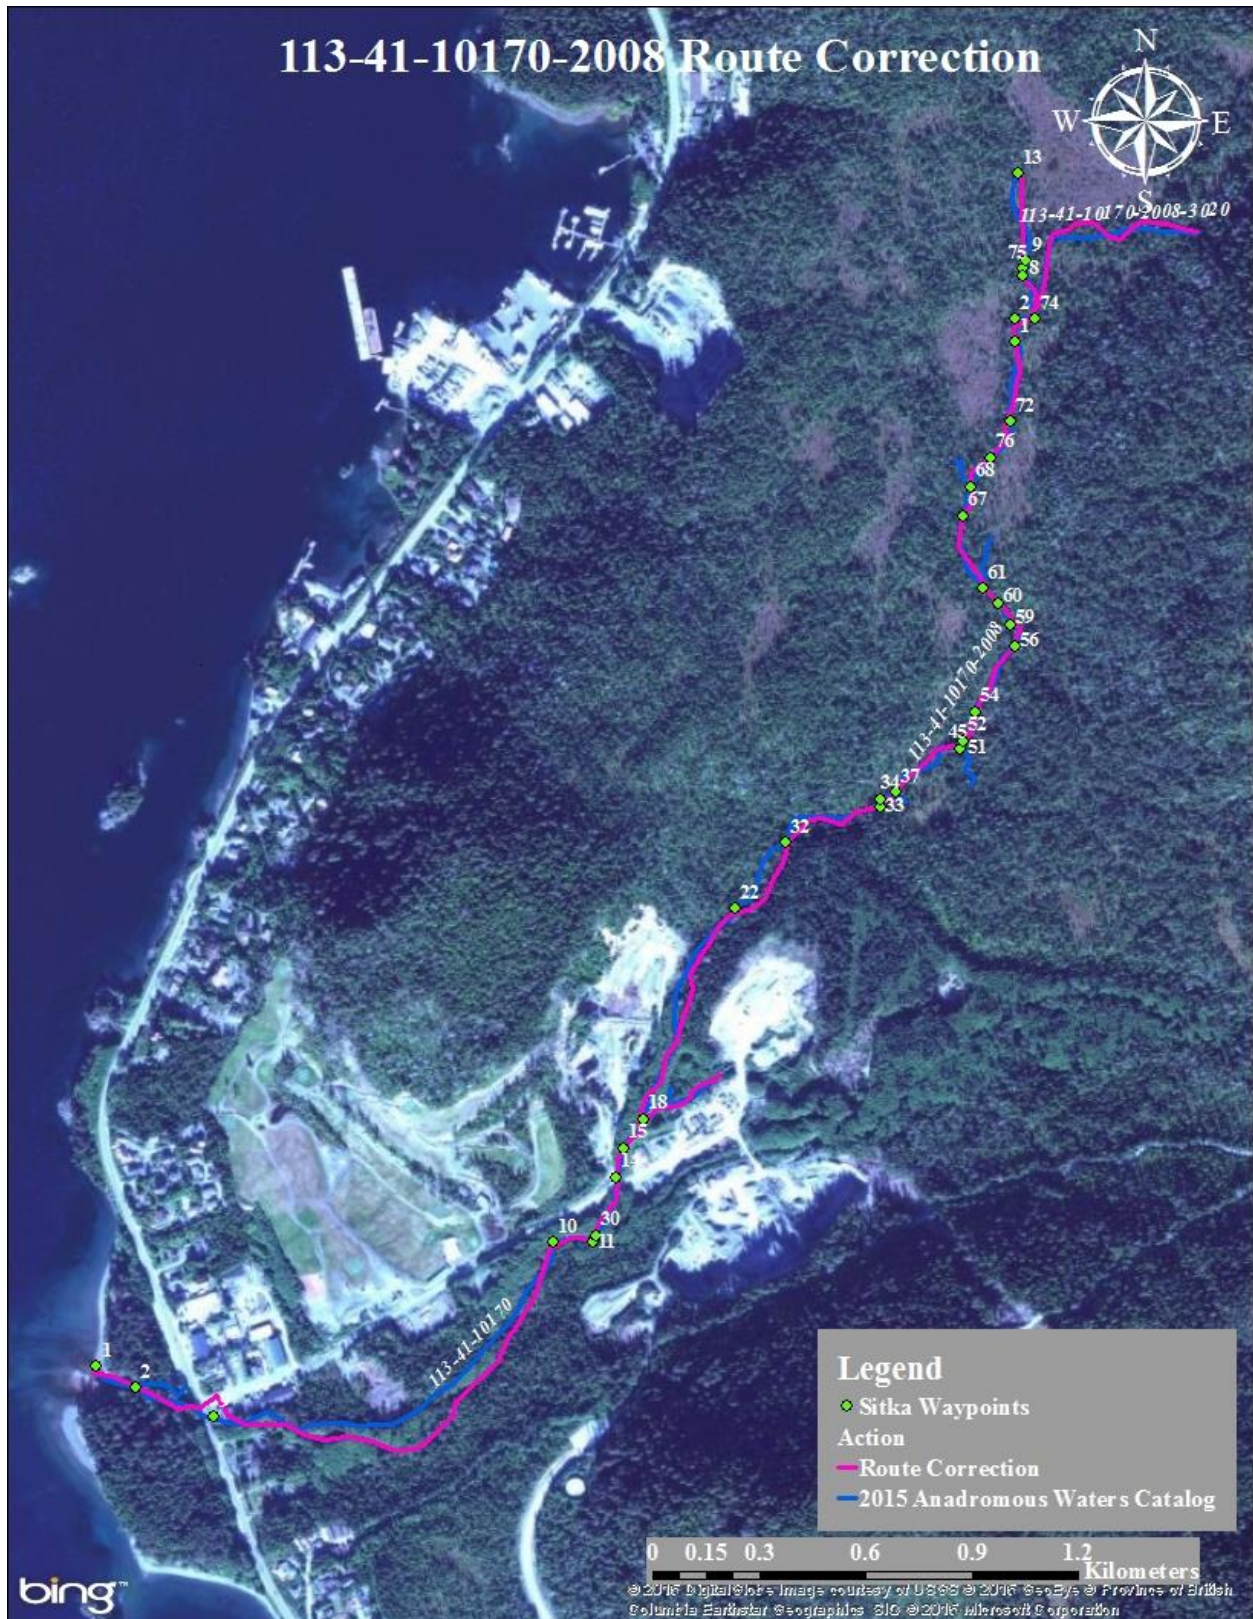
Figure 1.—113-41-10170-2008 route correction map.

113-41-10170-2008**CORRECTION****Water body name:****Survey date:** 6/7/2012**Water body number:** 113-41-10170-2008**Species & Lifestage:** CHs, COp, Ps**Watershed:** Sitka Sound-Frontal Pacific Ocean**MTR:** C055S063E **Quad:** Sitka A-5**Findings:** We surveyed this stream using a backpack electrofisher and GPS (Table 1). This stream provides excellent rearing habitat for coho salmon and Dolly Varden char.**Recommendations:** Correct the current route in the AWC (Figure 1).**Nomination:** 12-569

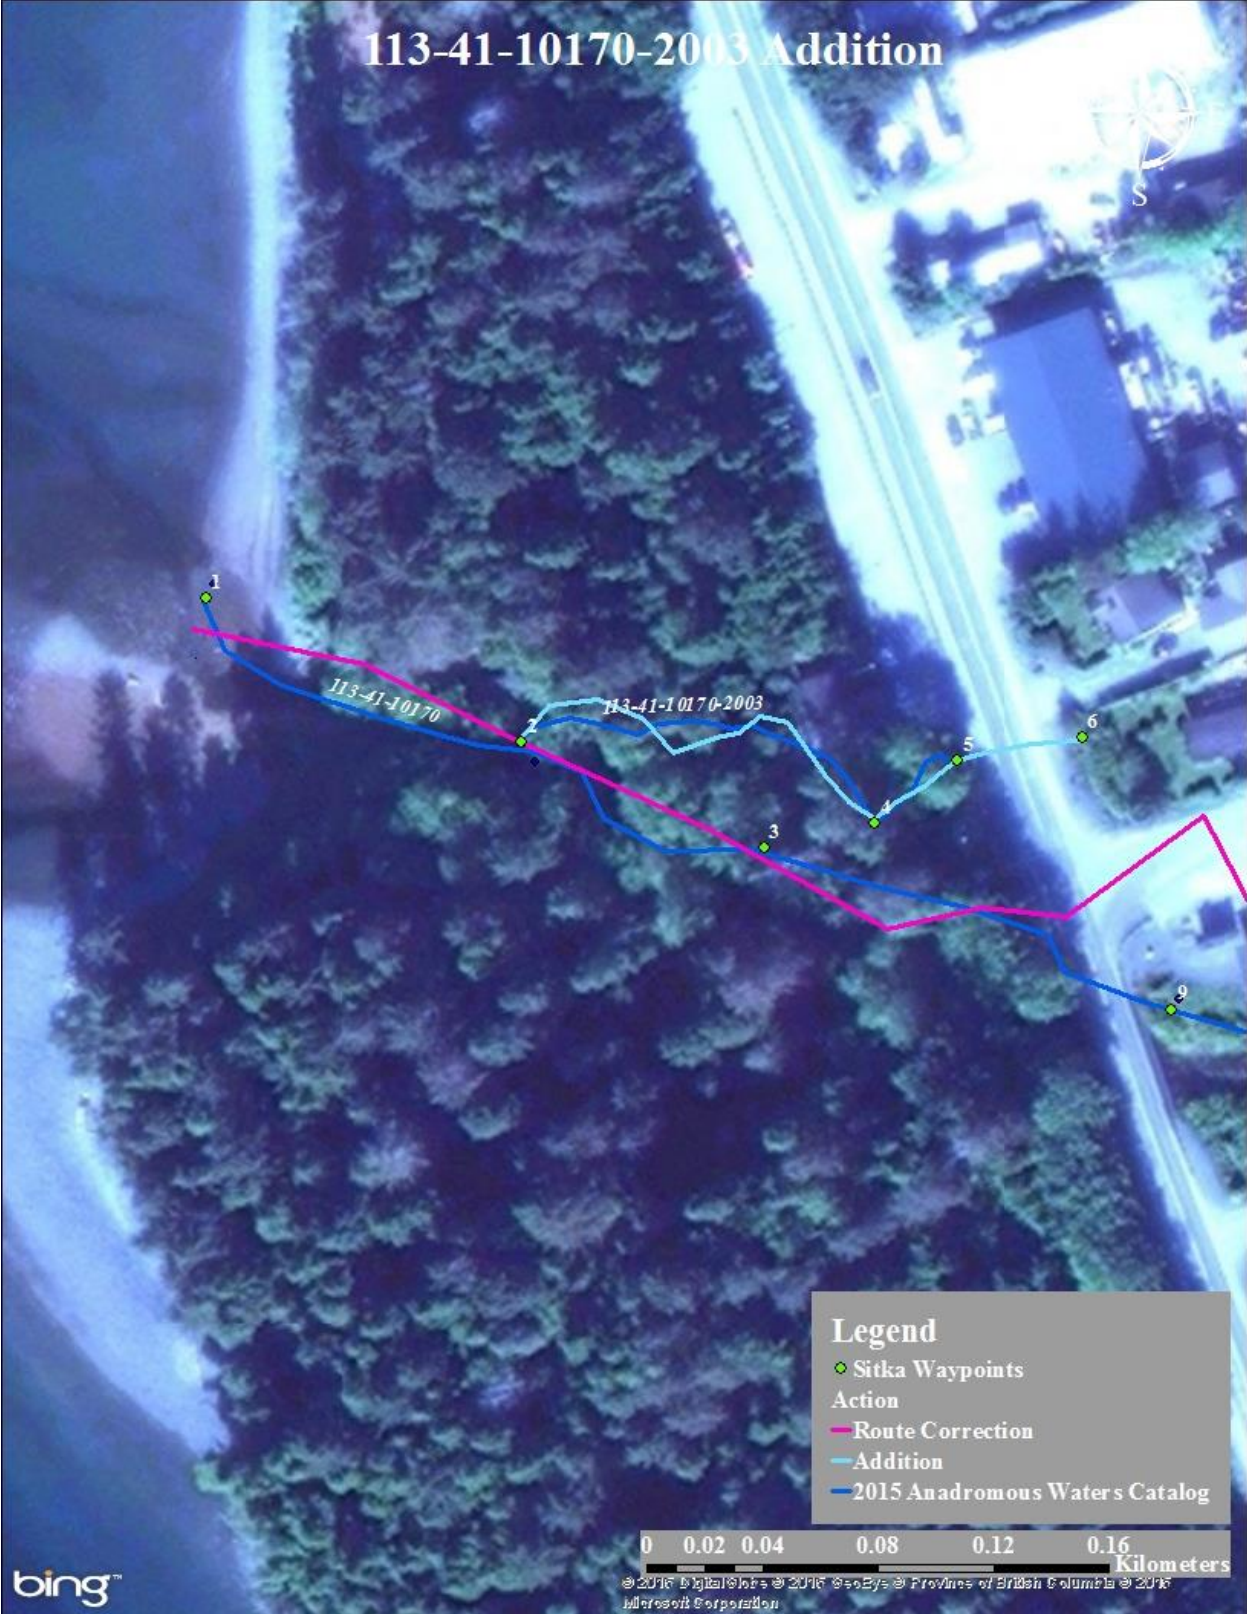
Figure 1.—113-41-10170-2003 addition map.

Findings: We surveyed this tributary using a backpack electrofisher and GPS (Table 1). This short braided stream provides rearing habitat for coho salmon and Dolly Varden char. We followed the stream up to a culvert below Halibut Point Road. We captured coho above the culvert, but were unable to track the stream above the culvert where it entered another culvert through a parking area. We found another stream nearby that may be a source of water however we found no fish in this stream.

Recommendations: Add stream to the AWC (Figure 1).

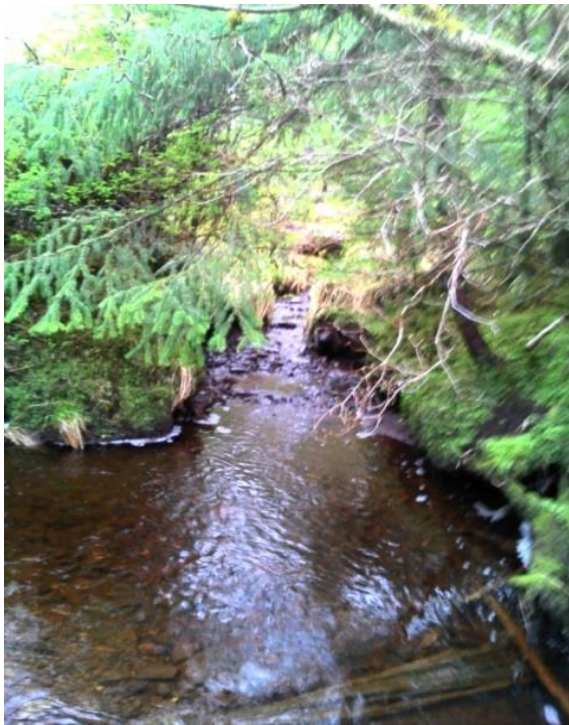
Figure 1.–Looking downstream on 113-41-10170-2008-3007.

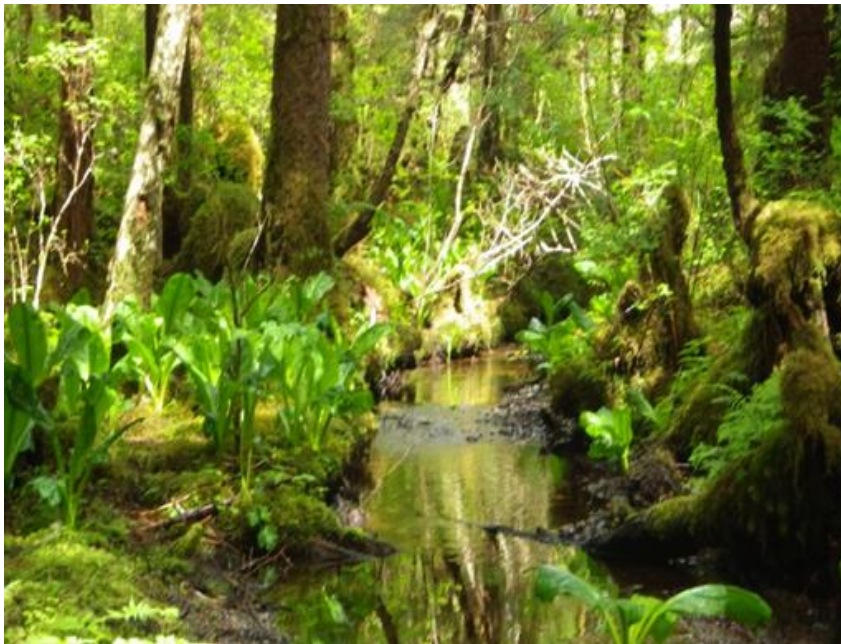
Figure 1.–Looking upstream on 113-41-10170-2008-3017.

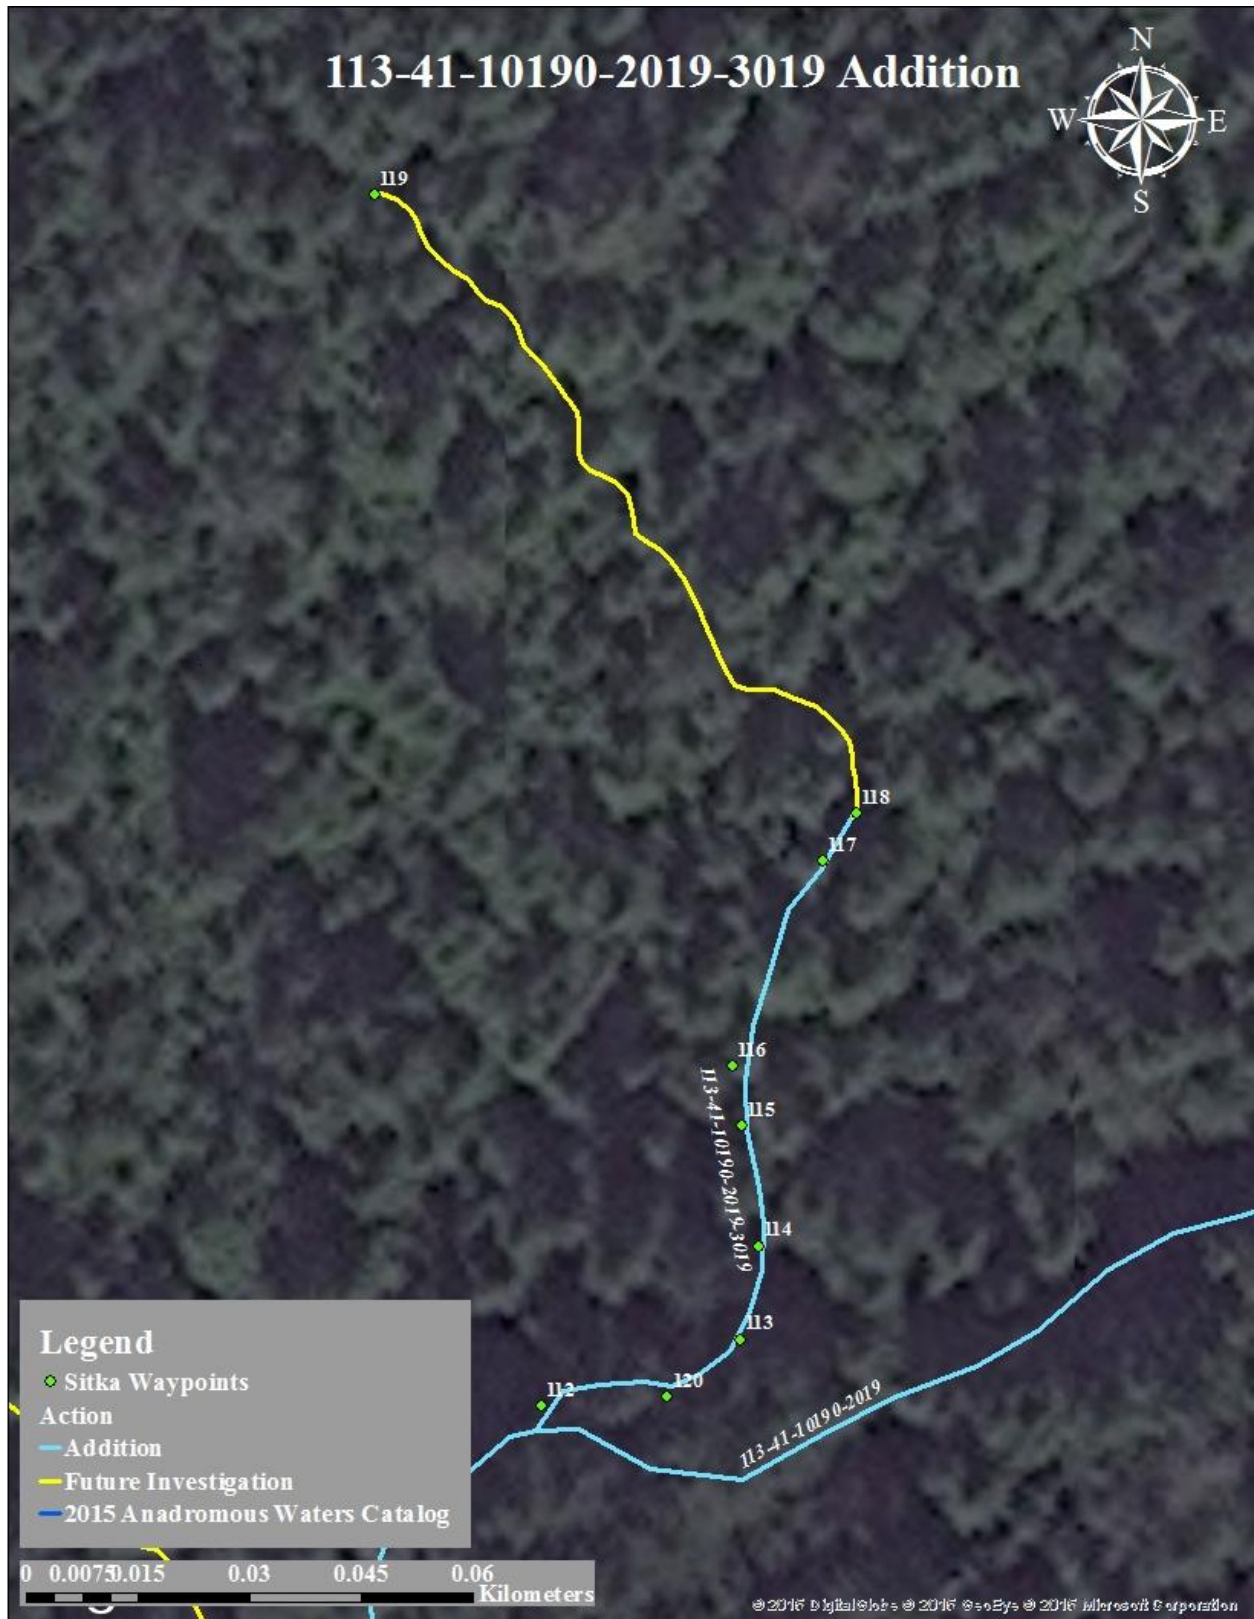
Figure 1.—113-41-10190-2019-3019 addition map.

113-41-10190-2019-3019**ADDITION****Water body name:****Survey date:** 6/21/2012**Water body number:** 113-41-10190-2019-3019**Species & Lifestage:** CO**Watershed:** Eastern Channel-Frontal Sitka Sound**MTR:** C055S064E **Quad:** Sitka A-4**Findings:** We surveyed this tributary using a backpack electrofisher and GPS (Table 1). This small stream provides excellent coho salmon rearing habitat.**Recommendations:** Adding this stream course to the AWC (Figure 1).**Nomination:** 12-520
