# Pink Salmon Use of the Tye Lake Hydro Tailrace

***TECHNICAL REPORT NO. 17-01***

**PINK SALMON USE OF THE TYEE LAKE HYDRO TAILRACE**

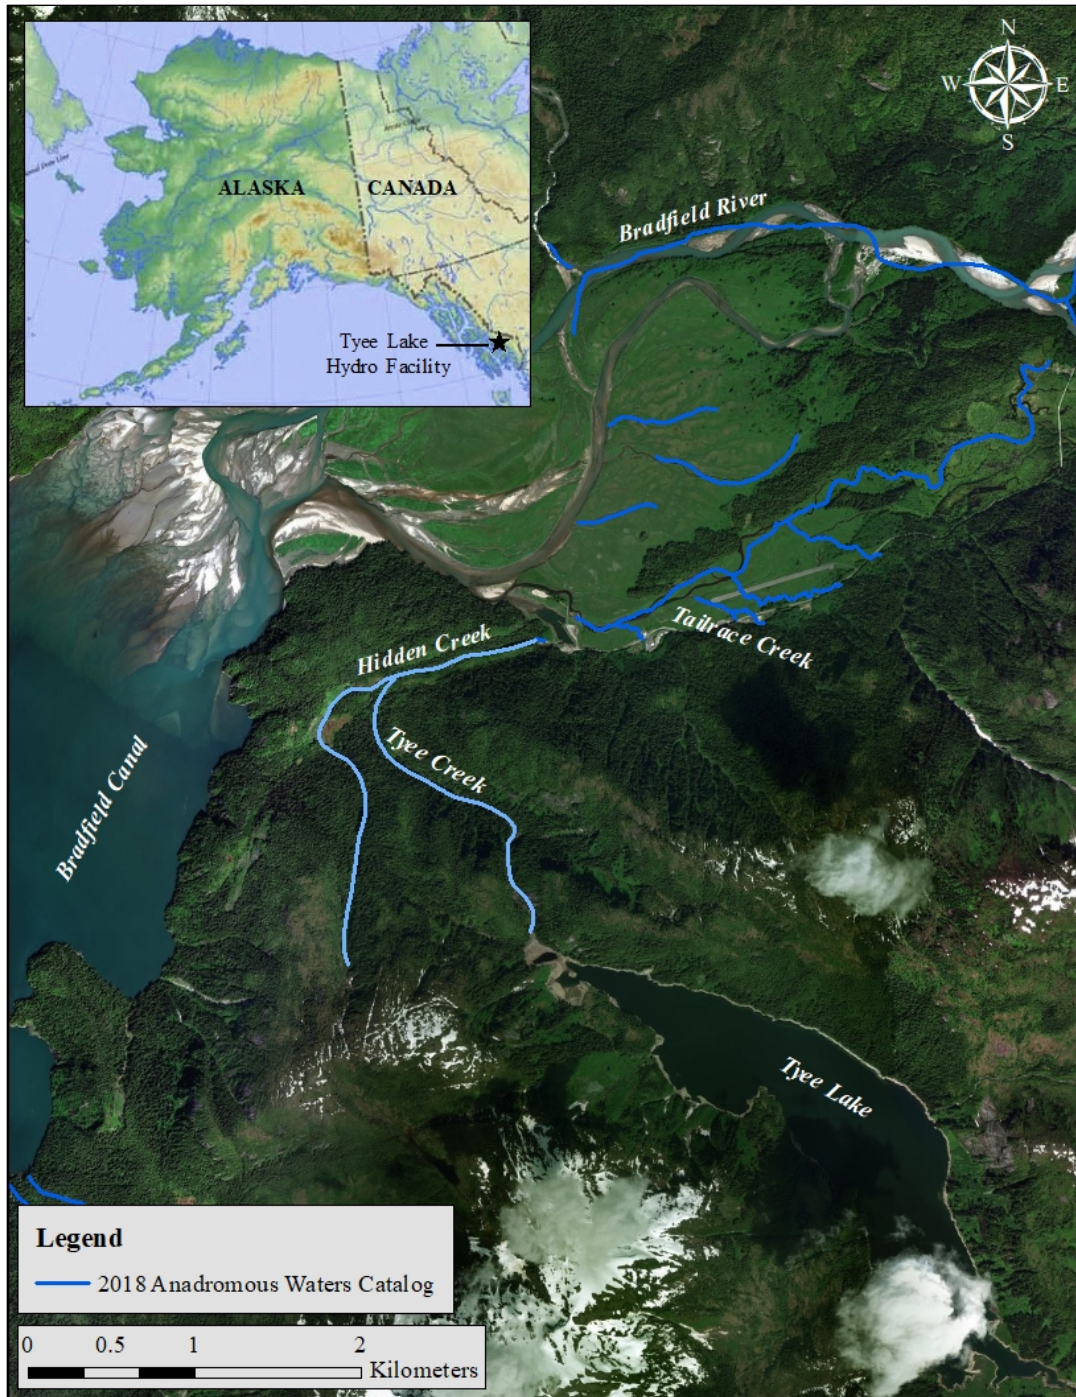
Figure 1.–Tye Lake hydroelectric facility map.

The Tye Lake hydroelectric facility is located at the head of Bradfield Canal in the Tongass National Forest, about 63 km southeast of Wrangell and 33 km west of the U.S./Canada border by air (Figure 1).

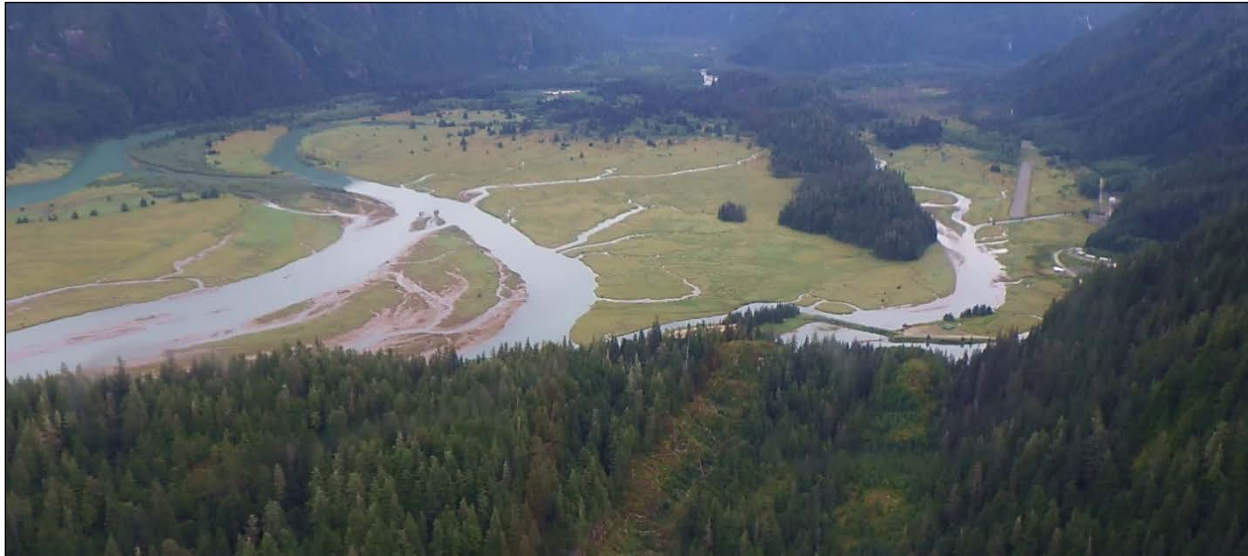
Figure 2.—Bradfield River (left) and Tyee Lake hydroelectric facilities (right).

The facility generates power by withdrawing water through a lake-tap at about 375 m elevation<sup>c</sup> and transporting the water through a drop shaft, a 2,500 m power tunnel, and a 400 m penstock to a powerhouse (FERC 1981) equipped with two turbines near tidewater on the south side of the Bradfield River delta (Figure 2). The turbines discharge water into a 350 m tailrace designed as an experimental salmon spawning channel known as Tailrace Creek. Between 1984 and 2010, the facility provided power to Petersburg and Wrangell and generally produced less than 10 MW of power. Since completing construction of the Swan–Tyee transmission line intertie in 2010 to provide hydroelectric power to Ketchikan, the facility now operates up to the design capacity of 25 MW.<sup>d</sup>

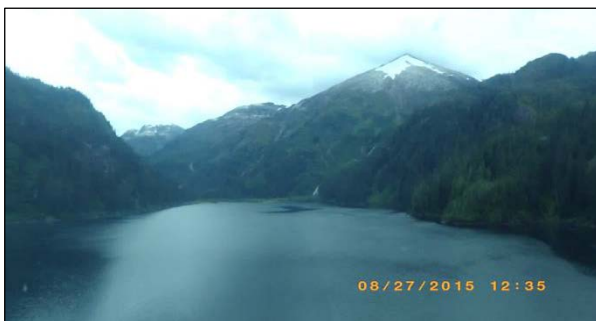
Figure 3.—Tyee Lake, looking upstream.

Tyee Lake is southeast of Wrangell near the head of the Bradfield Canal at 425 m elevation in subalpine terrain (Figure 3). The 434 acre lake measures about 4 km long, less than 0.6 km wide, 100 m deep, and is surrounded to the east and west by steep rock cliffs that rise to 1,500 m peaks (Dwight 1980). The main inlet creek drains into the lake from the southeast, and the outlet drains to the northwest. The Tyee Lake drainage area is about 37 km<sup>2</sup> and mean annual precipitation is about 406 cm (Dwight 1980).

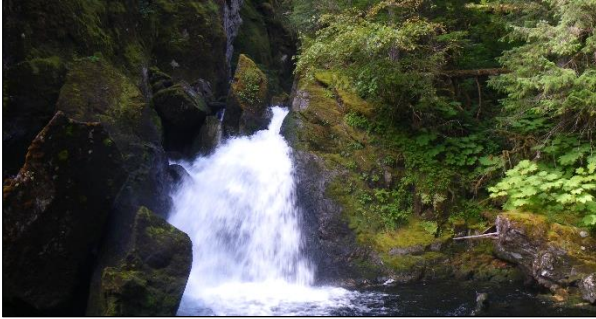
Figure 5.–Hidden Creek waterfall.

Tyee Creek, the Tyee Lake outlet stream, begins on the northwest side of the lake at 425 m elevation, flows for about 1.7 km through a series of cascades and waterfalls, joins Hidden Creek<sup>i</sup> at about 30 m elevation, below which Hidden Creek flows northeast for about 1 km and into Bradfield Canal. About 140 m upstream of the mouth near the extent of tidal influence, a 5.5 m waterfall prevents upstream fish passage (Figures 5–8).<sup>j</sup>

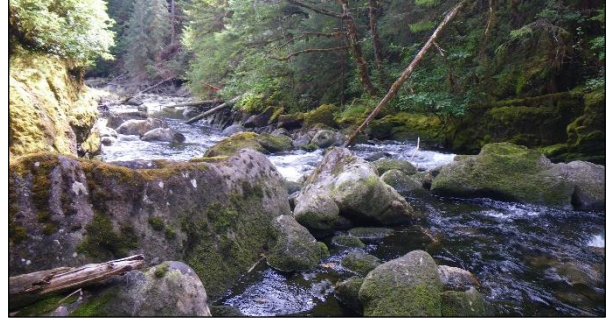
Figure 6.–Hidden Creek at low tide, downstream view from the waterfall.

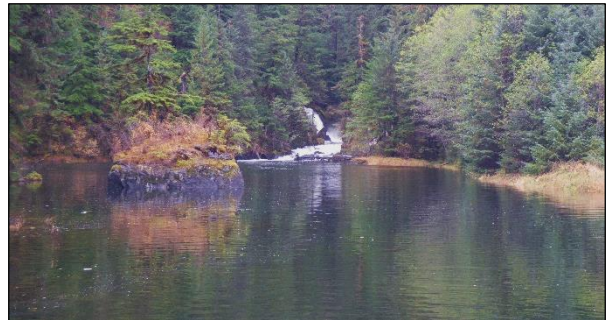
Figure 8.–Hidden Creek at mid-tide, upstream view of the waterfall.

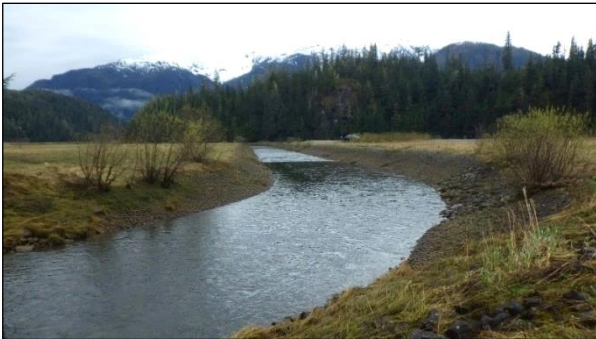
Figure 9.–Tailrace Creek at -1.5 ft tide, downstream view from the powerhouse.

Tailrace Creek<sup>o</sup> begins at the hydroelectric powerhouse and flows through about 350 m of tidal wetlands into Hydro Creek<sup>p</sup> (Figures 9, 10). After Tailrace Creek construction, biologists captured juvenile coho salmon, Dolly Varden char, and sculpin in Tailrace Creek and observed spawning chum and pink salmon (Kelly 1987).

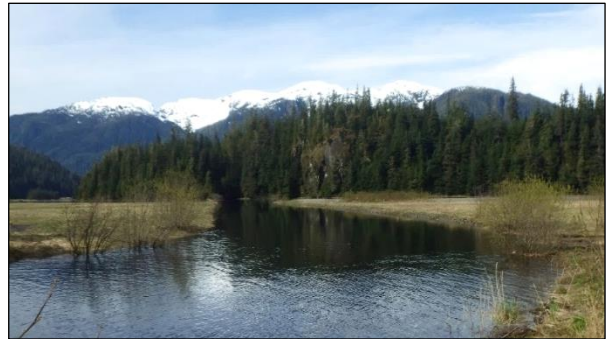
Figure 10.–Tailrace Creek at +18.5 ft tide, downstream view from the powerhouse.

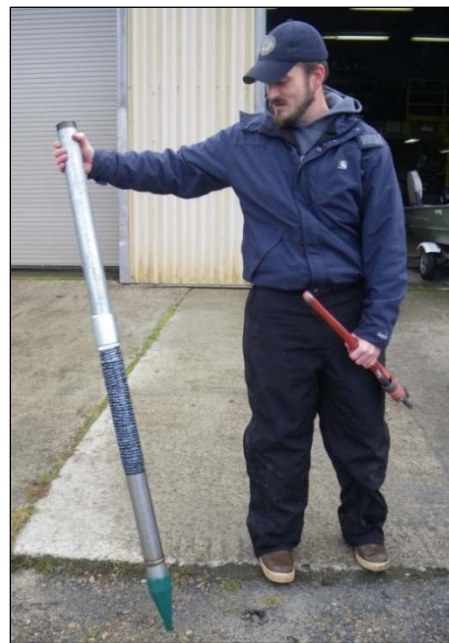
Figure 12.—Well point housing for the intragravel water quality data logger.

We built a housing for each data logger using 5 cm x 1.57 m galvanized well points equipped with 60 cm of stainless steel mesh (Figure 12). We sealed the upper 33 cm of mesh with 100% silicone auto/marine sealant and PVC tape to encourage intragravel water flow in the lower 28 cm of mesh screen, the expected pink salmon redd depth (Groot and Margolis 1991). We installed both well points in the stream bed using a post pounder until the steel mesh was no longer visible. We placed rocks in the well points so the bottoms of the data loggers were level with the bottom of the open mesh, lowered the data loggers into the well points, wrapped Teflon tape around well point cap threads, capped the well points, and taped the caps with PVC tape to prevent inundation during high tide.

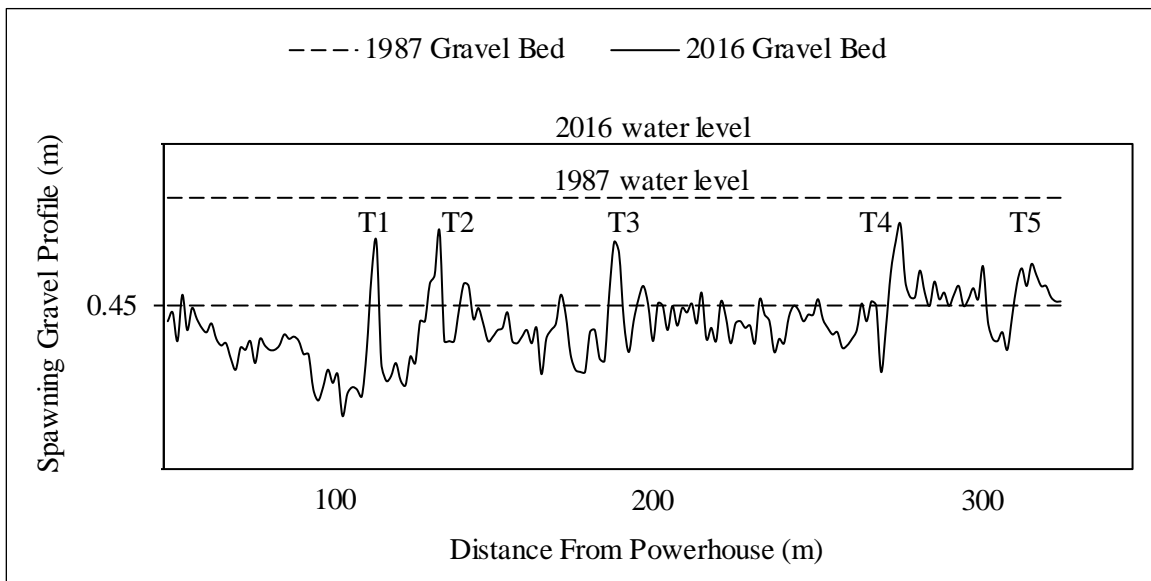
Figure 13.–Long profile of the channel measured at low tide.

During low tide,<sup>r</sup> we measured a long profile of the channel at the tailrace center<sup>s</sup> at about 0.6 m increments using a stadia rod and GPS. We measured channel bed wetted width (m) and bankfull width (m) using a measuring tape strung tightly perpendicular to the stream at each of the five transects. We measured channel bed slope (%) between the center of each transect with a clinometer.

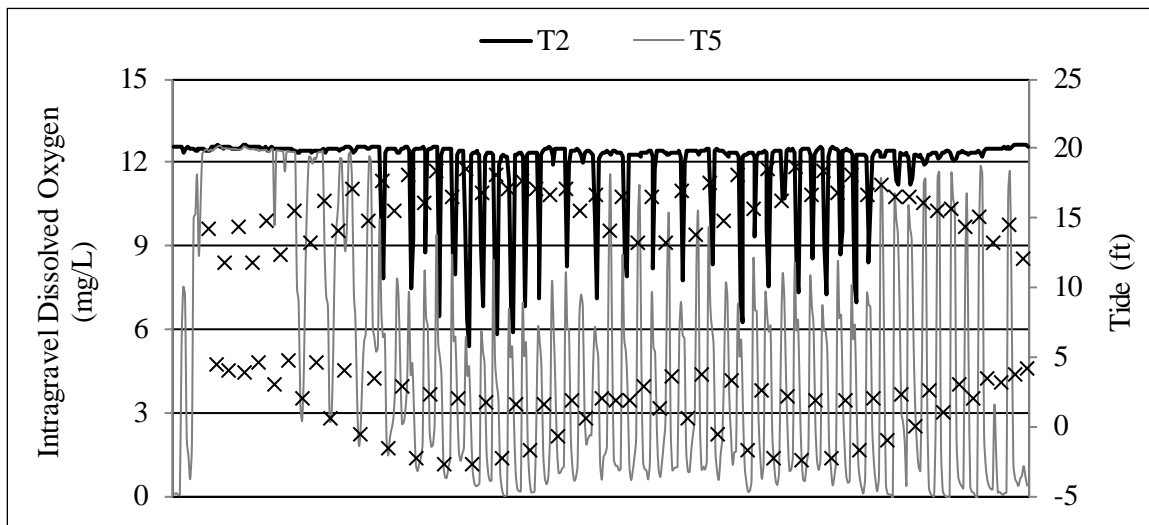
Figure 15.—Tailrace Creek intragravel dissolved oxygen and tidal stage (x) data, January 1–31, 2016.

Intragravel dissolved oxygen concentrations were suitable for pink salmon embryo and alevin development at T2 where concentrations mirrored surface water concentrations, similar to the 1980s study results (Kelly 1987); concentrations at T5 were low and may not support developing pink salmon embryos and alevins.

Tidal influence affected intragravel water quality at T5 during tides greater than about 14.5 ft, causing water temperature, dissolved oxygen and salinity concentrations to increase. During tides less than 14.5 ft, intragravel temperature mirrored the T2 data while dissolved oxygen concentration was lower, usually less than 3 mg/L.

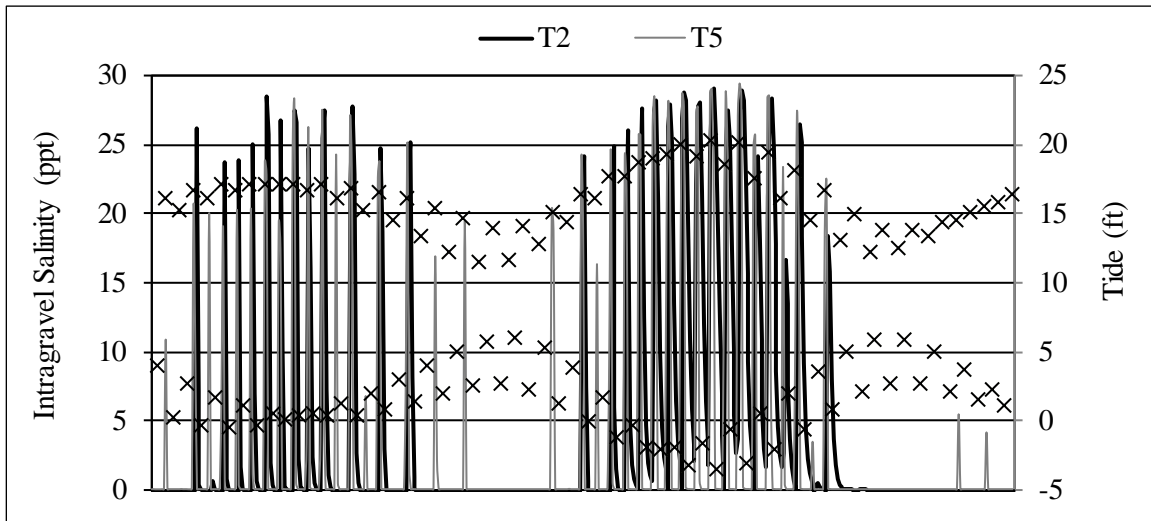
Figure 16.—Tailrace Creek intragravel salinity and tidal stage (×) data, March 1–31, 2011.

Intragravel water temperatures and salinity concentrations at T2 and T5 were within the optimal range for pink salmon embryo and alevin development (Groot and Margolis 1991, Raleigh and Nelson 1985, Reiser and Bjornn 1979, Weber Scannell 1991). Intragravel temperatures were slightly warmer than surface water during low tide and fluctuated as much as 5 °C during one tide cycle, similar to other intertidal pink salmon spawning habitat study results (Helle et al. 1964).
