Technical Report No. 17-08

# Duck Creek Realignment Monitoring, 2012-2016 Final Report

Alaska Department of Fish and Game

Division of Habitat

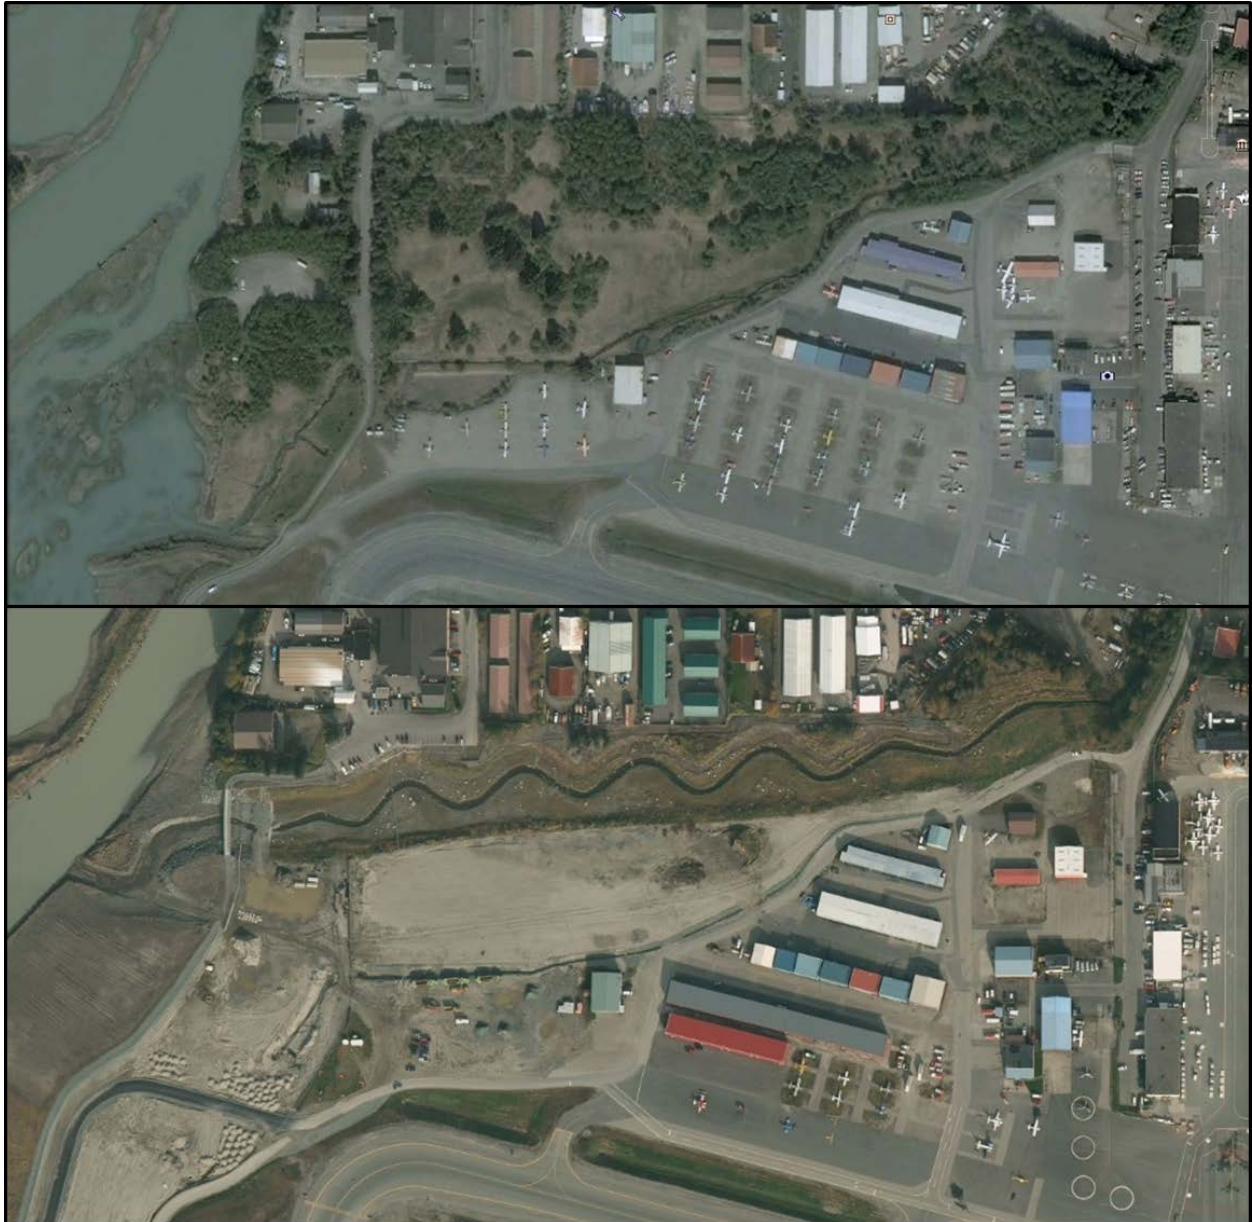
Figure 1.–Duck Creek before (top) and after (bottom) channel realignment.

In 2010, JNU realigned Duck Creek about 100 m to the north to increase airport capacity and efficiency and to reduce risks posed to aviation from wildlife (Figure 1).

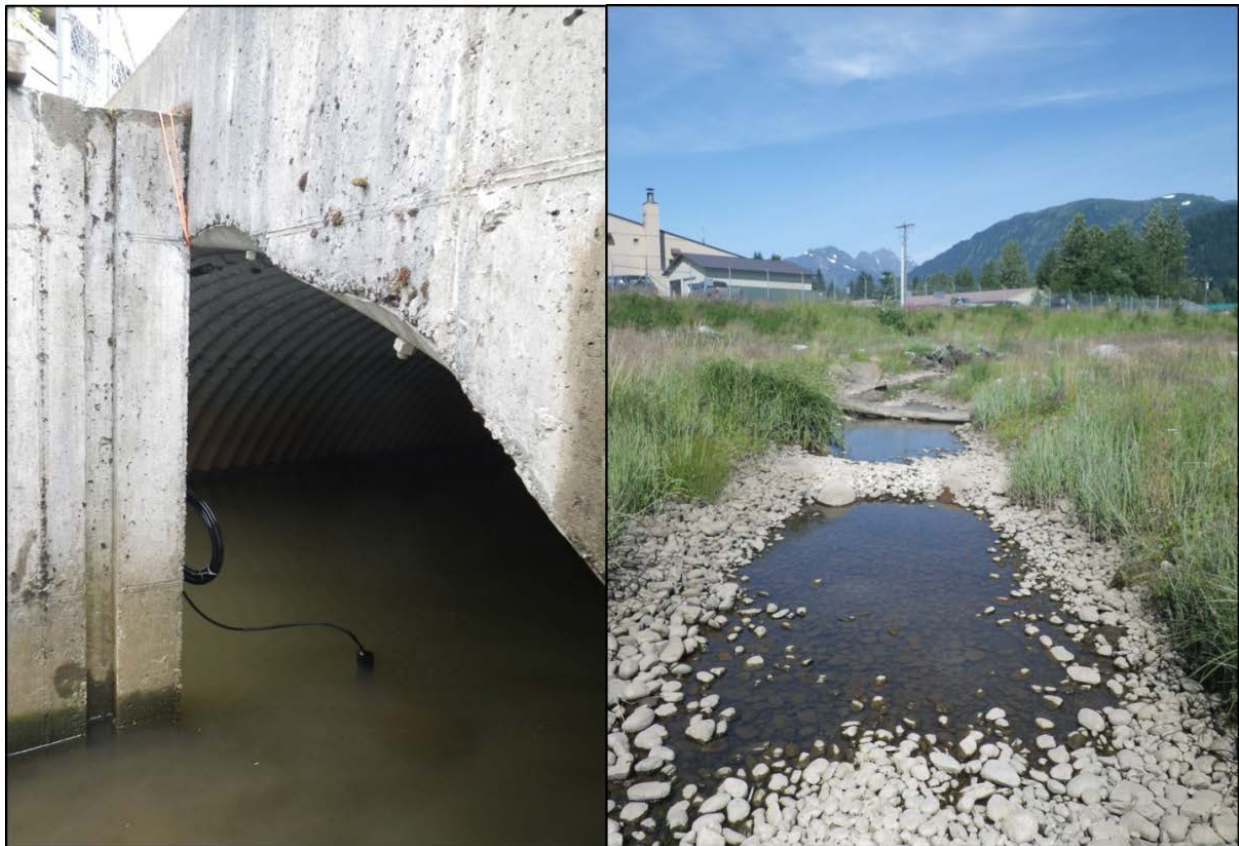
Figure 6.—Water quality sonde (left) and discontinuous flow in the realignment (right).

We mounted a *YSI 600LS* water quality sonde on a rebar stake driven into the streambed under the Cessna Drive Culvert to record hourly water temperature and depth measurements during the ice free season each year. We used a framing level and tape measure to check sonde height against a benchmark on a nearby concrete wall and calibrated stage data among years. We noted the time and date when discontinuous flow impeded fish passage in the realignment and correlated these events with sonde depth measurements to better understand how often low flow limits fish movement (Figure 6). We present graphed water level and temperature data along with the annual proportion of the recording period when fish passage was obstructed by low flow in a table.

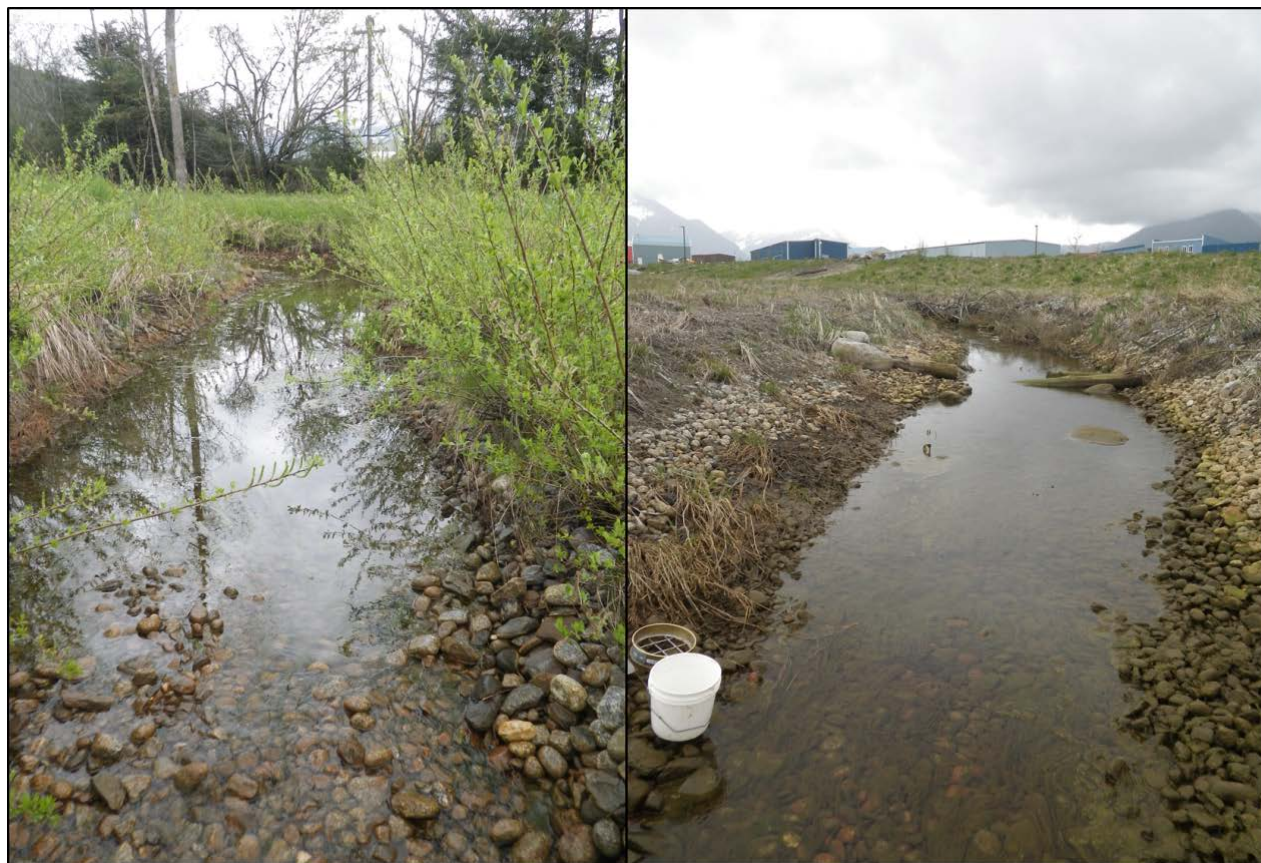
Figure 7.—Spawning substrate sampling sites 1 (left) and 2 (right).

We measured spawning substrate size annually to assess spawning habitat quality and changes at two sites over time. Site 1 is located at the top of the realignment above the influence of tides less than 19.5 ft and site 2 is about 300 m downstream and is inundated with a mixture of brackish sea water and fresh water from the Mendenhall River at tides greater than 18 ft (Figures 2, 7). We used a McNeil sampler to take three replicate samples from sites directly downstream of pool tails in the thalweg of riffles where the water begins to accelerate (Valentine 1995). We worked the McNeil sampler into the substrate and excavated substrate in the basal core (15 cm

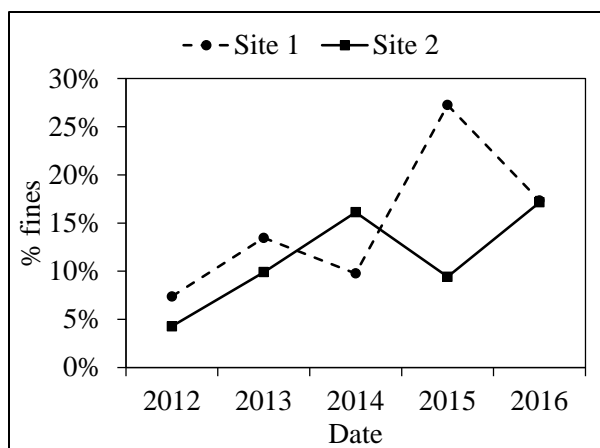
Figure 10.–Sites 1 and 2 mean percent fines, 2012–2016.

Mean values from three replicates sampled at Sites 1 and 2 showed trends of increasing percent fines (<2.36 mm) and decreasing mean particle diameter (Table 3; Figures 10, 11). We observed spawning substrate in the realignment lacked medium, fine, and very fine gravel size classes (2–18 mm diameter). Based on visual observations, substrate downstream of the security fence, which was not from the same source as upstream, appeared to contain all size classes and was imbedded in fine sediments about 5 cm below the surface making it difficult to excavate.

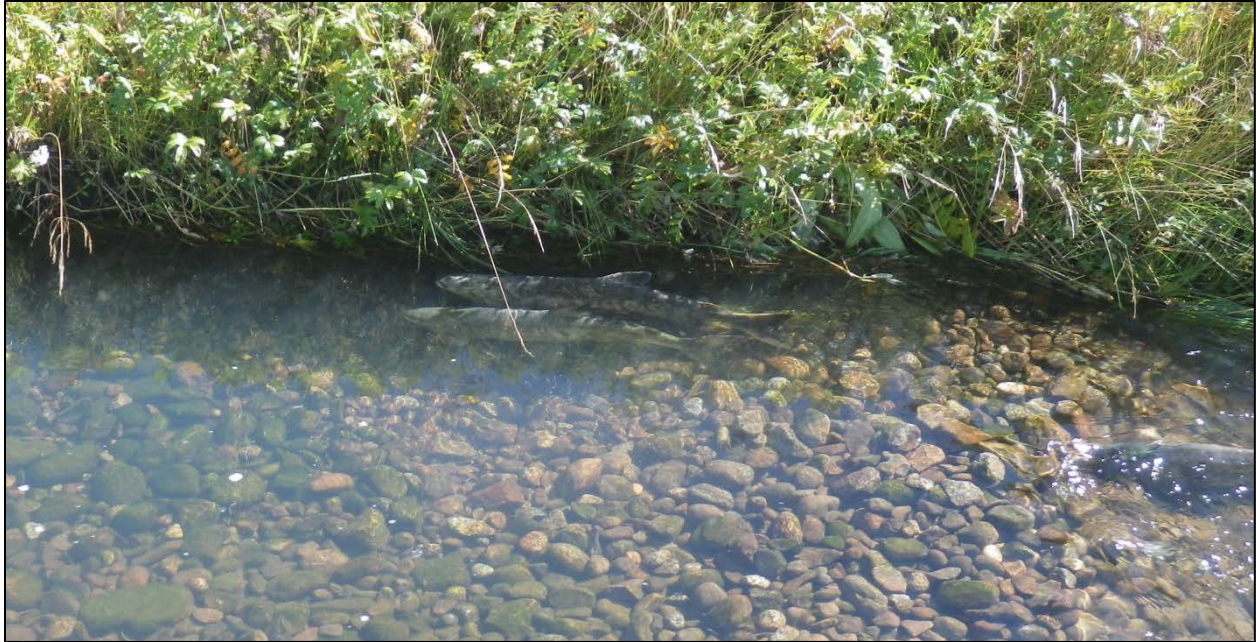
Figure 16.—Adult chum salmon constructing a redd, August 13, 2015.

We recorded live and dead adult chum and pink salmon in Duck Creek during weekly spawning surveys between July 15 and September 19, annually (Table 5). We observed redd construction by spawning pairs, adult fish trapped in pools during dry conditions, and loose eggs littering the creek bottom from pre-spawn mortalities (Figures 16, 17). Checks of fresh chum carcasses in 2013 and 2015 showed 21/24 and 19/32 fish died before spawning. Pink salmon observations were highest in 2015 with several hundred animals observed compared to all other years where counts ranged from 0–13.

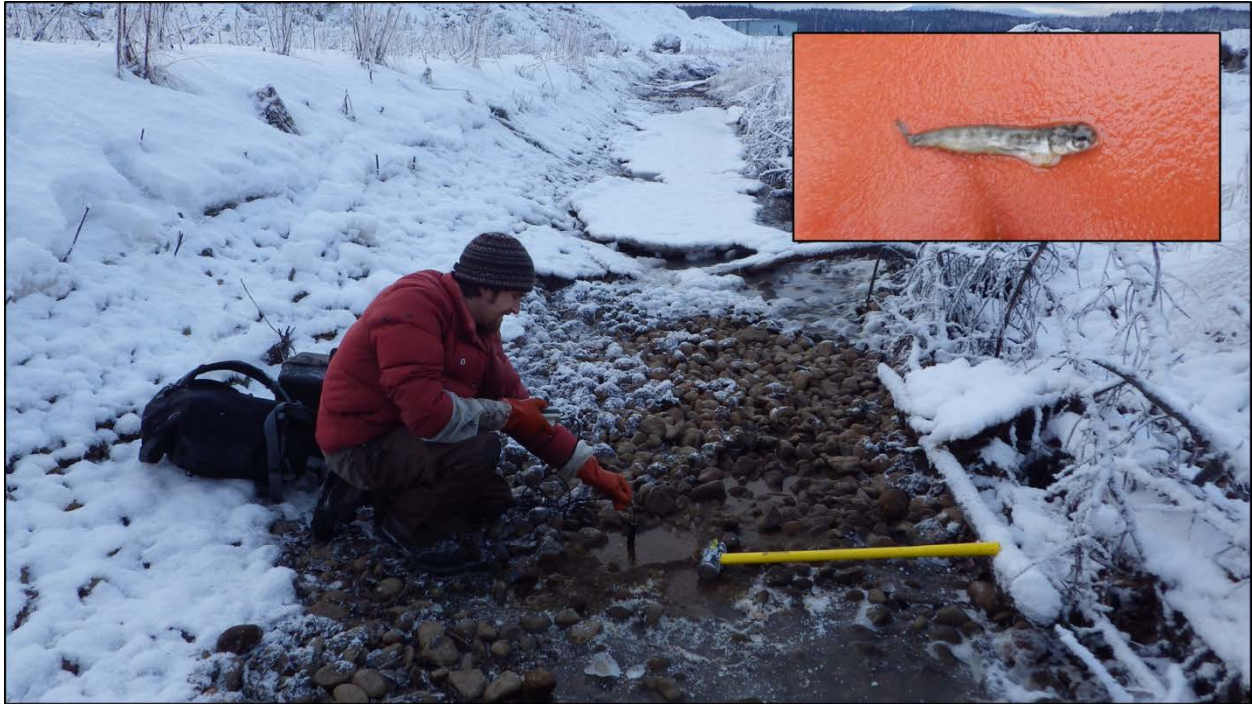
Figure 18.—Redd excavation and dead chum fry (inset), December 18, 2012.

In November and December of 2012, 2013, and 2014, we sampled stream gravel throughout the realignment to assess egg viability (Figure 18; Table 6). In each year we found only dead and degraded salmon eggs and alevins. Ice was present during the surveys with some areas of the stream frozen solid into the gravel and others retaining stagnant water. We recorded DO values in stagnant water and found them generally increasing with movement downstream where tidal influence is more regular and ice cover was reduced (Table 6). Below the security fence, where

the bentonite liner is not present, the channel was consistently dry until water seeping from the Mendenhall River entered the stream 60 m from the mouth of Duck Creek.

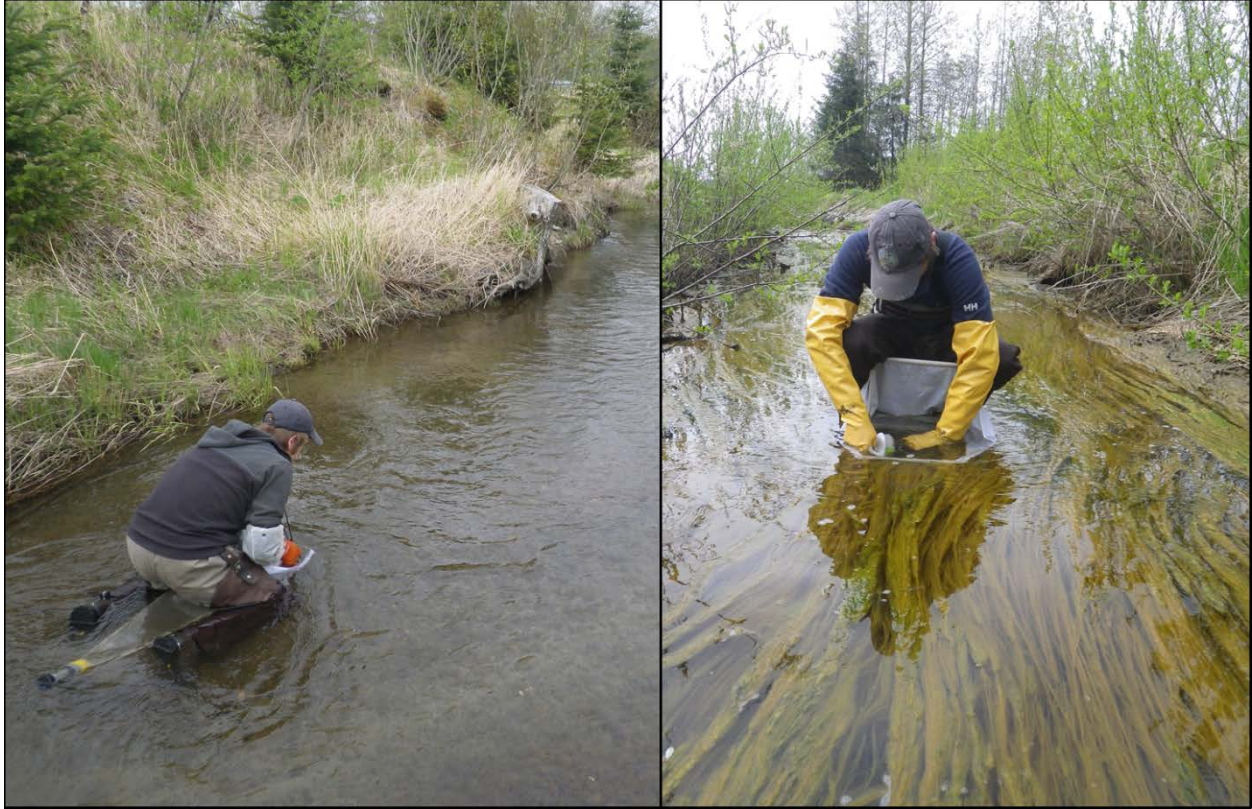
Figure 20.–Jordan Creek (left) and Duck Creek (right) benthic macroinvertebrate sampling sites.

We generally did not find environmentally sensitive EPT taxa in Duck Creek samples (0.0% EPT; Table 7; Figure 19; Appendix C). Pollution tolerant taxa, such as chironomids and annelids, were abundant. Shannon Diversity and Evenness, and % EPT values were consistently higher in Jordan Creek than Duck Creek (Table 7). We observed 25 taxonomic groups across all 5 years of Duck Creek sampling, including 2 EPT taxa. We observed 26 taxonomic groups across all 5 years of Jordan Creek sampling, including 10 EPT taxa (Appendix C). Invertebrates per m<sup>2</sup> ranged from 2,588–9,391 in Duck Creek and 1,495–9,133 in Jordan Creek across all years. The Jordan Creek site is 3 ft lower in elevation than the Duck Creek site, though field observations indicate tidal influence at the two sites produces similar salinity conditions (maximum recorded 0.4 ppt at both sites; Figure 20).

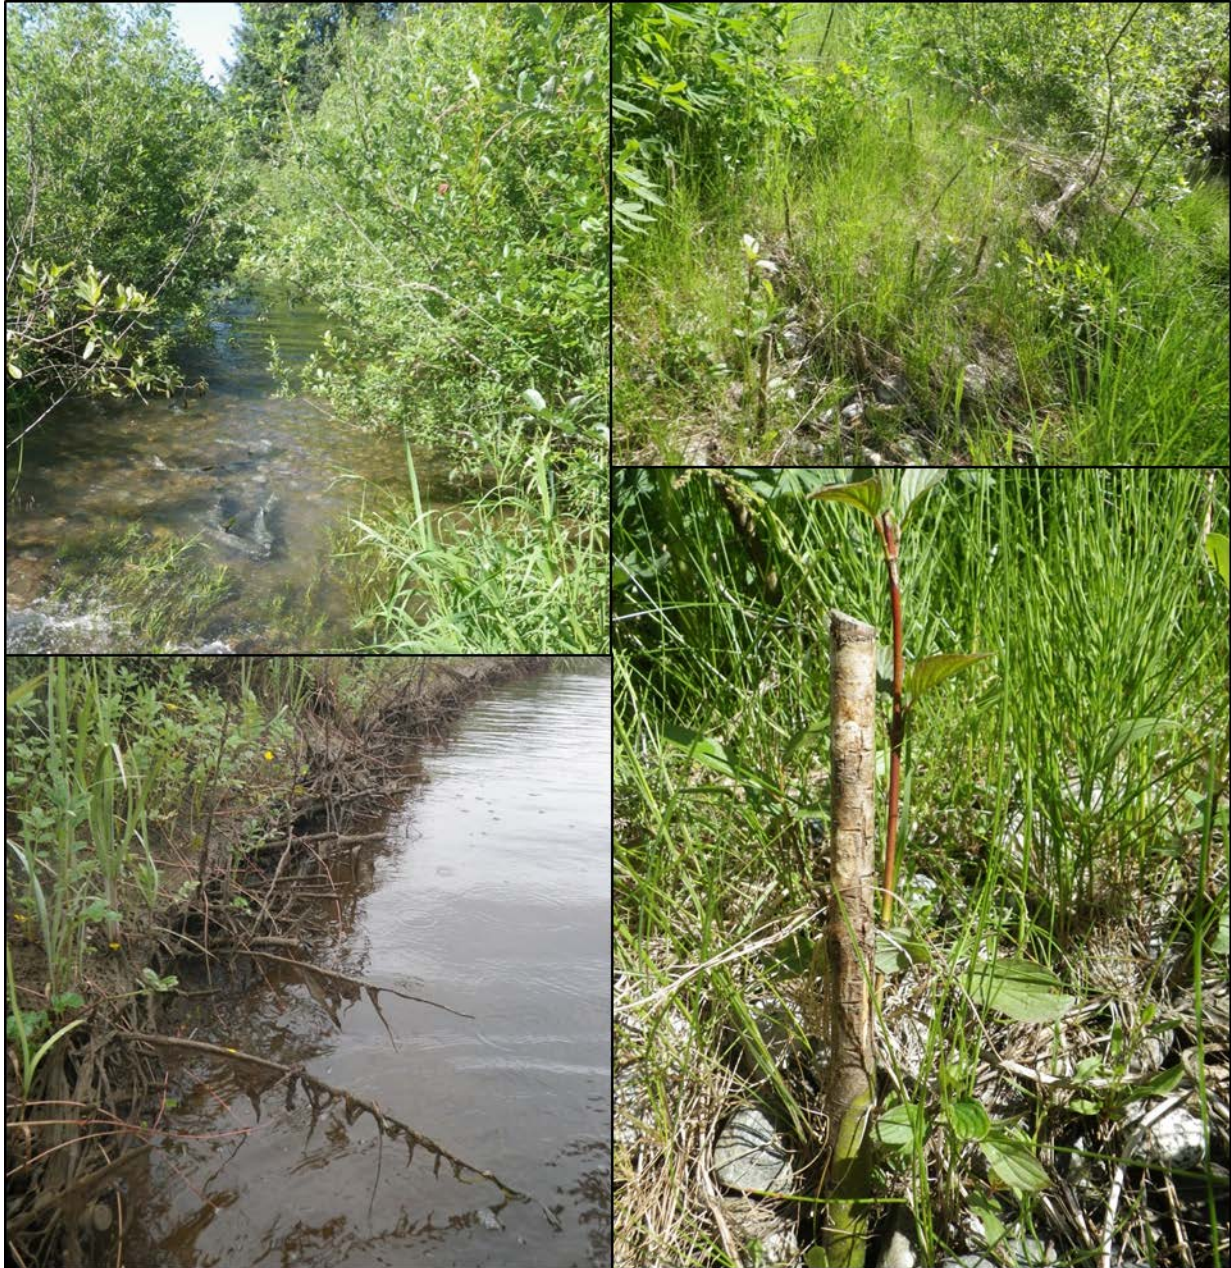
Figure 21.—Successful (top left, lower right), and unsuccessful (top right, bottom left) willow plantings.

We observed seeding, willow staking, and bank treatments in Duck Creek produced mixed results for vegetative growth. Willow plantings upstream of photo point six grew well and have matured to form a canopy cover over the channel upstream of photo point two (Figure 21). Some willows that were not watered following planting<sup>i</sup> failed to regenerate and willow stakes downstream of photo point six failed to grow due to tidal flooding (Figure 21).

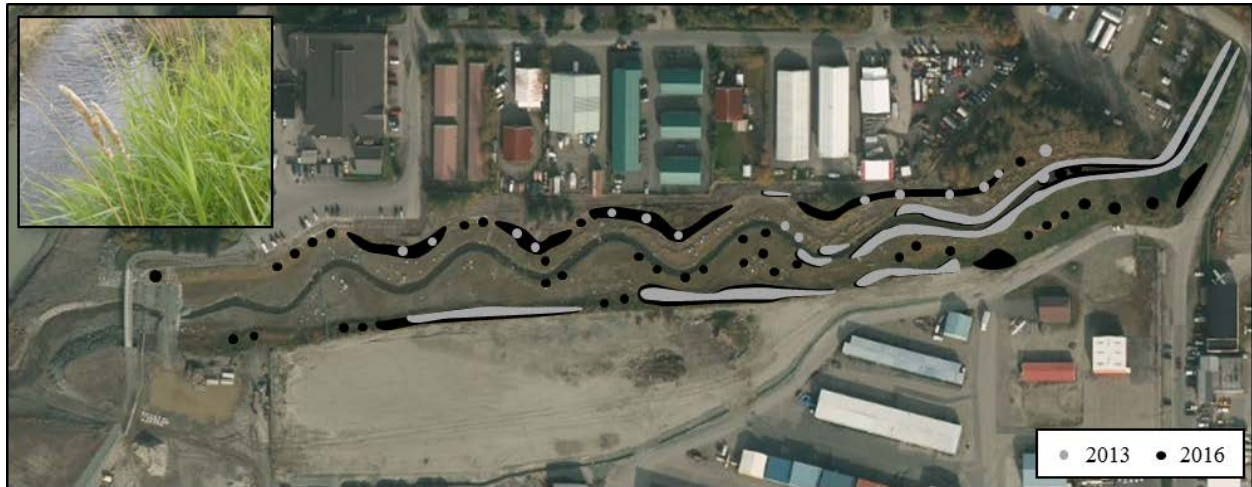
Figure 22.—Reed canary grass (inset) expansion map.

The hydroseed mix used above photo point eight has flourished with native species including bluejoint reedgrass *Calamagrostis canadensis* and lupine *Lupinus arcticus*. The invasive orange hawkweed *Hieracium aurantiacum* and reed canary grass, both present upstream, have established in the realignment. Reed canary grass has expanded its coverage through the realignment each year (Figure 22).

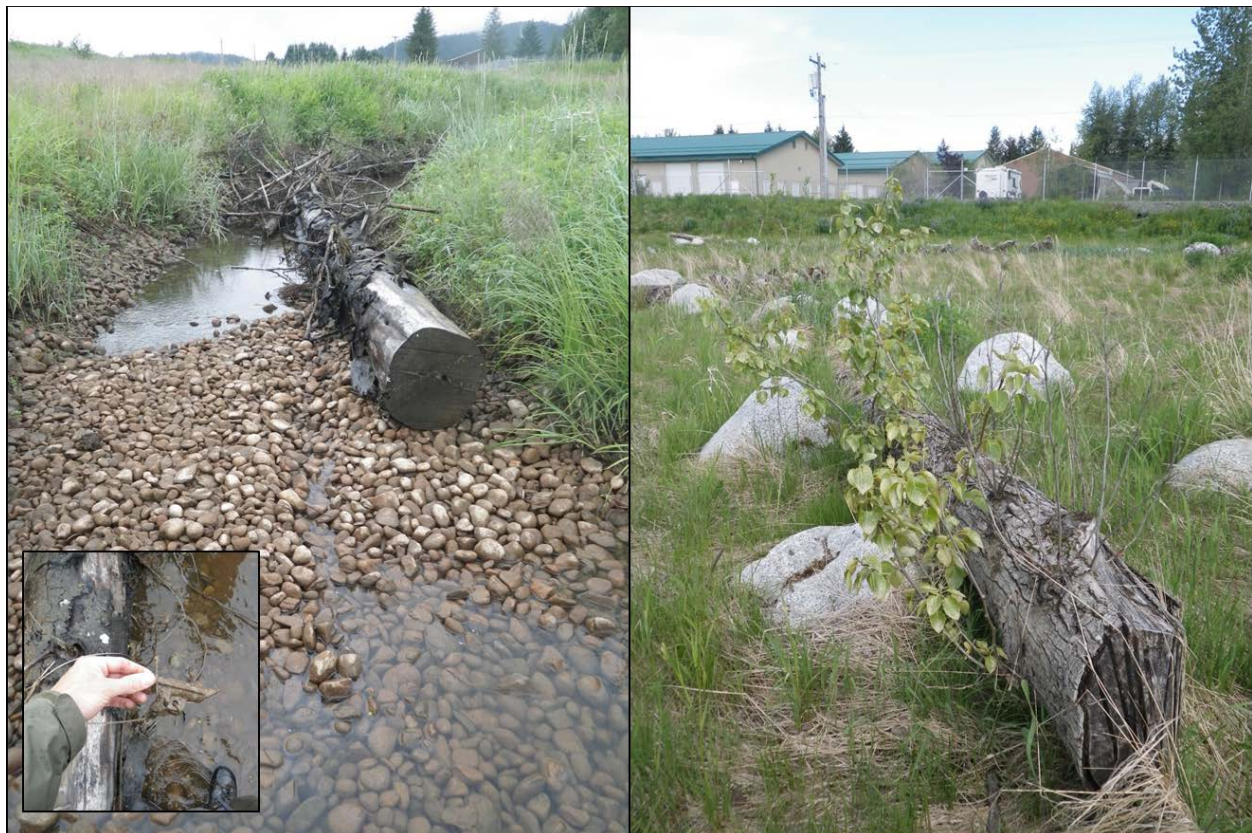
Figure 23.—Spruce tree anchor (inset) failure (left) and floodplain cottonwood (right).

The cabled spruce visible at photo point 6A broke loose during February, 2013, when heavy icing and 19 ft tides occurred, but remains in the area providing habitat function (Figure 23). The cross log weir at minnow trap site two was lifted out of place following similar events and remains at the high tide line on the floodplain. The cabled spruce trees lost their needles within a few months of placement, but retained limbs (Photo points 5, 8, 9 in Appendix C). Cottonwood trees placed in the floodplain have generated new growth (Figure 23).
