Technical Report No. 18-08

Hoonah Airport Mitigation Monitoring, 2013–2018 Final Report

TECHNICAL REPORT NO. 18-08

**HOONAH AIRPORT MITIGATION MONITORING, 2013–2018
FINAL REPORT**

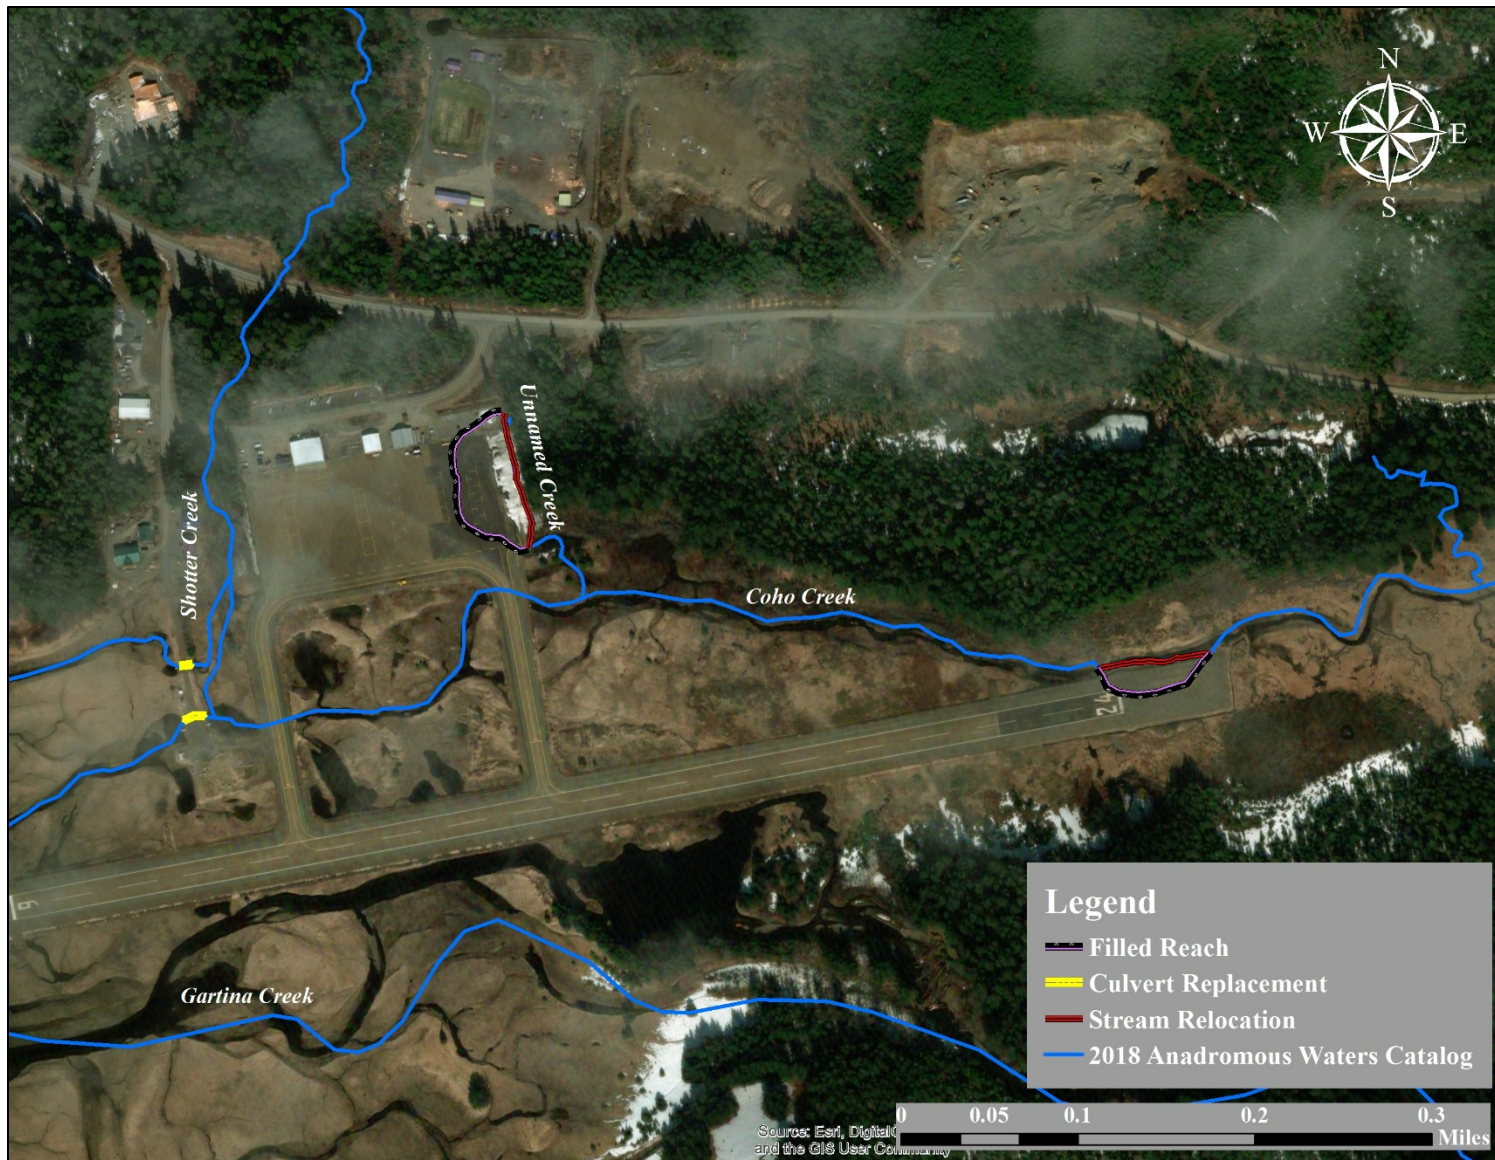
Figure 1.-Hoonah Airport.

In 2012 and 2013, the ADOT&PF completed the following projects to mitigate the unavoidable loss of 2.21 acres of wetlands and 1,132 linear ft of stream from construction (Figure 1; ADOT&PF 2012):

- Installed a 120-inch culvert in Coho Creek;
- Replaced a perched 48-inch culvert with a new a 60-inch culvert in Shotter Creek;
- Constructed 450 linear ft of new stream channel in Coho Creek; and
- Constructed 500 linear ft of new stream channel with alcoves in Unnamed Creek.

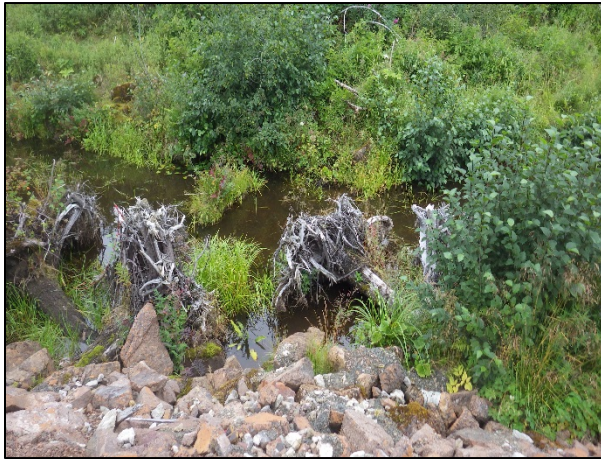
In 2013 and 2015, ADOT&PF conducted as-built surveys of the Coho Creek relocation and culvert installation and the project engineer concluded they were constructed as designed (Figures 2, 3). We used photo points and documented no observable changes to the culvert over 5 years.

Figure 2.—Root wads embedded in relocated reach of Coho Creek, July 2016.

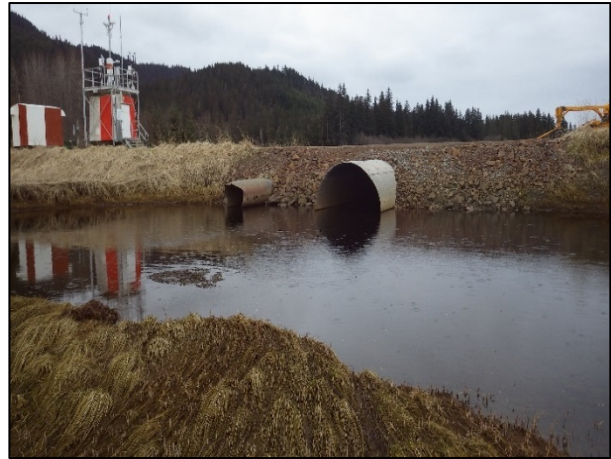
Figure 3.—Coho Creek culvert after installation, April 2015.

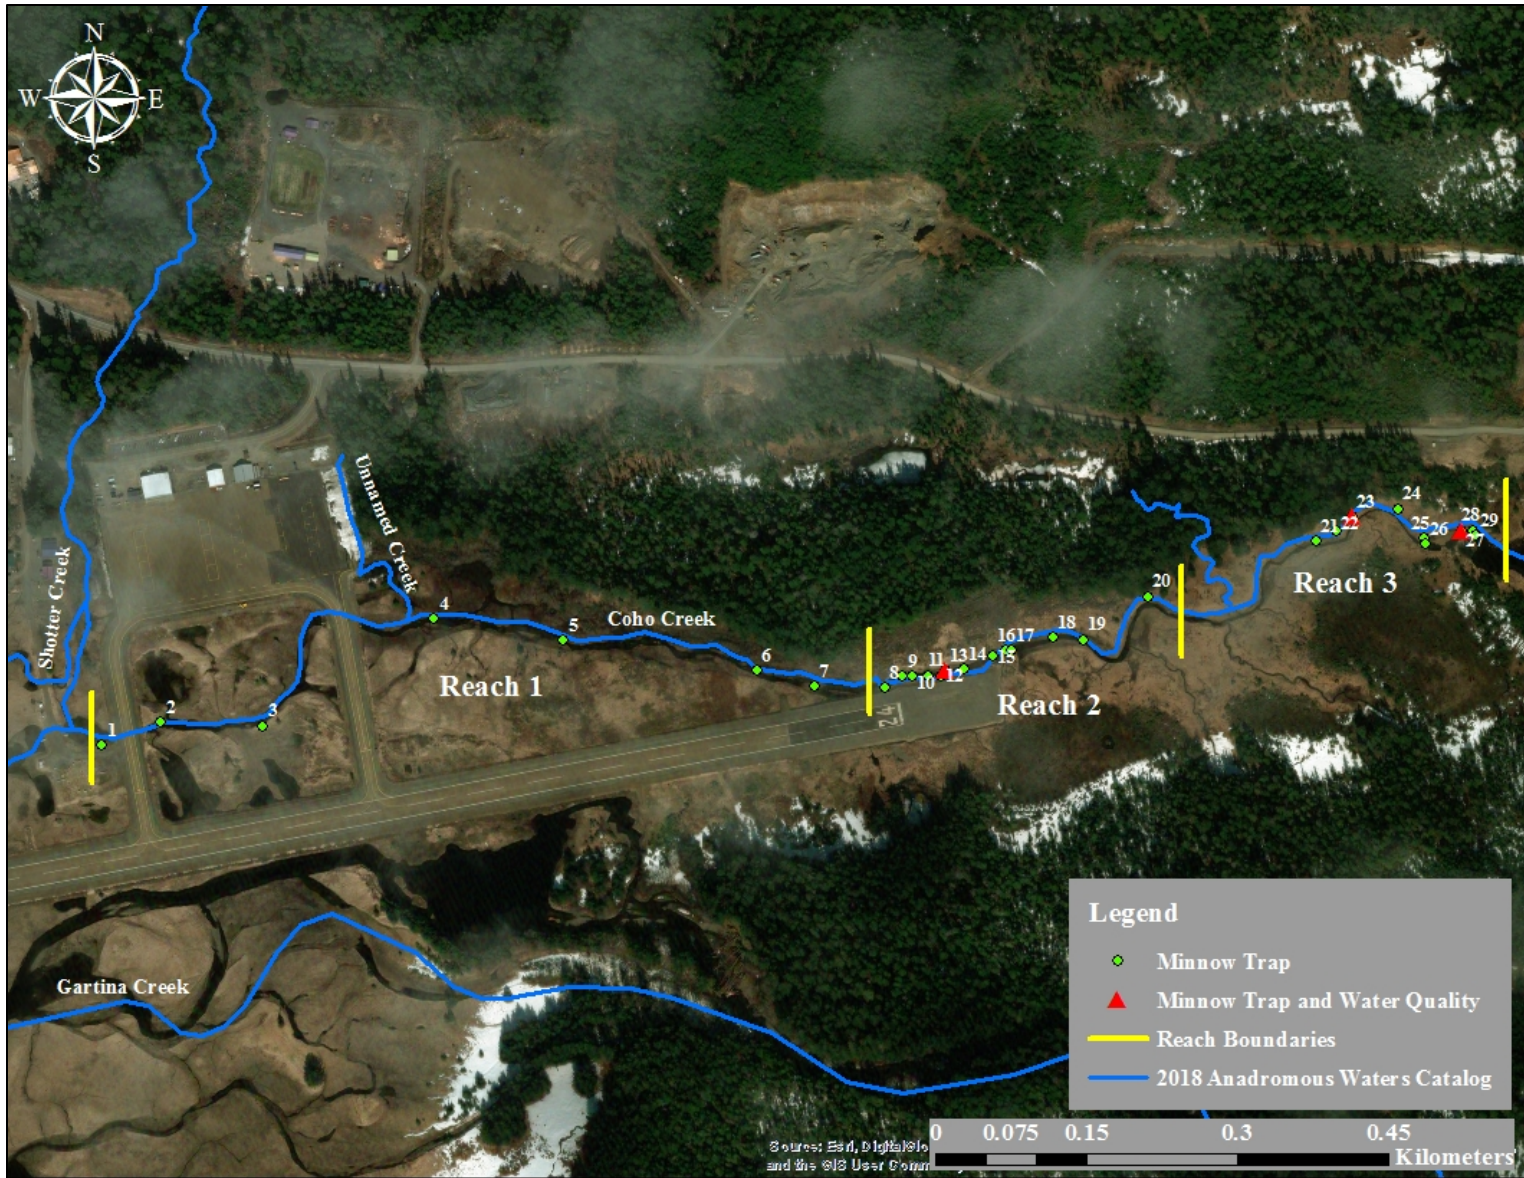
Figure 4.–Coho Creek reaches and minnow trap and water quality locations.

We established three sample reaches in Coho Creek (Figure 4):

We captured juvenile coho salmon, cutthroat trout, Dolly Varden char, sculpin, and threespine stickleback. The number of salmonids we captured varied between reach, season, and year, and were similar to pre-construction sampling results. The mean number of coho salmon captured per minnow trap was the greatest in Reach 2 and winter catches were more than summer (Figures 5, 6).

We measured water quality in Coho Creek at locations 13, 23, and 28 (Figure 4; Table 4).

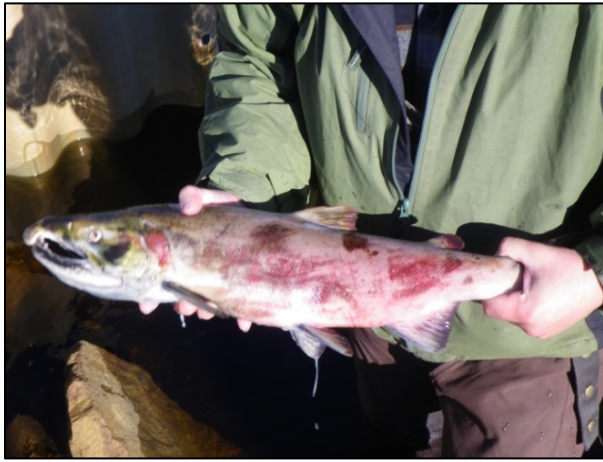
We counted adult salmon and carcasses upstream of the culvert replacement (Table 2; Figure 7). On October 1, 2014 we observed 1 coho salmon on a redd upstream of the stream relocation (Figure 8).

Figure 7.–Coho salmon carcass observed in Coho Creek, October 1, 2014.

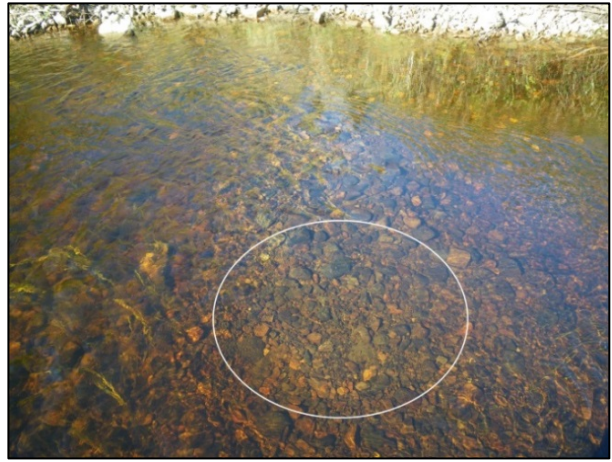
Figure 8.–Coho salmon redd in Coho Creek.

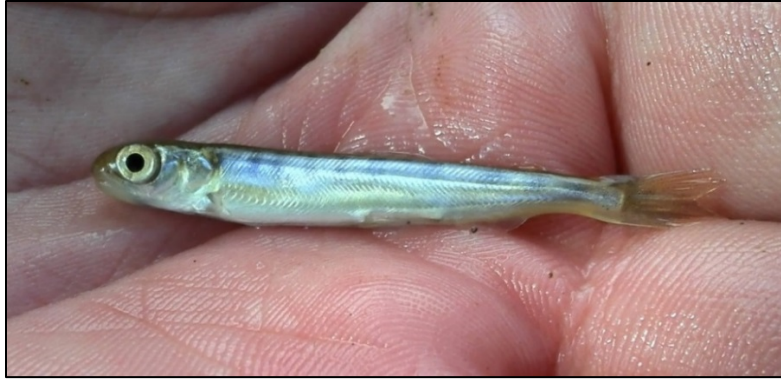
We captured juvenile coho, chum, and pink salmon, sculpin, threespine stickleback, and starry flounder with a beach seine in the estuary downstream of the culvert replacement (Table 3; Figure 9). Prior to April 2014, chum salmon fry were not documented in Coho Creek. We submitted this information and it was accepted in the Anadromous Waters Catalog (AWC).

Figure 9.–Chum salmon fry captured in Coho Creek.

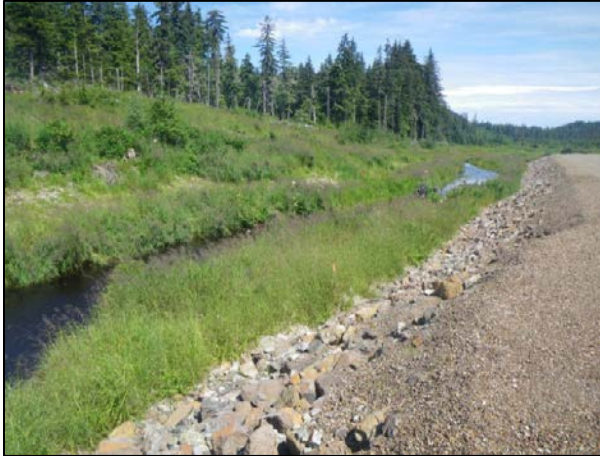
We documented that the relocated reach of Coho Creek completely revegetated with low grasses and ferns (Figures 10, 11). Since the beaver dam has been removed, the creek has reestablished a channel and the open water habitat has been replaced by palustrine-emergent and palustrine scrub-shrub wetlands (Figures 12–15).

Figure 10.—Relocated reach, July 2014.

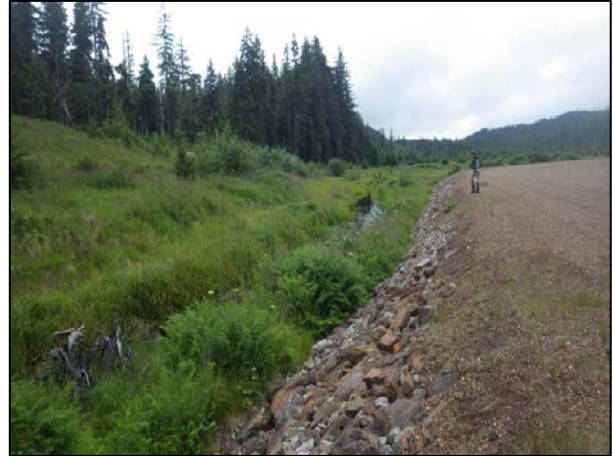
Figure 11.—Relocated reach, July 2017.

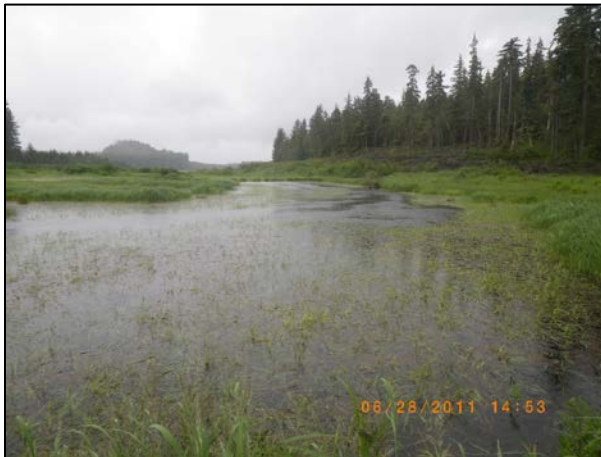
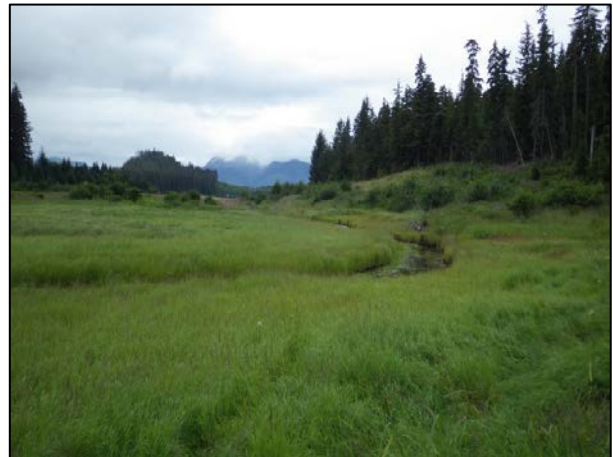
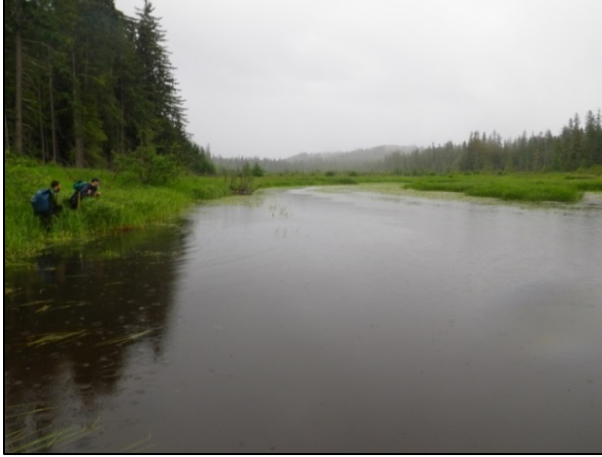
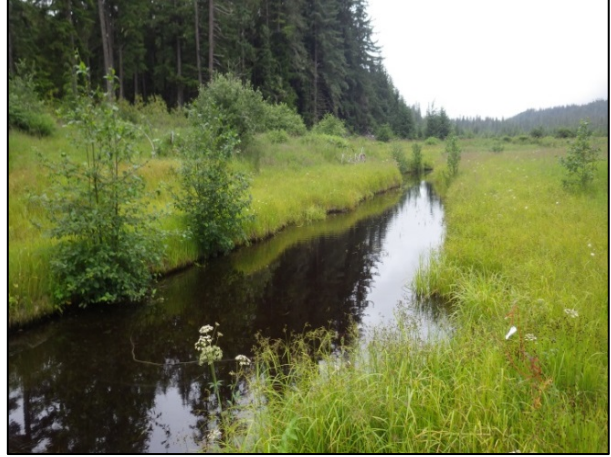
Figure 12.—Looking downstream at Coho Creek before the beaver dam removal, June 2011.

Figure 13.—Looking downstream at Coho Creek after the beaver dam removal, September 2013.

Figure 14.—Looking upstream at Coho Creek before the beaver dam removal, June 2011.

Figure 15.—Looking downstream at Coho Creek after the beaver dam removal, September 2013.

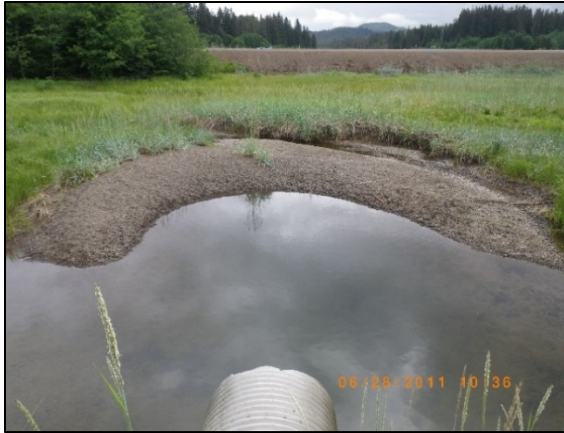
In 2013 and 2015, ADOT&PF conducted an as-built survey of the Shotter Creek culvert replacement and the project engineer concluded the culvert was installed as designed (Figures 16–19). We used photo points and documented no observable changes to the culvert over 5 years.

Figure 16.—Inlet of Shotter Creek culvert pre-construction, June 2011.

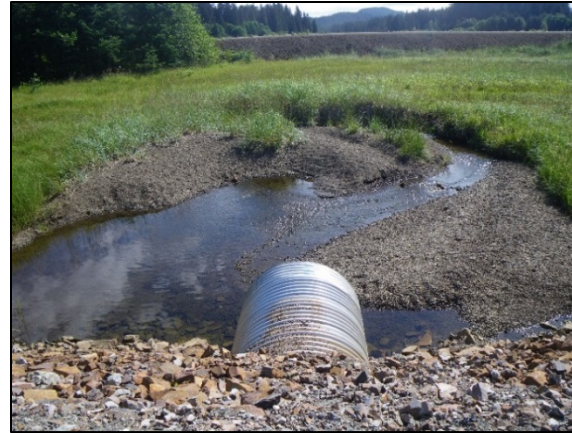
Figure 17.—Inlet of Shotter Creek culvert post-construction, July 2014.

ADOT&PF replaced the Shotter Creek culvert as specified, and it is functioning as designed. Freshwater connectivity with the intertidal zone has been restored, and while the stream continues to provide summer and overwintering habitat for salmonids, more juvenile coho salmon used Shotter Creek as overwintering habitat prior to culvert replacement. We documented adult coho and pink salmon can freely pass upstream of the structure. We also captured pink and chum salmon fry in a beach seine, suggesting pink and chum salmon adults are spawning in the intertidal reach. We added pink and chum salmon use of the water body in the AWC. Water quality at the Shotter Creek sampling station remained similar throughout the study.

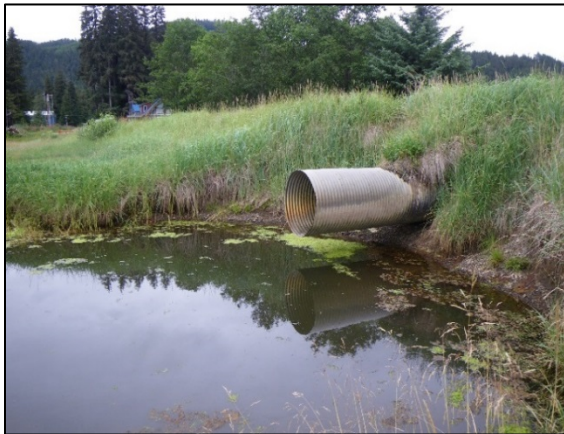
Prior to replacement, the culvert was perched and there was no freshwater connectivity with the intertidal zone except during flood stages. Over time Shotter Creek formed a channel parallel to the access road and merged with Coho Creek.

Figure 18.—Perched outlet of Shotter Creek culvert pre-construction, August 2010.

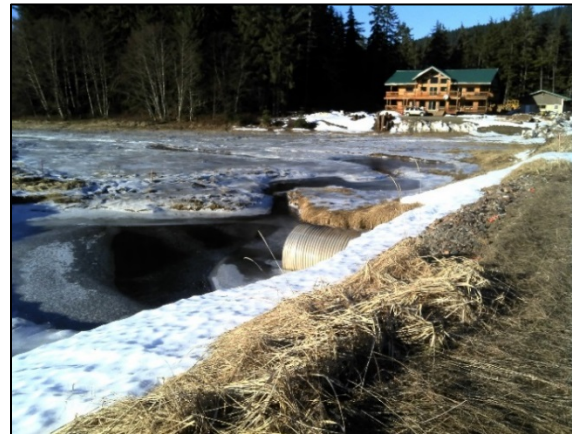
Figure 19.—Outlet of Shotter Creek culvert post-construction, February 2014.

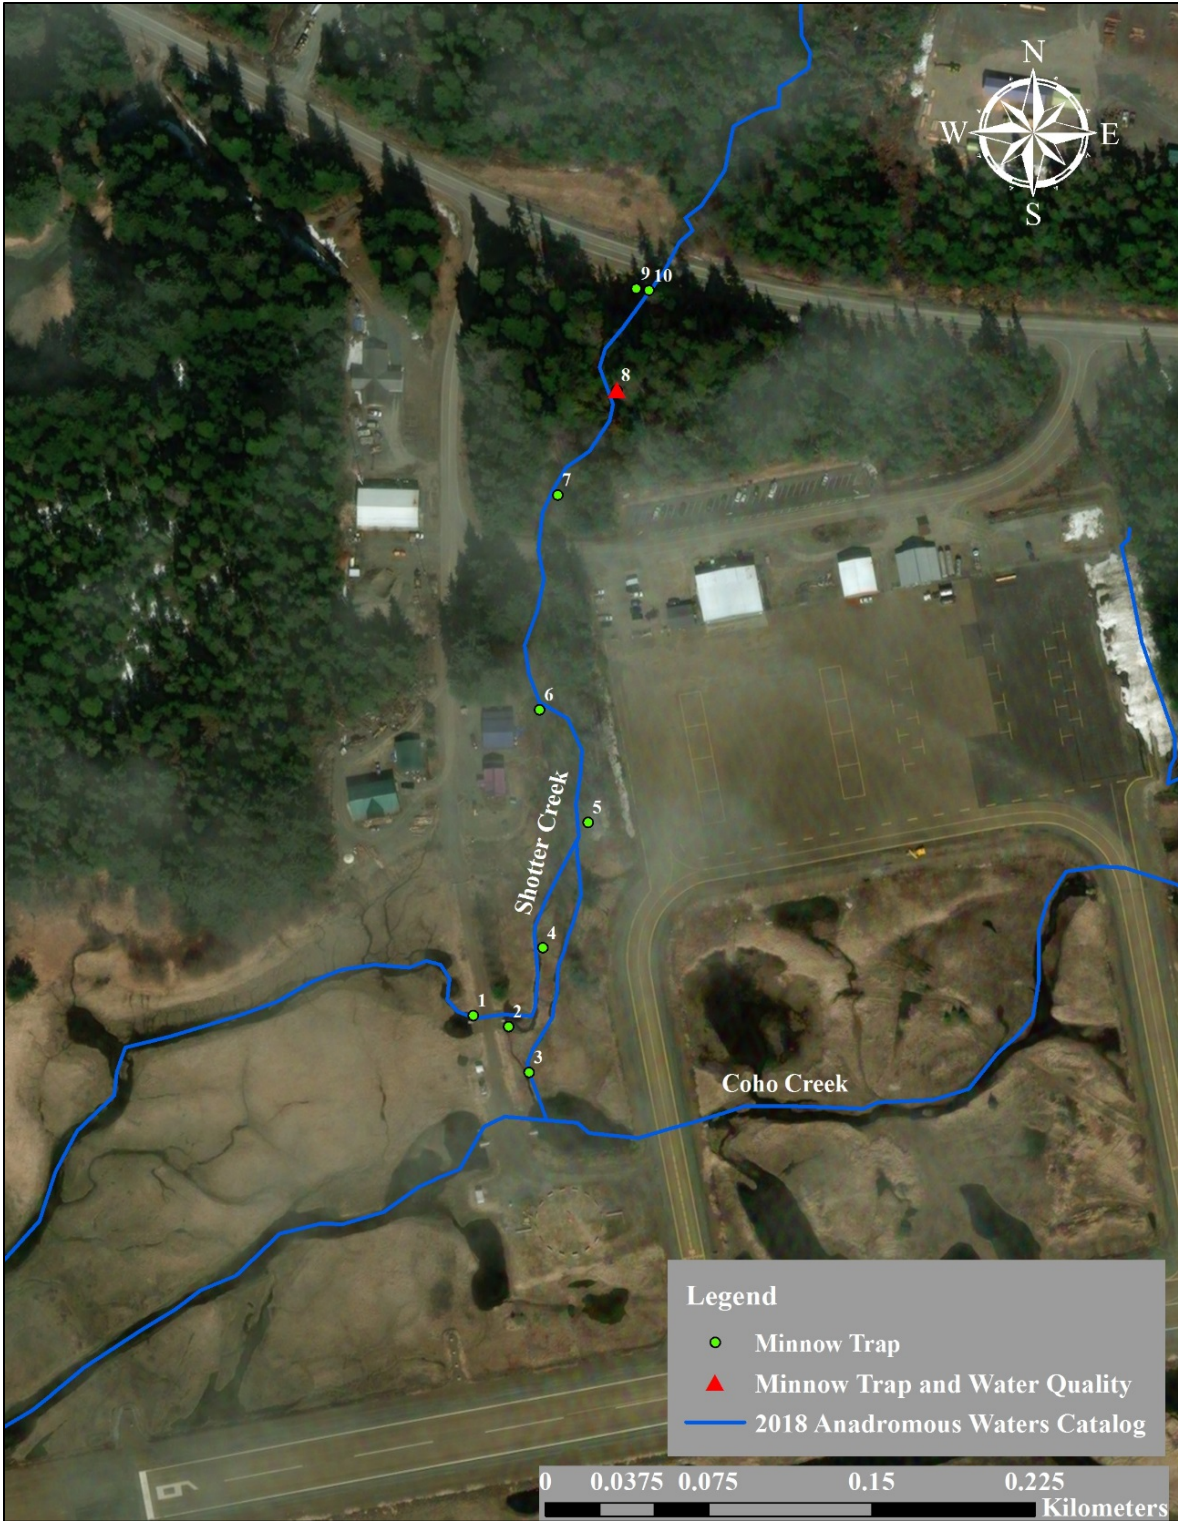
Figure 20.—Shotter Creek minnow trap and water quality locations.

We set 10 minnow traps at established locations and captured juvenile coho salmon, cutthroat trout, Dolly Varden char, sculpin, and threespine stickleback (Figures 20–22). The number of salmonids we captured varied between seasons and years. The mean number of coho salmon captured per minnow trap was more in the summer (Figure 23). We generally captured more coho salmon per minnow trap in the winter during pre-construction monitoring.

We measured water quality at location 8 (Figure 20; Table 7).

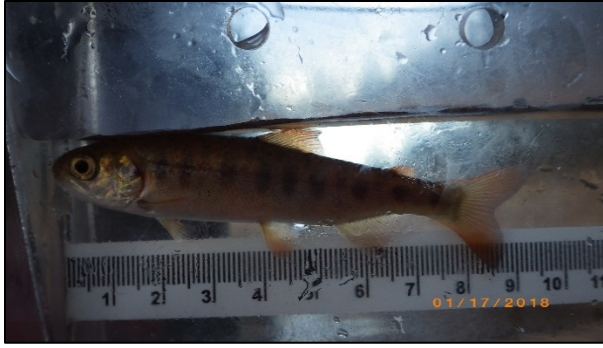
Figure 21.—Coho salmon captured in Shotter Creek, January 2018.

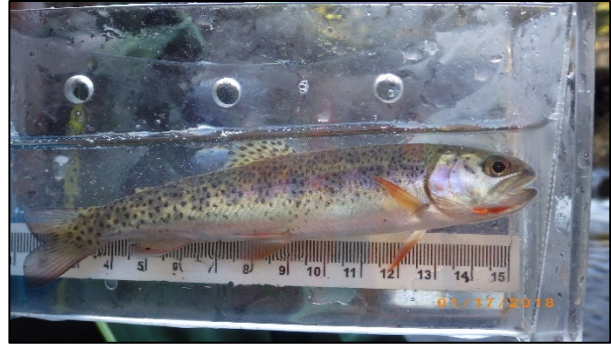
Figure 22.—Cutthroat trout captured in Shotter Creek, January 2018.

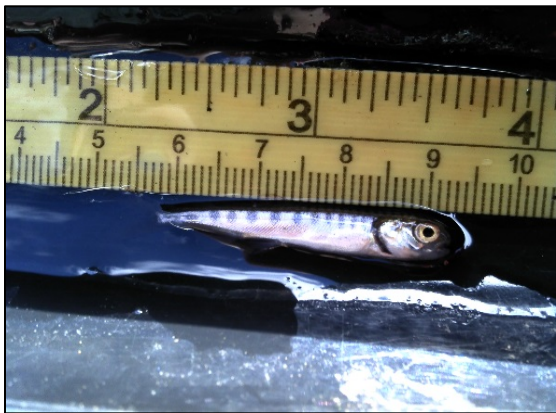
We captured juvenile coho, chum, and pink salmon, sculpin, threespine stickleback, and starry flounder with a beach seine in the estuary downstream of the culvert. (Table 6). Prior to April 2014, chum salmon fry were not documented in Shotter Creek and prior to April 2016 pink salmon fry were not documented in Shotter Creek (Figures 24, 25). We submitted this information and it was accepted in the AWC.

Figure 24.–Chum salmon fry captured in Shotter Creek, April 2014.

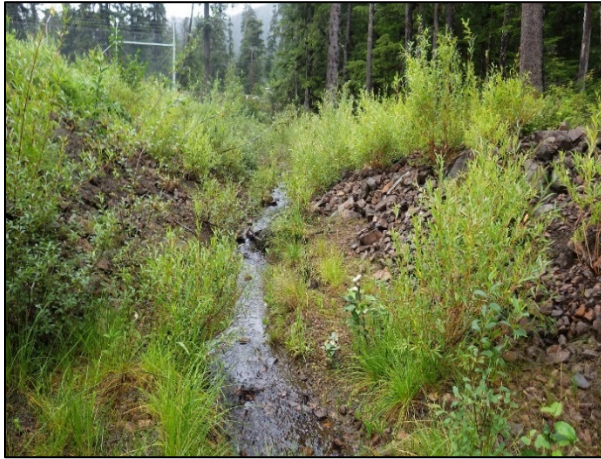
In 2013 and 2015, ADOT&PF conducted an as-built survey of the Unnamed Creek relocation and the project engineer concluded the relocation and alcoves were constructed as designed (Figures 26, 27).

Figure 26.–Unnamed Creek, August 2017.

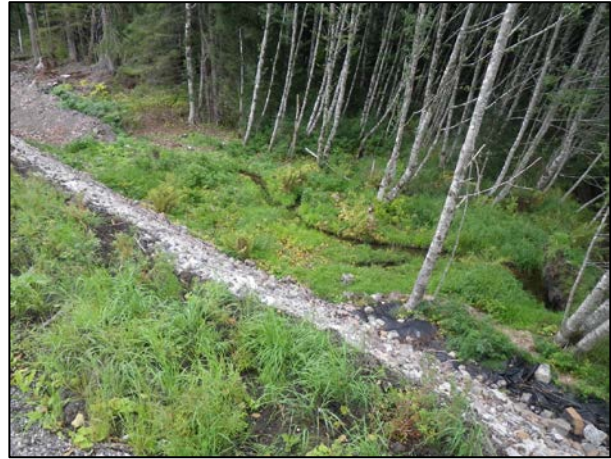
Figure 27.–Looking down at the alcoves, September 2013.

The relocated reach periodically provides summer and overwintering habitat for salmonids, including coho salmon. Low water and overgrown vegetation prevented us from setting minnow traps in the alcoves, so their value as fish habitat is unknown. We did not document adult salmon in Unnamed Creek. Water quality at the Unnamed Creek sampling station remained similar throughout the study with salinity the highest throughout the study. The Unnamed Creek riparian has nearly all revegetated except for the south end of the east bank where we found sand and gravel accumulating from snow plowing.

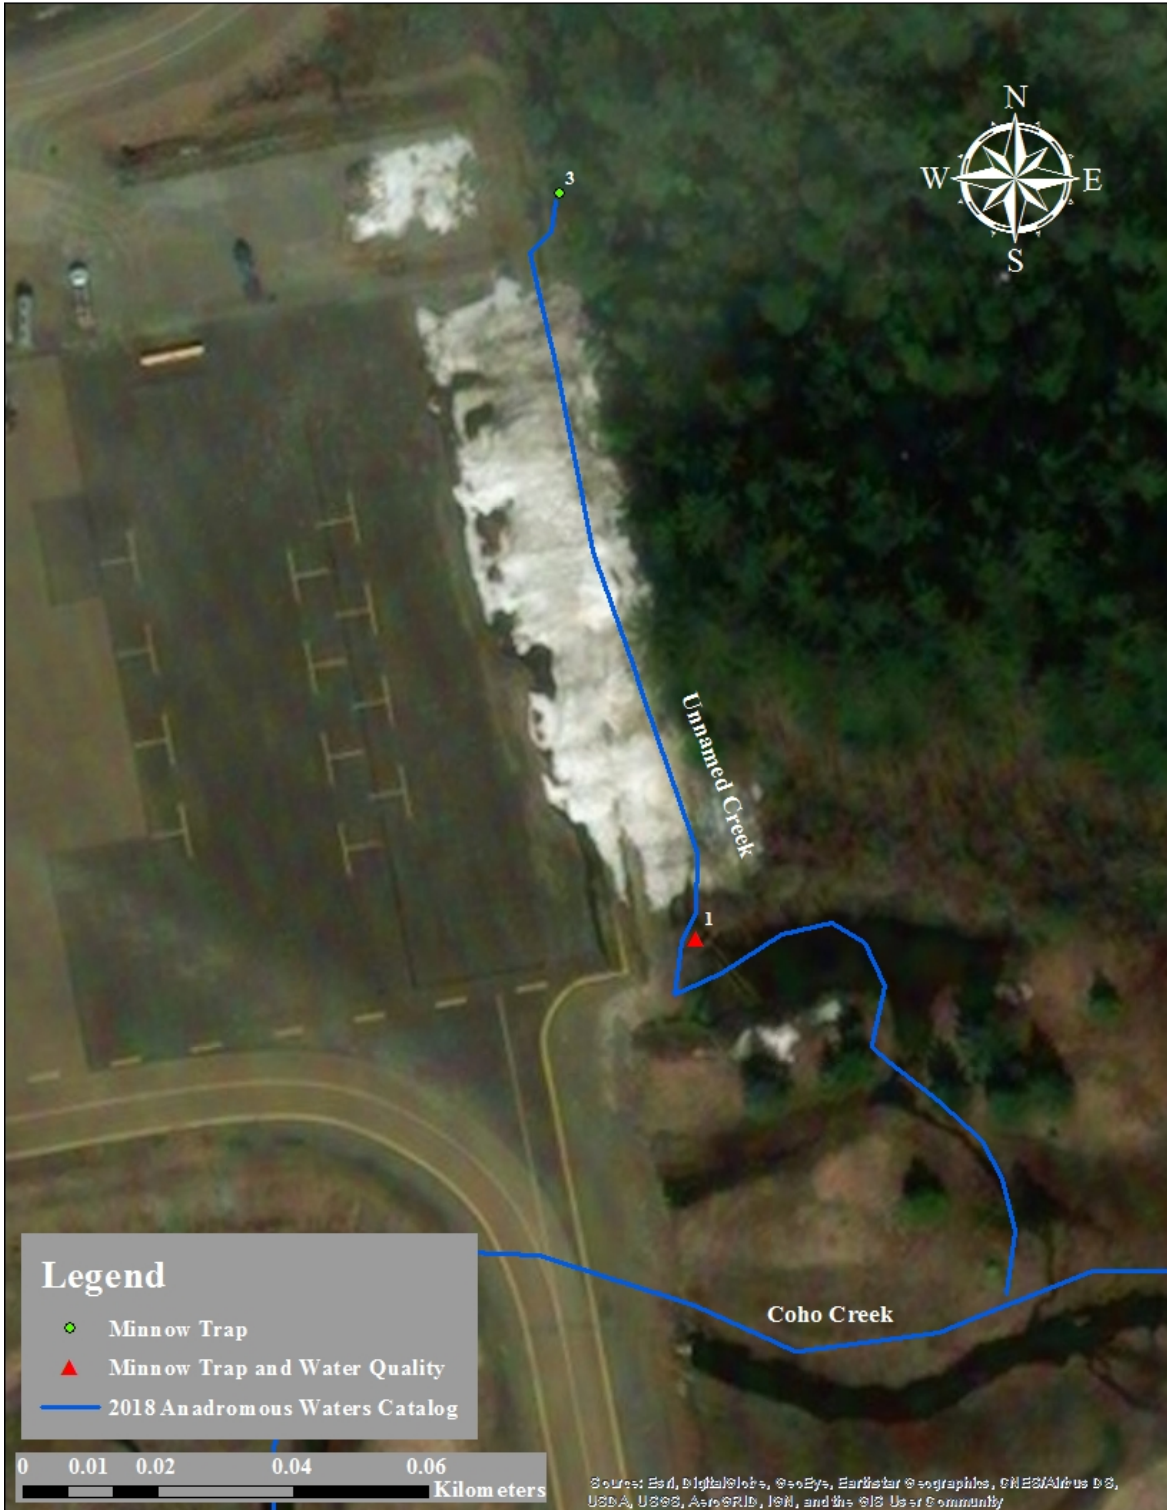
We set up to 5 minnow traps in Unnamed Creek, always setting one minnow trap in the pool at the downstream end of the relocated reach and one in the pool immediately upstream of the relocated reach (Figure 28). We set other minnow traps within the reach if water was available. We captured juvenile coho salmon, cutthroat trout, Dolly Varden char, sculpin, and threespine stickleback. The number of salmonids we captured varied between seasons and year, with coho salmon being the most common species. The mean number of coho salmon captured per minnow trap was generally more in the summer than the winter and we captured more coho salmon per minnow trap during all sampling events^e than during pre-construction (Figure 29). Prior to 2014, Unnamed Creek was known to provide habitat for juvenile coho salmon, but this information was never submitted to the AWC. We submitted this information and it was accepted in the AWC.

Figure 28.—Unnamed Creek minnow trap and water quality locations.^f

^f Note the aerial imagery shows snow was plowed into Unnamed Creek.

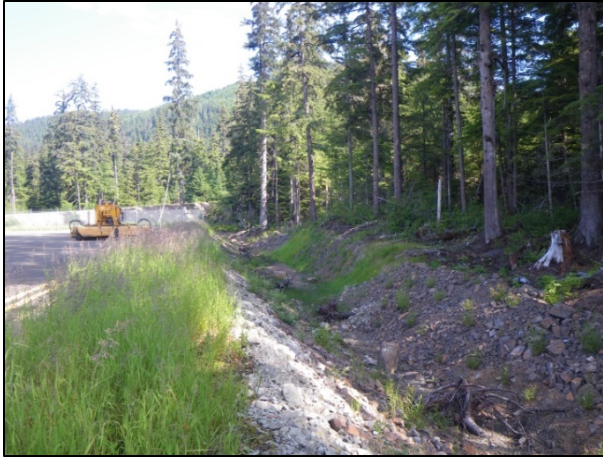
During some of our site visits to Unnamed Creek there was little to no water in the relocated reach (Figure 30). We usually observed the most water in the fall and winter (Figure 31). The root wads that were placed in the creek during construction are fish passage barriers at low water (Figure 32). In the winter, ADOT&PF Maintenance and Operations staff plows snow from the airport apron into Unnamed Creek and blocks fish passage until the water erodes out a channel under the snow (Figures 33–36).

Figure 30.—Dry relocated reach, July 2014.

ADOT&PF relocated Unnamed Creek as specified. However, when water levels are low, water flows subterranean in some locations and the root wads placed in the creek to provide fish habitat present a juvenile fish passage barrier. Given the obstruction, we recommend moving or altering the root wads to allow fish passage at all flows.

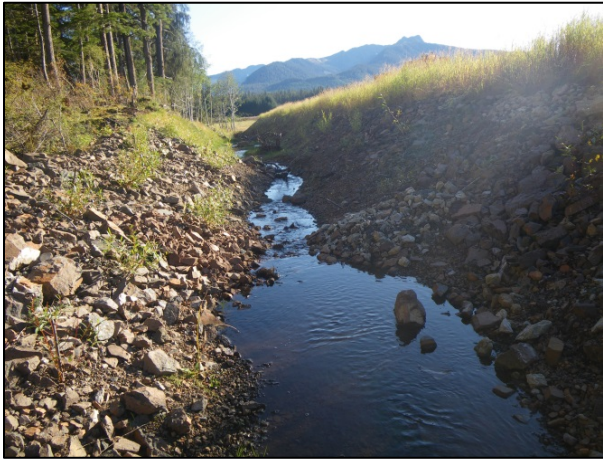
Figure 31.—Most flow we documented in the relocated reach, October 2014.

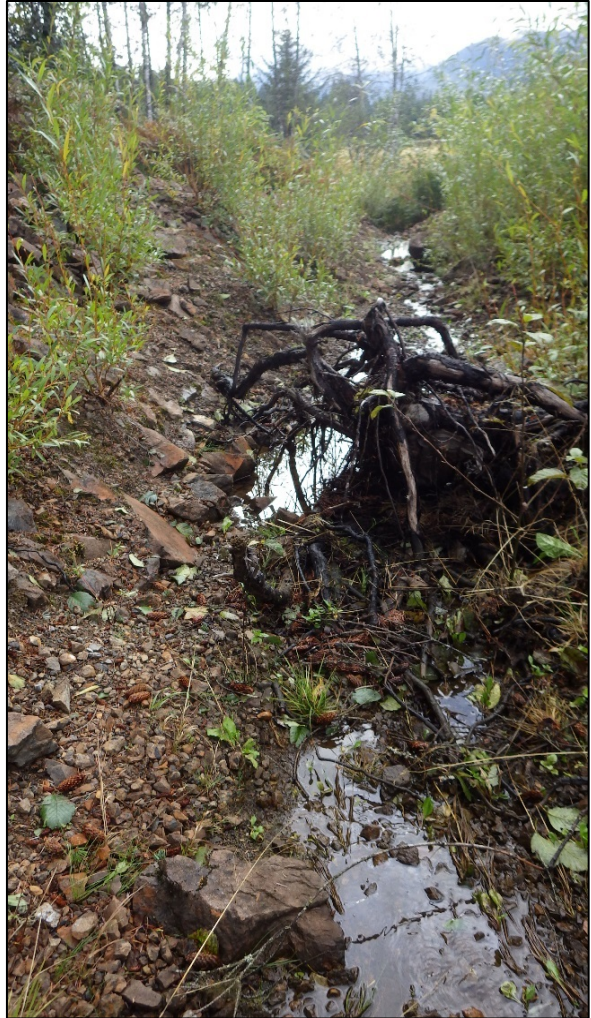
Figure 32.—Root wad blocking fish passage during low water, September 2016.

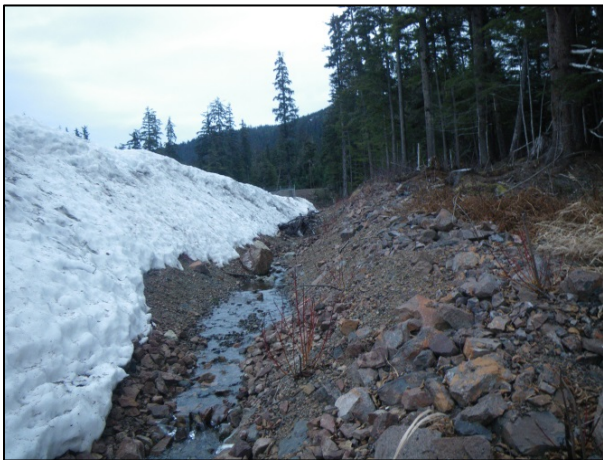
Figure 33.—Unnamed Creek the day before a fresh snowfall, January 6, 2015.

According to Special Condition No. 7 in USACE Permit POA-2010-0682, “Snow disposal and/or storage will not occur within the newly constructed stream channels of Coho Creek and the unnamed tributary to Coho Creek”. We recommend ADOT&PF comply with the permit, or if the activity will continue, apply for a USACE Permit modification and a Fish Habitat Permit. A Fish Habitat Permit will include conditions to prevent further stream degradation and fish passage blocks.

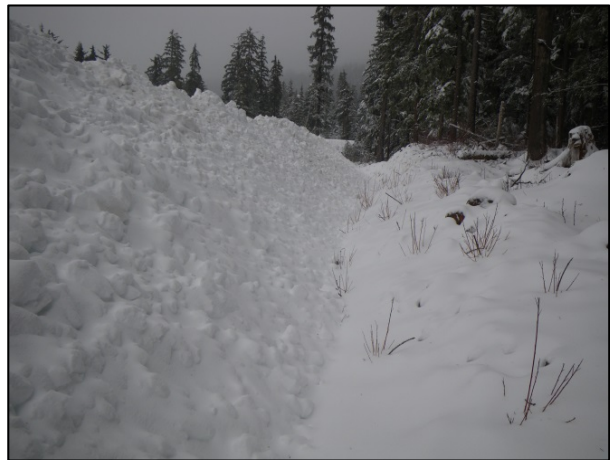
Figure 34.—Unnamed Creek the day after ADOT&PF plowed the apron, January 7, 2015.

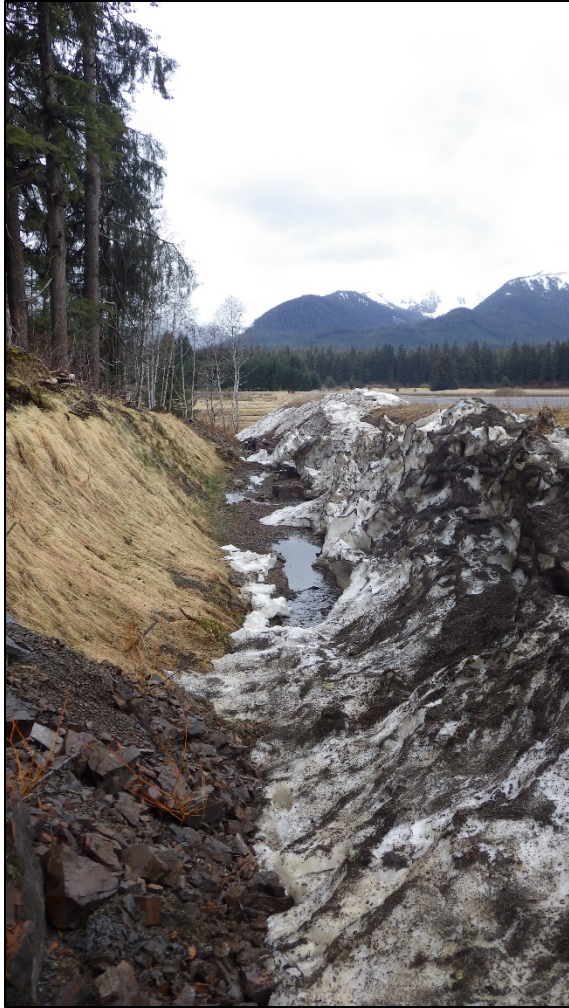
Figure 35.–Unnamed Creek, April 2015.

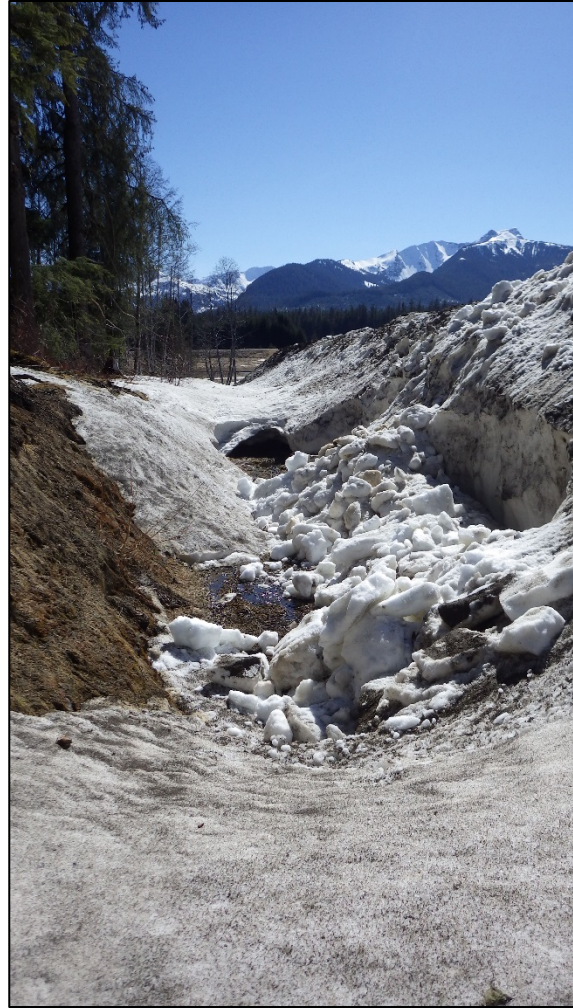
Figure 36.–Unnamed Creek, April 2017.

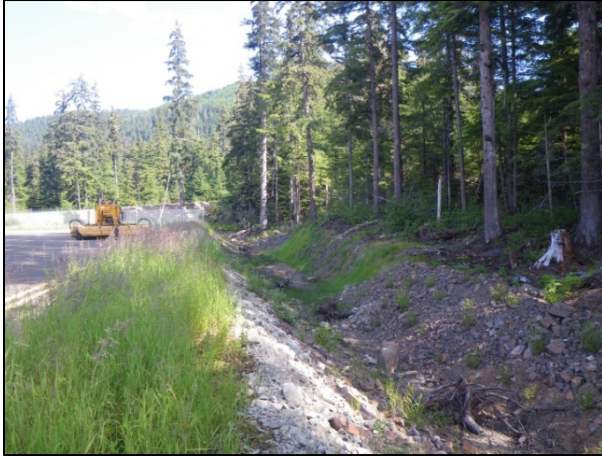
We documented that the relocated reach of Unnamed Creek revegetated with willows and grasses, except the south end of the east bank only had a few surviving willows (Figures 37–39). Sand and gravel from the plowed snow has started to build up on the bank and is falling into the creek and may prevent vegetation from growing (Figure 40).

Figure 37.—Unnamed Creek, July 2014.

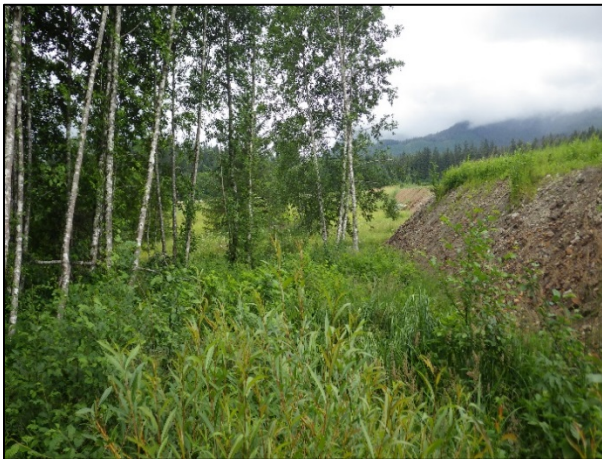
Figure 39.—Unvegetated bank of Unnamed Creek.

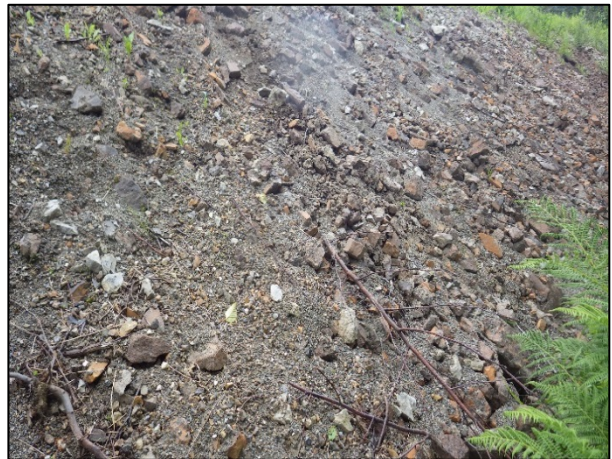
Figure 40.—Sand and gravel from snow melt on the bank of Unnamed Creek.
