# Appendix A: Angoon

## Guide to direct fieldwork for cataloging anadromous water bodies in Southeast Alaska

## ANGOON SURVEYS

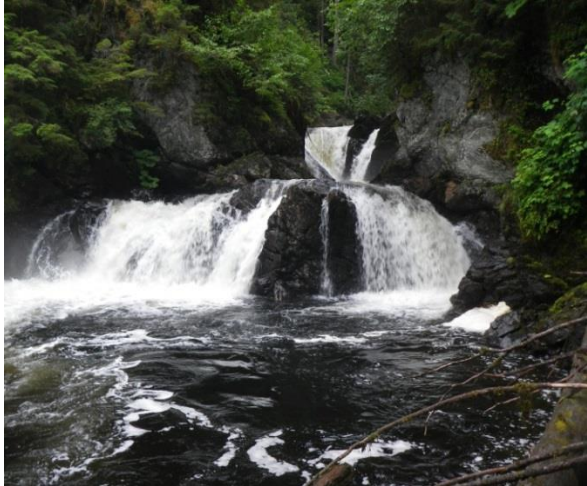
**Findings:** We surveyed Thayer Creek using an electrofisher, handnet, and GPS (Table 1). There is a series of water falls approximately 1250' upstream from the mouth of the creek that we determined are fish passage barriers (Figures 1, 2). Below the falls we visually identified adult pink salmon, chum salmon, and sockeye salmon and captured rearing coho salmon (Figures 3, 4). The substrate below the falls was gravel and cobble. Upstream of the waterfall, the creek flows through a bedrock gorge, then opens up to a low gradient stream with gravel and cobble substrate. We surveyed a tributary in this area and caught resident cutthroat trout and Dolly Varden char.

Figure 1.—First 12' waterfall with 20' deep plunge pool.

**Recommendations:** Correct the anadromous section of Thayer Creek in the AWC and add rearing coho salmon and sockeye salmon presence (Figure 5).

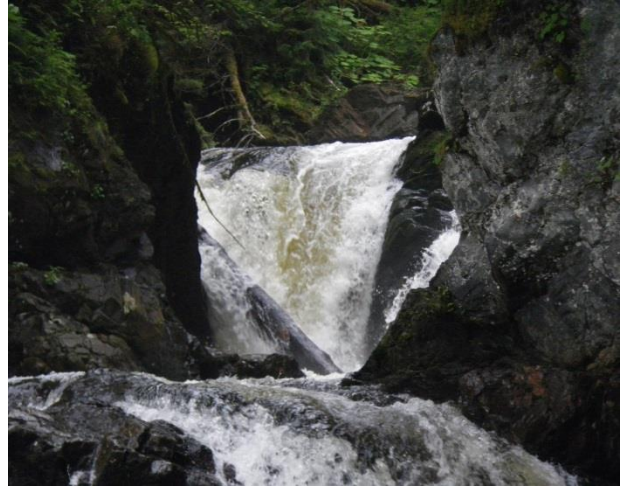
Figure 2.—Second 14' waterfall with no plunge pool.

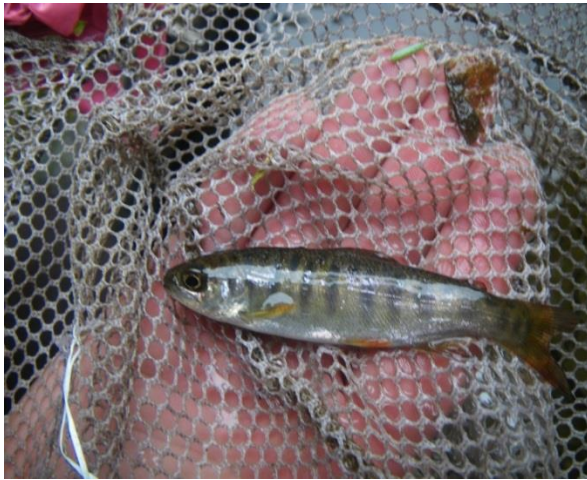
Figure 3.—Coho salmon caught below waterfall in Thayer Creek.

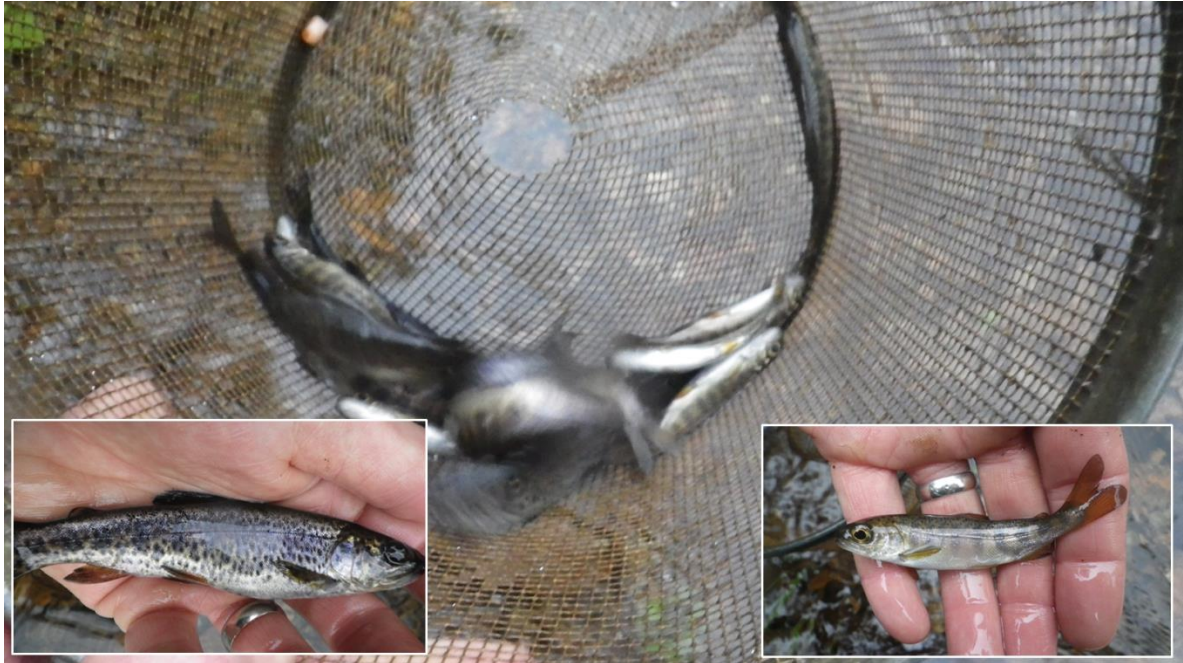
**112-67-10350****CORRECTION****Water body name:** Hasselborg Creek**Survey date:** 8/27/2015**Watershed:** Kootznahoo Inlet-Frontal Chatham Strait**Species & Lifestage:** CHs, COrs, Ps, CTpr, DVp, SHp, Ss**MTR:** C049S069E **Quad:** Sitka C-1**Findings:** I caught 20 juvenile coho salmon in a minnow trap at waypoint 811 and visually observed >100 spawning sockeye beginning at waypoint 812 while moving downstream (Table 1, Figures 1,2).**Recommendations:** Correct the species list to include rearing coho salmon and spawning sockeye salmon at specified waypoints 811 and 812.**Nomination:** 16-553

Figure 1.-10 cutthroat trout (left) and 20 juvenile coho salmon (right) captured in a minnow trap.

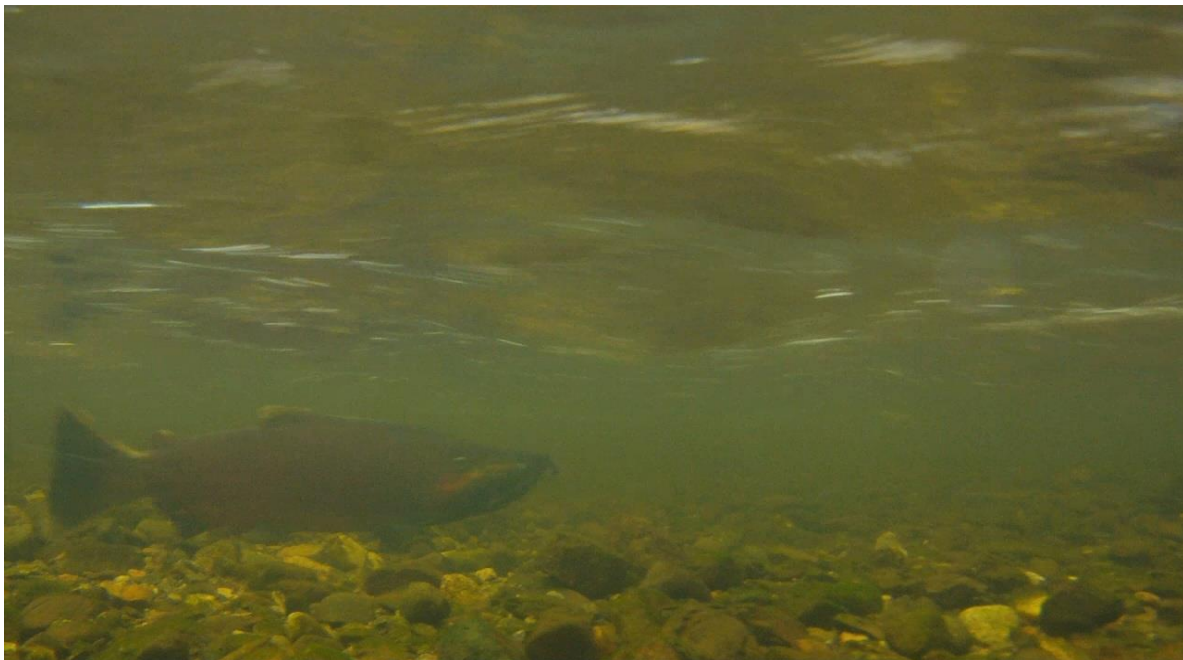
**Findings:** I observed 15 adult coho salmon in the lower reach of Kanalku Creek (Table 1, Figures 1, 2). I did not observe these fish spawning.

Figure 1.–Adult coho salmon in the intertidal area of Kanalku Creek.

**Recommendations:** Please correct the species list to include coho salmon presence in the AWC, and survey for spawning activity if in area during the fall.
