# Appendix L: Lynn Canal

## Guide to direct fieldwork for cataloging anadromous water bodies in Southeast Alaska

# LYNN CANAL SURVEYS

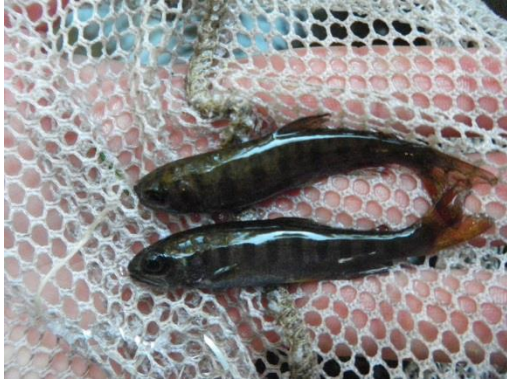
Figure 2.—Captured rearing coho salmon.

**Findings:** We surveyed this cataloged stream using a backpack electrofisher and a GPS (Table 1). We caught juvenile coho salmon (Figure 1). This stream is wide and has great spawning gravel almost to the waterfall (Figure 2). There is a 30-40' waterfall that is the upper extent of anadromous fish use (Figure 3).

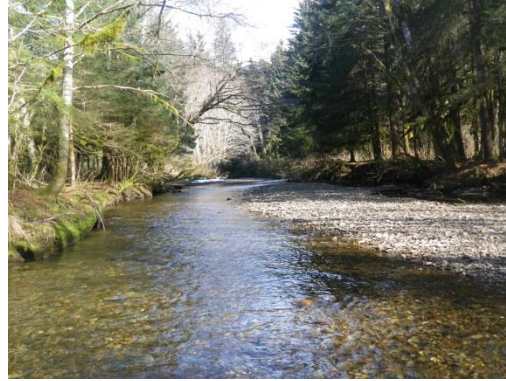
Figure 3.—Wide streambed and low flows in early spring.

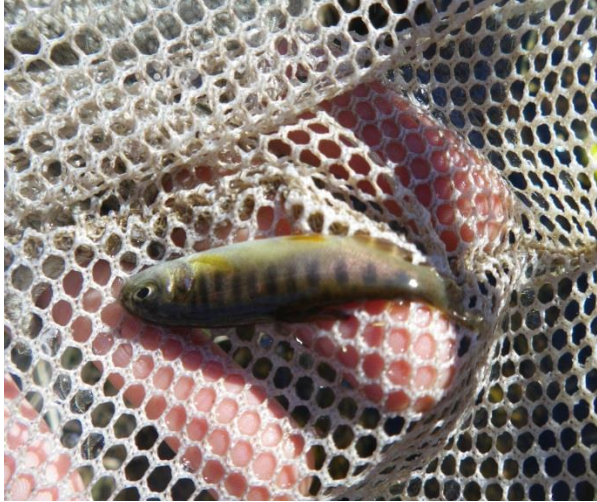
Figure 6.–Rearing coho salmon.

**Findings:** We surveyed this stream using a backpack electrofisher and a GPS (Table 1). We caught juvenile coho salmon and cutthroat trout (Figure 1). This tributary is beautiful and has good spawning gravels (Figure 2). We did not find a barrier to fish passage, but stopped catching anadromous fish.

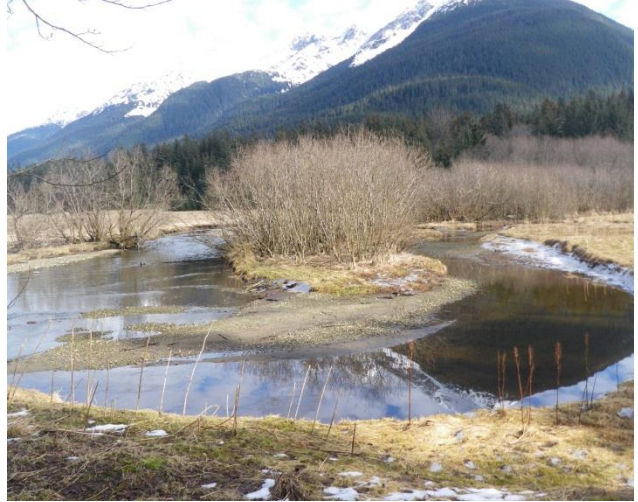
Figure 7.–Tributary in right of photo entering Sawmill Creek.

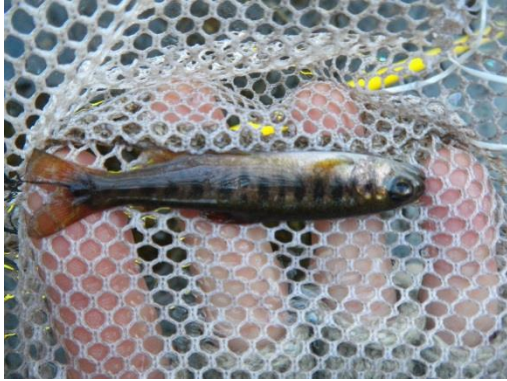
Figure 8.—Captured coho salmon.

**Findings:** We surveyed this stream using a backpack electrofisher and a GPS (Table 1). We caught juvenile coho salmon (Figure 1) and cutthroat trout. This is a small tributary and has good flow and gravels for fish (Figure 2). We found fish all the way up to the hillside that has a rock chute that is a barrier to fish passage (Figure 3).

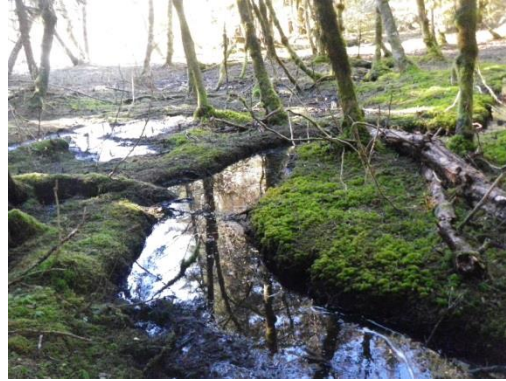
Figure 9.—Near the upper extent of stream.

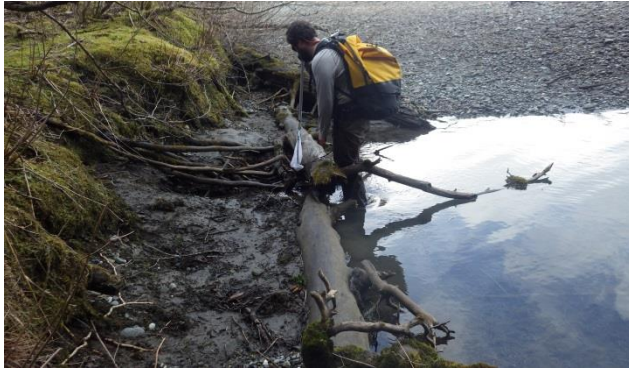
Figure 12.–Habitat biologist Ben Brewster observes the spring-fed upper limit of 115-10-10800-2007.

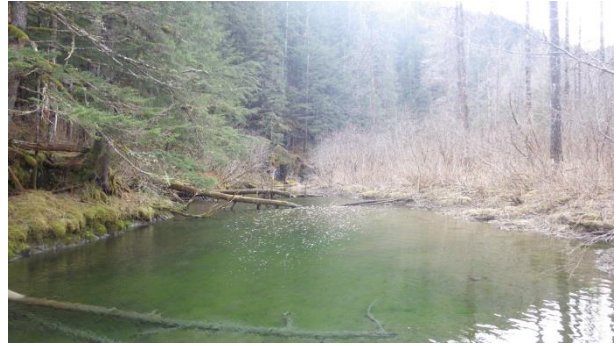
Figure 17.—Looking upstream at the series of beaver dams on 115-10-10800-2011.

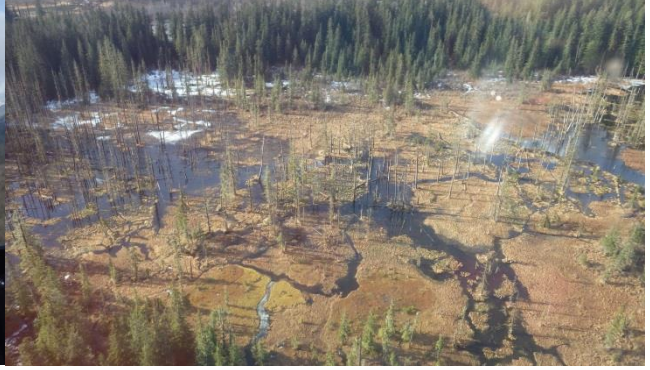
Figure 23.—Beaver complex on Sullivan River.

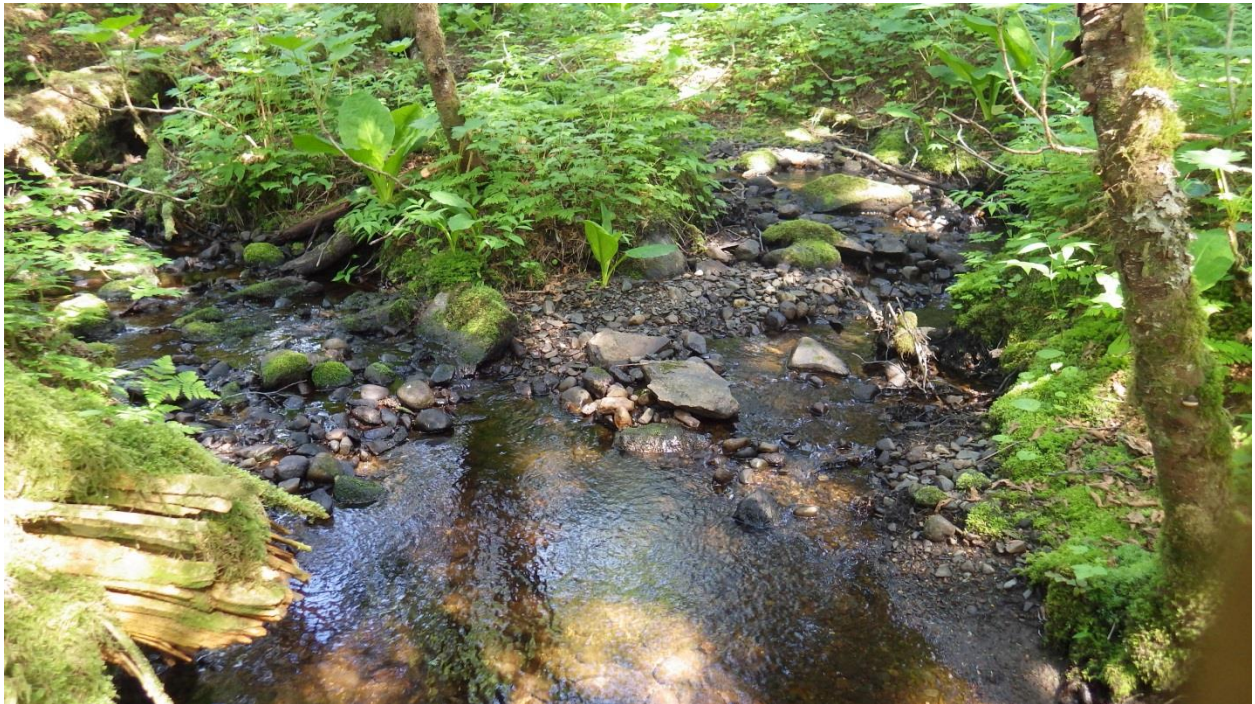
**Findings:** We sampled this stream with a backpack a backpack electrofisher and GPS (Table 1). We documented juvenile coho salmon rearing up to waypoint 72 (Figure 1). Fish habitat likely extends past waypoint 72, however due to low water we could not sample further (Figure 2). We will sample again at higher flows.

Figure 31.- 115-10-10200-2005 representative reach.
