**Technical Report No. 23-08**

## **Eklutna River Aquatic Habitat Monitoring – 2021-2022**

**EKLUTNA RIVER AQUATIC HABITAT MONITORING 2021-2022**

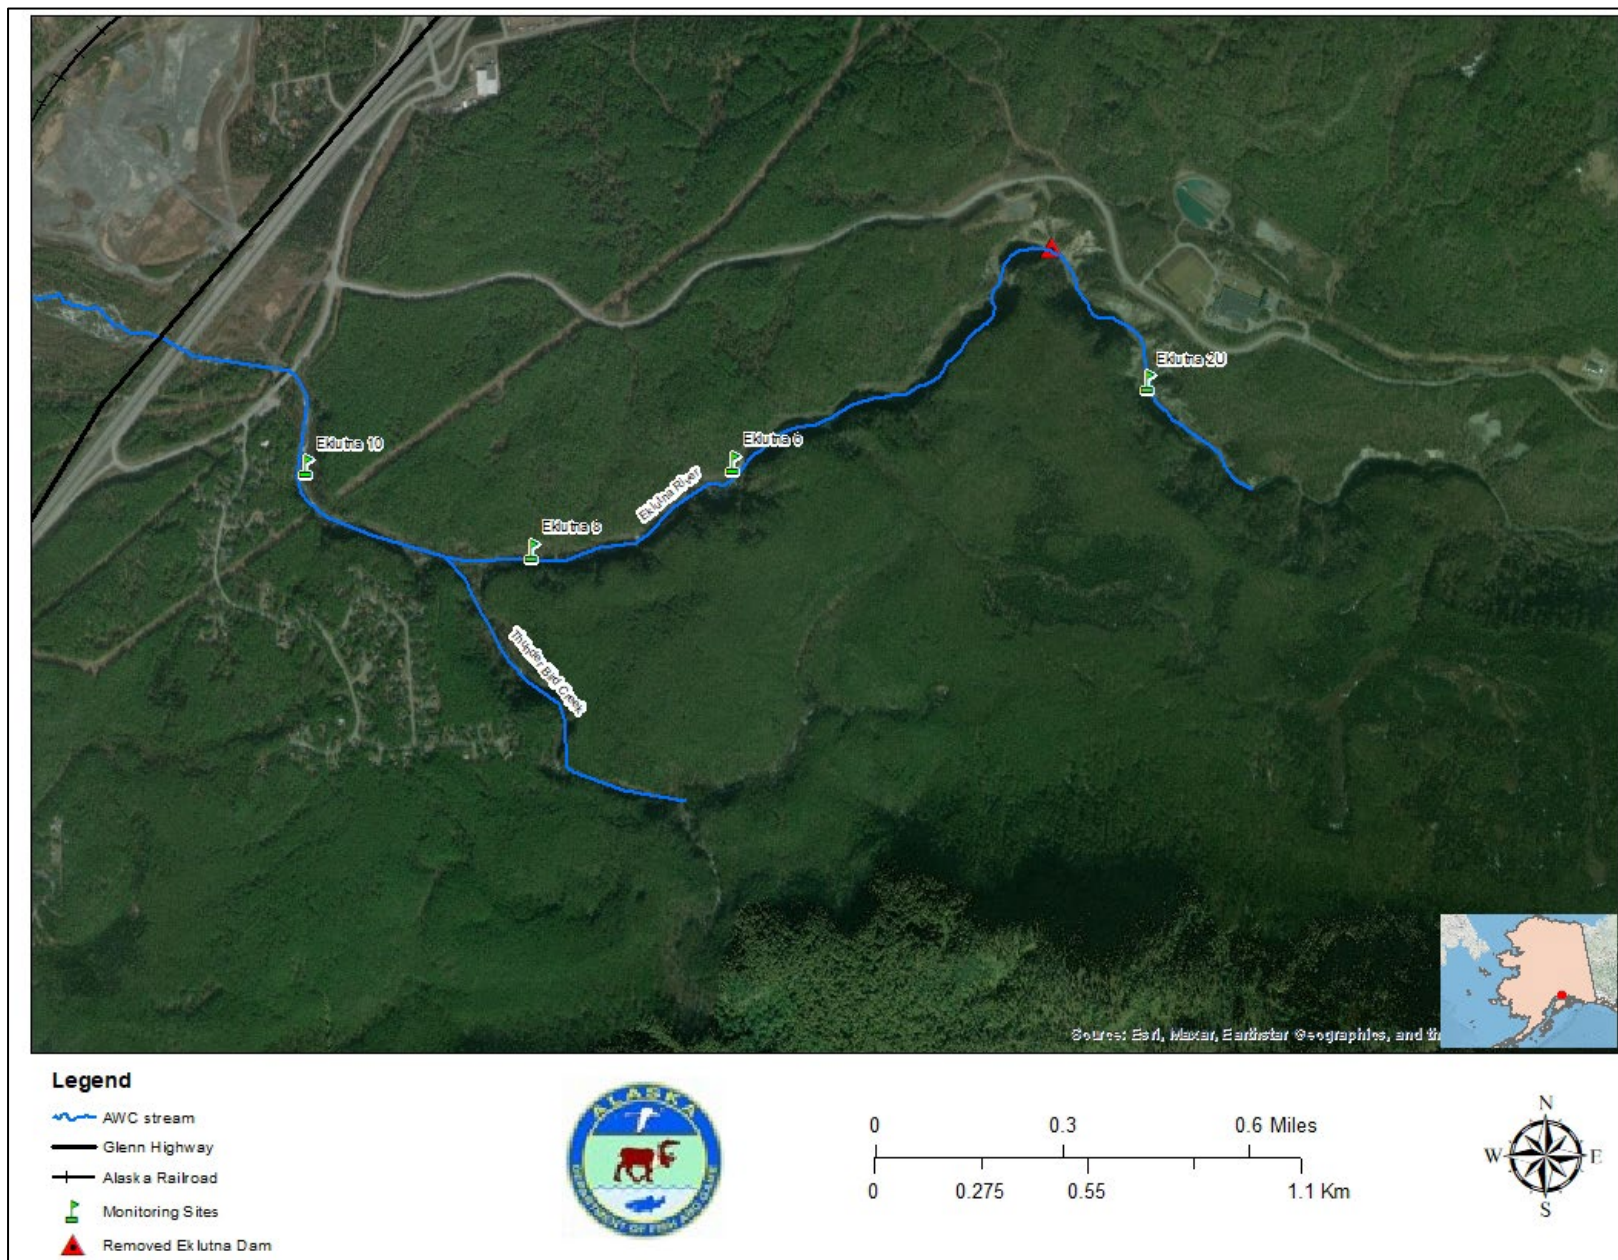
Figure 2.– Eklutna River Monitoring Site Map

The complete suite of monitoring locations is shown in Figure 2.

Prior to the completion of dam removal, three monitoring sites were established in the Eklutna River (Table 1). Two monitoring sites were selected upstream from the Thunder Bird Creek confluence and one monitoring site was selected downstream. Each monitoring site was selected at a location representative of proximal upstream and downstream conditions.

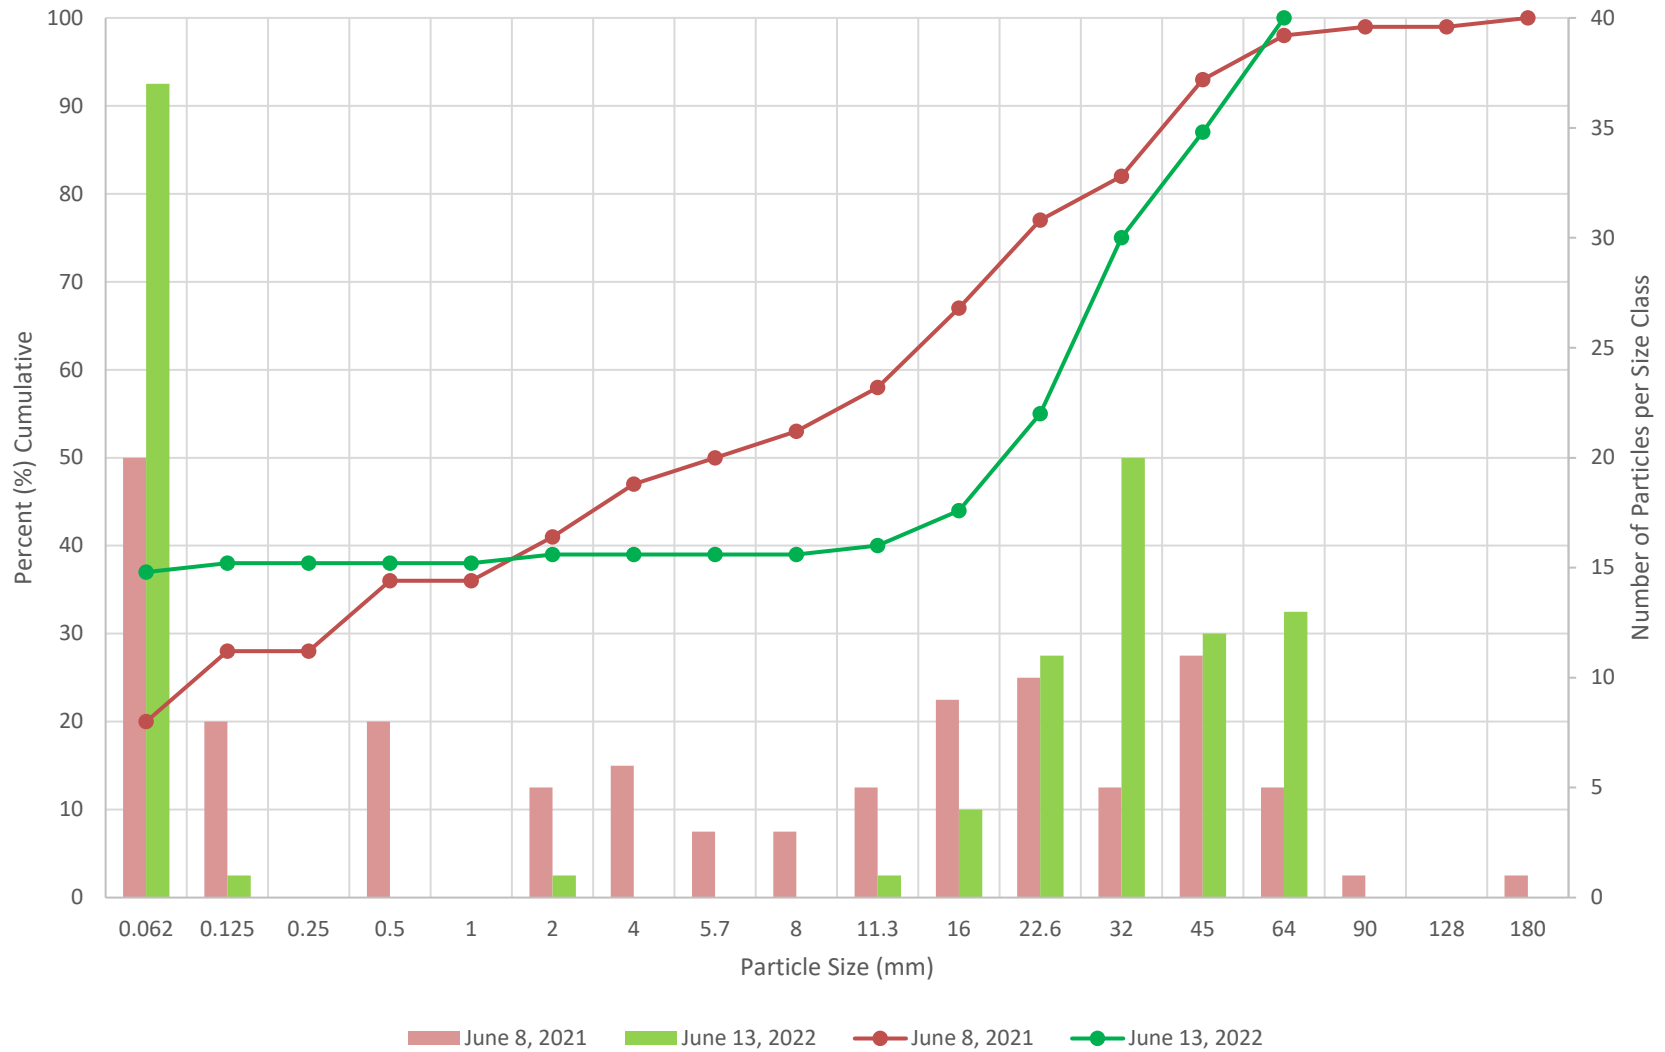
### Eklutna Cross Section 2U Substrate Composition

More silt and gravel sized particles were present in the channel substrate in 2022 than 2021 and overall the channel substrate increased slightly. The D<sub>50</sub> values increased from fine gravel (4-8 mm) to coarse gravel (16-32 mm) while the D<sub>84</sub> values were categorized as very coarse gravel (32-64 mm) for both years.

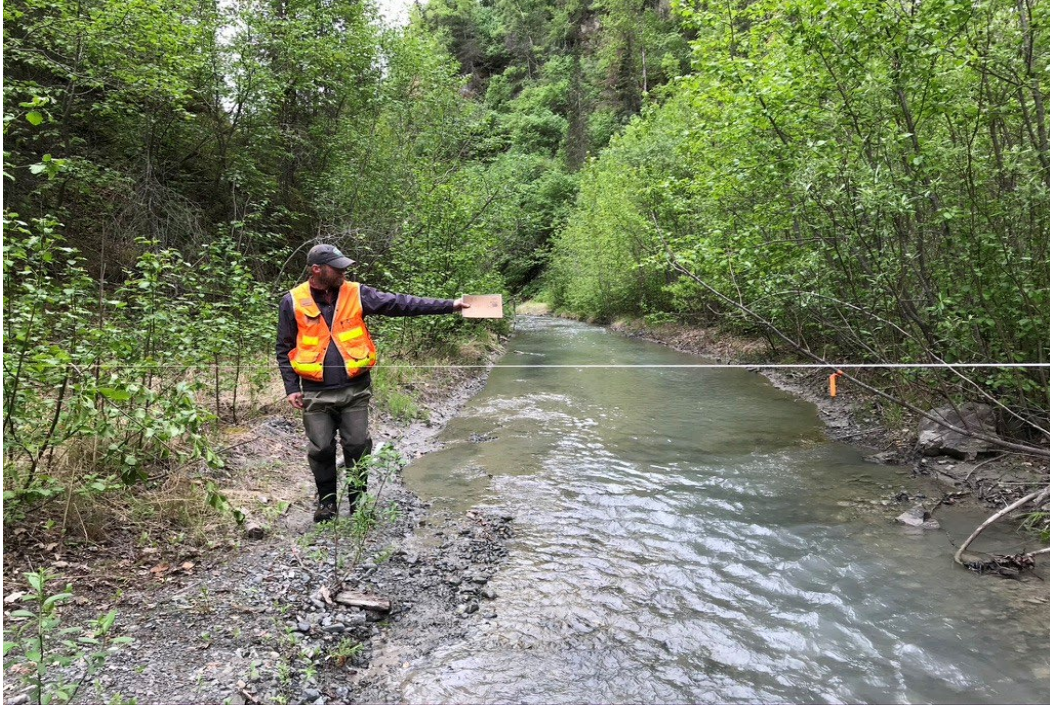
Eklutna 2U looking upstream – June 8, 2021

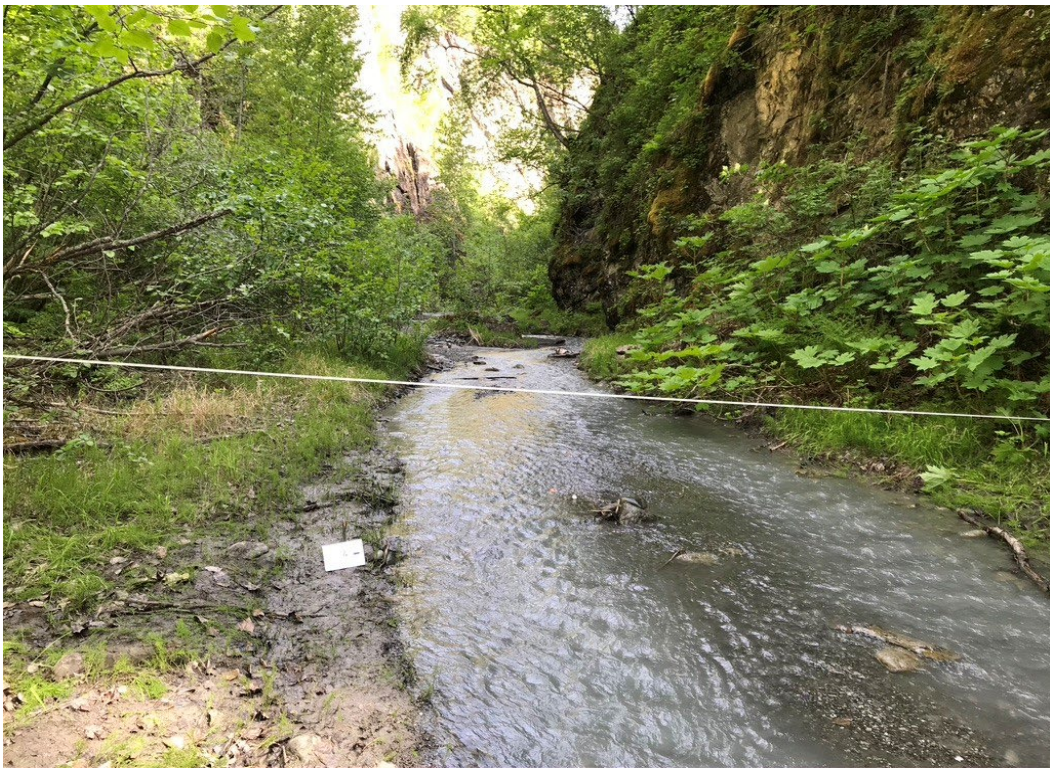
Eklutna 6 looking upstream – June 9, 2022

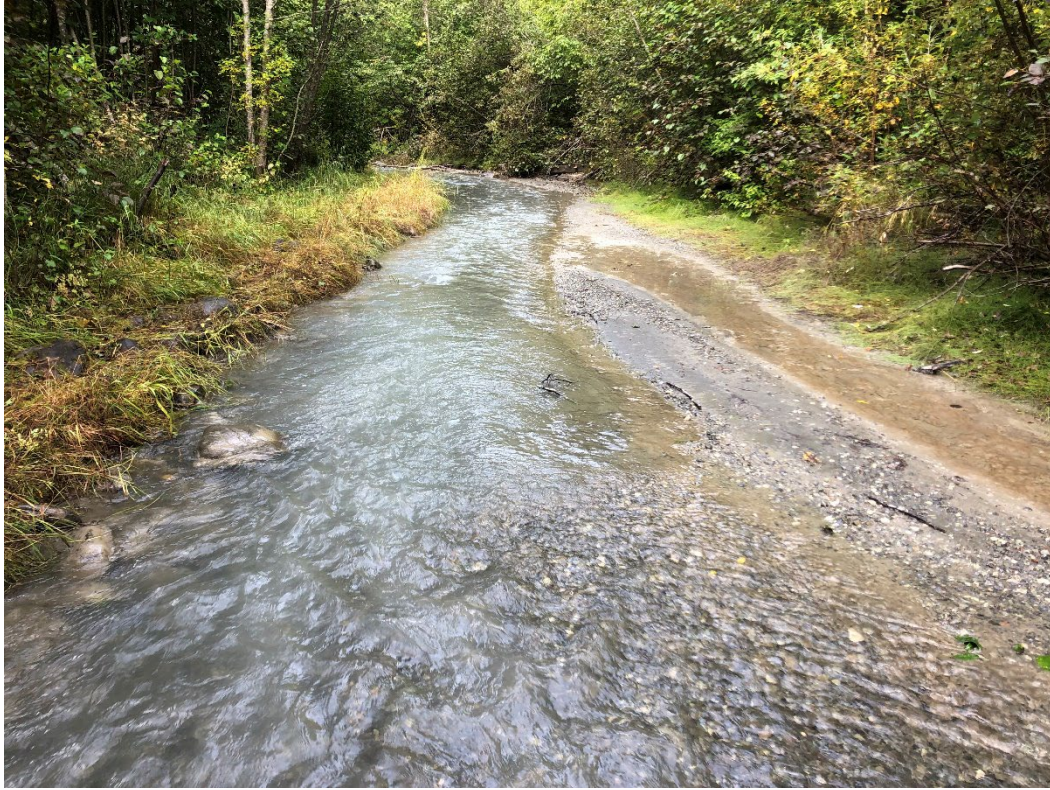
Eklutna 8 looking downstream – August 31, 2021

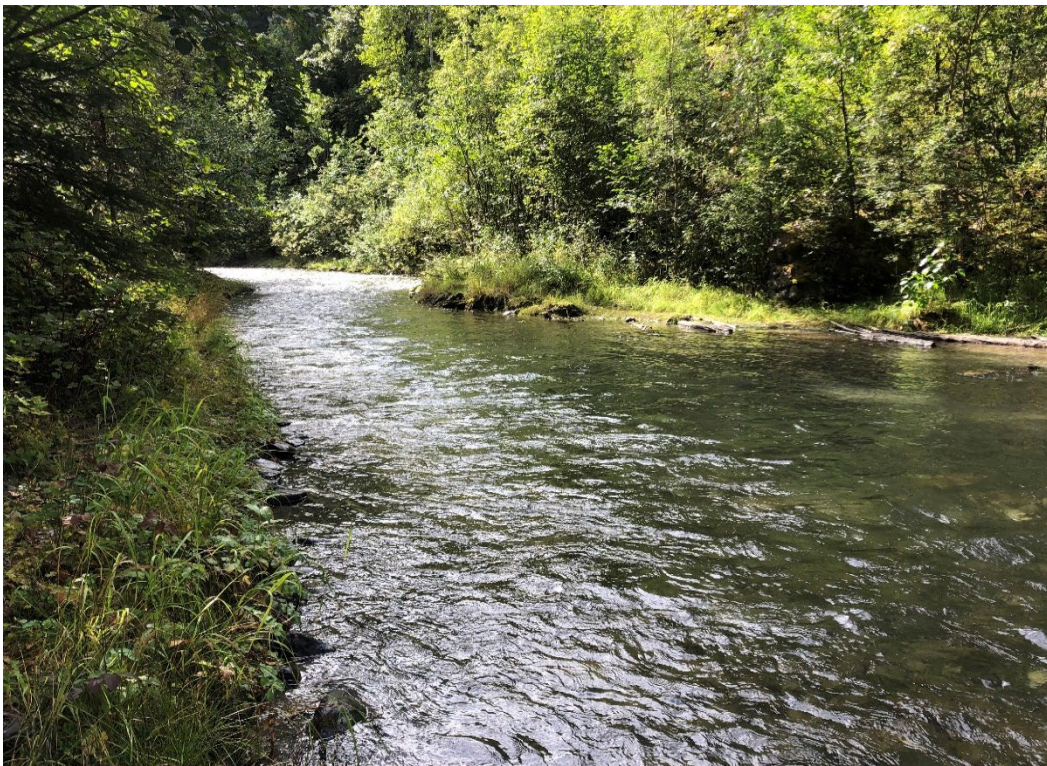
Eklutna 10 looking upstream – August 31, 2021
