GOOSE GREEN GULCH: FISH AND WILDLIFE HABITAT IN A FORMER
GRAVEL MINE SITE

Technical Report No. 90-1

Alaska Department of Fish & Game
Division of Habitat

December 1990

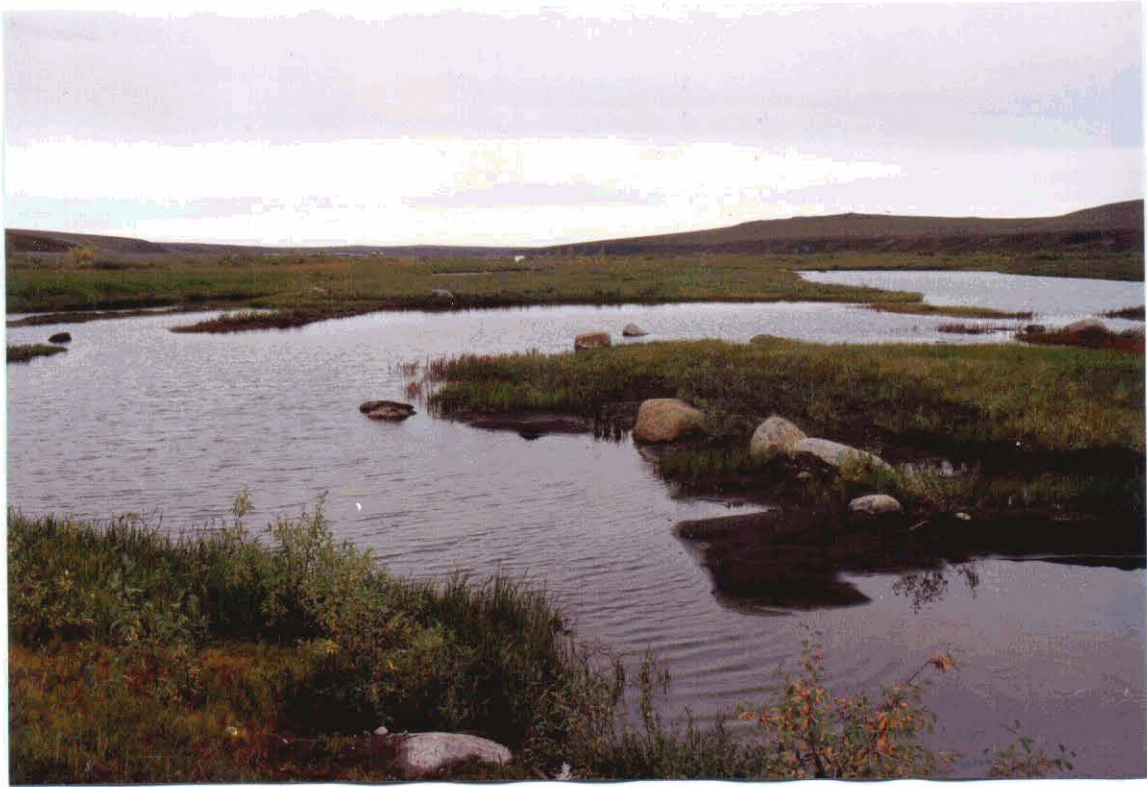
Photograph 1. Primary pond of Goose Green Gulch with shoreline features such as islands, spits, embayments, and emergent vegetation. (Photo by M.H. Robus)

The ponds in Goose Green Gulch contain a diversity of features that are beneficial to and used by fish. The irregular shape of the ponds provides extensive shoreline for development of emergent vegetation. This vegetation provides cover for fish and may provide food and cover for aquatic invertebrates that in turn may be eaten by fish. This vegetation also may contribute to site productivity by stabilizing the shoreline and pond bottom, and by adding nutrients to the system through leaching or plant decomposition. The variation in depths of the ponds also contributes to this site's productivity by enabling the establishment of diverse emergent and submerged aquatic plants.

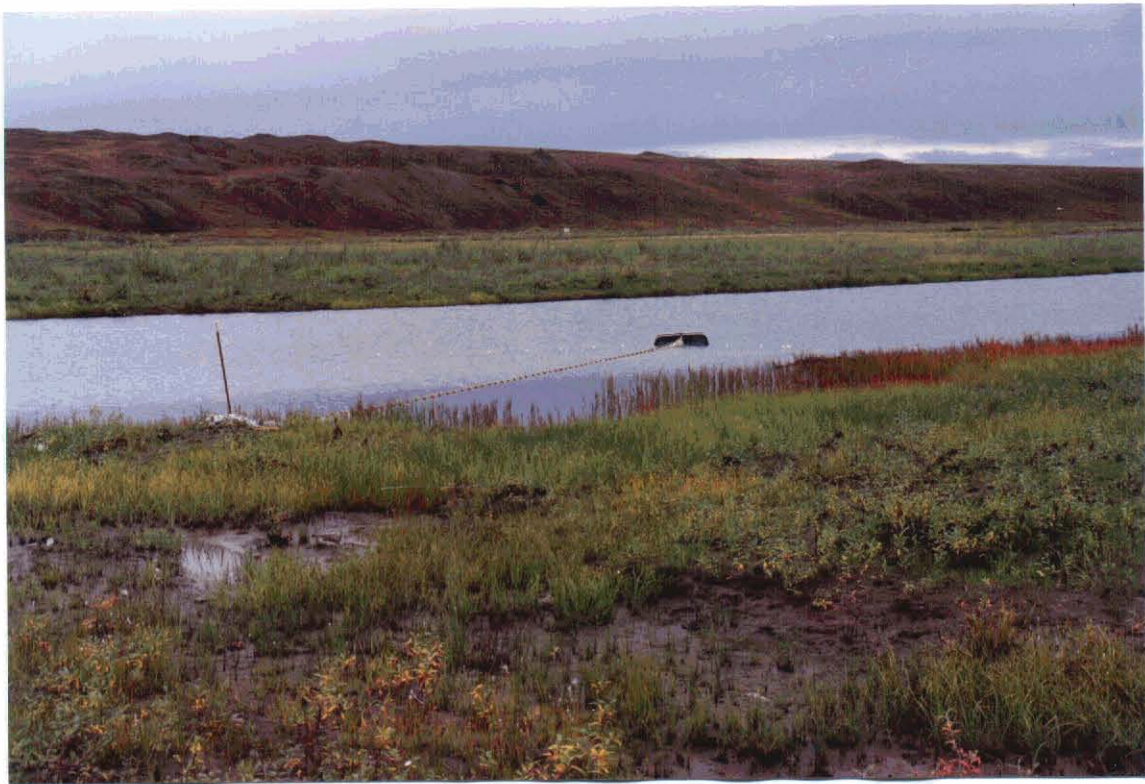
Photograph 2. Fyke net in the primary pond of Goose Green Gulch. Pendent grass (*Arctophila fulva*) is in the foreground. (Photo by M.H. Robus)

Arctophila fulva is a conspicuous emergent aquatic plant at Goose Green Gulch, particularly in late August when this species' leaves turn red (Photo 2). This plant is common in wetlands throughout the arctic, and wetlands containing *Arctophila* are valuable for waterbirds. *Arctophila* grows in dense stands in selected locations along pond margins of Goose Green Gulch and scattered in areas of the ponds that are generally less than 30 cm (12 in) deep.

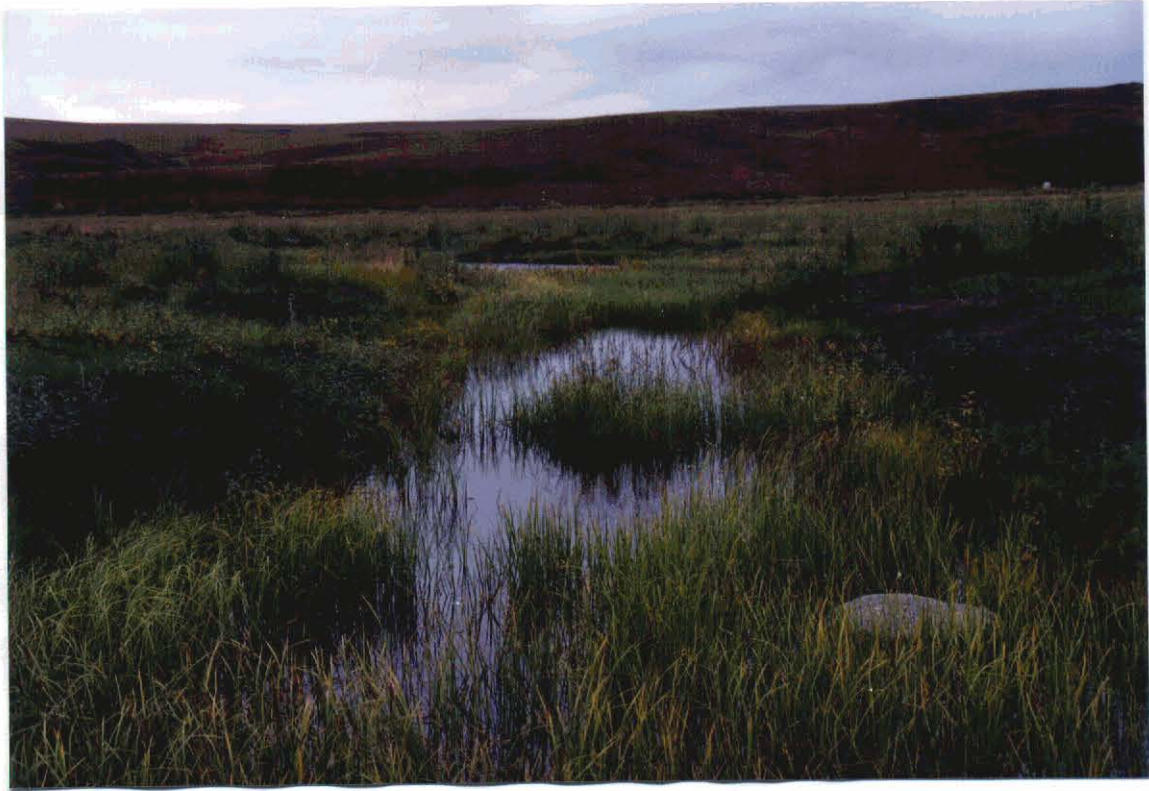
Photograph 3. Dense sedges (*Carex* spp.) in one of the shallow channels connecting two ponds within Goose Green Gulch. (Photo by M.H. Robus)

Grasses, sedges, willows, and forbs currently grow within much of Goose Green Gulch. Within the immediate vicinity of the ponds and in the channels connecting ponds are extensive stands of sedges (*Carex aquatilis*, *Eriophorum angustifolium*, and *E. Scheuchzeri*), and occasional stands of pendent grass (*Arctophila fulva*) (Photos 2 and 3). These species are common along the margins of these waterbodies, although in areas where water depths are less than 30 cm (12 in), emergent aquatic species (*Hippuris vulgaris*, *Arctophila fulva*) grow throughout the shallow areas. Stands of the sedge *Carex aquatilis* are dense, particularly within the channels connecting the ponds. These channels are generally less than 25 cm (10 in) deep (in August) and apparently provide excellent conditions for growth of sedges.

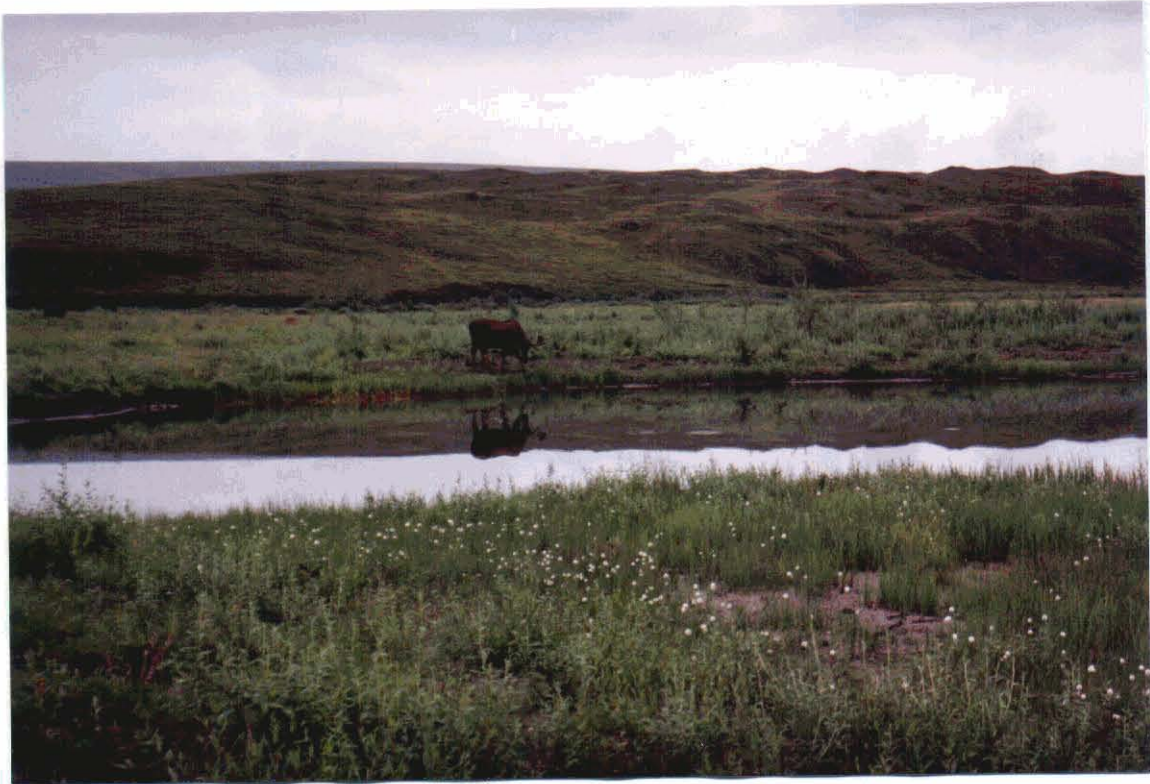
Photograph 4. Willows and sedges are abundant in the northern half of Goose Green Gulch. Bull moose browsing willows. (Photo by J.F. Winters)

Willows are present throughout the site, but are most abundant in the area of the ponds and along the outer margins of the site (Photo 4). Willows are less abundant in the drier portions of the site that support higher densities of grass. Feltleaf willow (*Salix alaxensis*) is the most common willow within the site. Several *S. alaxensis* plants approach 2 m (6.5 ft) in height, and may be survivors of the 1978 Alyeska experimental willow planting program. Most of the willows within the site, however, are less than 1 m (3.3 ft) tall. The 91 m (300 ft) buffer zone left between the work area and the Sagavanirktok River channel contains extensive stands of willows that likely contributed to the seed source for recolonization of the site by willows. Lesser numbers of *Salix hastata* and *Salix glauca* also occur in the site.

Large mammals that used or traveled through Goose Green Gulch included moose (*Alces alces*) and caribou (*Rangifer tarandus*). Tracks from both species were present in the site during both years. In July 1990, we observed one bull moose feeding on feltleaf willow shoots in the area of the pond complex (Photo 4).

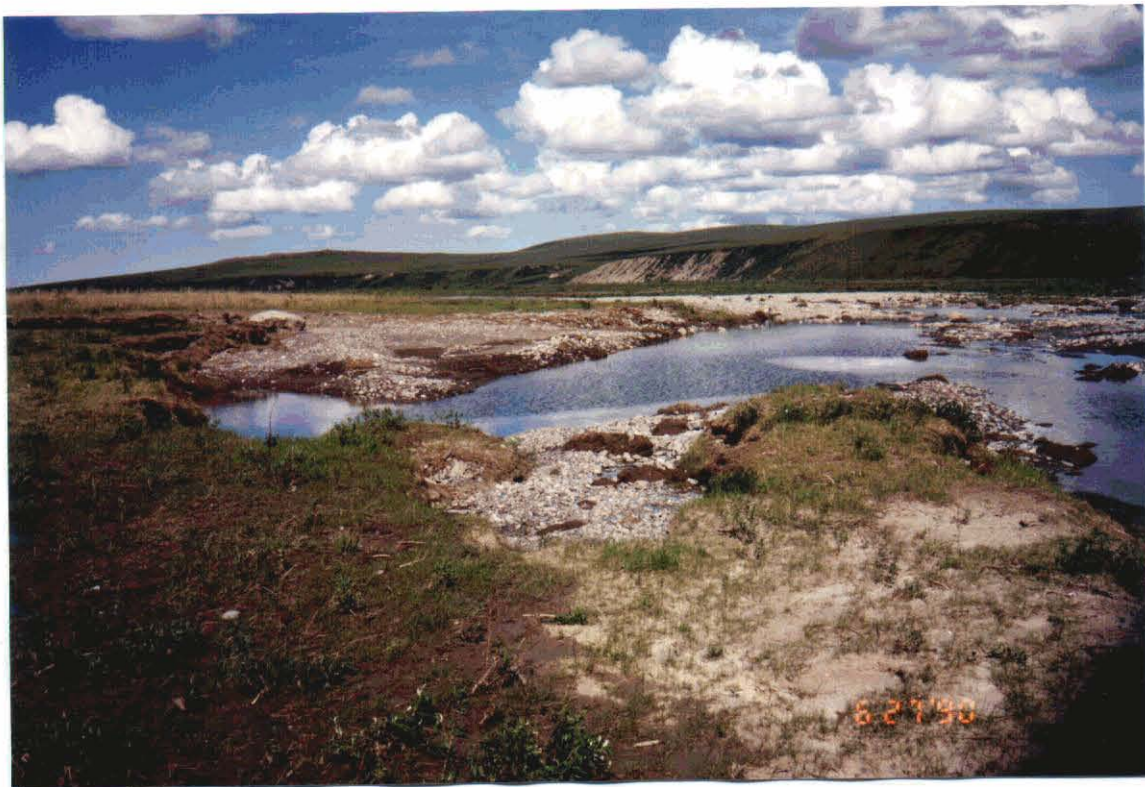
Photograph 6. Typical erosion in the southern half of the site from the 1990 spring flood. (Photo by J.F. Winters)

In addition to the effects of sedimentation, scour and erosion modified extensive areas of Goose Green Gulch. An extensive area of cobble and boulders up to 75 m (245 ft) wide begins where floodwaters entered the site at its southern end (Photos 5 and 6). This disturbed area extends to the pond complex. Scour holes up to 1.2 m (4 ft) deep occur along the western edge of the disturbed area. Floodwaters leaving the site along the northeast site boundary also removed a portion of the willow buffer/transition zone such that the site now almost merges directly with the sparsely vegetated gravel bar to the east. Floodwaters also widened the outlet channel from about 5 m (16 ft) to about 15 m (50 ft) for much of its length.

The extensive erosion within the site from the 1990 spring flood suggests the site is becoming less stable. Should erosion continue, Goose Green Gulch likely will be bisected longitudinally by a newly formed channel of the Sagavanirktok River (see photo 5). The rate at which this site transformation occurs will depend on the frequency, timing, and severity of flood events. The vegetated buffer along the southeastern border of the site probably moderates the effects of flood events through stabilization of the streambank and by decreasing the velocity of a portion of the floodwaters flowing through the site during a flood event. Construction of an erosion-control structure along the southeastern border of Goose Green Gulch, along with blockage of the slough forming the southern boundary of the site, could reduce or eliminate erosion within Goose Green Gulch's boundaries. Such a structure, however, may require yearly maintenance, considering the magnitude of flood events of the Sagavanirktok River in this portion of its drainage.
