# **FISH USE OF CROOKED CREEK AFTER REMOVAL OF A FISH BARRIER**

**Technical Report 95-1**

**Alaska Department of Fish and Game  
Habitat and Restoration Division**

**January 1995**

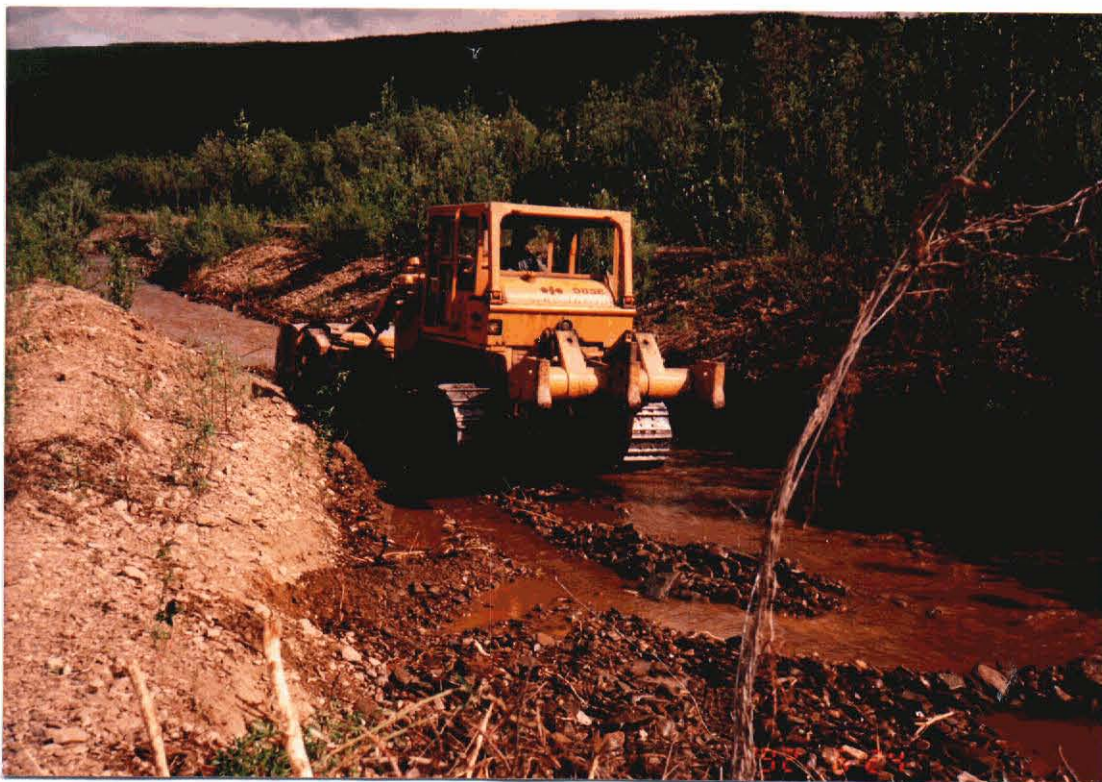
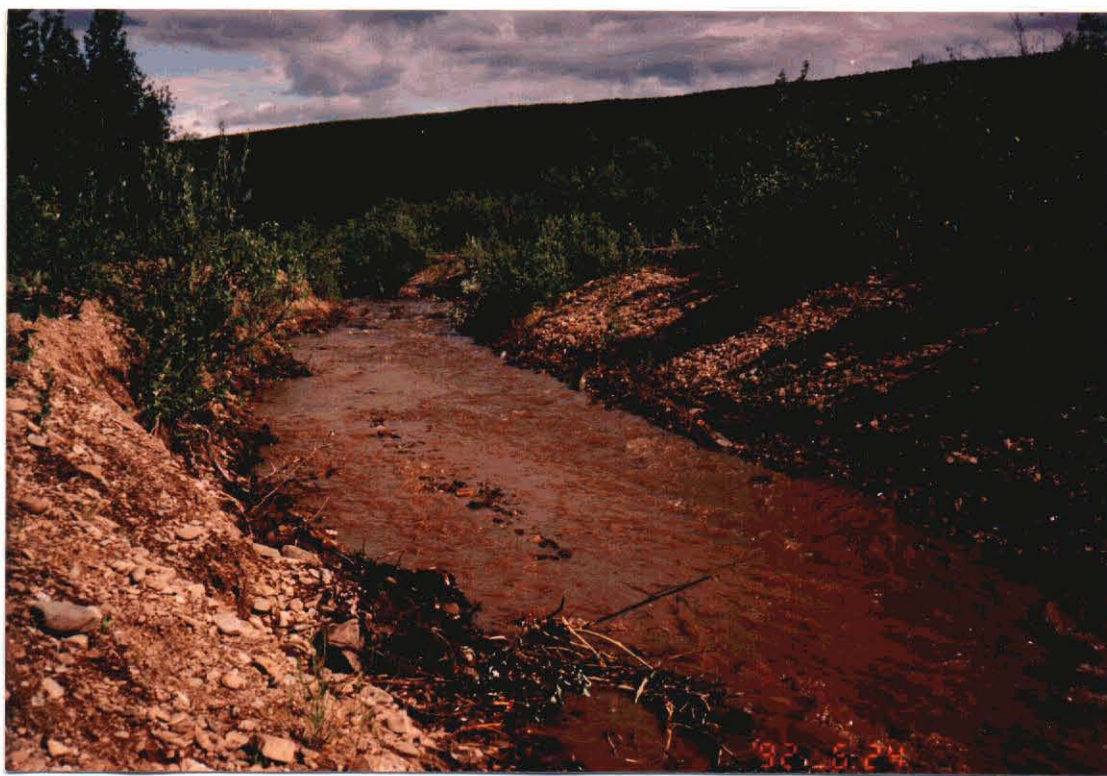
Figure 2. Dozer removing gabion structure from Crooked Creek (top photo) and sample reach #2 following completion of instream work (bottom photo).

Rehabilitation work in Crooked Creek was initiated by the University of Alaska Fairbanks as mitigation for an unauthorized wetland fill associated with the Poker Flats Rocket Research Site. Rehabilitation of Crooked Creek began on June 23, 1992, and was complete by the 24th (Figure 2). About 168 m of stream channel were ripped with a Komatsu 85E dozer to destroy gabion baskets and to remove the fish barrier. Total instream time was 3.5 hours. Gabion wires were bladed to the downstream end of the work area and removed. The fish block at the upstream end of the work area was ripped and bladed to remove the 1 m vertical waterfall. Upon completion of ripping, a pilot channel was constructed by angling the dozer blade creating a channel along the left limit of the creek. The stream channel was bladed extensively to distribute the 1 m vertical change in water elevation over a distance of about 91 m. Gabion wires remaining in the channel were clipped and removed manually. Water quality in Crooked Creek was highly turbid during instream dozer work but was clear within 20 minutes after dozer activity was complete. Willows uprooted during the instream work were left in the stream channel. Pool habitat that existed prior to rehabilitation work was changed to shallow-riffle habitat.
