**Technical Report No. 11-10**

# **Haines Highway Mile 25 to the Border: 10-Year Mitigation Monitoring**

Alaska Department of Fish and Game

Division of Habitat

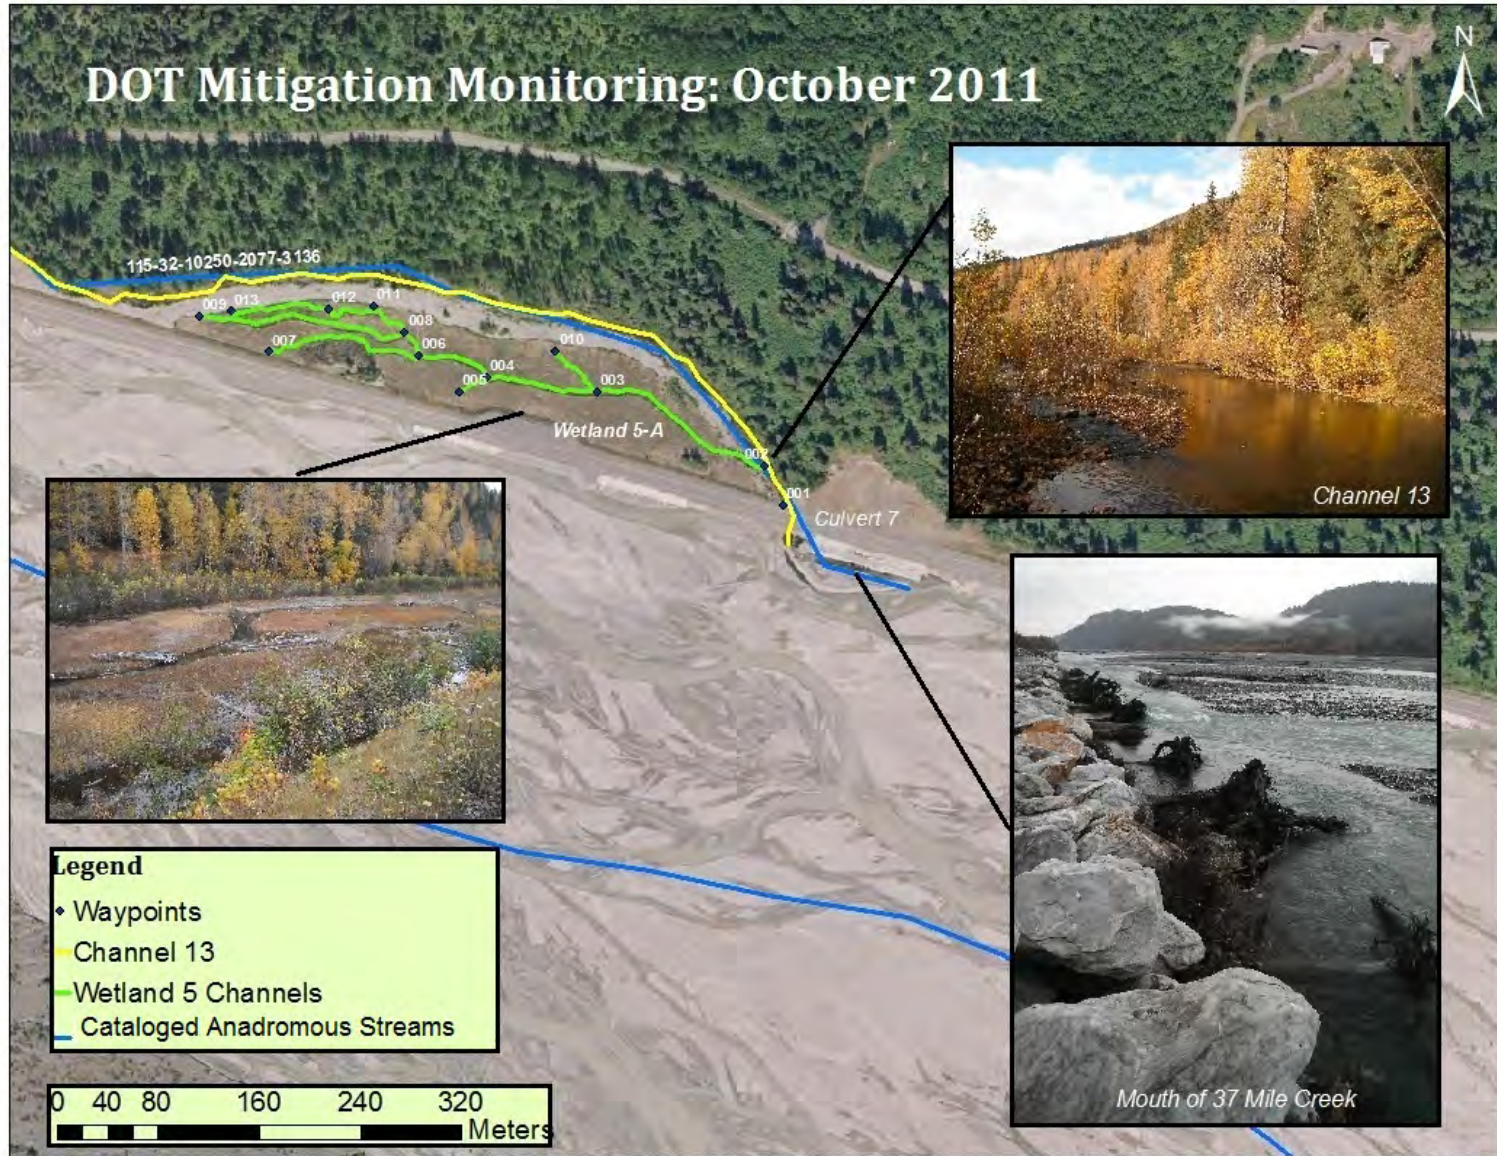
Figure 3.-WT-5 Section A map.

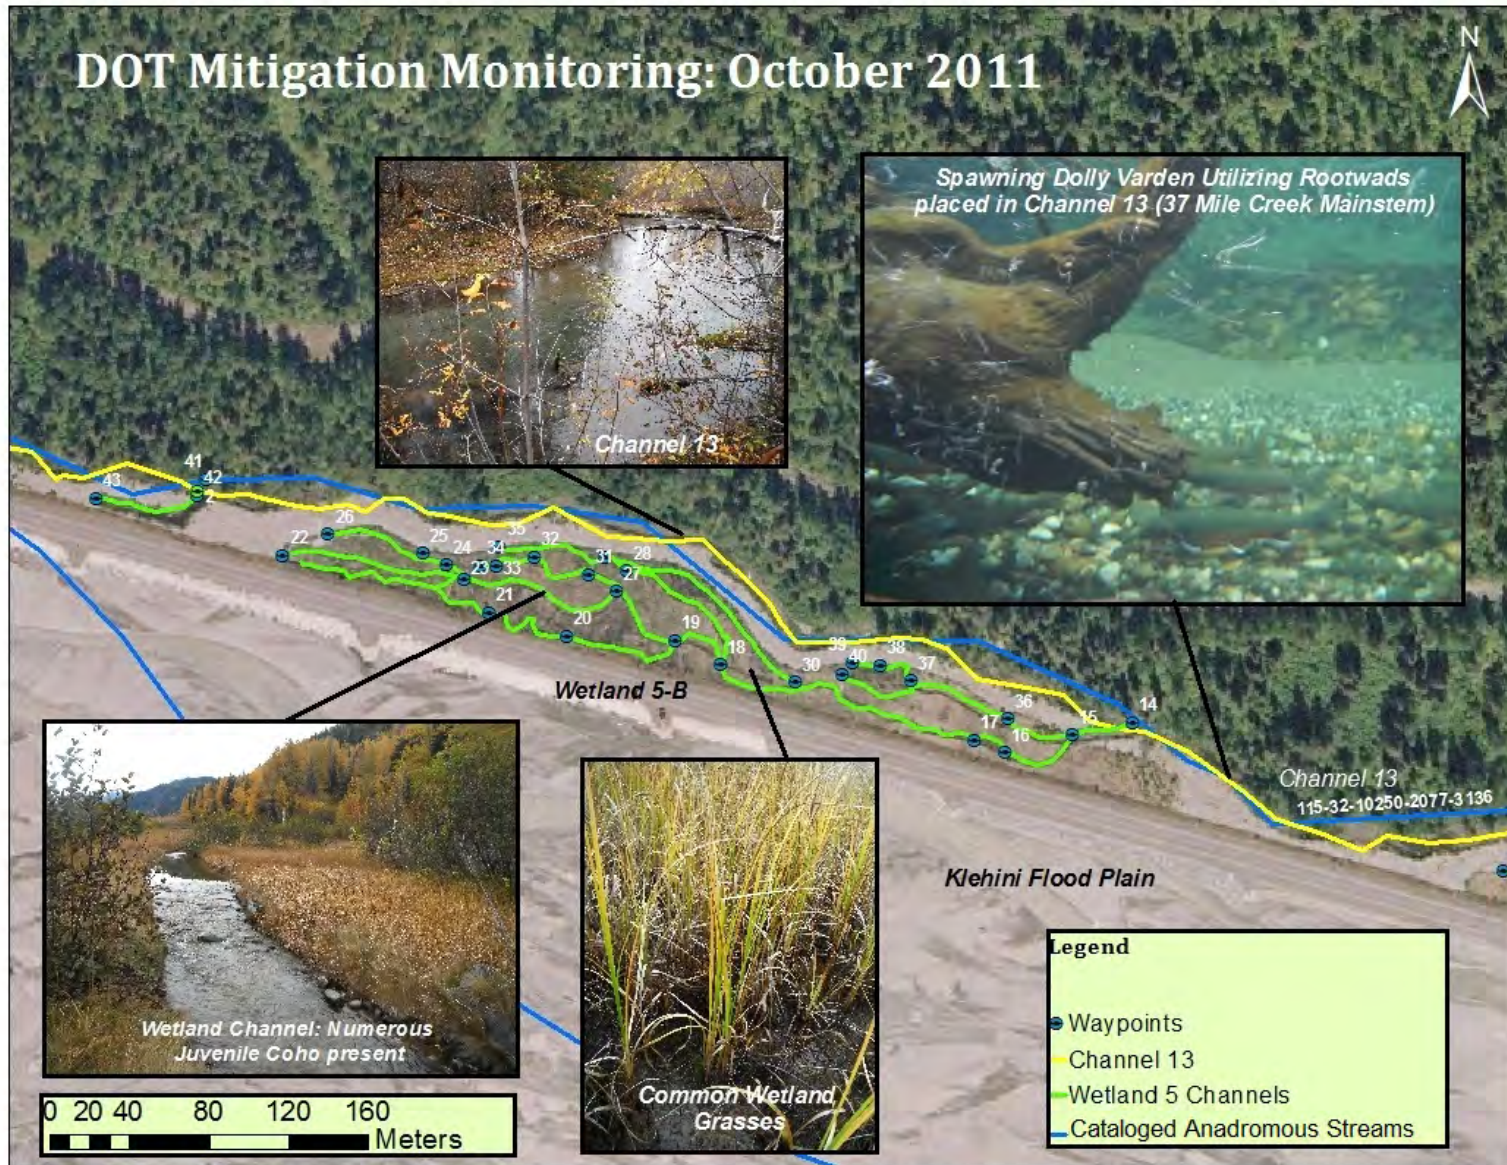
Figure 4.-WT-5 Section B map.

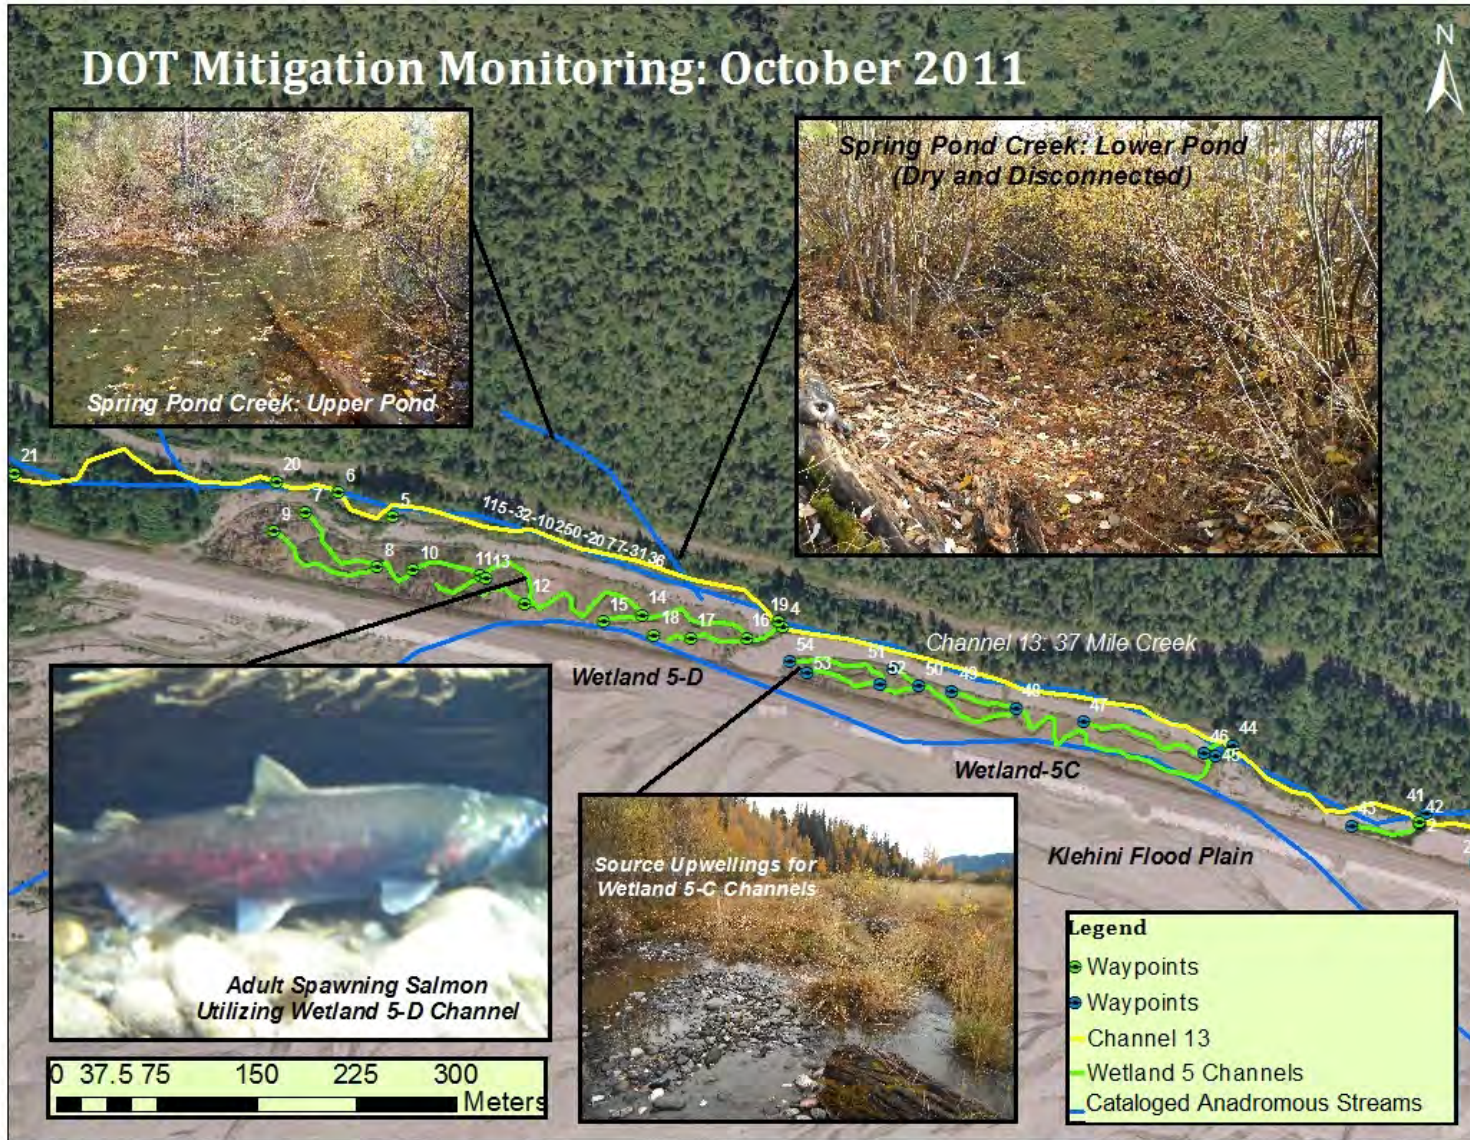
Figure 5.-WT-5 Section C and D map.

We documented fish presence in WT-5 in all of the stream channels during both the June and October surveys. During the October survey, we observed thousands of juvenile salmonids in the channels. We observed one adult coho salmon in a stream channel of wetland 5-D (Figure5). During the June survey, we captured juvenile fish with a net for identification. We visually observed salmonids in the stream channels during October foot surveys. Table 2 outlines fish capture data from the June survey.

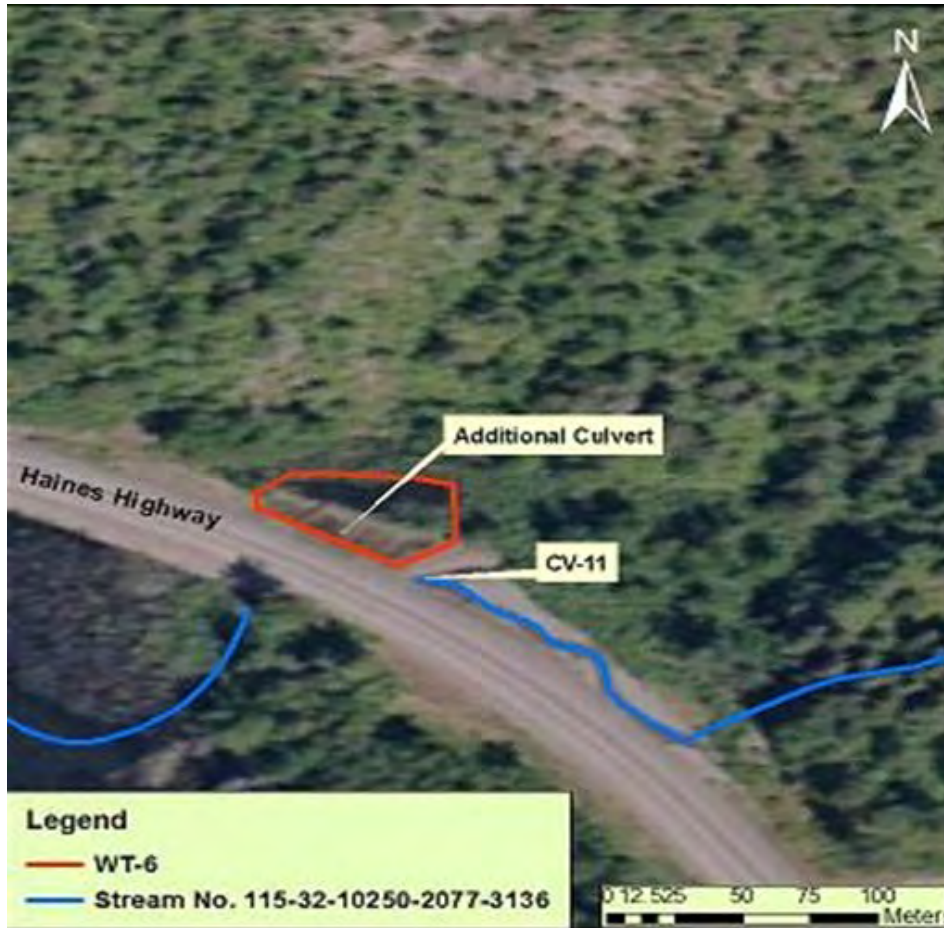
Figure 7.—Map of WT-6.

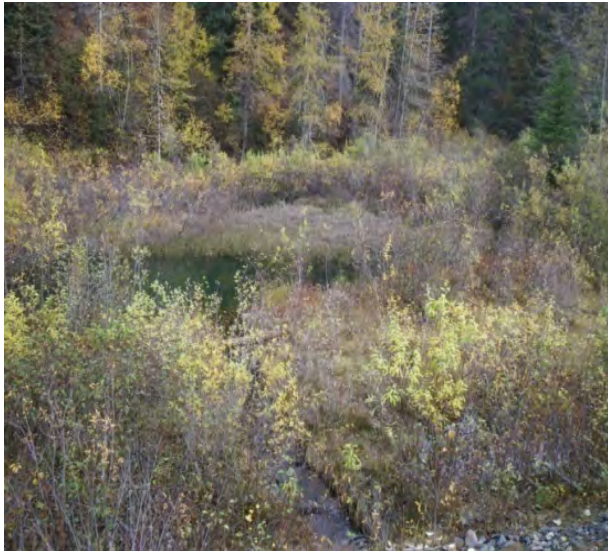
We documented vegetation cover and ground saturation during our survey of wetland WT-6. Grasses and deciduous shrubs are well established in WT-6 (Figure 8). A smooth walled plastic culvert (approximately 24 inches) under the highway drains a small pond in the center of WT-6. The culvert drains into another wetland/ pond area (37 Mile Creek) on the southwest side of the highway. WT-6 is separated from 37 Mile Creek by a large berm, and groundwater is the primary source of water in the wetland.

Figure 8.—WT-6.

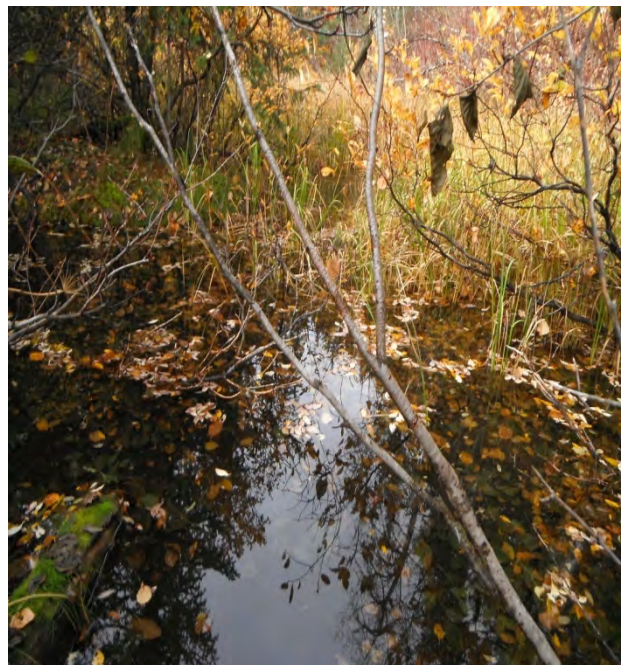
During our survey the water level in CH-18 was very low (Figure 18), and we did not observe salmonids. We placed a baited minnow trap in the channel for approximately 4 hours and did not capture any salmonids. Riparian vegetation along CH-18 is very thick with deciduous trees and shrubs. The streambed in CH-18 is comprised of sand and organics, except for a gravel area near the inlet to culvert CV-10. The channel drains 37½ Mile Pond (Stream No. 115-32-10250-2077-3136-4018-0010; Figure 19) located just upstream.

Figure 19.—37½ Mile Pond upstream of CH-18.

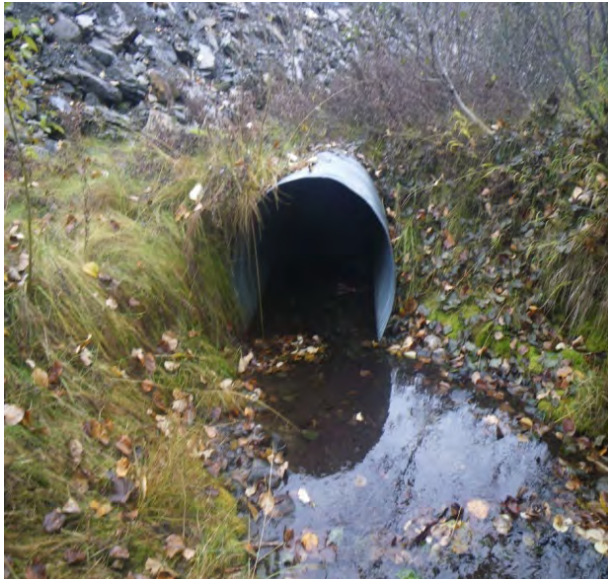
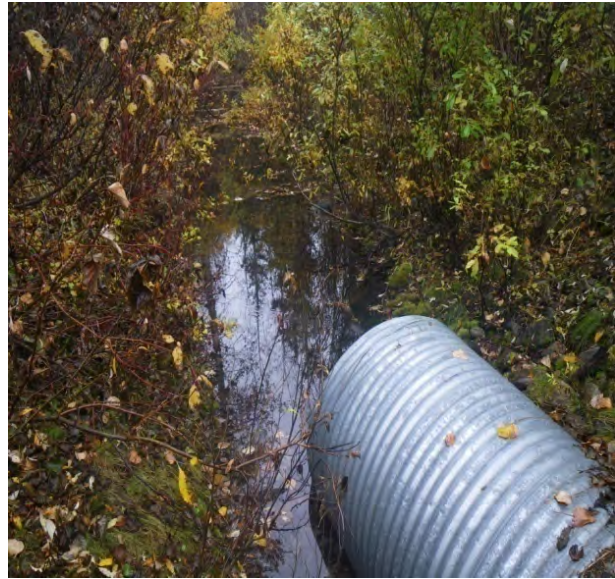
Streambed material within culvert CV-8 (Figure 26 and 27) is comprised of sand and organics, and appears to be stable. The culvert is the appropriate size for the stream, and water velocity through the culvert does not appear to change or represent a fish passage barrier. We set baited minnow traps near the culvert inlet and outlet for 24 hours and captured 5 Dolly Varden char (45–100 mm) and 2 coho salmon (50 mm) near the inlet, and 41 coho salmon (40–75 mm) near the outlet.

The mitigation objective for culvert CV-8 has been achieved. The culvert provides fish passage, and currently there are no recommendations to modify the CMP.

Figure 26.–Culvert CV-8 inlet.

Figure 27.–Culvert CV-8 outlet.

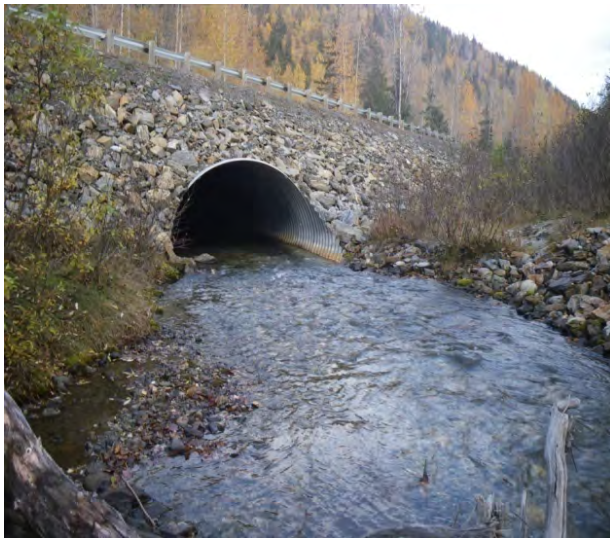
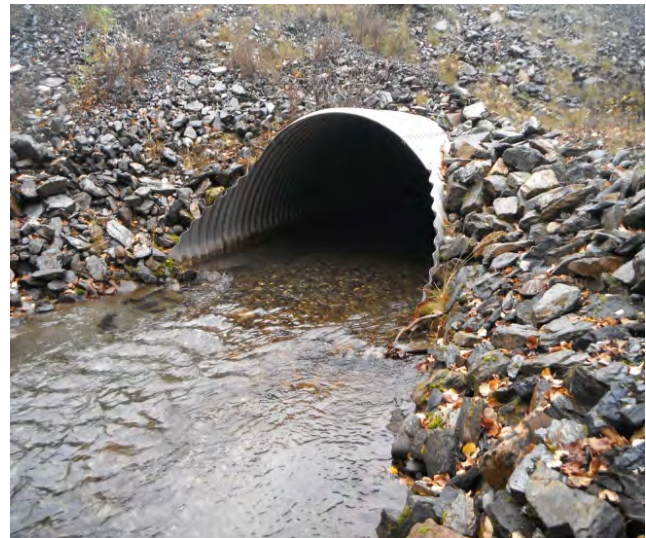
Culvert CV-9 is a 126-foot long by 14-foot 3-inch wide by 9-foot 7-inch high aluminum structural plate pipe arch culvert (Figure 28 and 29). The culvert is located on 37 Mile Creek, connecting stream channels CH-14 and CH-15. ADOT&PF placed approximately 1 foot 6 inches of class I riprap topped with 6 inches of gravel in the culvert. A bypass channel located near the inlet to CV-9 (stream channel CH-15) limits flood flows through the culvert.

Figure 28.–Culvert CV-9 inlet.

Figure 29.–Culvert CV-9 outlet.

The mitigation objective for culvert CV-9 has been achieved. There is a potential for increased water velocity during high water to limit juvenile fish passage through the culvert. We recommend habitat biologists return to culvert CV-9 during high flows to re-survey the culvert.

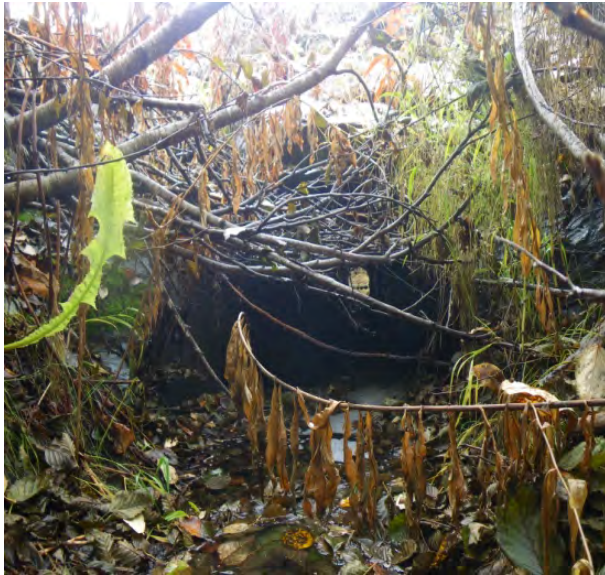
Culvert CV-10 is a 100-foot long by 54-inch wide CMP (Figure 30 and 31). The culvert is located on 37½ Mile Creek, directly downstream of stream channel CH-18. ADOT&PF placed approximately 1 foot of class I riprap topped with 6 inches of gravel in the culvert.

Figure 30.–Culvert CV-10 inlet.

Figure 31.–Culvert CV-10 outlet.

During our survey we were unable to determine if the mitigation objective for culvert CV-10 has been achieved. We recommend habitat biologists return to survey the culvert when water levels are higher.

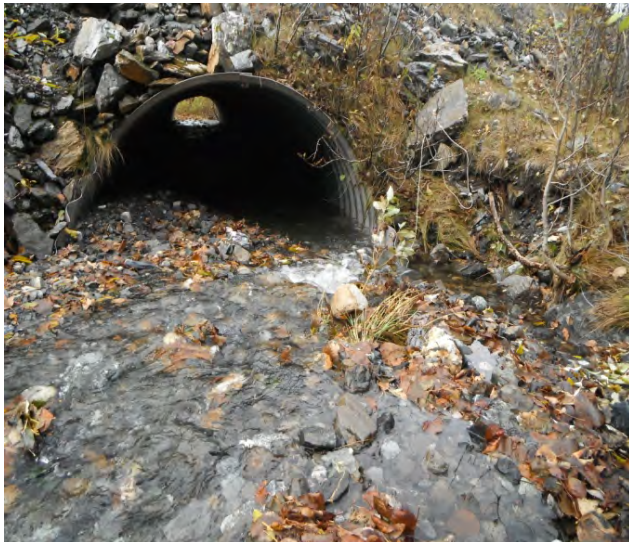
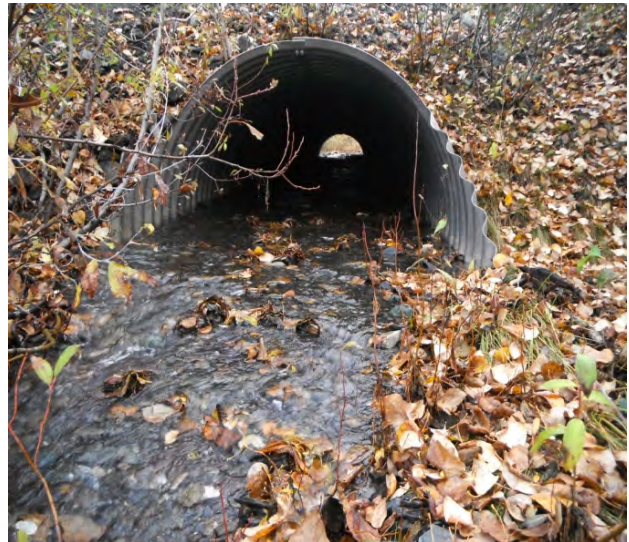
Culvert CV-11 is a 100-foot long by 9-foot wide CMP (Figure 32 and 33). The culvert is located on 37 Mile Creek, adjacent to wetland WT-6. ADOT&PF placed approximately 2 feet of class I riprap topped with gravel in the culvert.

Figure 32.—Culvert CV-11 inlet.

Figure 33.—Culvert CV-11 outlet.

During our survey we were unable to determine if the mitigation objective for culvert CV-11 has been achieved. We recommend habitat biologists return to the site to survey the culvert again before we determine if the mitigation objective has been met.
