# Appendix: Skagway

## Guide to direct fieldwork for cataloging anadromous water bodies in Southeast Alaska

## SKAGWAY SURVEYS

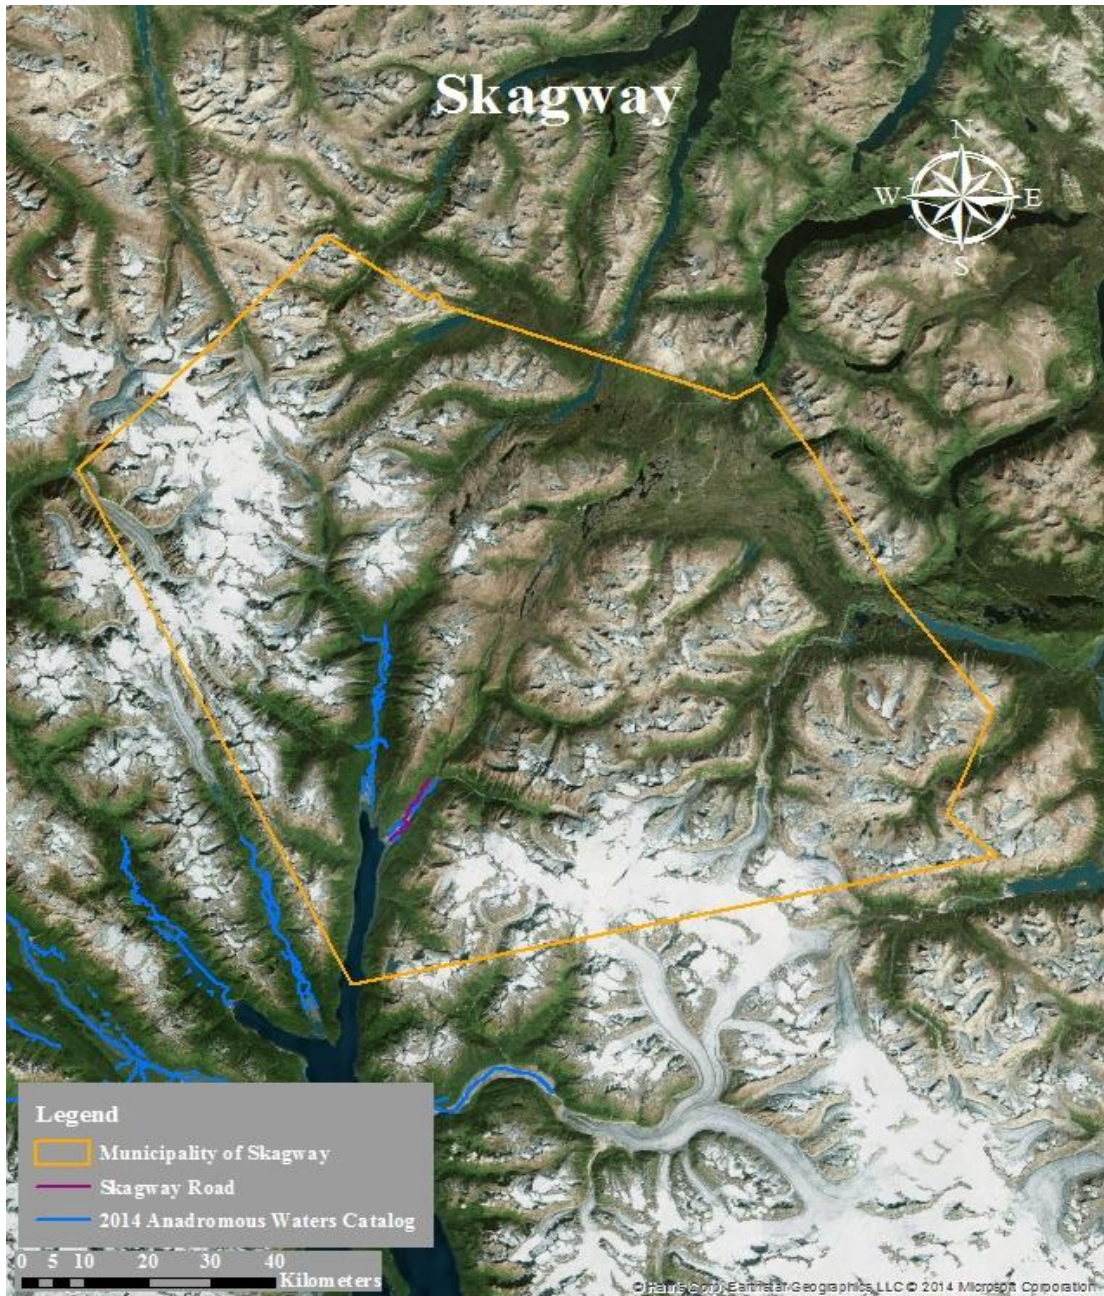
Figure 1.—Skagway survey map.

Skagway, population 1,031, is located 90 miles northeast of Juneau at the northernmost end of Lynn Canal, at the head of Taiya Inlet, and just west of the Canadian border with British Columbia (Figure 1).<sup>1</sup>

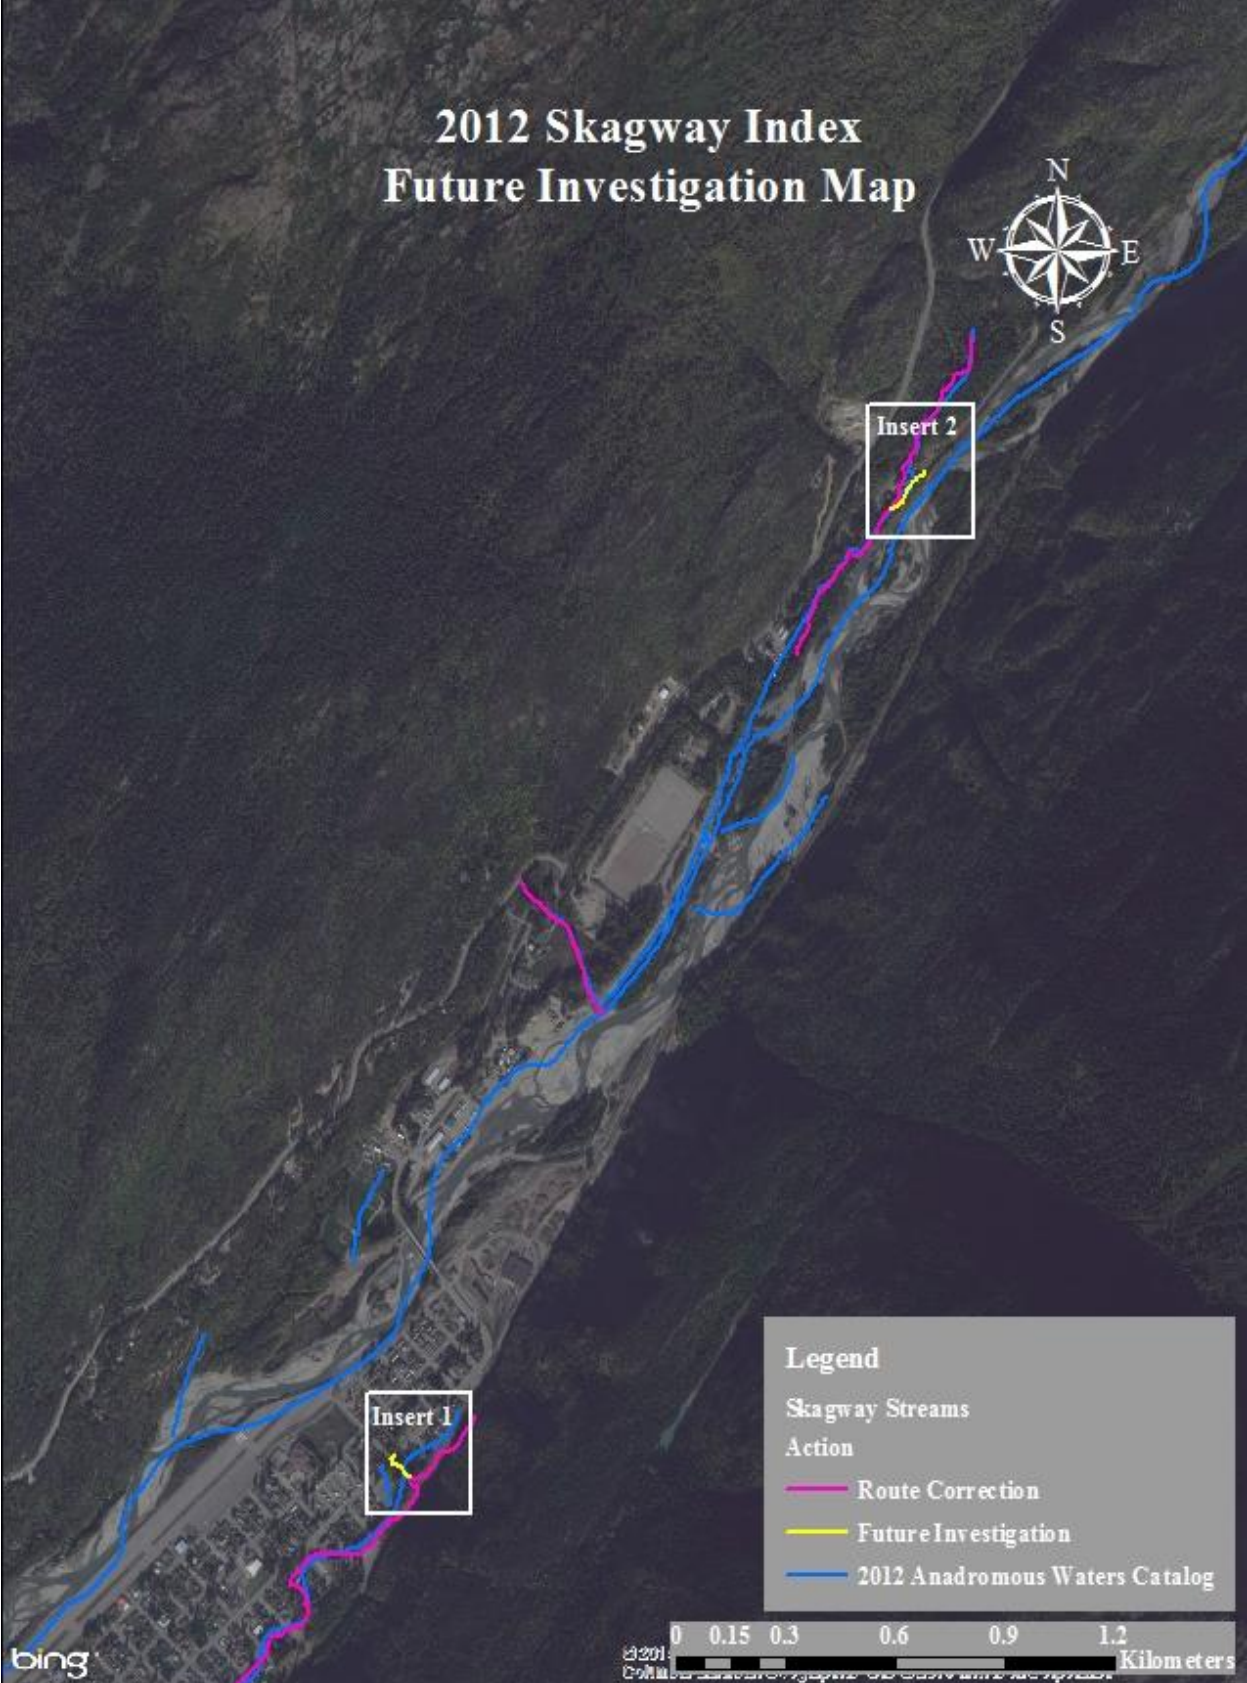
Figure 1.-2012 Skagway index future investigation map.

## SKAGWAY STREAMS REQUIRING FUTURE INVESTIGATION

Table 1.—Start points of Skagway streams requiring future investigation.
