TECHNICAL REPORT NO. 24-02

EKLUTNA RIVER AQUATIC HABITAT MONITORING 2021-2023

Alaska Department of Fish and Game
Habitat Section, Anchorage
333 Raspberry Rd., Anchorage, AK 99518

January 2024

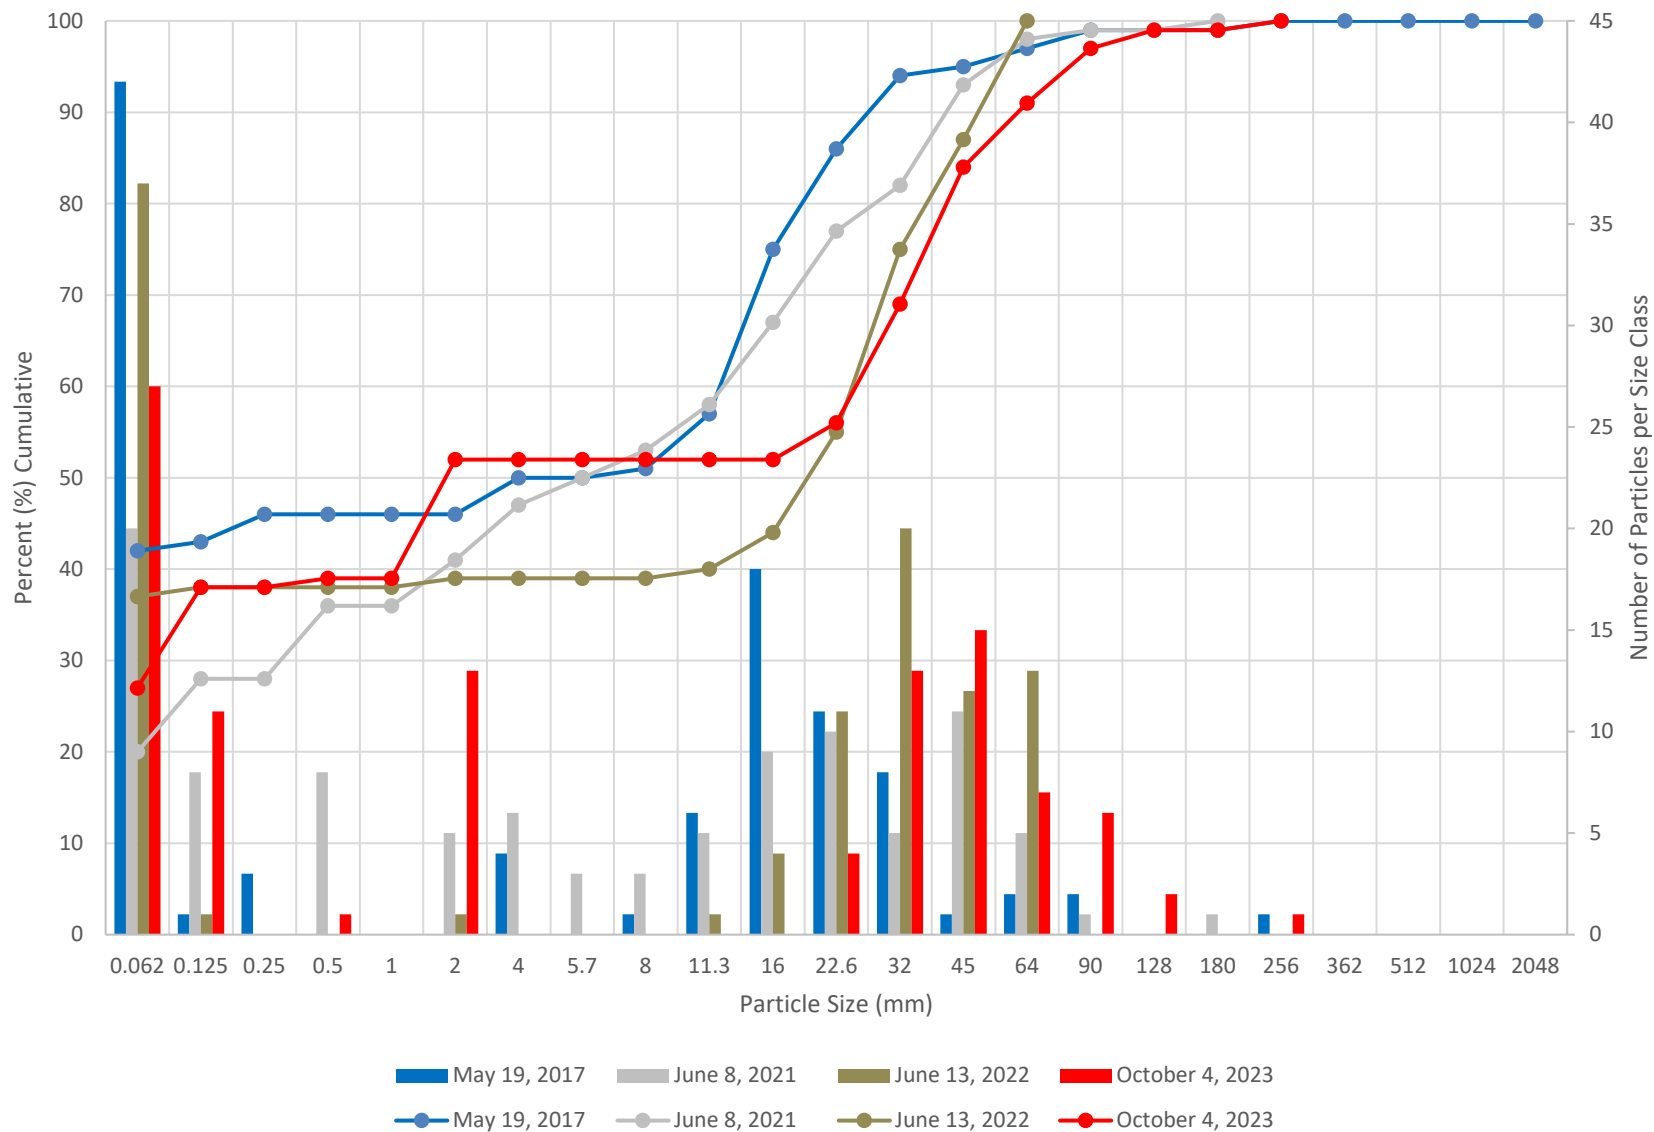
Eklutna Cross Section 2U Substrate Composition

At the monitoring site located above the deconstructed lower dam (Eklutna 2U) scouring of the bed was observed compared to the 2017 survey conducted prior to the lower dam deconstruction. There was a slight change in the channel dimensions at this location after the controlled flow releases in 2021. Between 2021 and 2023 there was a slight decrease in the D_{50} particle size after an increase in 2022 while the D_{84} particle size remained categorized as very coarse gravel. Particle sizes and channel dimensions were similar between 2022 and 2023. Water quality at this site were generally un-noteworthy, however pH was consistently high, ranging from 8.10 to 8.62. At monitoring site Eklutna 6 (site just below the deconstructed dam site), the channel aggraded nearly two feet in over half the channel between 2017 and 2023. More sand and gravel sized particles were observed in 2023 as compared to 2017. There was a slight increase in D_{50} substrate size but a slight decrease in D_{84} substrate composition. This is likely the result of the removal of the lower dam and controlled flow releases in the fall of 2021. No changes of note were observed between 2022 and 2023. Water quality at this site was generally un-noteworthy; however, pH was consistently high, ranging from 8.10 to 8.70.

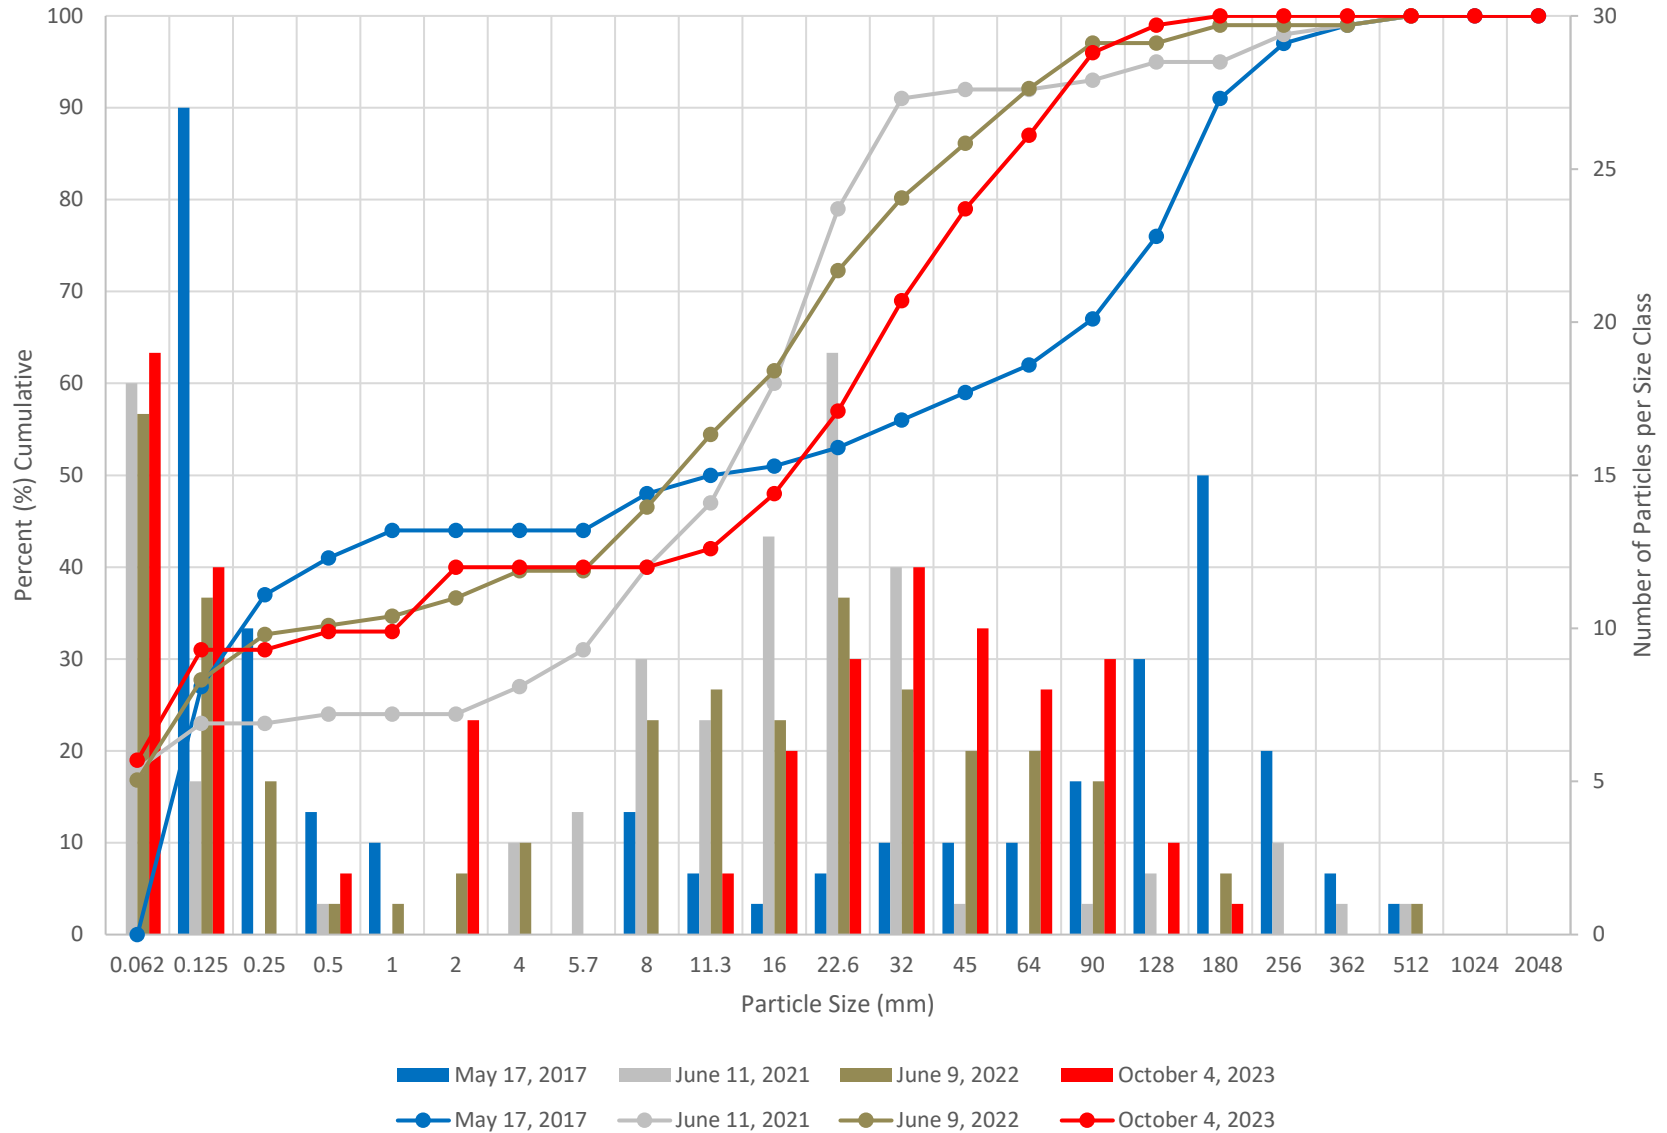
Eklutna Cross Section 6 Substrate Composition

This cross section showed the most changes after the lower dam removal in 2018 and after the controlled flow releases. Significant aggradation occurred in the main channel at this monitoring location downstream of the former dam site. About two feet of material aggraded in the main flow channel which caused the bankfull width to decrease and the bankfull elevation to increase. The aggradation pushed the channel to the left bank (looking downstream) and created a side channel on the right bank. Very little changed at this cross section between 2022 and 2023 after returning to a continuous low-flow regime.

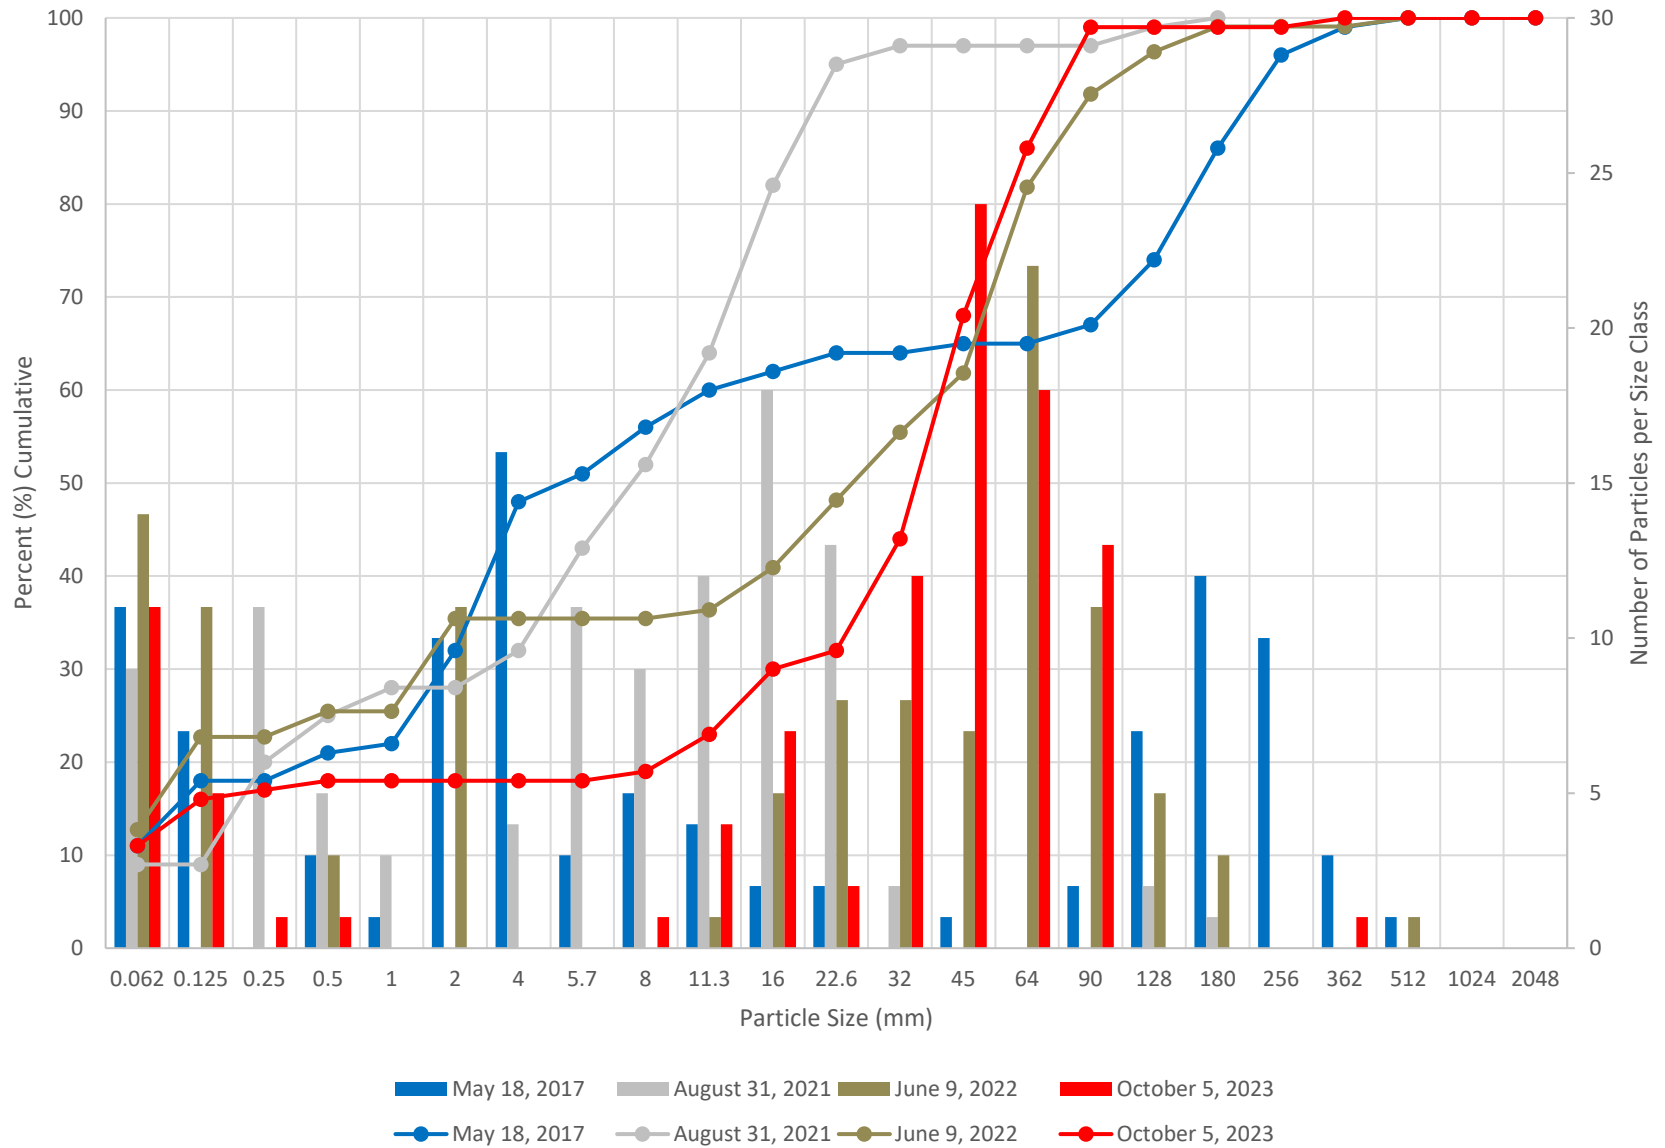
Eklutna Cross Section 8 Substrate Composition

The channel cross-section at monitoring site 8 showed about a foot of aggradation between pre- and post-lower dam removal with minor changes observed after the controlled flow releases. Aggradation occurred at the site which increased both the bankfull width (+3.7 feet) and the bankfull elevation (+0.2 feet) between 2021 and 2023. The channel thalweg elevation increased but remained in the same location. Minor aggradation occurred between 2022 and 2023 at this cross section after returning to a continuous low-flow regime.

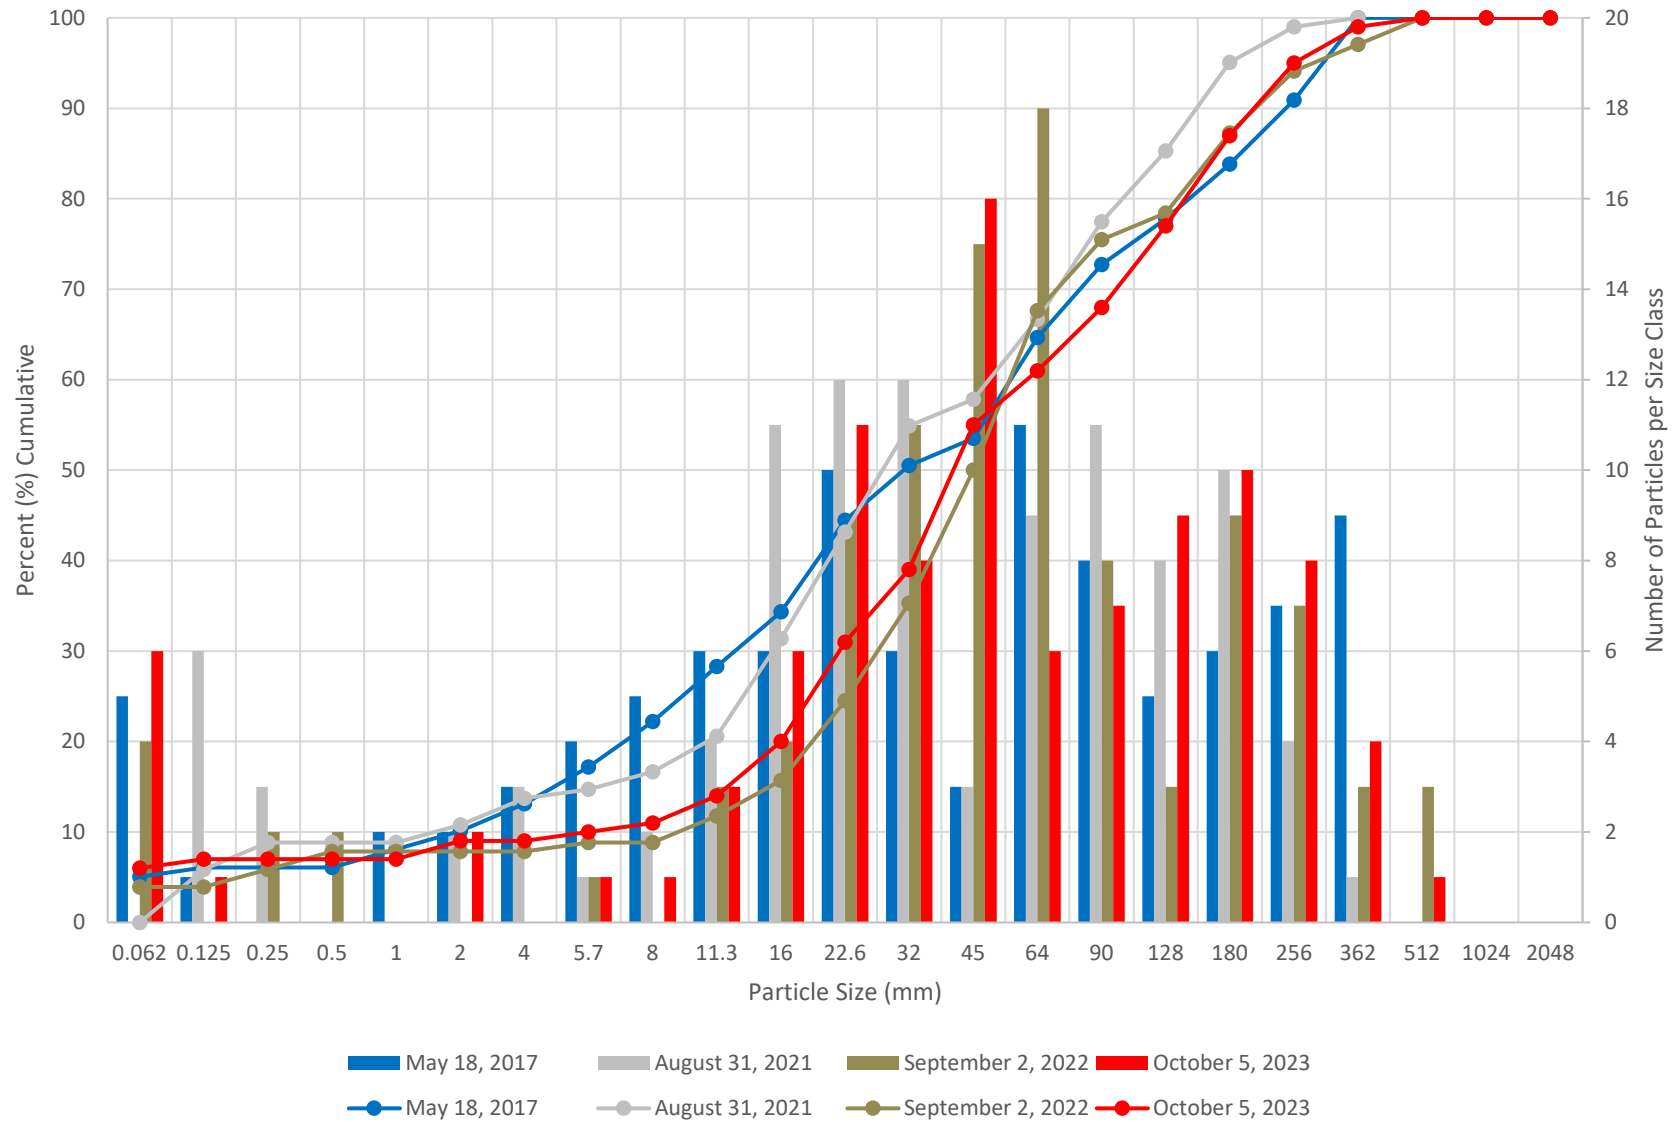
Eklutna Cross Section 10 Substrate Composition

The channel cross section at this monitoring location showed very minor changes throughout the monitoring period. There was some aggradation and minor scour after the controlled flow releases, but the bankfull elevation, bankfull width, and thalweg remained relatively unchanged. The aggregation on the left bank scoured out, returning to pre-controlled flow release conditions, between 2022 and 2023.
