## Nomination Form Anadromous Waters Catalog

## 111-50-10680 Tributary 1

**ADDITION**

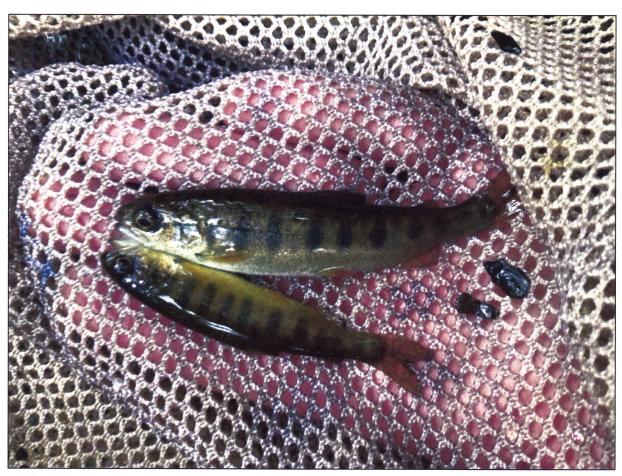
Figure 1.–Juvenile coho salmon captured at waypoint 1039.

Findings: We surveyed this uncataloged stream using a backpack electrofisher and GPS and captured juvenile coho salmon. The stream has marginal habitat upstream of a small culvert where the channel becomes overcrowded by woody debris, but has quality rearing habitat

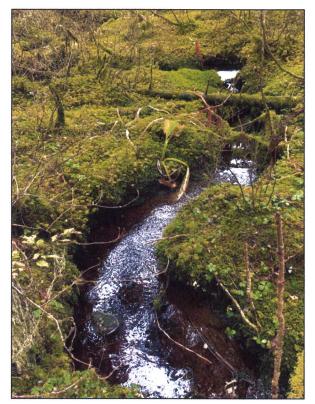
Figure 2.—Tributary 1 at waypoint 1040.

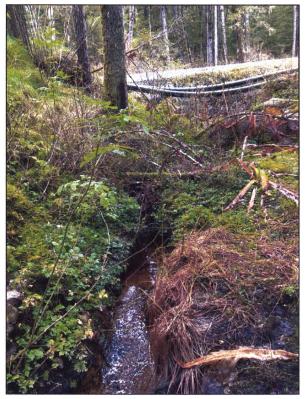
Figure 3.—Overcrowded channel just downstream of culvert outlet at waypoint 1041.

Waypoint Latitude Longitude	Latitude	Longitude	Notes	Stream	Stream	Habitat	Gradient	Sample	Sample
			Width ft	Substrate	Features	%	Effort	Results	
1041	58.339455	-134.584845	Continued CO capture	1-2	Small Gravel	Cut	2-4	EF	2 CO
			~15' downstream of		Fine Organic	Banks			
			culvert at road crossing.			SWD			
			Quality rearing habitat						
			persists up to this point,						
			interspersed with small						
			stretches of subterranean						
			flow. Between here and						
			culvert outlet, the channel						
			is overcrowded by						
			overgrown roots, brush,						
			and riprap nearer outlet.						
			Marginal habitat upstream						
			of pipe. Shocked several						
			pools upstream of pipe; no						
			fish observed.

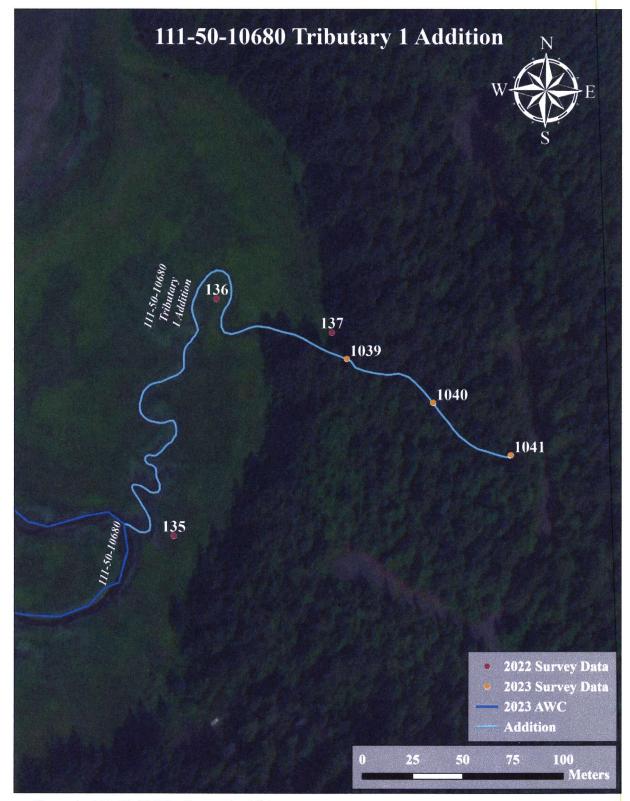
Figure 4.–111-50-10680 tributary 1 addition map.

Recommendations: Add this uncataloged stream to the anadromous waters catalog for rearing

coho salmon (Figure 4). Nomination: Pending
